2019 CENTRAL MARCO BEACH REGRADE PROJECT 2.5-YEAR MONITORING SUMMARY

DEP PERMIT 0235209-008-JM USACOE PERMIT SAJ-2016-01224(IP-WDD)

PREPARED BY
HUMISTON & MOORE ENGINEERS
HM File No. 23065

2019 CENTRAL MARCO BEACH REGRADE PROJECT 2.5-YEAR POST-CONSTRUCTION MONITORING SUMMARY

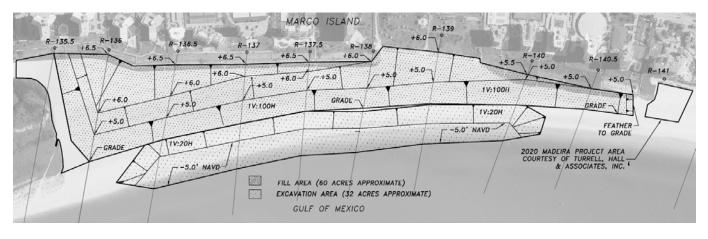
Figure 3. Central Marco Island Regrade Project - 2019 Design Plan

The 2019 project, shown in **Figure 3**, included the regrading of the beach from monument R-135.5 south to R-140.8, and the excavation of the shoreline swash zone region to -5 feet NAVD to provide the sand needed to improve and build the beach profile. This regrade and building of the beach profile established an intermediate berm with a progressive seaward slope to reduce ponding by creating an approximate landward elevation of 6.5 feet NAVD along the dune area generally descending to approximately 3 feet NAVD at the seaward edge, and a foreshore slope of 1:20 vertical to horizontal to -5 feet NAVD. The area of excavation was an area experiencing accretion, as the proposed excavation restored the seaward slope to an approximate 2009 condition. Also, the north and south ends of the area of excavation were offset from the ends of the grading area to minimize the potential for impacting adjacent areas.

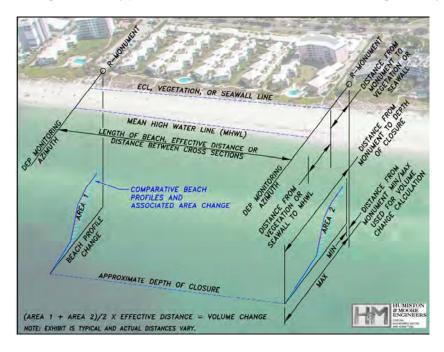
Figure 5. Schematic Diagram for Typical Shoreline and Volumetric Change Analysis

Figure 5 is a schematic depiction of the elements involved in the analysis of shoreline and volume change in this report. Two adjacent DEP reference monuments and associated monitoring azimuths are shown along with the mean high-water line (MHWL), and approximate depth of closure (DOC). Also shown are comparative beach profiles at the adjacent monuments and the associated area change between the monitoring survey profiles to be compared. Shoreline change is the difference in the beach width for different monitoring surveys. Volumetric change, determined by the formula shown (at the bottom of the figure) for the average end area method, utilizes the cross-sectional area change for different monitoring surveys at adjacent monuments and the length of beach between those monument profiles. The comparative profiles are analyzed from the post-construction vegetation line to the approximate (DOC) as shown in the figure.
