**2020 SOUTH MARCO BEACH NOURISHMENT PROJECT
TWO-YEAR POST-CONSTRUCTION
ANNUAL MONITORING SUMMARY**

April 2022

**DEP PERMIT 0235209-008-JC
USACOE PERMIT SAJ-2005-2726(SP/MOD-MMB)**

PREPARED BY
HUMISTON & MOORE ENGINEERS
HM File No. 29018

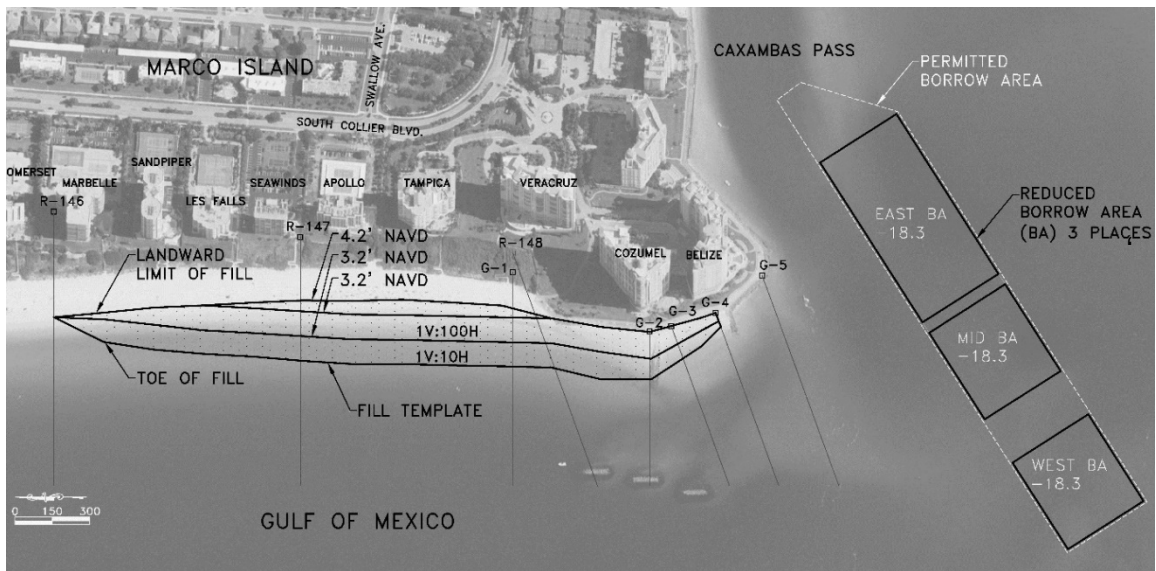
Figure 3a. 2020 Design Plan

On April 9, 2020 the 2020 South Marco Island Beach Nourishment Project, shown in **Figure 3a**, was completed placing approximately 79,100 cubic yards of sand dredged from Caxambas Pass on the beach from monument R-146 south to G-4. Additionally, the contractor, Florida Dredge & Dock LLC, placed approximately 4,000 cubic yards of sand dredged from Caxambas Pass near monument R-141, shown in **Figure 2**, for the Madeira Condominium in coordination with the agent for the project, Turrell, Hall & Associates, authorized under DEP Consent Order OGC Case No. 19-1445 dated December 18, 2019. An onsite screening process was employed to remove shell prior to placement of the dredged material on the beach. The process removed approximately 4,800 cubic yards of shell used to improve part of the Tigertail Beach vehicle access; the balance was barged to a local barge loading/unloading area near East Marco Bay and was hauled offsite by a contractor, Earthtech Enterprises. The severance fee for the material hauled offsite was submitted to the DEP on December 7, 2020.

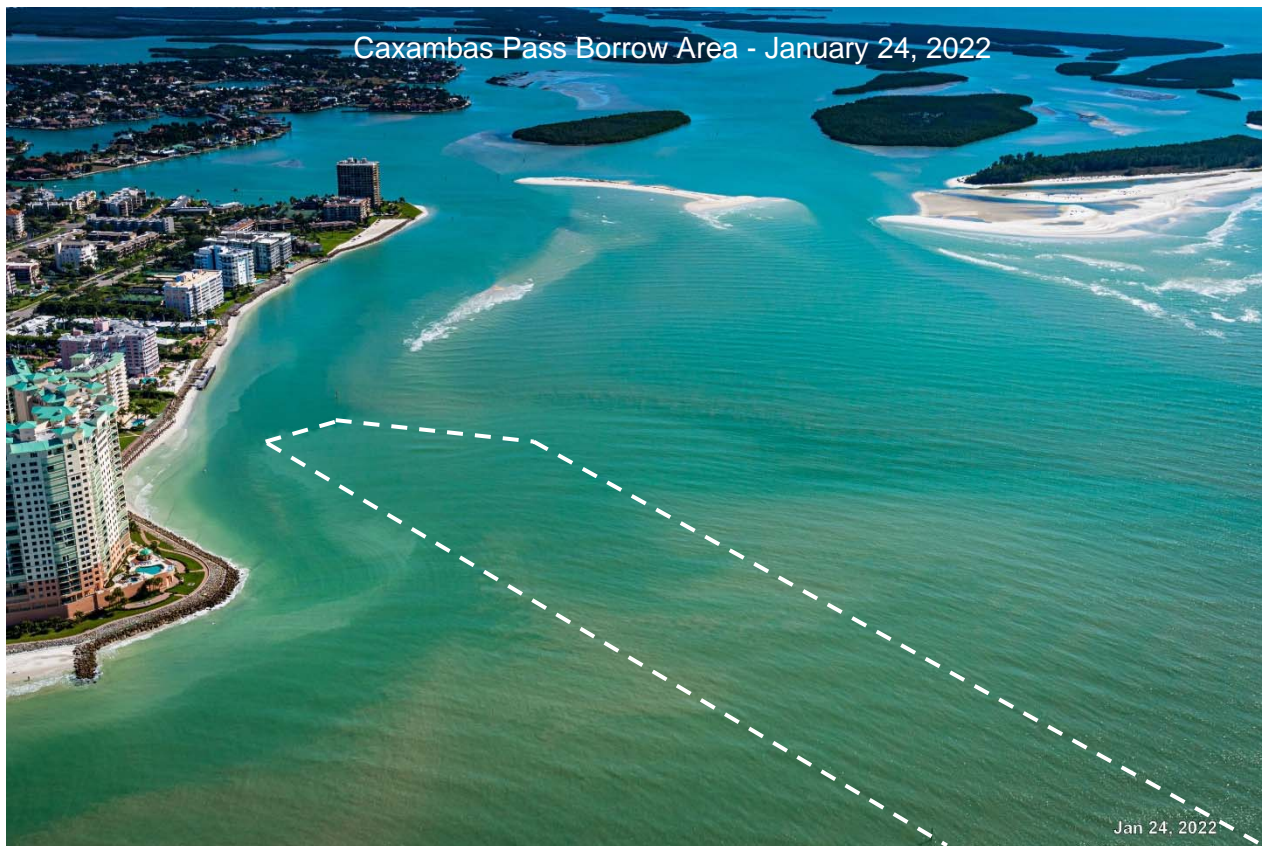
FIGURE 7a. CAXAMBAS PASS INLET PERMITTED DREDGE TEMPLATE - CONTOUR MAP APRIL 2020 (POST-CONSTRUCTION SURVEY)

The borrow area was surveyed immediately pre and post-construction in February and April 2020 respectively, and most recently in January 2022. Approximately 90,000 cubic yards of sand were dredged from the reduced borrow area (as described in the Design Plan section of this report) during the 2020 nourishment project. There is approximately 109,000 cubic yards of sand available within the permitted template based on the January 2022 survey, representing an approximate 17,000 cubic yard gain since the April 2020 post-construction survey, and an associated infilling rate of approximately 10,000 cubic yards (17,000cy/1.7yrs) per year. **Figure 7a** shows the borrow area contours immediately post-construction in April 2020, **Figure 7b** shows the contours almost two years later in January 2022, and **Figure 7c** shows the contour change from 2020 to 2022. In **Figure 7c**, darker shades of brown represent greater material accumulation while blue shades indicate loss. Much of the material remaining in the borrow area limits after project completion had a relatively higher shell content than the material placed on the beach during the 2020 project.

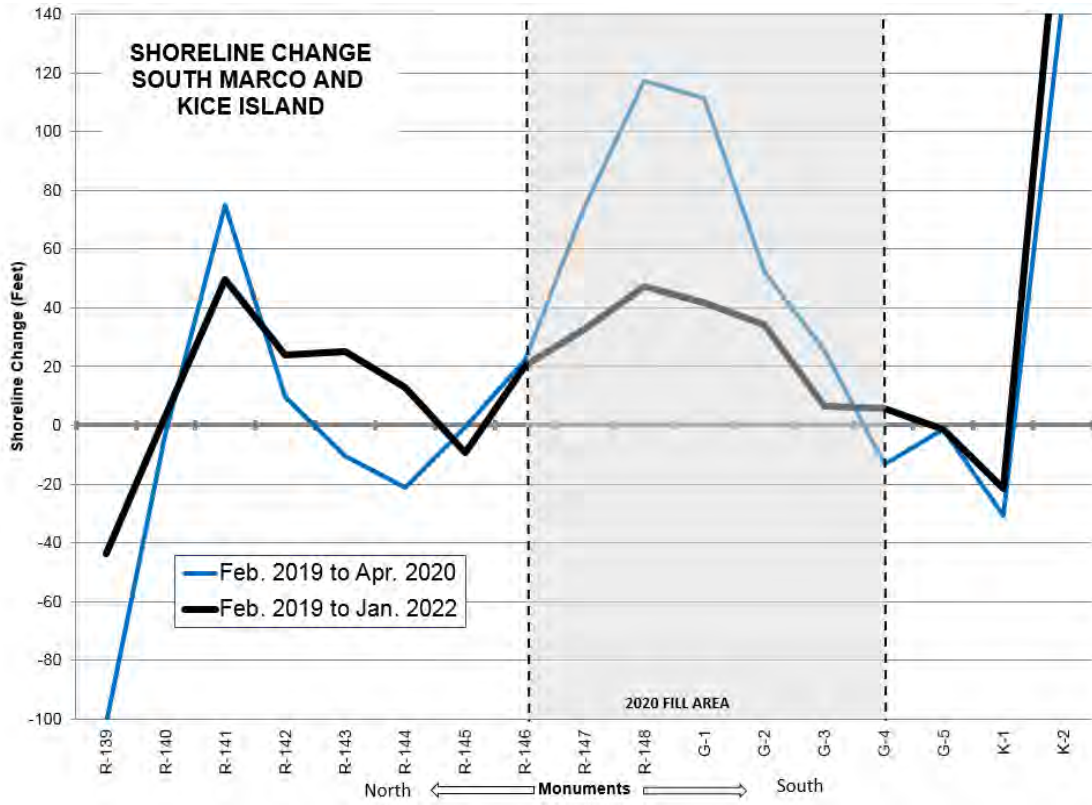
Figure 8a. Shoreline Change - DEP Monument R-139 through K-2

Shoreline change is compared in **Figure 8a** showing the change in beach width from the February 2019 pre-construction monitoring survey to the April 2020 and January 2022 post-construction monitoring surveys. The increase in beach width due to the 2020 project construction and the work near the Madeira Condominium at the south end of the 2019 beach regrade project is evident in the 2019 to 2020 plot. The same trend is shown in the 2019 to 2022 plot with a decrease in width near R-141 and R-148 and an associated increase in beach width to the south from R-142 to R-144 and from G-3 to G-4 as sand migrates southward. A similar trend is shown in **Figure 8b** depicting the volume change for the same time period and monitoring area. Note, there is an increase in volume north of the project area from R-139 south to R-146 as the regrade project area equilibrates.⁷ **Figure 8c** plots the dry beach width for the pre, post, one-year and two-year post-construction surveys. The figure shows the average beach widths for the reach: north of the project area, the project area, and Kice Island. As shown in **Figure 8a** the project area lost width. The spit off of Kice Island continues to migrate east toward the island; volume and shoreline change can be misleading but in general the island remains stable.

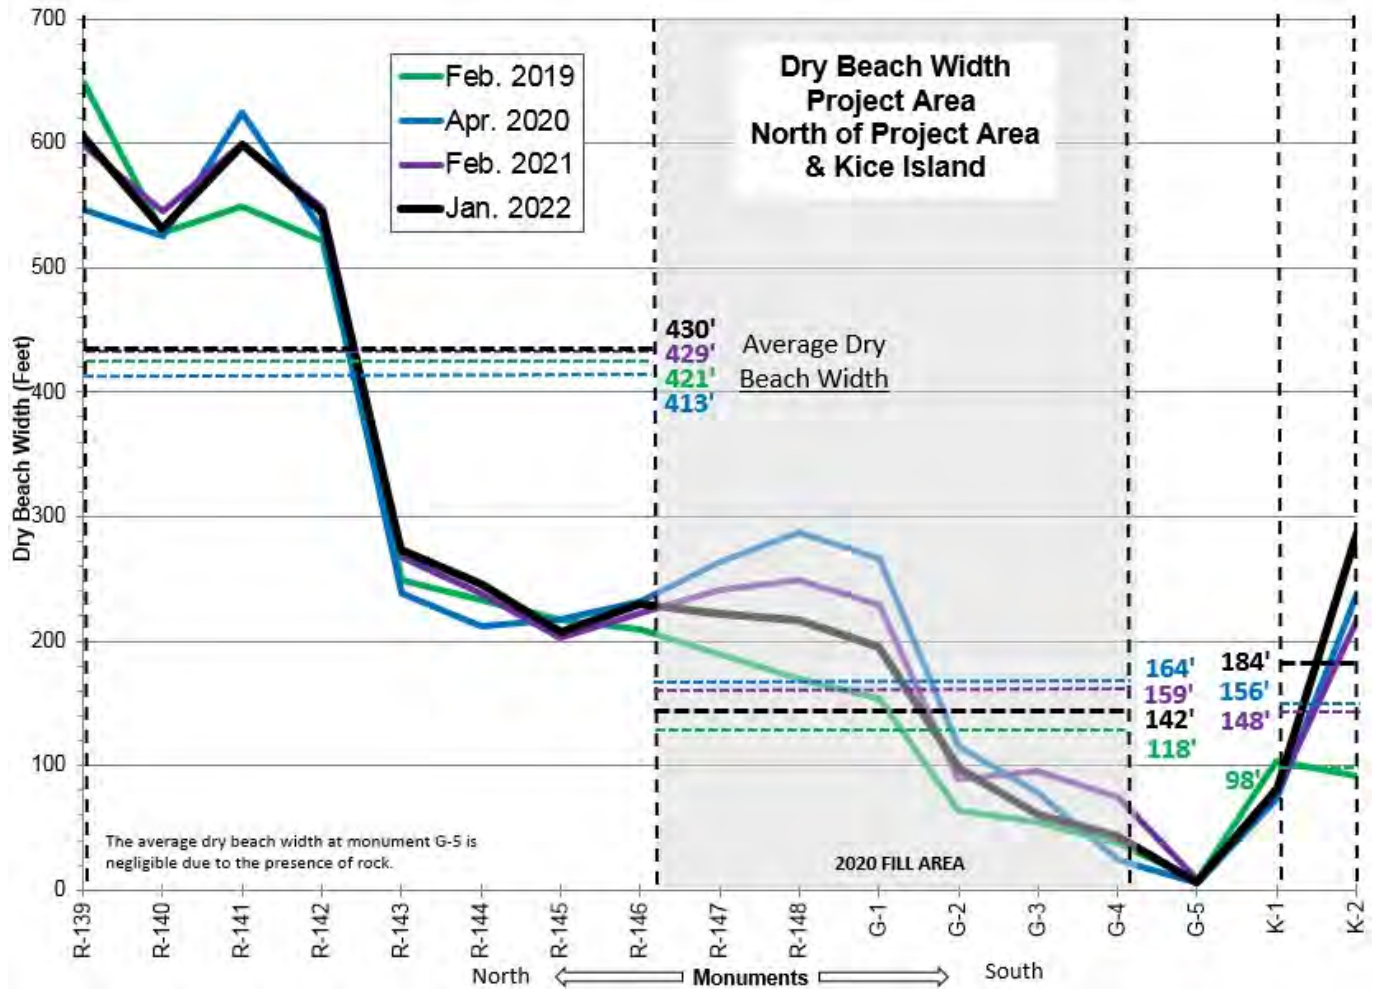
Figure 8c. Dry Beach Width

shaded in gray for the pre, post, and monitoring surveys. Generally, the beach width narrows from north to south ranging from 600 feet (600; Table 3c) wide at monument R-141 to approximately 10 feet (8; Table 3c) at monument G-5. Monuments G-2 through G-5 are located along the existing seawall within the groin field at the south end of Marco Island. Monument G-5, having no dry beach, is located at the south terminal groin adjacent to the north side of Caxambas Pass. The average width of the project area beach increased from 118 feet pre-construction to 142 feet two-years post-construction.

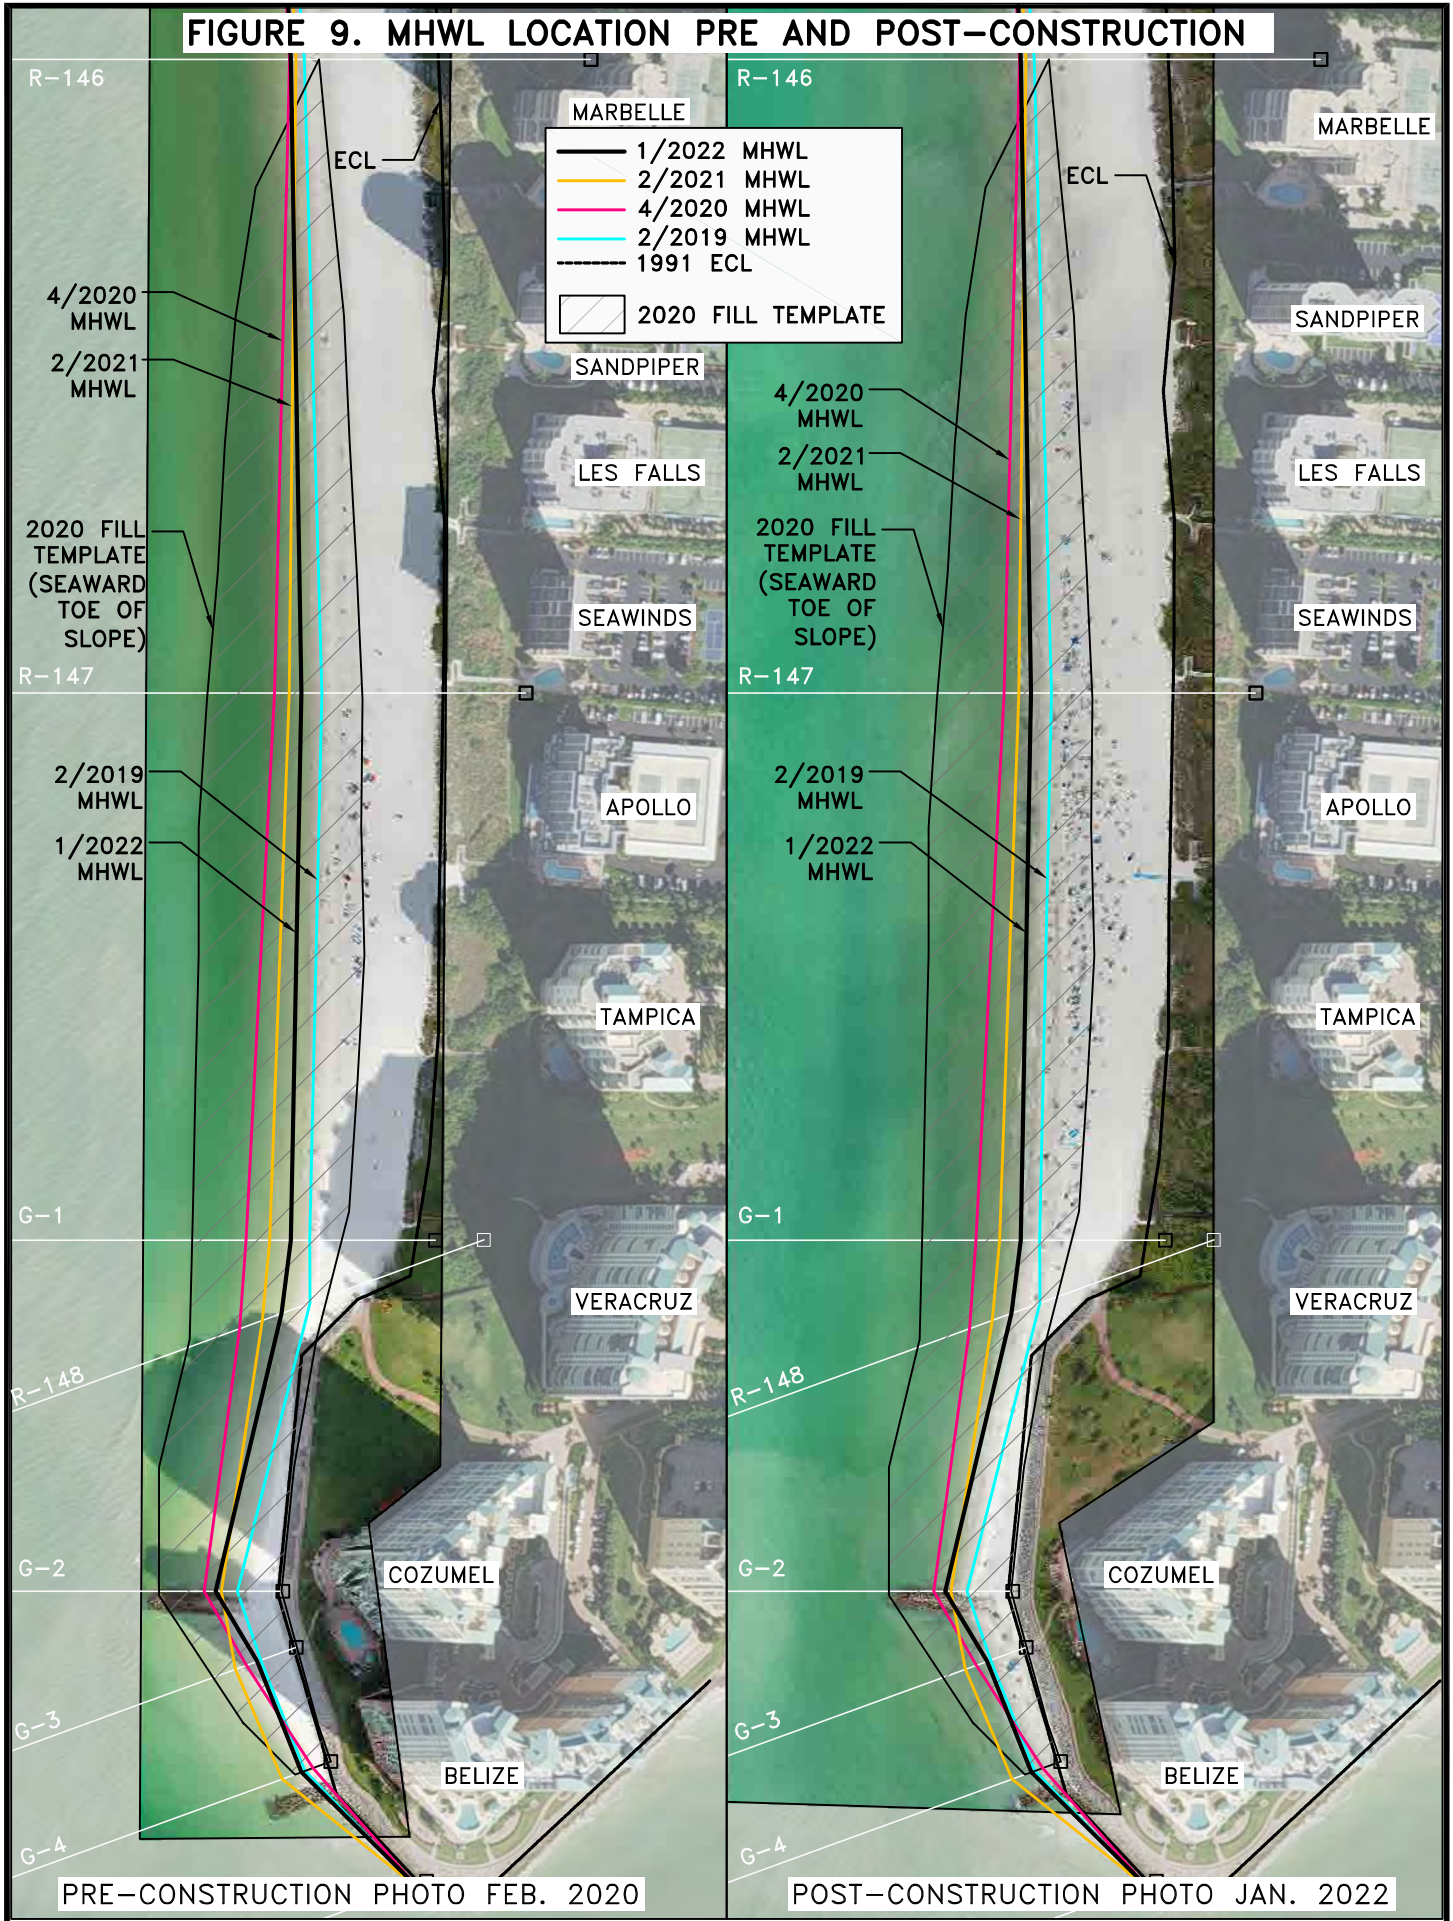
FIGURE 9. MHWL LOCATION PRE AND POST-CONSTRUCTION

Figure 9 shows the pre and post-construction locations for the MHWL, the fill template, ECL, and names of the condominiums adjacent to the project area fill template overlaid on rectified aerial images acquired immediately pre-construction and two years post-construction. Generally, beach widths remain between the immediate pre and post-construction conditions from R-146 south to the terminal groin at G-2.
