Clam Pass Physical and Tidal Monitoring Report 2021 and Post Construction Summary 2022

August, 2022

Prepared for
Pelican Bay Services Division

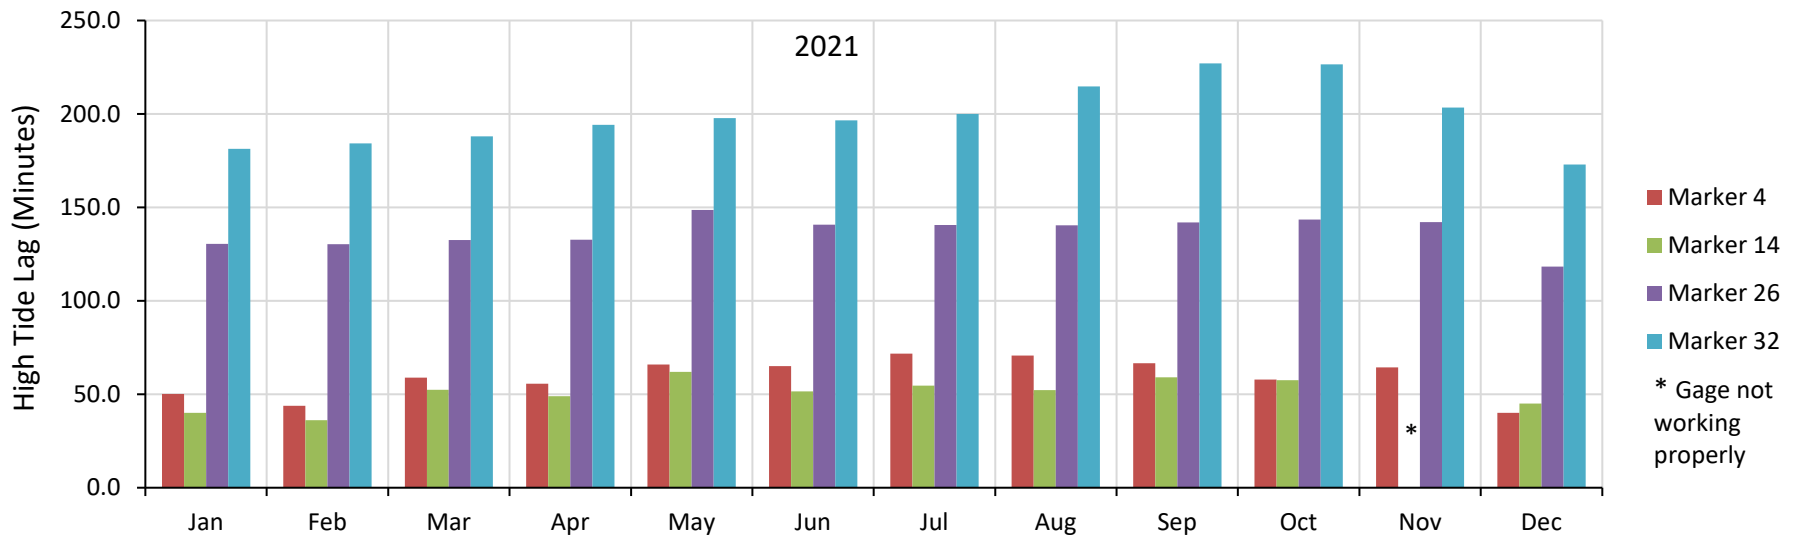
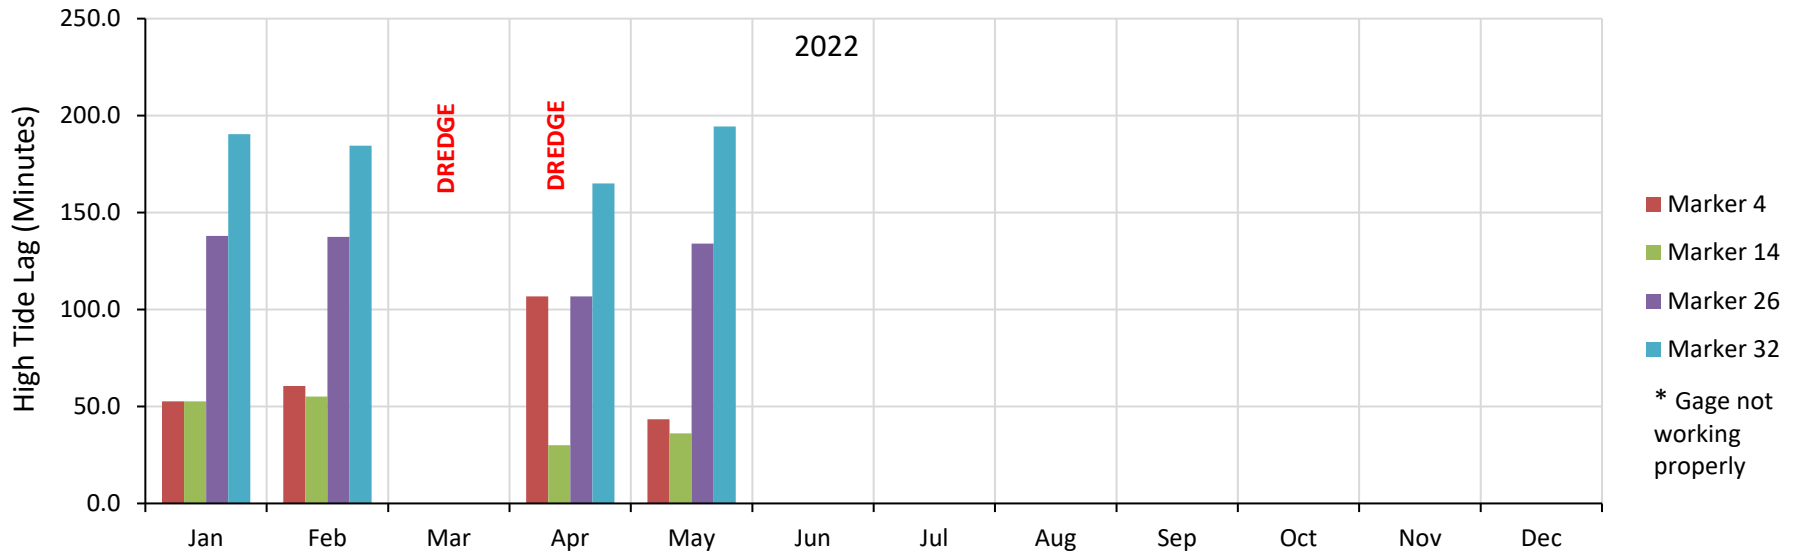
Figure 4 – Monthly High Tide Time Lag Averages – 2021/2022

Figures 4 & 5 present a monthly average of the low tide and high phase lags over the monitoring period of 2021/2022. Marker 4 and 14 are located near the inlet and provide a good indication of inlet condition. Monthly high and low tide lags were very low in January 2021 immediately following the maintenance grading completed in early January. The lags then increased to peak in July before declining during the second half of 2021. In January 2022, tide lag increased to the range of the July peak and the dredge project was scheduled to proceed. Following completion of dredging in April 2022, tide lags have been generally low, except for Marker 4 in April of 2022, which recorded only the initial week after reopening. Monthly time lags at Markers 26 and 32 remained the same suggesting no shoaling of the connector channels.

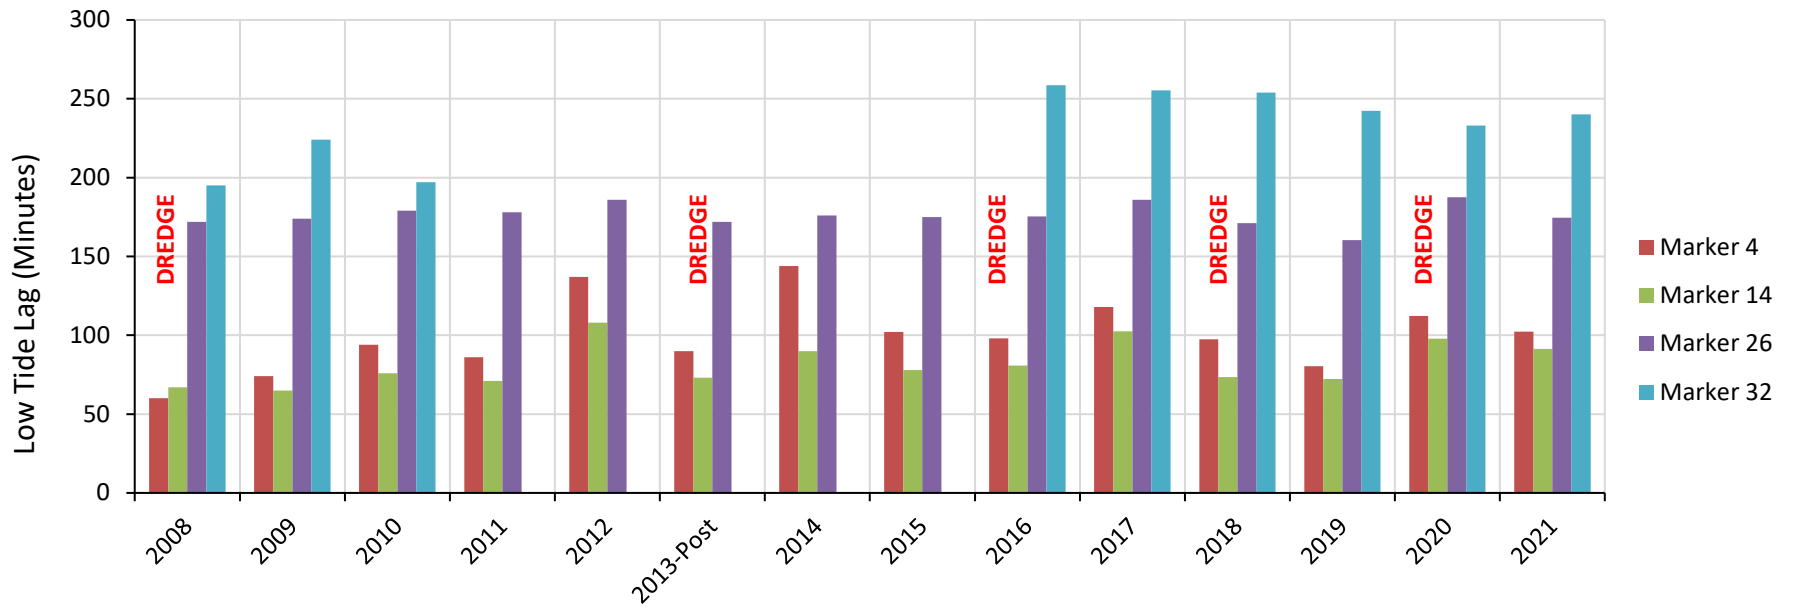
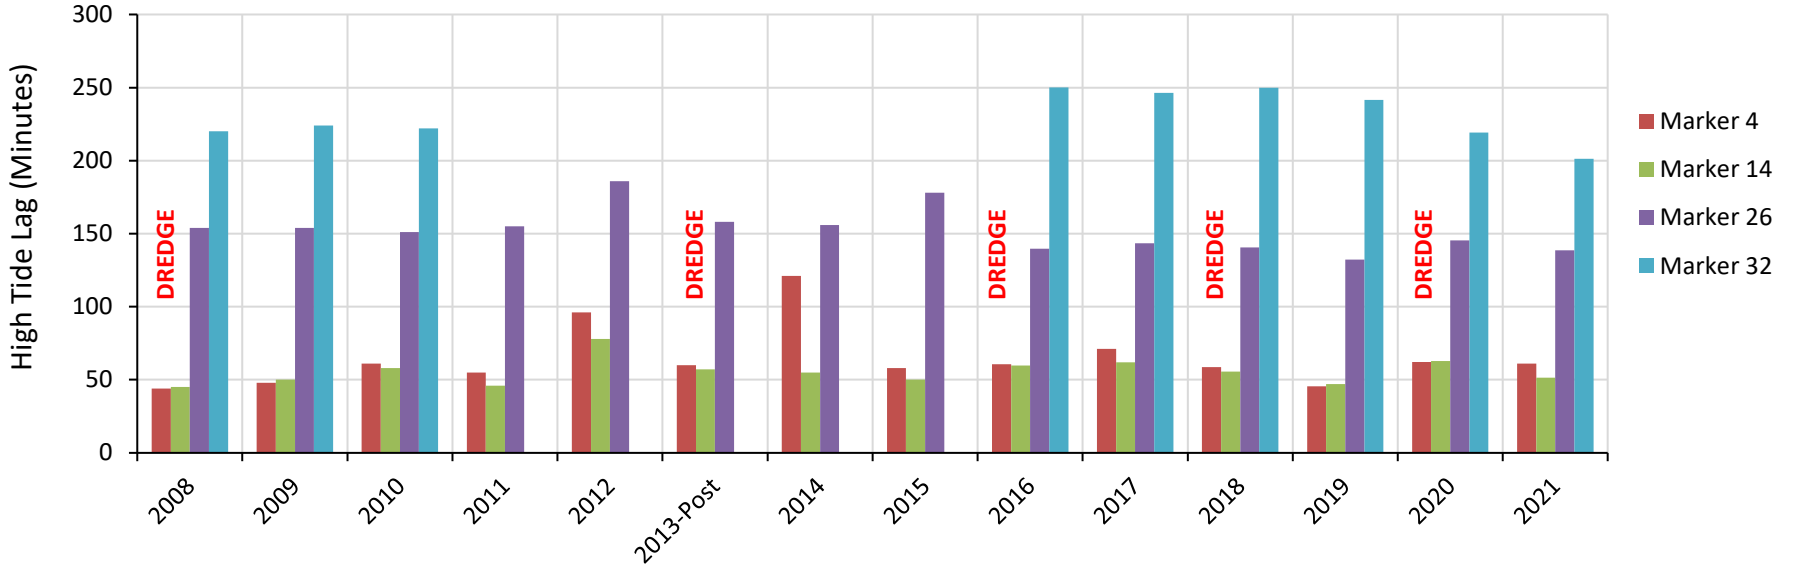
Figure 6 – Yearly Low & High Tide Time Lag Averages – 2008 to 2021

Figure 6 shows the annual averages of low tide and high tide phase lags from 2008 to 2021. The data indicates that the annual time lags for 2021 were slightly higher at Marker 4 and 14, but did not require the intervention that was needed during 2020. The spreading of sand from Clam Pass Park beach toward the north appears to be slowing. The high and low tide time lag at Markers 26 and 32 have declined since 2018, which may represent an improvement of flow conditions to these areas.

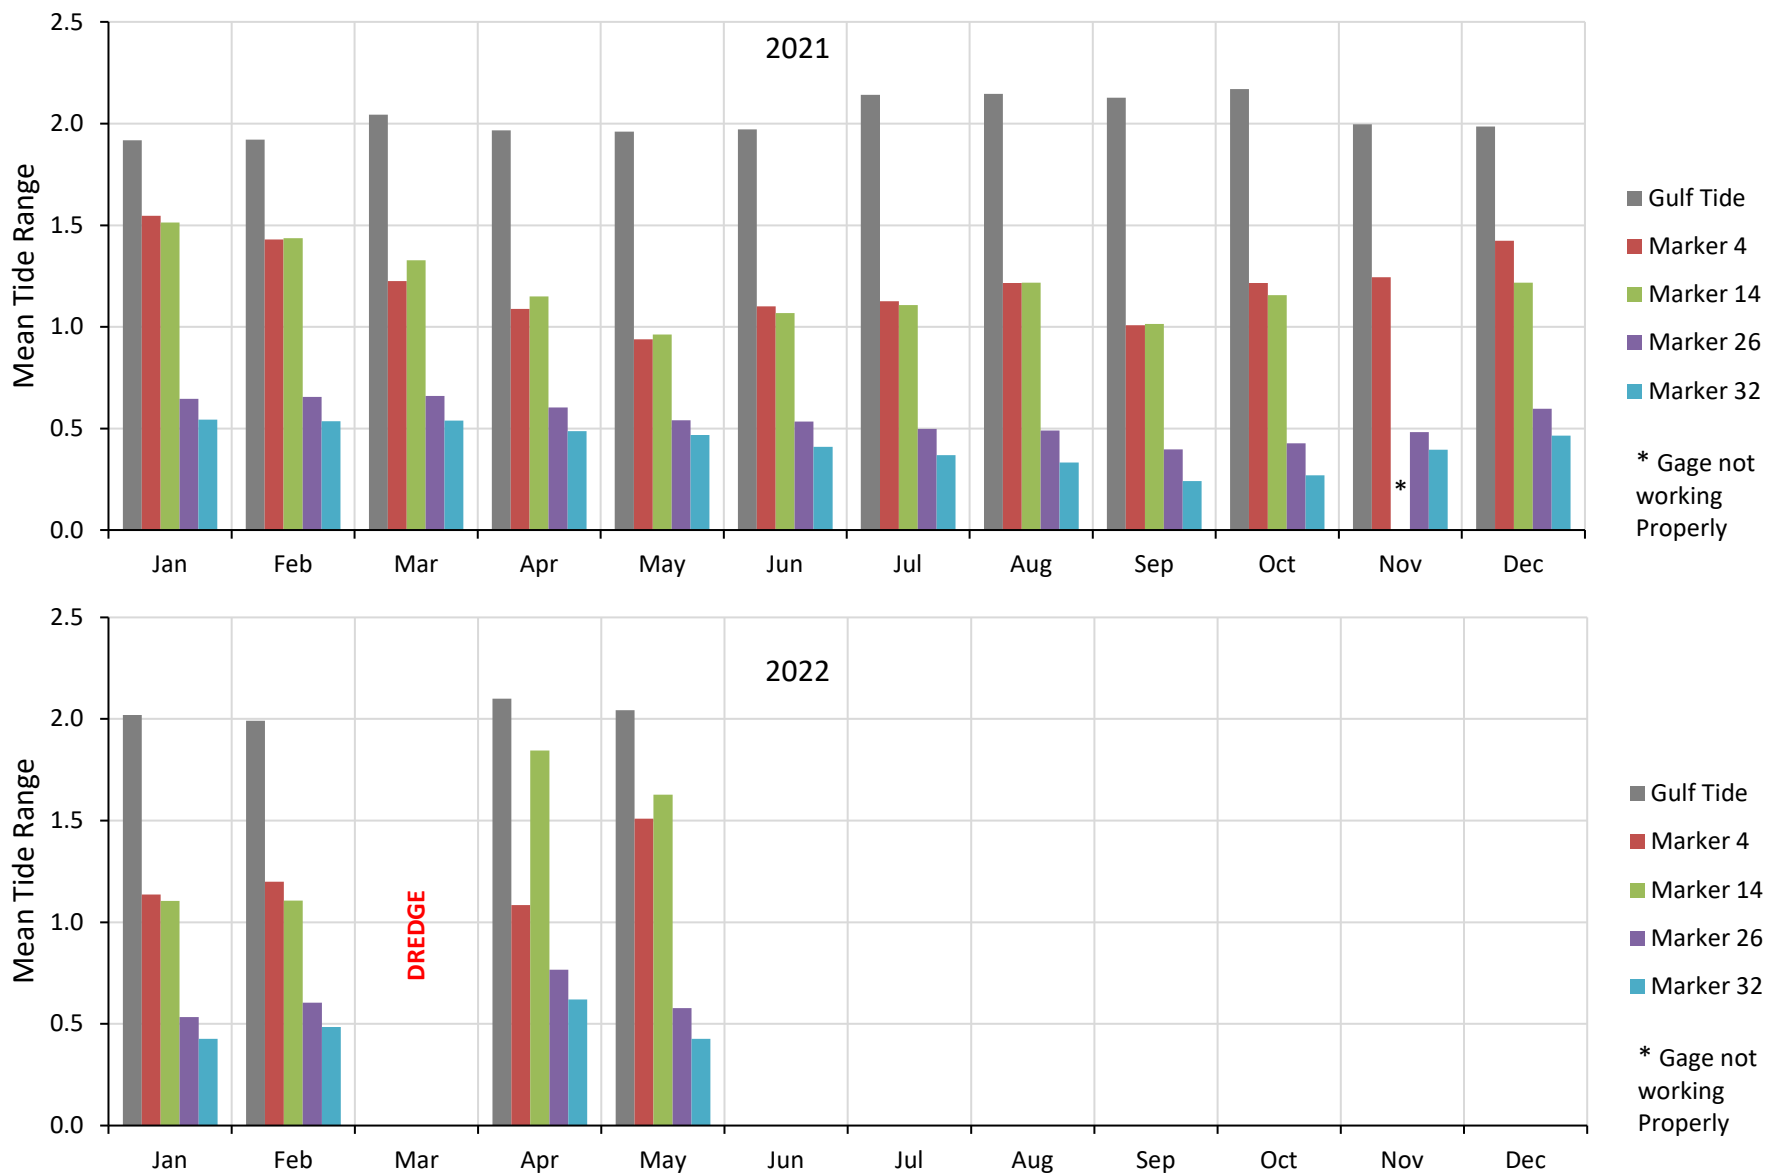
Figure 8 – Monthly Average Tide Range – 2021/2022

Figure 8 shows the monthly average tidal ranges for the monitoring period of 2021/2022. The Gulf tide range was around 2 feet, while the Marker 4 & 14 gauges (near the pass) tide ranges began 2021 near 1.5 feet, then fell to around 1 foot during the summer months. Near the end of 2021, tide ranges began to increase, but again returned to just over 1 foot in early 2022. At this point the decision was made to proceed with the dredging project. The tidal ranges at Marker 26 and 32 showed a similar pattern, beginning the year high, then declining, recovering slightly, and again declining prior to the 2022 dredging.

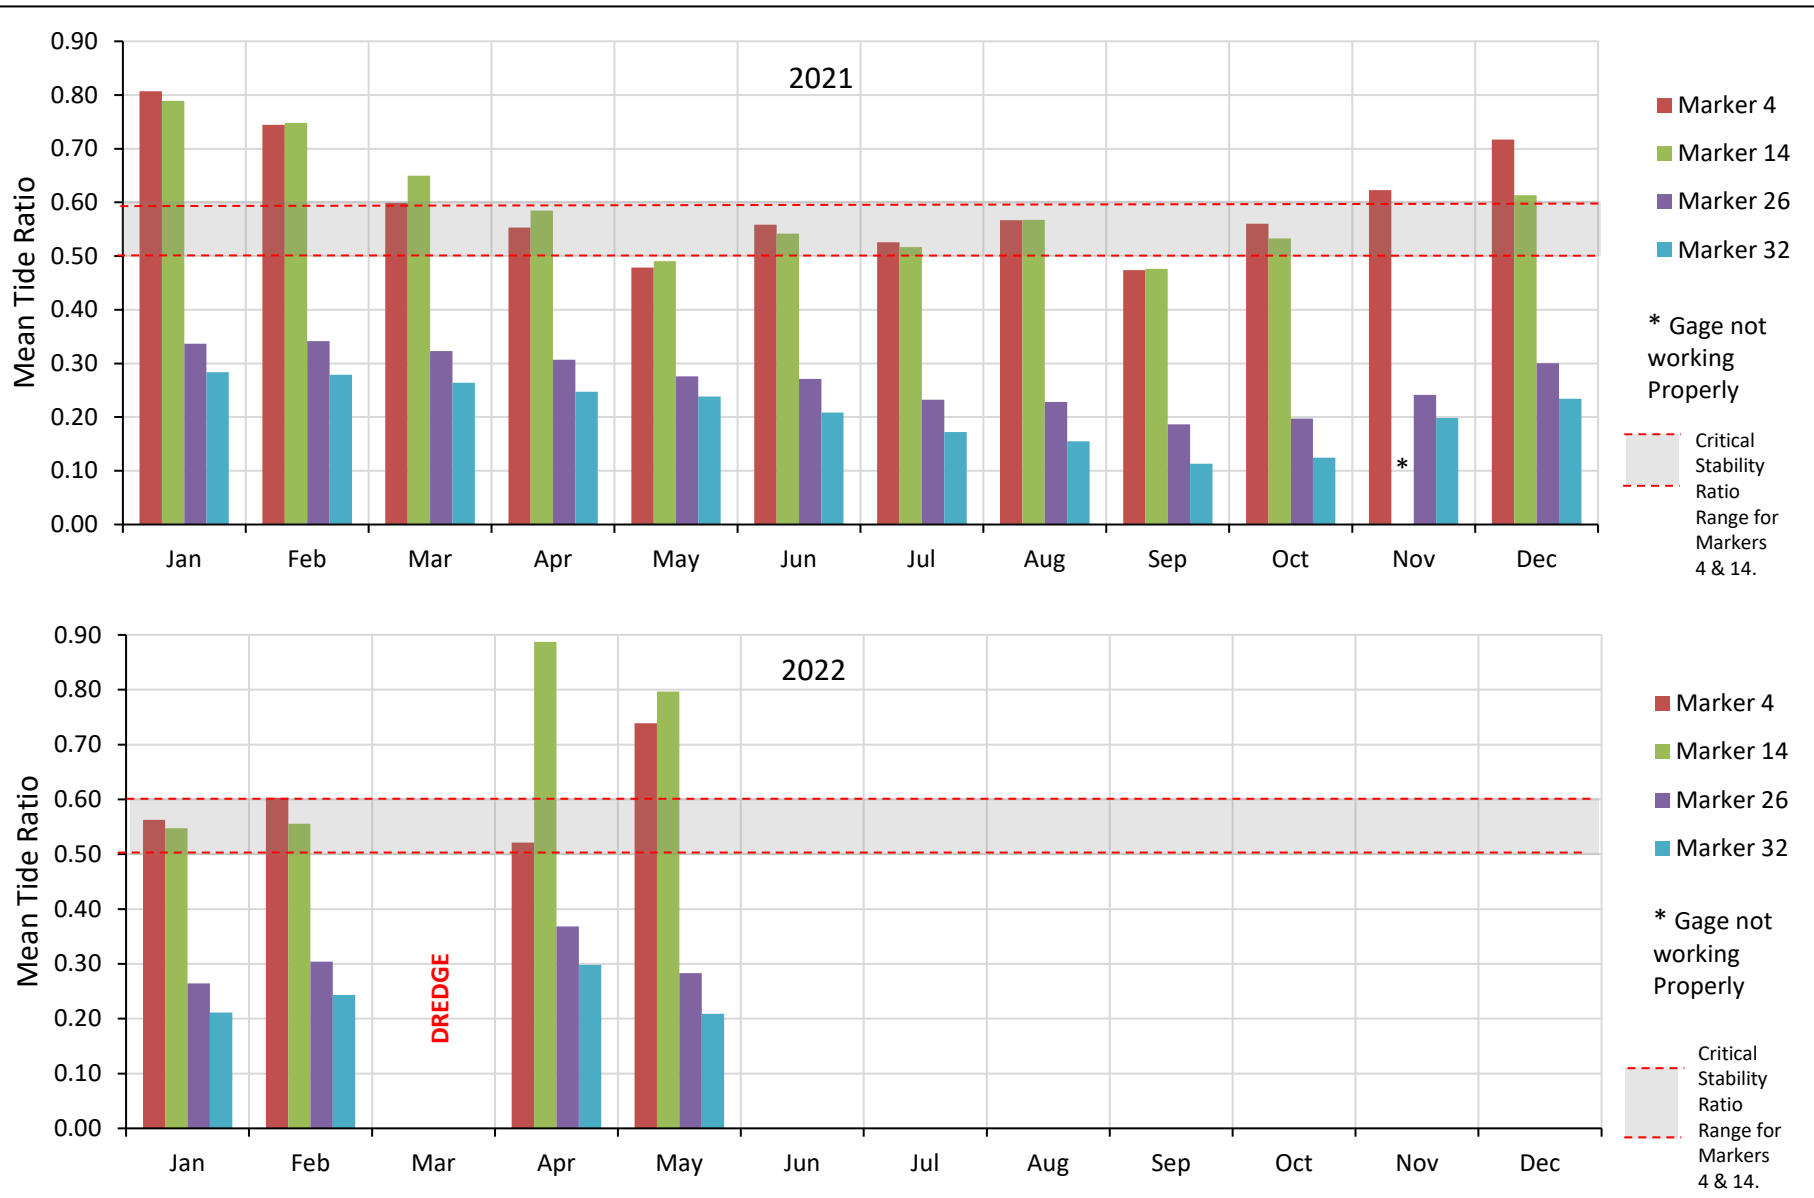
Figure 9 – Monthly Average Tide Range Ratio – 2021/2022

Figure 9 shows the monthly average tide ratios for the monitoring period of 2021/2022. Tide ratios at Marker 4 & 14 entered the critical stability range in April but remained generally stable through October when they began to improve. The ratios again entered the critical stability range in January and the dredge project was scheduled. The dredge project resulted in much higher ratios, indicating improved tidal exchange in the bays.

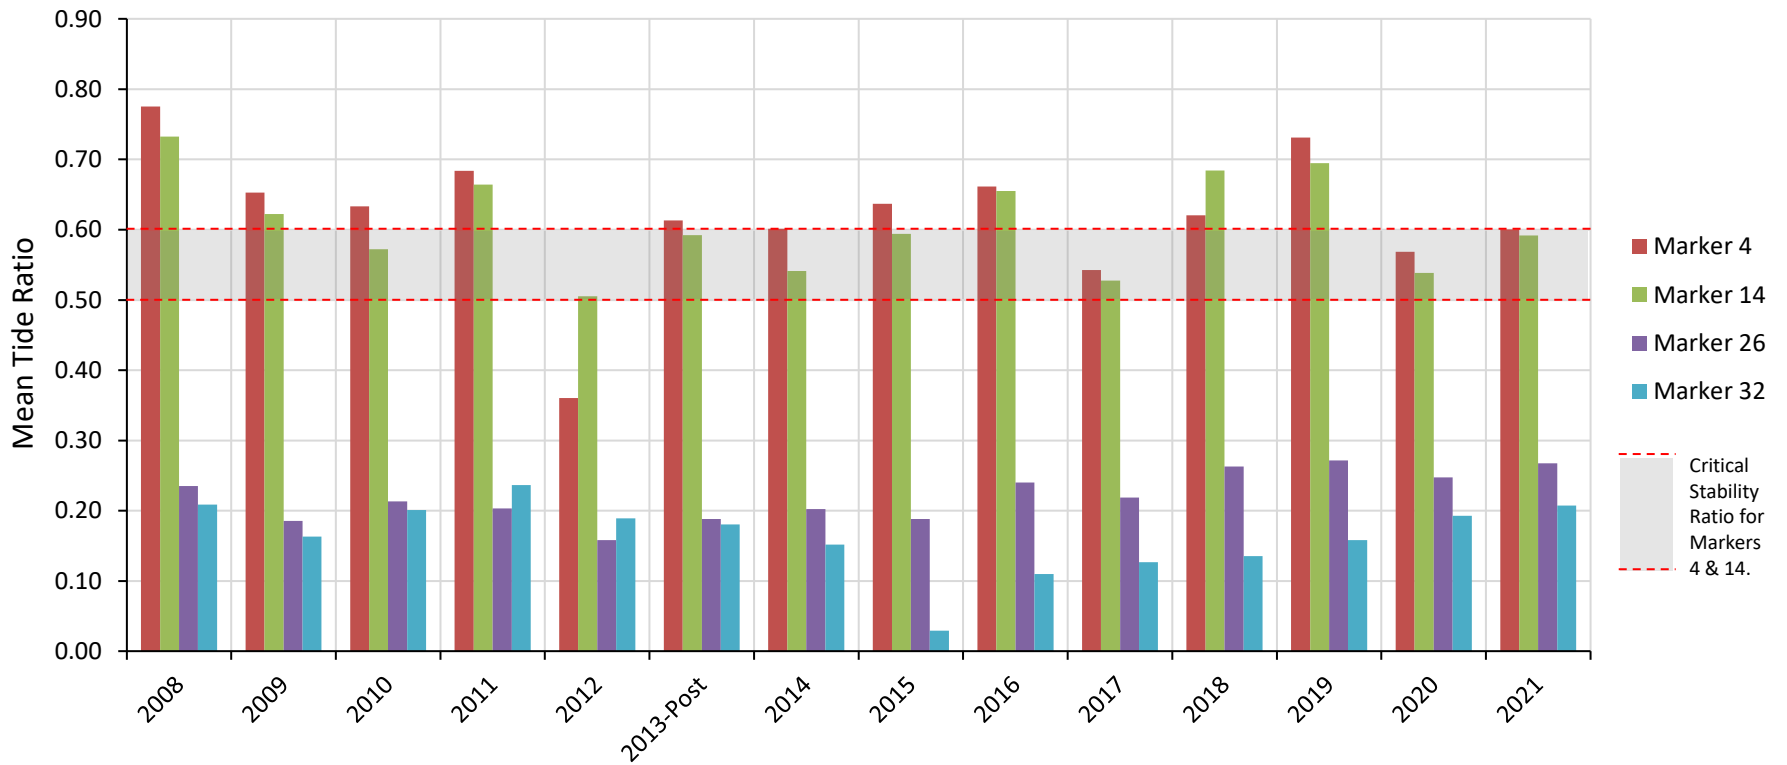
Figure 10 – Average Annual Tide Range Ratio – 2008 to 2021

Average annual tidal ranges and ratios for Clam Pass are presented in **Figure 10** for the time period between 2008 and 2021. The average annual tidal ranges remain within the range of typical values. The average ratios for 2021 at Marker 4 and 14 were in the range of 0.6. This represents an improvement from 2020. The dredging completed in early 2022 is anticipated to produce an even higher tide range ratio for 2022 if similar conditions persist.
