PROJECT: RADIO ROAD EAST MSTU MAINTENANCE

FIELD REPORT No. 4

CONTRACT: LANDSCAPE & IRRIGATION MAINTENANCE, AFFORDABLE LANDSCAPING SERVICE & DESIGN LLC

MAINTENANCE FIELD VISITS PERFORMED ON 11/15/13 AND 12/5/13

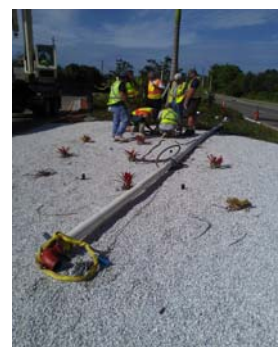
NEMW pulled the pump and investigated the conditions on 11/15/13. The well is still producing a lot of sand and rocks, which is clogging the check valve and causing the pump to cycle on & off. According to the well driller, Tom Miller, this area is known for being a difficult area to achieve a well with the right conditions, and it may take some time to develop the well.

Pump & drop pipe pulled

A new flapper type check valve has been installed to replace the poppet type at the pump discharge this valve hopefully will be more forgiving dealing with the sand that is being pumped

It was requested that a relay be installed so that it will start the pump only when a watering cycle is initiated this will be done by the end of today. In the event of a check valve failure the pump will not be cycling on and off when the system is idle.

Program feature has been added that will shut the system down if it is in a cycling condition before it heats up and comes off the pipe

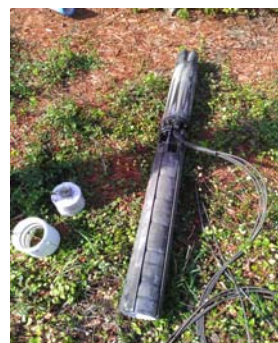
Pump

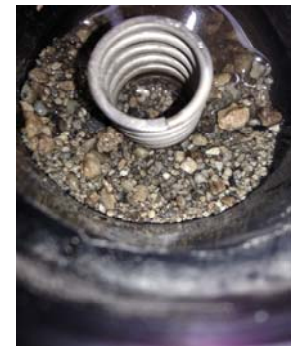
Filter Flush System: The filters are becoming clogged with debris too quickly for the system to operate. Additional sand keeps being pulled into the pump system and accumulating in the filters. Proposed Fix: Wire the filtration system into the Motorola System (Controlled by Roger) so that the filters can be backwashed at least 3 times a day.

*Filter cartridge w/ debris*

NEMW accomplished the corrective action on 11/27/13: The wire connection from the Motorola control and the backwash filters is complete and has been tested.

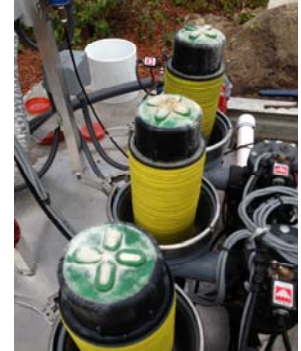
*Tops of filter cartridges w/ sand*

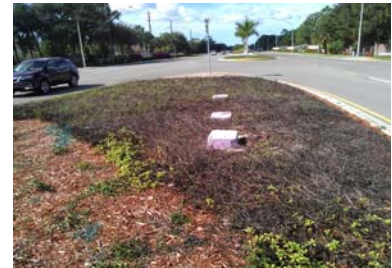
1. ALS has cut back the Beach Dune Sunflower, and it has come back with new growth in some places. The overall appearance is still not good, and is likely not acceptable to the surrounding communities. UGS has provided replacement options for consideration by the Committee, and comparative costs will be provided by ALS.

*Beach Dune Sunflower has been trimmed and still looks bad*

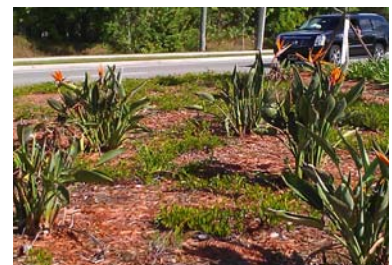
*Bird of Paradise in bloom*

9. The Bird of Paradise are starting to bloom.

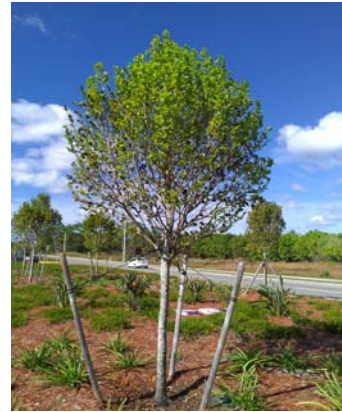
3. The Pigeon Plum trees have been re-staked where needed. The replacements have not been made yet; ALS is currently getting prices from suppliers. Several of the Pigeon Plum are showing signs of improvement, and have new foliage flushing out. The Spider Lily and Golden Creeper under the Pigeon Plum are also looking better, with new foliage and more vigorous growth.

*Pigeon Plum with new growth*

Remove and replace (2) dead Pigeon Plum

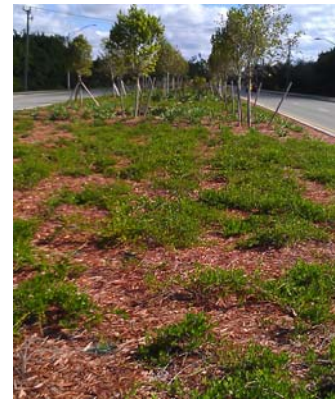
*Golden Creeper w/ new growth & filling in*

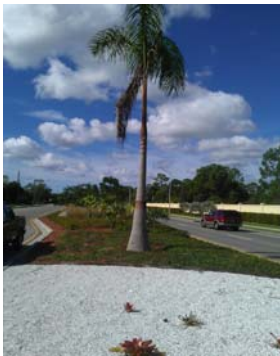
19. One Royal Palm on Median #34 looks very weak & thin.

*Royal Palm on Median 34*

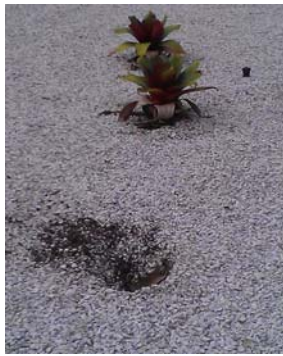
17. One Imperial Bromeliad was stolen on Median #32.

*Bromeliad stolen*

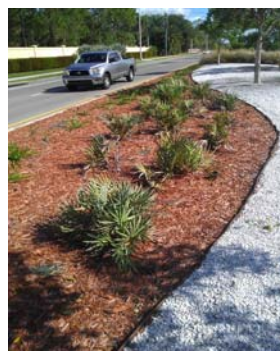
7. The Silver Saw palmetto still has some brown foliage; Tom Hecker previously recommended to not remove the brown foliage, as the dying fronds return nutrients to the plant. Once fertilizers are applied, the palmetto should put out more green foliage so the brown fronds will not be as noticeable.

*Silver Palmetto still brown*

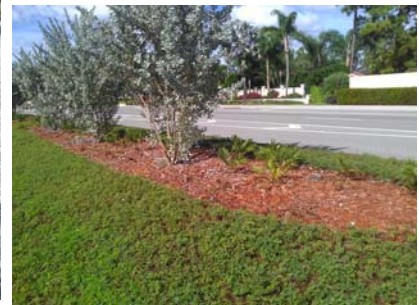
16. Several beds of Coontie under the Silver Buttonwood are turning brown & dying out. Al is to check for possible causes. This is the area covered by the DC Controller, so it may be due to a lack of water.

*Coontie under Silver Buttonwood browning out*
