Pier Substructure

Naples Pier - Pier Wood Structure/Deck Replacement Conceptual Estimate

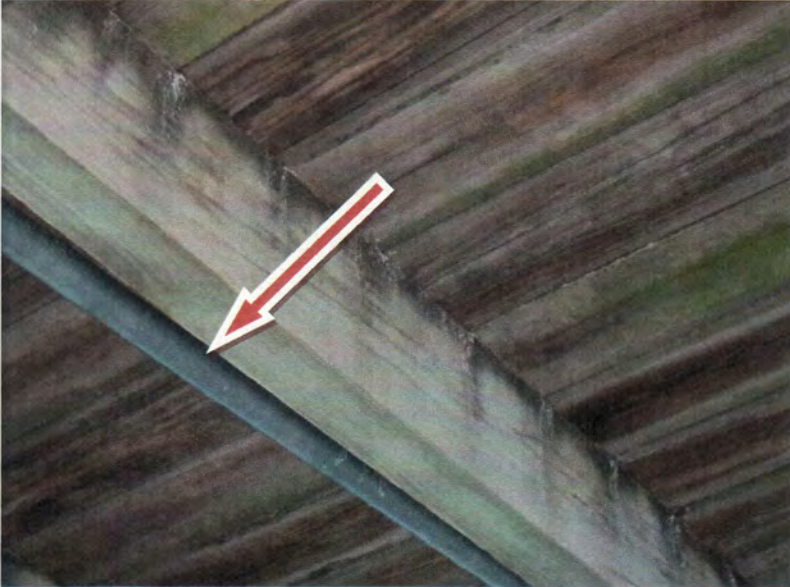
<p><u>Issue:</u> Pier # 12. The stress caused by the movement of the main power supply conduit is beyond the working strength of these thin plastic pipe straps. Note the conduit has dropped away from its strapping alongside the stringer.</p> <p><u>Resolution:</u> Provide new plastic pipe straps with better working strength and durability (i.e. more material thickness/cross-section, mass, etc).</p>

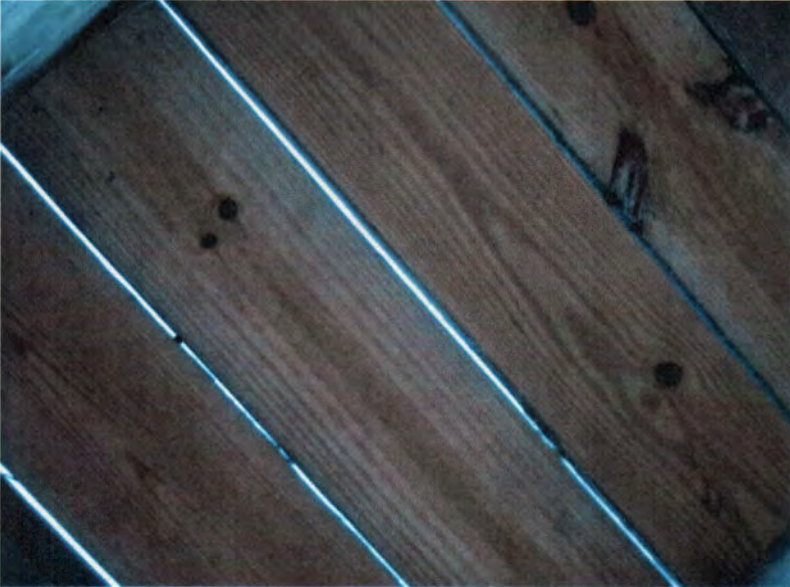
<p><u>Description:</u> Typical view of the substructure framing and the condition of the decking in the vicinity of Pier #12. Note the multiple replacement boards besides the old boards.</p>

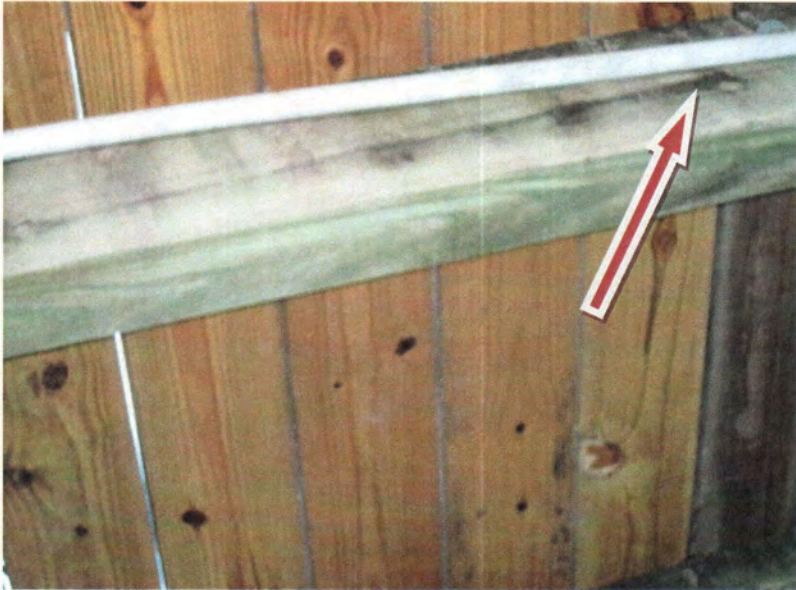
<p><u>Issue:</u> Pier #11 – Pier #12. The stress caused by the movement of the main power supply conduit is beyond the working strength of these thin plastic pipe straps.</p> <p><u>Resolution:</u> Provide new plastic pipe straps with better working strength and durability (i.e. more material thickness/cross-section, mass, etc).</p>

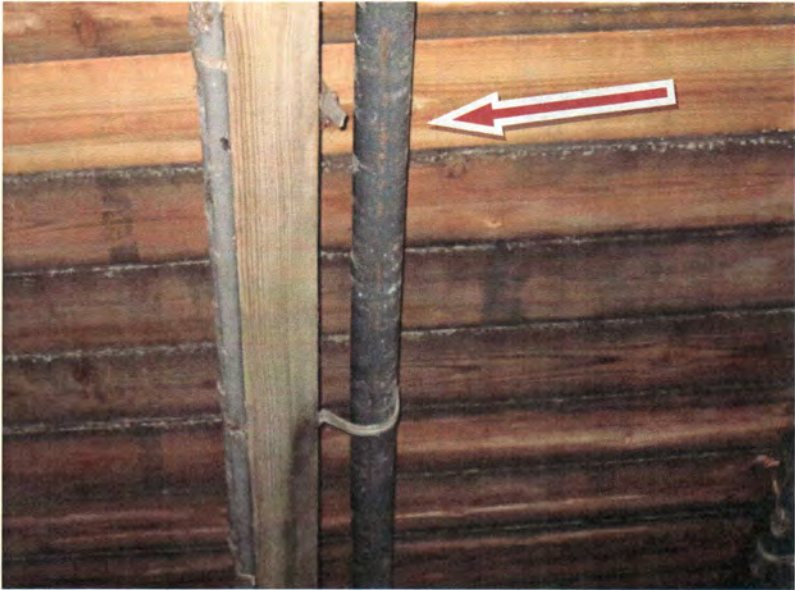
<p><i>Issue:</i> Pier #11-Pier #12. The stress caused by the movement of the main power supply conduit is beyond the working strength of these thin plastic pipe straps.</p> <p><i>Resolution:</i> Provide new plastic pipe straps with better working strength and durability (i.e. more material thickness/cross-section, mass, etc).</p>

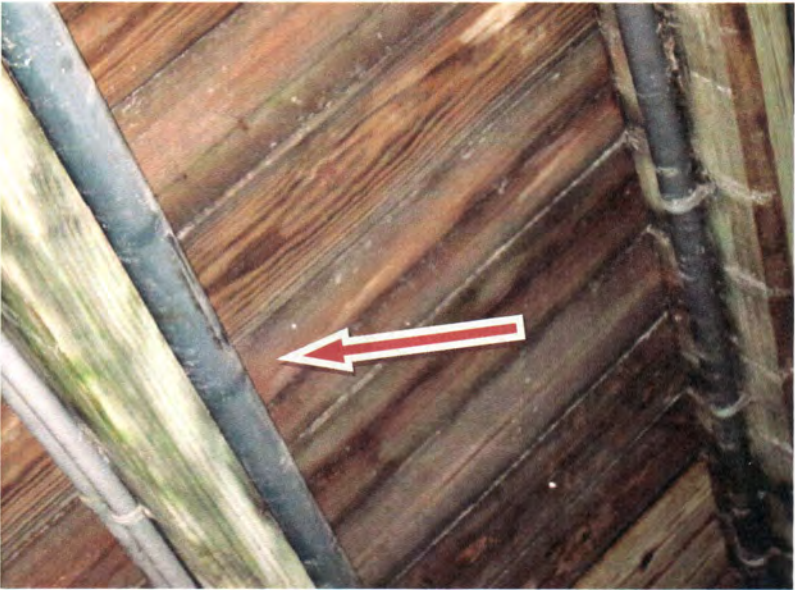
<p><i>Issue:</i> Pier #11 – Pier #12. The stress caused by the movement of the main power supply conduit is beyond the working strength of these thin plastic pipe straps.</p> <p><i>Resolution:</i> Provide new plastic pipe straps with better working strength and durability (i.e. more material thickness/cross-section, mass, etc).</p>

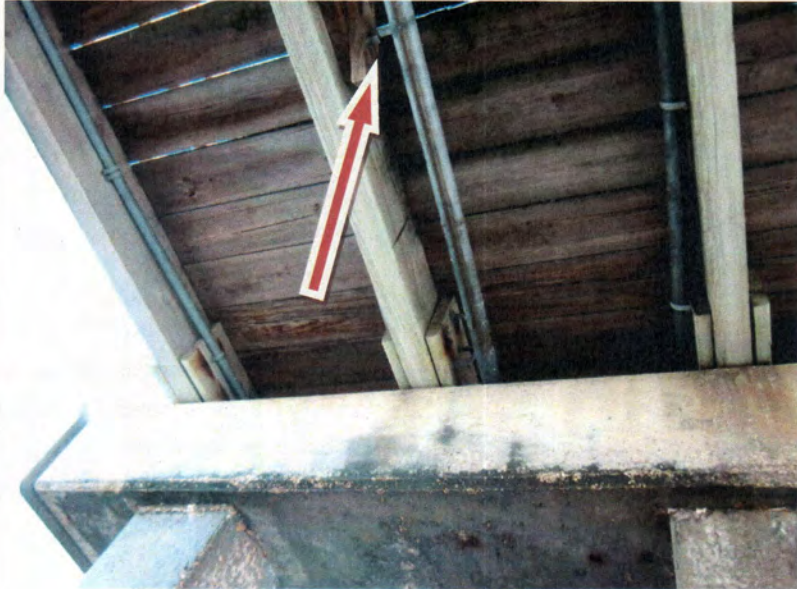
<p><i>Issue:</i> The stress caused by the movement of the main power supply conduit is beyond the working strength of these thin plastic pipe straps.</p> <p><i>Resolution:</i> Provide new plastic pipe straps with better working strength and durability (i.e. more material thickness/cross-section, mass, etc).</p>

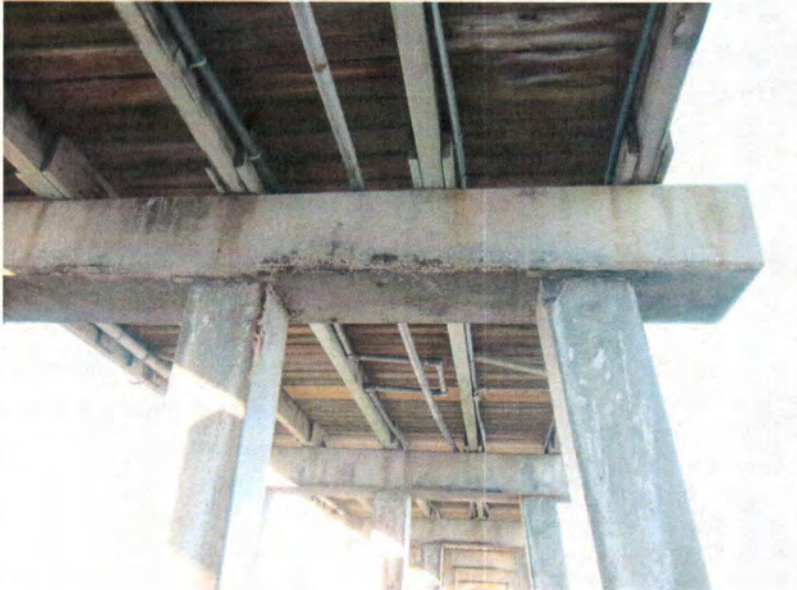
<p><i>Issue:</i> The stress caused by the movement of the main power supply conduit is beyond the working strength of these thin plastic pipe straps.</p> <p><i>Resolution:</i> Provide new plastic pipe straps with better working strength and durability (i.e. more material thickness/cross-section, mass, etc).</p>

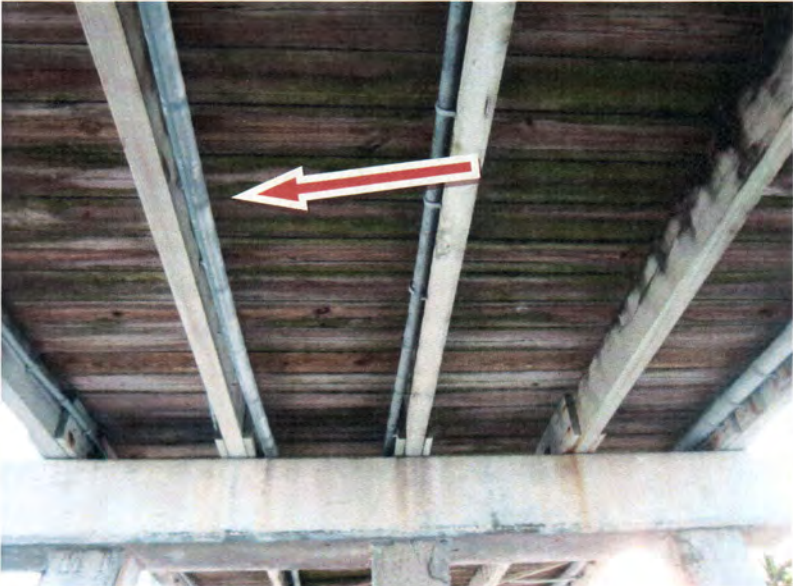
<p>Issue: The stress caused by the movement of the main power supply conduit is beyond the working strength of these thin plastic pipe straps. Note the conduit has dropped away from its strapping alongside the stringer.</p> <p>Resolution: Provide new plastic pipe straps with better working strength and durability (i.e. more material thickness/cross-section, mass, etc).</p>

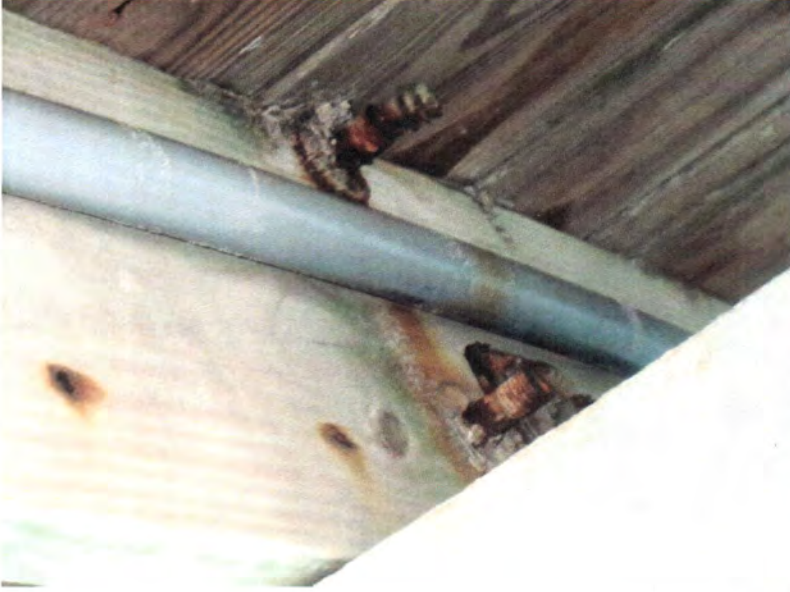
A close-up photograph showing a metal rail post connected to a wooden structure. The hardware, including a hex nut and washer, is heavily corroded and has been cleared from the end of the rail post. The surrounding metal and wood show signs of rust and wear.	<p><u>Issue:</u> Pier #9. See preceding issue. Note the two hex-nuts and a washer have corroded away and cleared from the end of the rail post thru-bolts causing potential faulty structural connections.</p> <p><u>Resolution:</u> Require immediate close inspection and repair/replacement.</p>

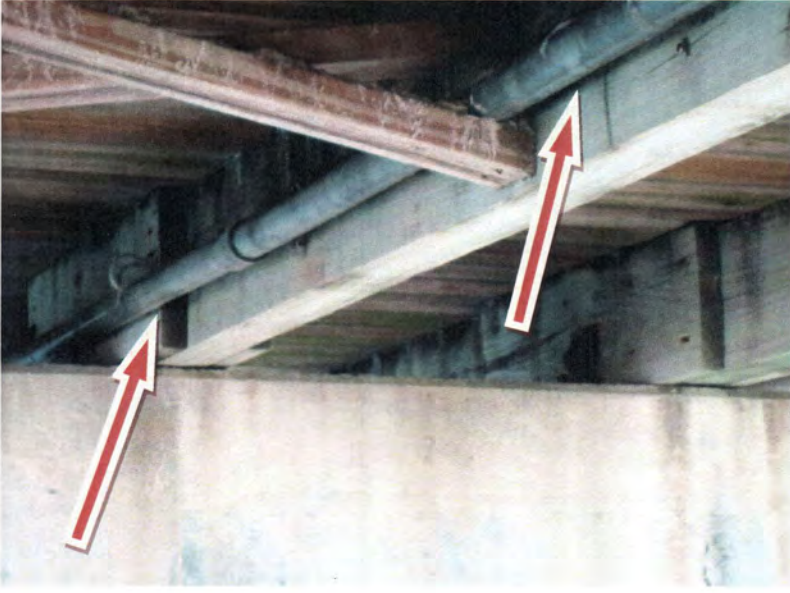
A photograph showing a main power supply conduit supported by thin plastic pipe straps. Two red arrows point to the straps, highlighting their condition. The straps appear to be under stress and may not be suitable for supporting the weight of the conduit.	<p><u>Issue:</u> The stress caused by the movement of the main power supply conduit is beyond the working strength of these thin plastic pipe straps.</p> <p><u>Resolution:</u> Provide new plastic pipe straps with better working strength and durability (i.e. more material thickness/cross-section, mass, etc).</p>

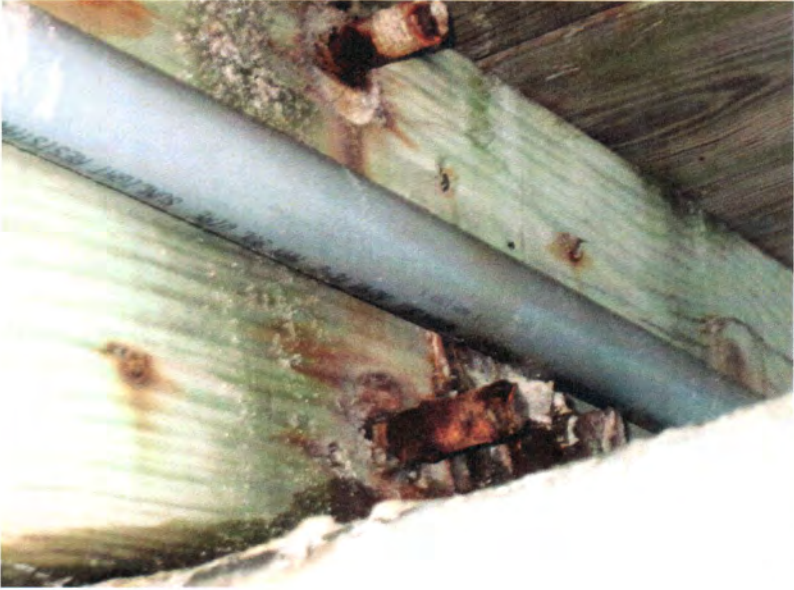
<p><u>Issue:</u> See preceding issue. Note hex-nuts and washers have corroded away and cleared from the end of the rail post thru-bolts causing potential faulty structural connections.</p> <p><u>Resolution:</u> Require immediate close inspection and repair/replacement.</p>

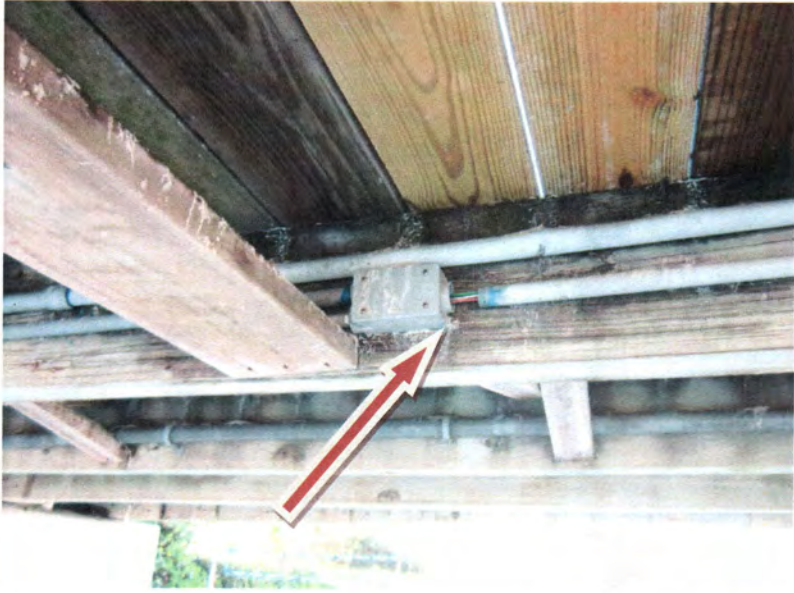
<p><i>Issue:</i> The movement of the deck under wind gust can pull pipe/conduit out of its joint and/or rip a pipe segment out of its strapping.</p> <p><i>Resolution:</i> Repair or replace all broken and loose pipe/conduit fitting and wiring when the deck boards are due for removal and replacement. Provide proper and durable pipe/conduit straps and hangers to ensure firm attachment and support against periodic dynamic loads.</p>

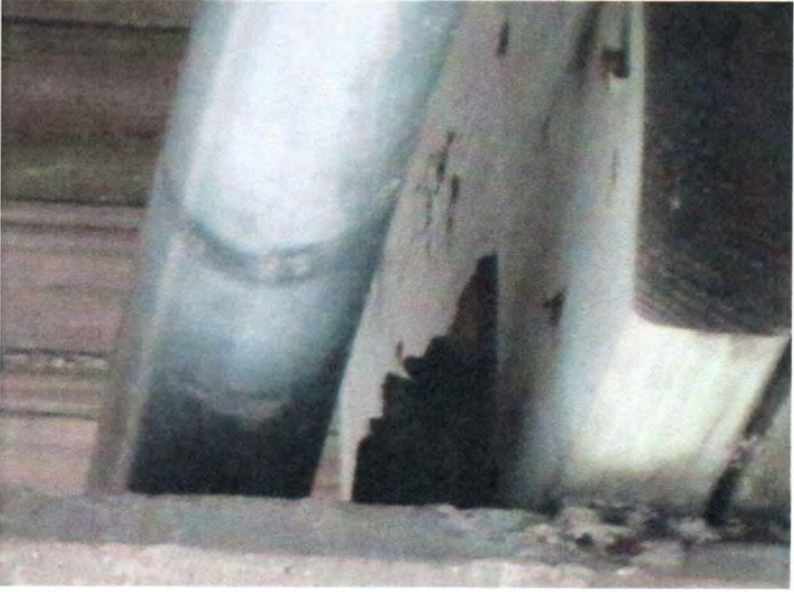
<p><i>Issue:</i> See preceding issue for metal hardware from Pier # 7 and beyond.</p> <p><i>Resolution:</i> See preceding resolution.</p>

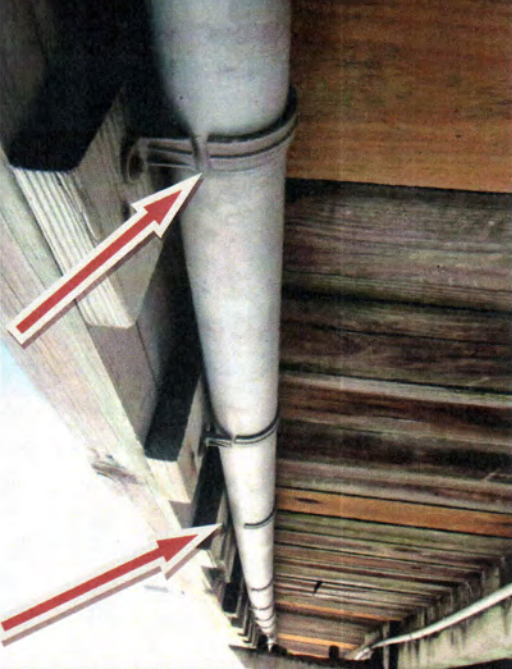
<p><i>Issue:</i> The stress caused by the movement of the main power supply conduit is beyond the working strength of these thin plastic pipe straps.</p> <p><i>Resolution:</i> Provide new plastic pipe straps with better working strength and durability (i.e. more material thickness/cross-section, mass, etc).</p>

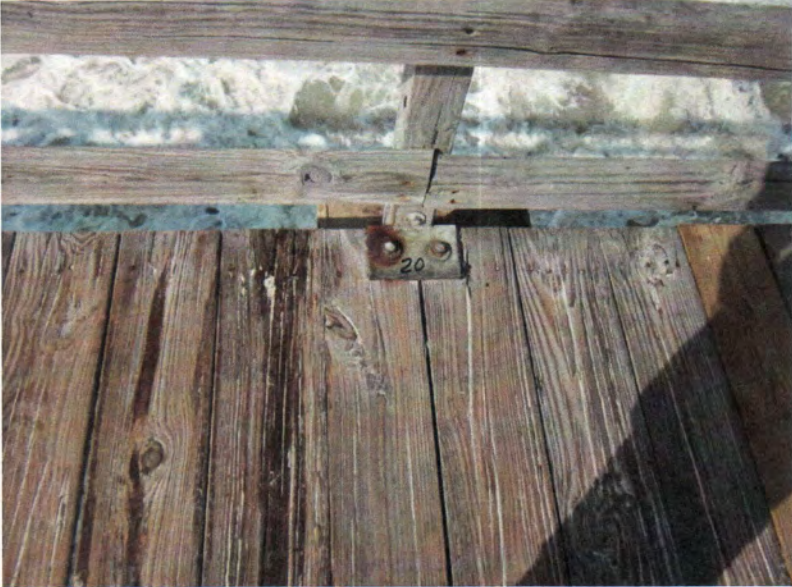
<p>Description: View over Pier #20. As the pier begins to go over water seaward, the impact of the sea environment is increasingly harsh on wood and metal hardware. Note the sign of decay on the board immediately to the left of the post. Note a decaying board on the left.</p>

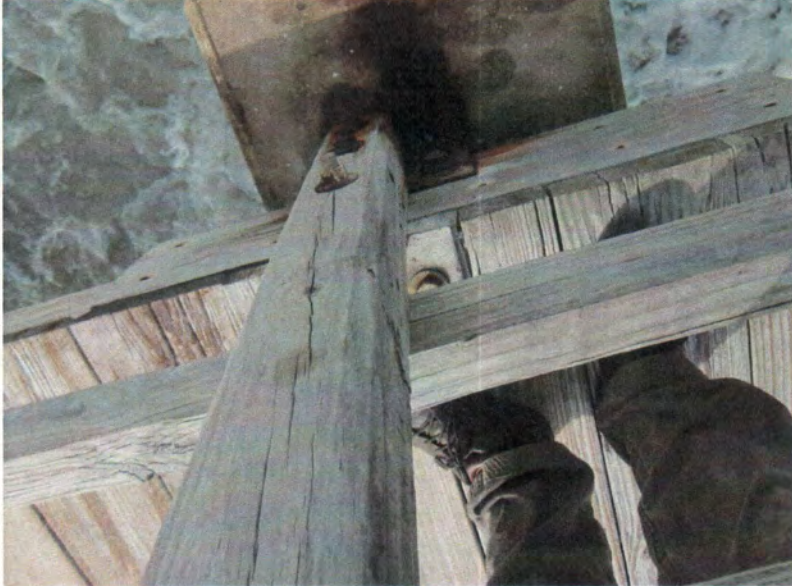
<p>Issue: The connection assembly on the pier is the most vulnerable to sea spray that brings split and decay on wood, and promotes accelerated corrosion of metal hardware.</p> <p>Resolution: Perform regular inspection and replace severely corroded washers and hex-nuts. In some case the galvanized clip angle may need replacement as well.</p>

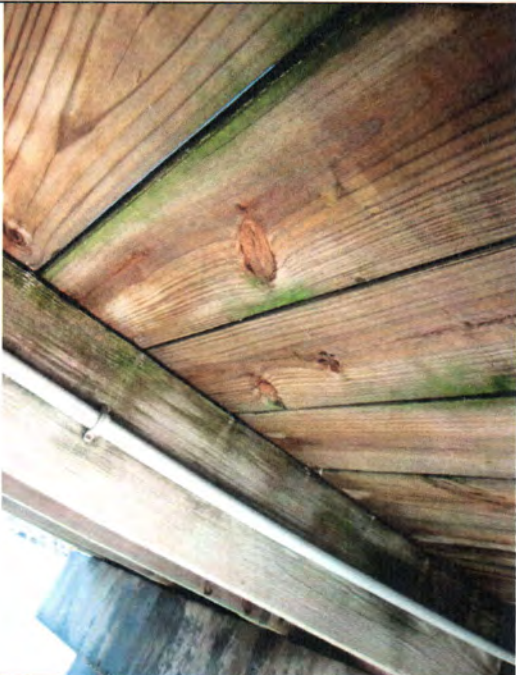
<p>Issue: In stormy day and high waves the deck is being washed in sea spray for the duration. Note the boards are soggy from such weather event.</p> <p>Resolution: Perform periodic inspection of the utility piping below deck. Repair/replace/remove broken piping. Provide new plastic pipe straps with better working strength and durability (i.e. more material thickness/cross-section, mass, etc).</p>

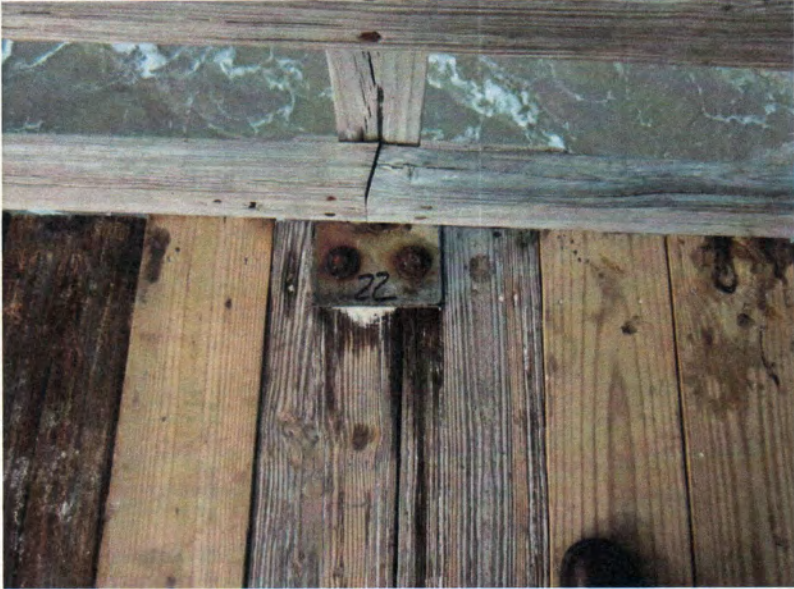
A photograph showing a view over Pier #22. The image displays several wooden planks. One plank on the left side is significantly decayed and discolored. A small metal plate with the number '22' is visible on one of the planks.	<p>Description: View over Pier #22. Note a decaying board to the left.</p>

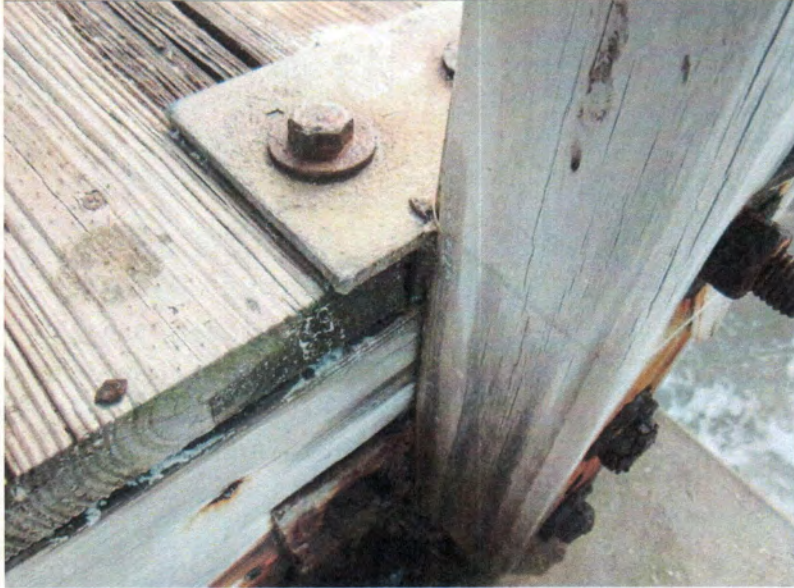
A close-up photograph of a metal connection assembly on the pier. The assembly consists of a metal plate, a bolt, a washer, and a hex-nut. The metal hardware shows significant corrosion and rust. The surrounding wood is also weathered and shows signs of decay.	<p>Issue: The connection assembly on the pier is the most vulnerable to sea spray that brings split and decay on wood, and promotes accelerated corrosion of metal hardware.</p> <p>Resolution: Perform regular inspection and replace severely corroded washers and hex-nuts. In some case the galvanized clip angle may need replacement as well.</p>

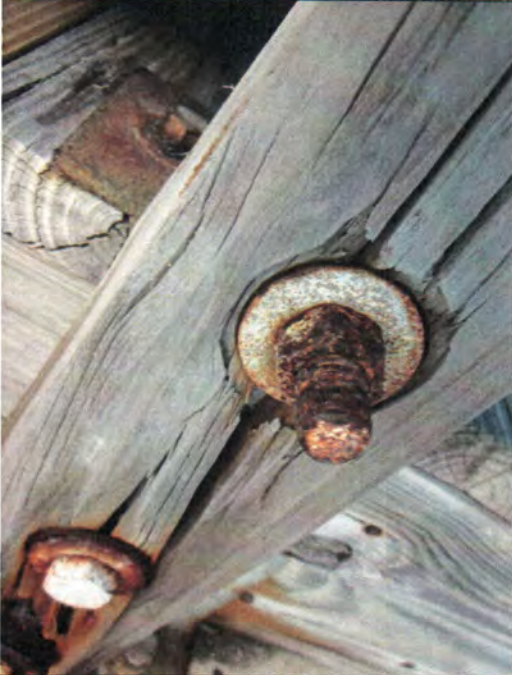
<p><u>Issue:</u> The connection assembly on the pier is the most vulnerable to sea spray that brings split and decay on wood, and promotes accelerated corrosion of metal hardware. Split/cracks in wood at the connection not only weaken the structural components but make it possible for sea spray to infiltrate connector holes, and subsequently corrodes the metal hardware from inside out.</p> <p><u>Resolution:</u> Perform regular inspection and replace severely corroded washers and hex-nuts. In some case the galvanized clip angle may need replacement as well.</p>

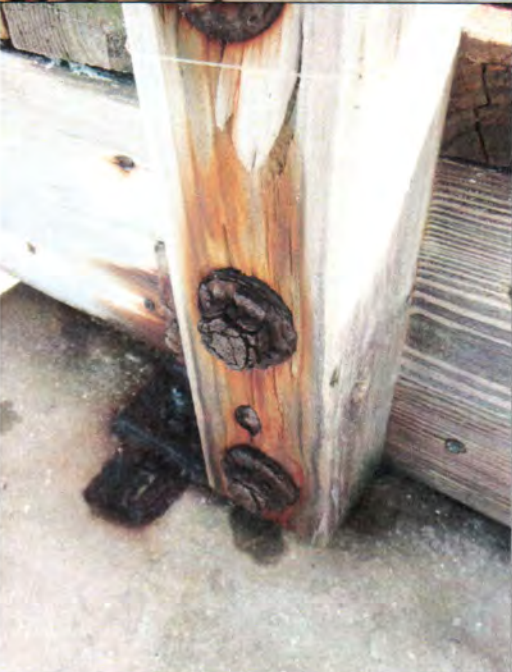
<p><u>Issue:</u> It's obvious that there's no connections strength left at the base of this one rail post. Also it appears that the anchor bolt/clip angle assembly can no longer be relied upon to hold down the stringer to the pile cap during wind uplift.</p> <p><u>Resolution:</u> Immediately inspect/remove/replace all deteriorated metal hardware.</p>

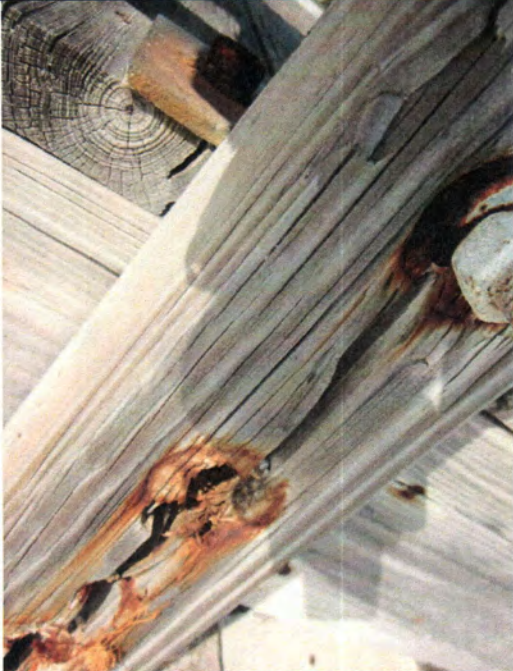
<p><u>Issue:</u> Similar pattern of rail post and thru-bolt connection issue. Note the middle thru-bolt connecting the rail post to the top part of the stringer is missing. The base has a wide split fiber from top bolt to bottom end.</p> <p><u>Resolution:</u> See preceding resolution.</p>

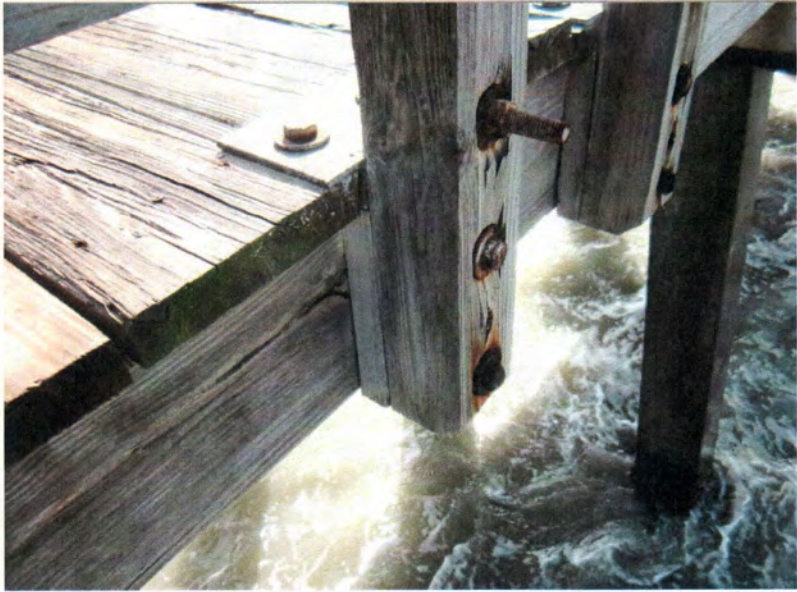
<p><u>Issue:</u> See preceding issue. This pair is only for mounting pedestrian lighting.</p> <p><u>Resolution:</u> See preceding resolution.</p>

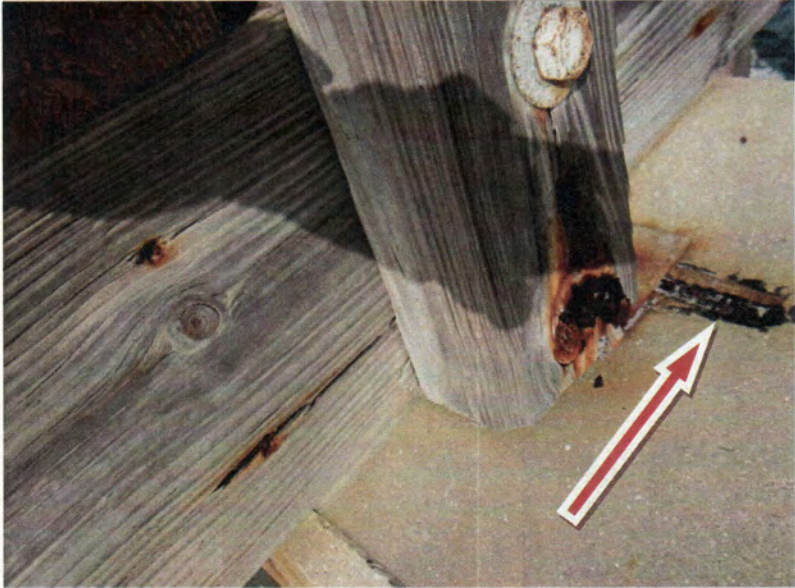
<p><u>Issue:</u> Similar pattern of rail post and thru-bolt connection issue.</p> <p>Note corrosion of the exposed adjustable-slot may preclude the provision that allows for stringer's lateral movement and adjustment.</p> <p><u>Resolution:</u> See preceding resolution.</p>

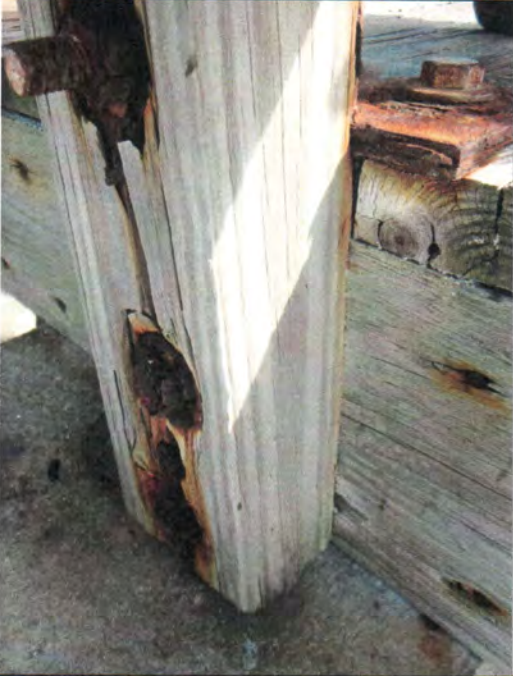
<p><u>Issue:</u> Similar pattern of rail post and thru-bolt connection issue.</p> <p>Even horizontal connection hardware is not spared by corrosion from sea spray at this post.</p> <p><u>Resolution:</u> See preceding resolution.</p>

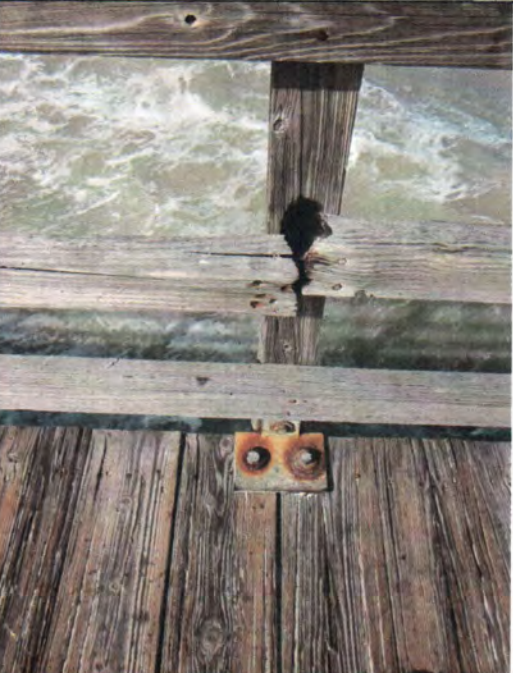
<p><u>Description:</u> Gaps between rail post and rail may look like an ideal spot to temporarily hold and/or hide a still-lit cigarette butt. Here is one of such location which accidentally caught on fire (possibly unnoticed burn) leaving a charred hollow as evidence on the post.</p> <p>Prohibiting smoking on the pier may be the ideal policy to safeguard against fire hazard by still-lit cigarette butts lodged in the wood cracks and crevices.</p>

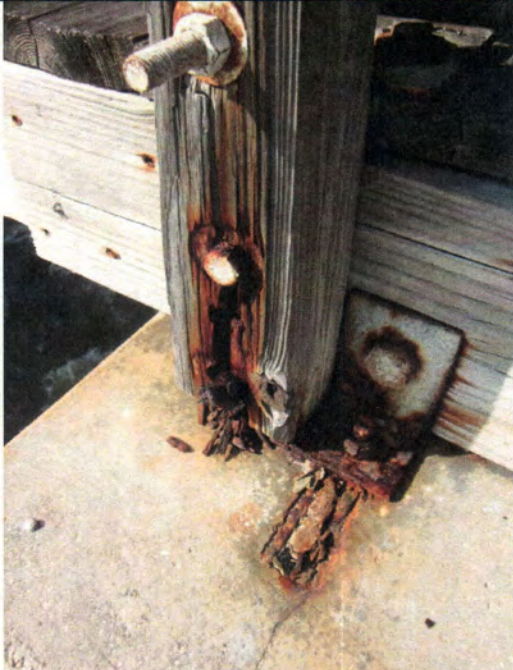
<p><u>Issue:</u> Similar pattern of rail post and thru-bolt connection issue.</p> <p>Note corrosion of the exposed adjustable-slot may preclude the provision that allows for stringer's lateral movement and adjustment.</p> <p><u>Resolution:</u> See preceding resolution.</p>

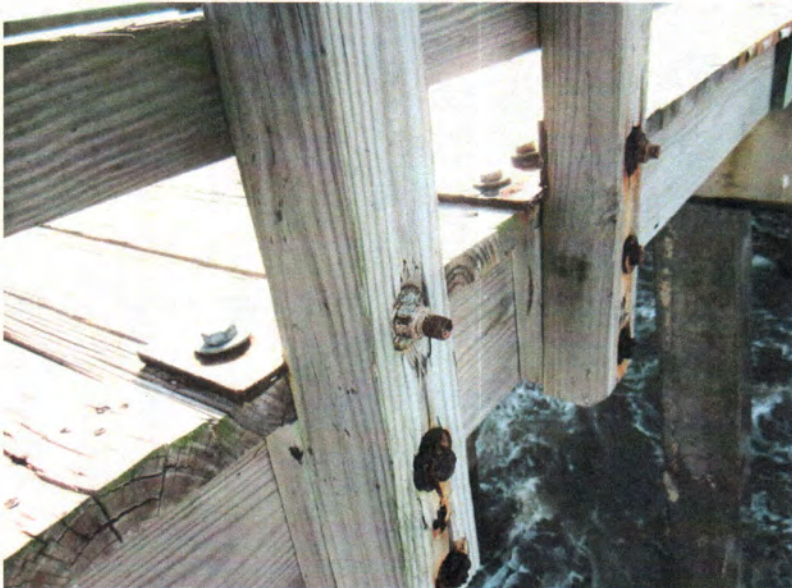
<p><u>Issue:</u> See preceding issue. This pair is only for mounting pedestrian lighting.</p> <p><u>Resolution:</u> See preceding resolution.</p>

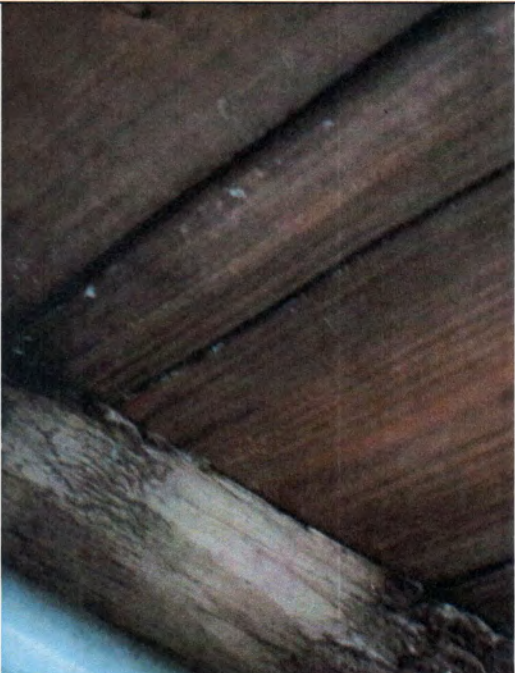
<p><u>Description:</u> Typical view of the substructure framing and the condition of the decking underside in the vicinity of Pier #32. Note the fiber split in the deck board despite its fresh appearance. Close up on the part of the stringer indicates some level of wood surface decay is taking place.</p>

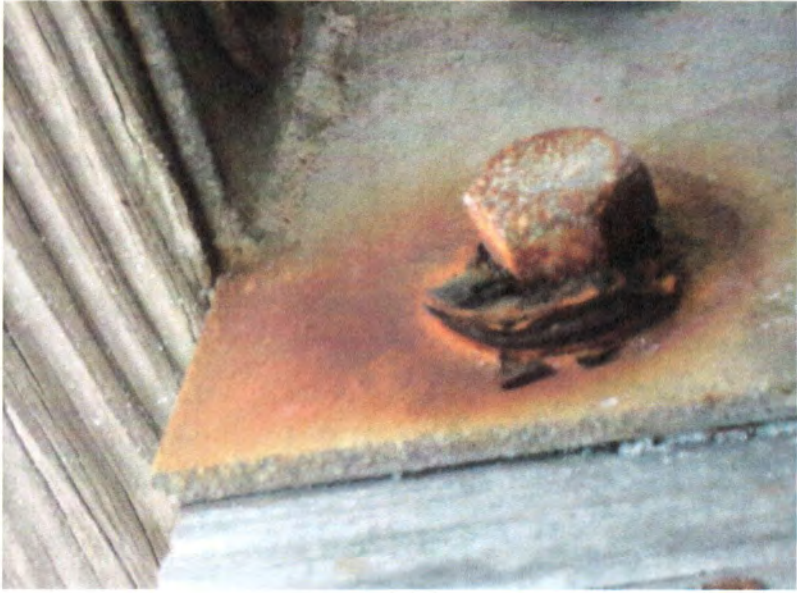
<p><u>Issue:</u> View of the post-to-deck clip angle lag screw connection undergoing early corrosion beginning with washers.</p> <p><u>Resolution:</u> See preceding resolution.</p>

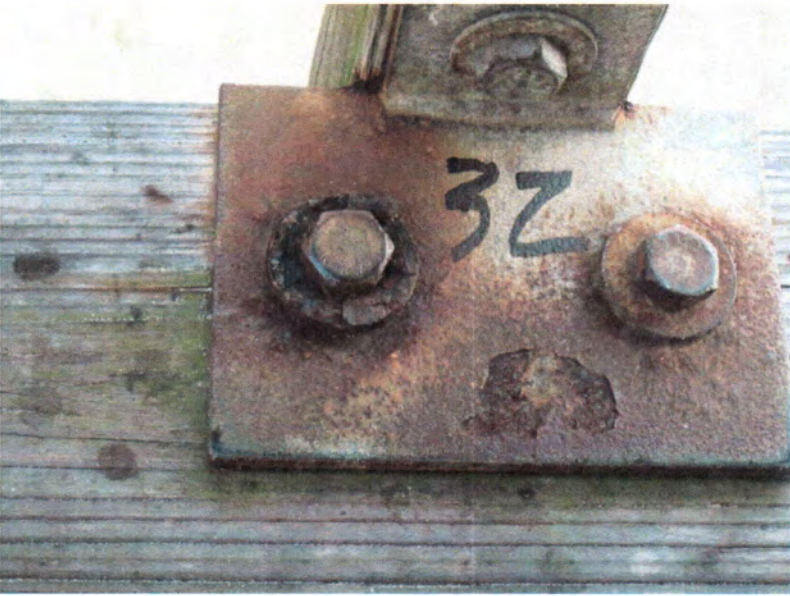
<p><u>Description:</u> View over Pier #32. Note horizontal connection hardware corrosion beginning with washers.</p>

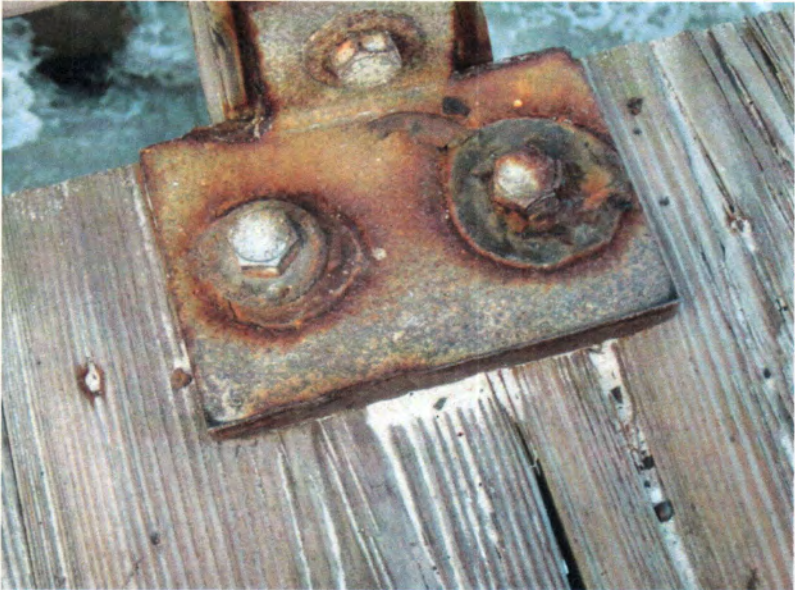
<p><u>Issue:</u> View of the post-to-deck clip angle lag screw connection undergoing early corrosion beginning with washers.</p> <p><u>Resolution:</u> See preceding resolution.</p>

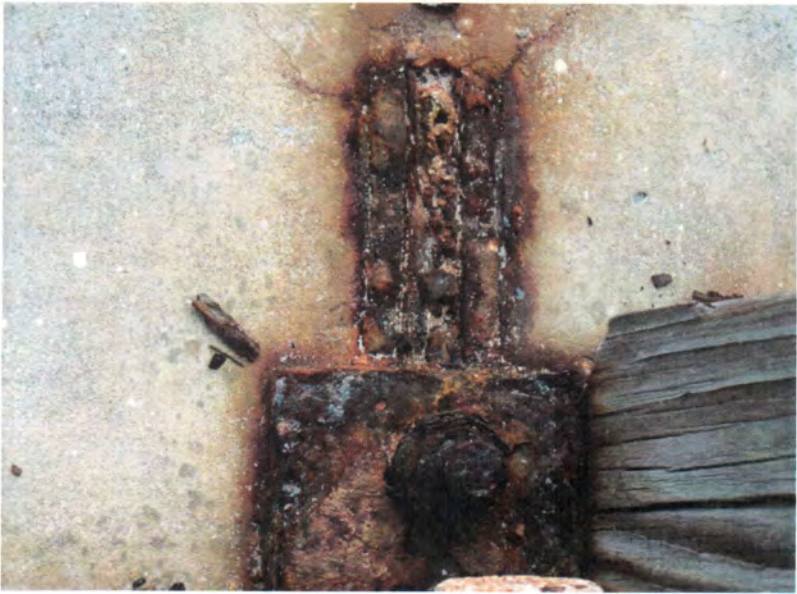
A close-up photograph showing a vertical wooden beam with a hole. A metal fastener is visible through the hole, and the wood around it appears to be damaged or charred. The background shows a concrete surface and some water.	<p><u>Issue:</u> Similar pattern of rail post and thru-bolt connection issue.</p> <p>Note corrosion of the exposed adjustable-slot may preclude the provision that allows for stringer's lateral movement and adjustment.</p> <p><u>Resolution:</u> See preceding resolution.</p>

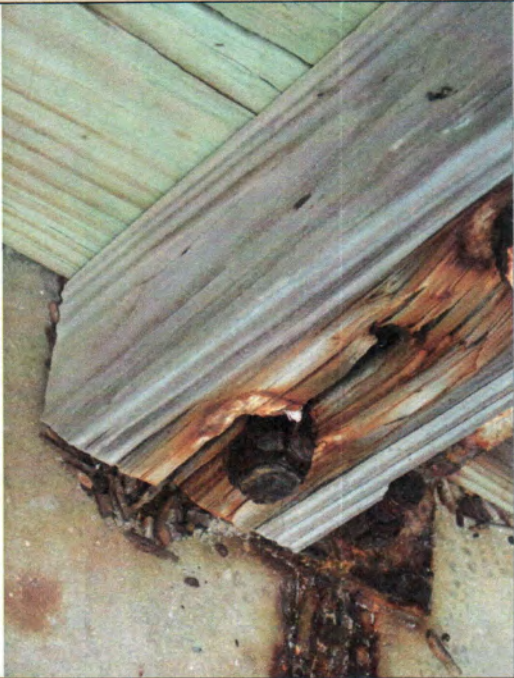
<p><u>Issue:</u> Similar pattern of rail post and thru-bolt connection issue.</p> <p>Note corrosion of the exposed adjustable-slot may preclude the provision that allows for stringer's lateral movement and adjustment.</p> <p><u>Resolution:</u> See preceding resolution.</p>

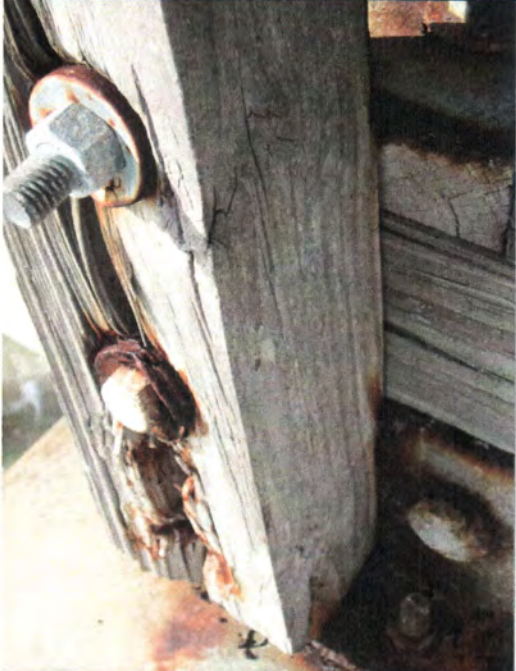
<p>Issue: Similar pattern of rail post and thru-bolt connection issue.</p> <p>Resolution: See preceding resolution.</p>

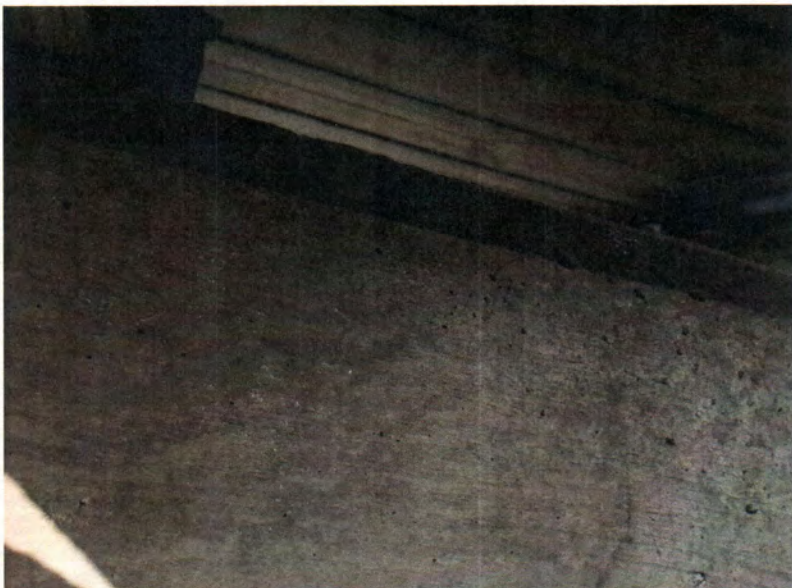
<p>Description: View of the underside at Pier #39. Note the electrical junction box with missing cover.</p>

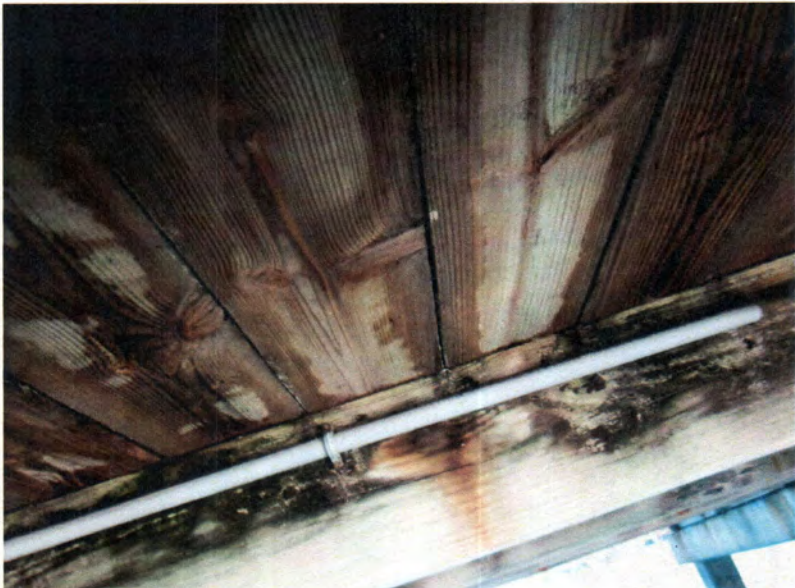
<p>Issue: In stormy day and high waves the deck is being washed in sea spray for the duration. Note the boards are soggy from such weather event. Note the small pipe/conduit appears to have been broken off.</p> <p>Resolution: Perform periodic inspection of the utility piping below deck. Repair/replace/remove broken piping. Provide new plastic pipe straps with better working strength and durability (i.e. more material thickness/cross-section, mass, etc).</p>

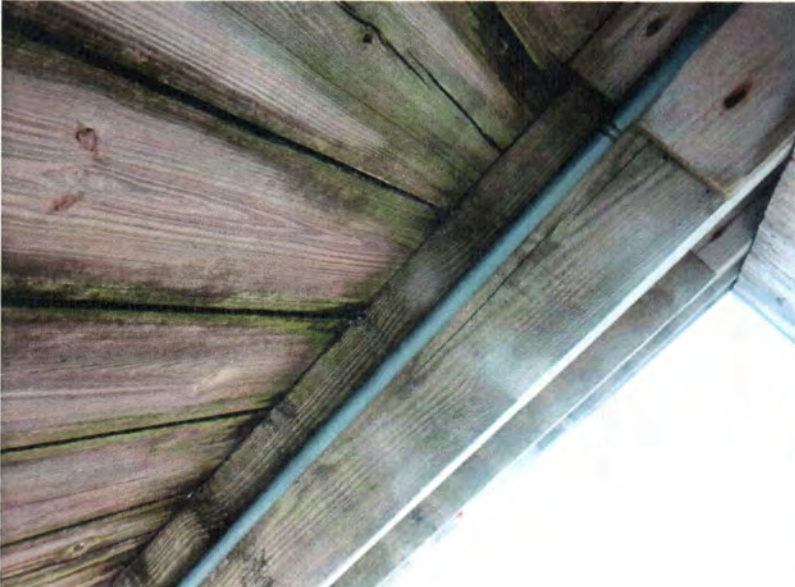
A close-up photograph of the wooden deck and utility piping. The wooden planks are weathered and show signs of damage, including a split fiber on the right. A blue utility pipe is visible, secured with a metal strap.	<p>Issue: In stormy day and high waves the deck is being washed in sea spray for the duration. Note the boards are soggy from such weather event. Note board with split fiber to the right.</p> <p>Resolution: Perform periodic inspection of the utility piping below deck. Repair/replace/remove broken piping. Provide new plastic pipe straps with better working strength and durability (i.e. more material thickness/cross-section, mass, etc).</p>

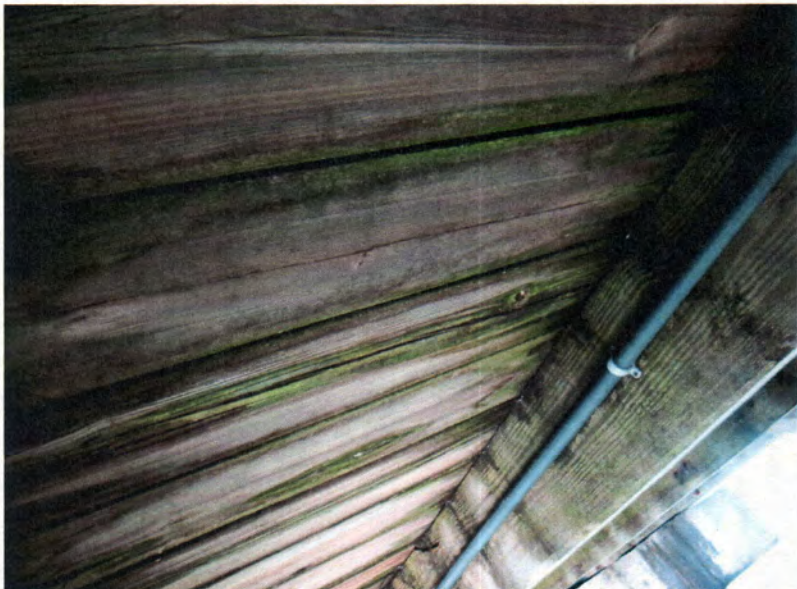
A close-up photograph of the wooden deck. The planks are dark and show signs of weathering, including a prominent vertical crack in the center of one plank. A blue utility pipe is visible running along the edge of the deck.	<p>Issue: In stormy day and high waves the deck is being washed in sea spray for the duration. Note the boards are soggy from such weather event. Note board with split fiber in the center.</p> <p>Resolution: Perform periodic inspection of the utility piping below deck. Repair/replace/remove broken piping. Provide new plastic pipe straps with better working strength and durability (i.e. more material thickness/cross-section, mass, etc).</p>

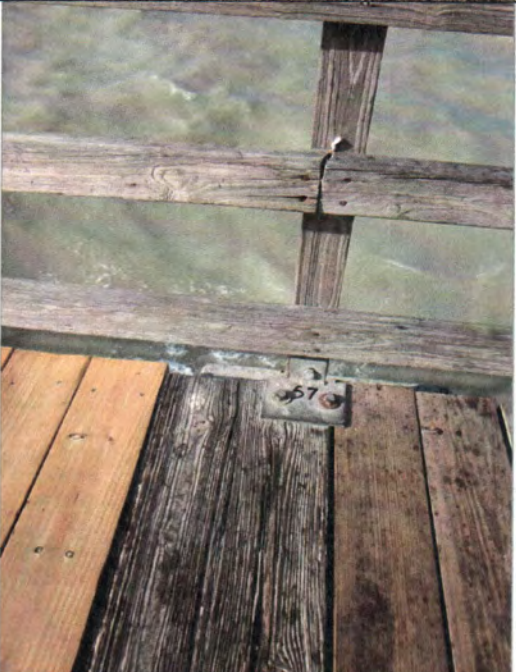
<p><u>Description:</u> View over Pier #57. Note the decaying board beside new replacement boards.</p>

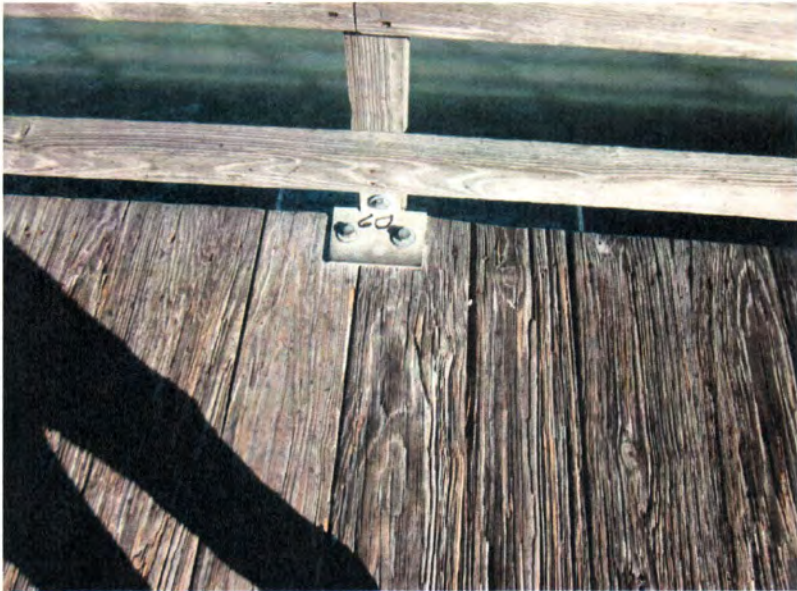
<p>Description: View over Pier #60. Note the decking displays severe wear and tear.</p>
