**COLLIER COUNTY TOURIST DEVELOPMENT COUNCIL
CATEGORY "A" GRANT APPLICATION**

Naples Pier Deck Replacement and Structural Renovation

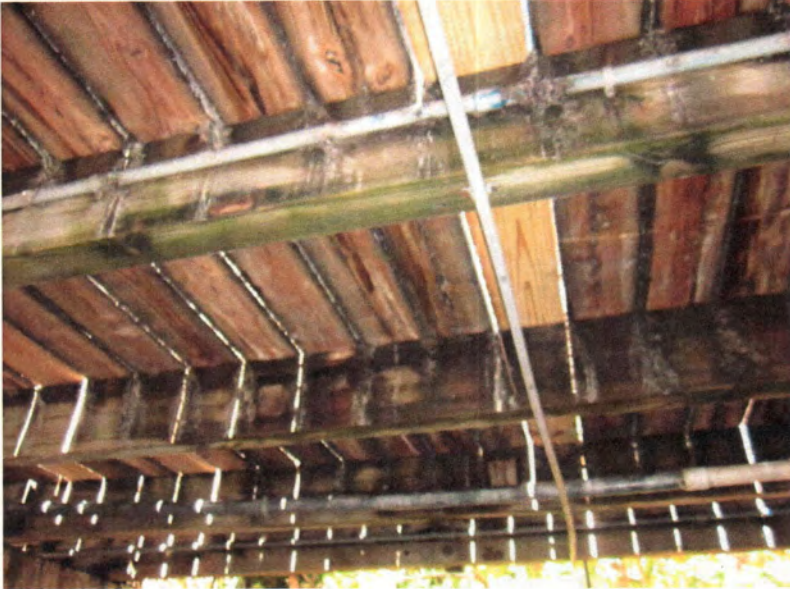
<p>Description: View of the decking underside in between Pier# 2 and Pier #3. The underside surface and the stringers appear to be in satisfactory condition. Note water piping and electrical conduits strapped to the stringers.</p>

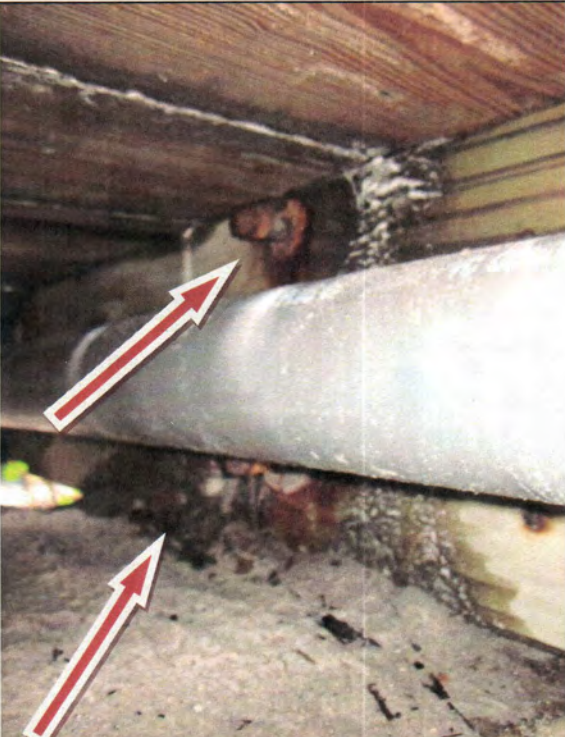
<p>Issue: Electrical conduits and small water pipes are strapped to the stringers with plastic straps or in some cases plastic hangers. Note the corroding washers and complete loss of hex-nuts, of both of the thru-bolt connectors, to corrosion, at the base of a rail post over Pier #3. The anchor bolt and clip angle appear to have completely corroded away as well.</p> <p>Resolution: Perform regular inspection and replace severely corroded washers and hex-nuts.</p>

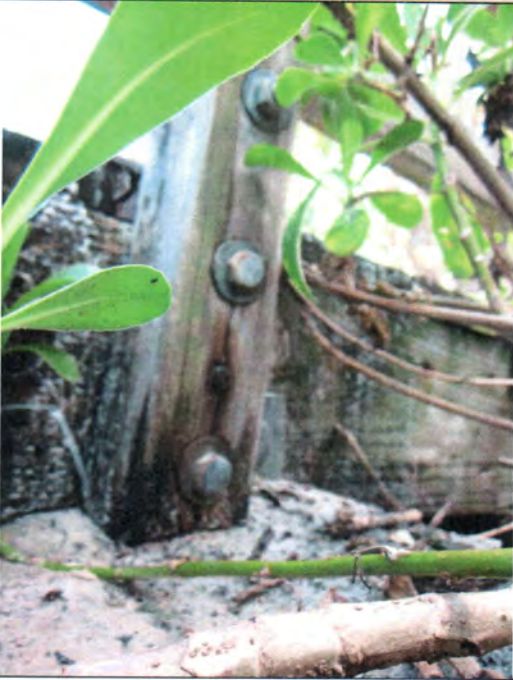
<p>Description: The thru-bolt connectors at the base of this rail post on the outside appear to be sound and free from corrosion, with the exception of the single nail in the middle.</p>

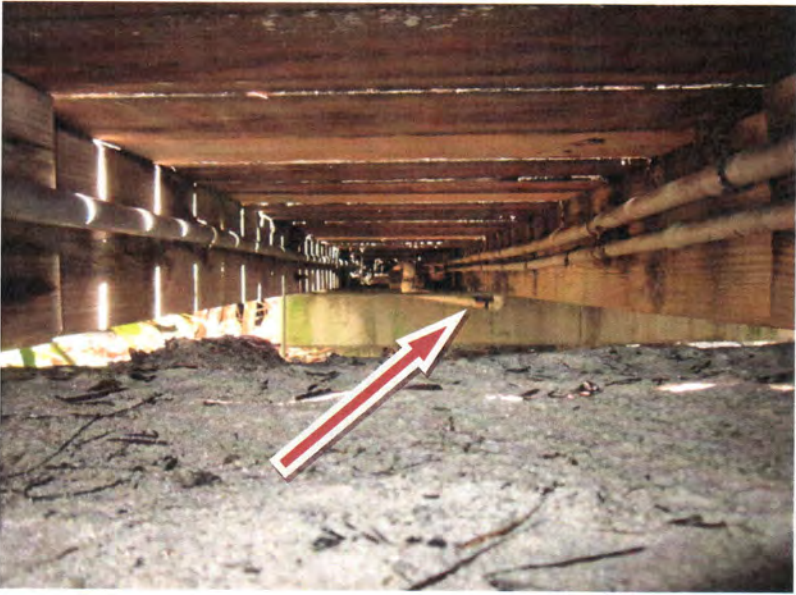
<p>Issue: View of the decking underside between the deck board span, looking back at Pier #3. Deck board underside and stringers appear satisfactory. There is an area of concrete spall along the edge of the pile cap beyond. Note water piping on right and electrical conduit on left.</p> <p>Resolution: Patch the spall spot with epoxy concrete to prevent further corrosion of the pile cap reinforcing bars.</p>

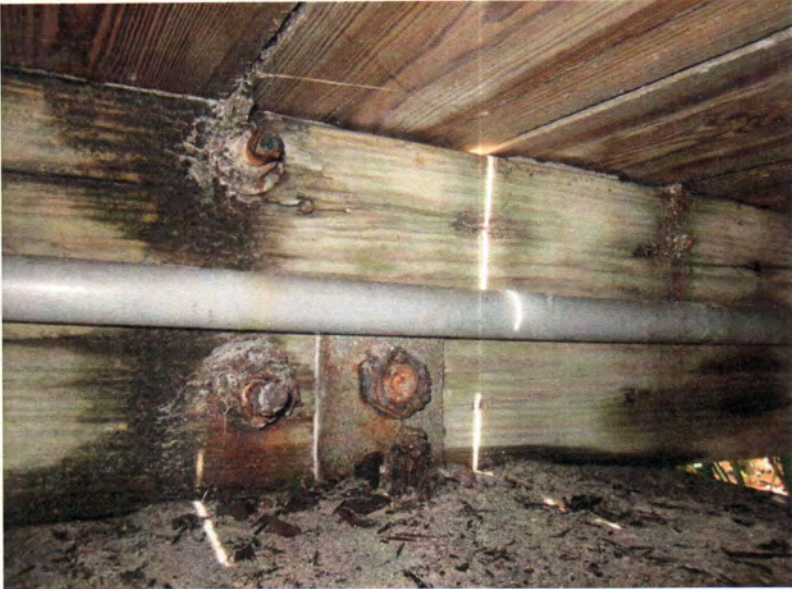
<p><u>Issue:</u> The rail post thru-bolt connectors and anchor bolt/ clip angle assembly on this side are undergoing severe corrosion as well.</p> <p><u>Resolution:</u> Perform regular inspection and replace severely corroded washers and hex-nuts. In some case the galvanized clip angle may need replacement as well.</p>

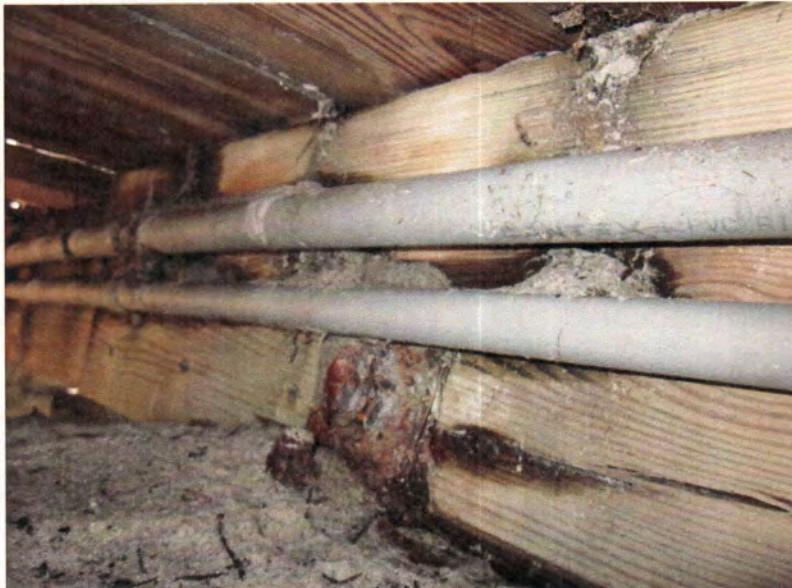
<p><u>Issue:</u> View of an inside stringer anchor bolt/clip angle assembly which is normally buried under the beach sand causing accelerated corrosion of the metal hardware.</p> <p><u>Resolution:</u> Regular inspection and replacement of deteriorated hardware is required.</p>

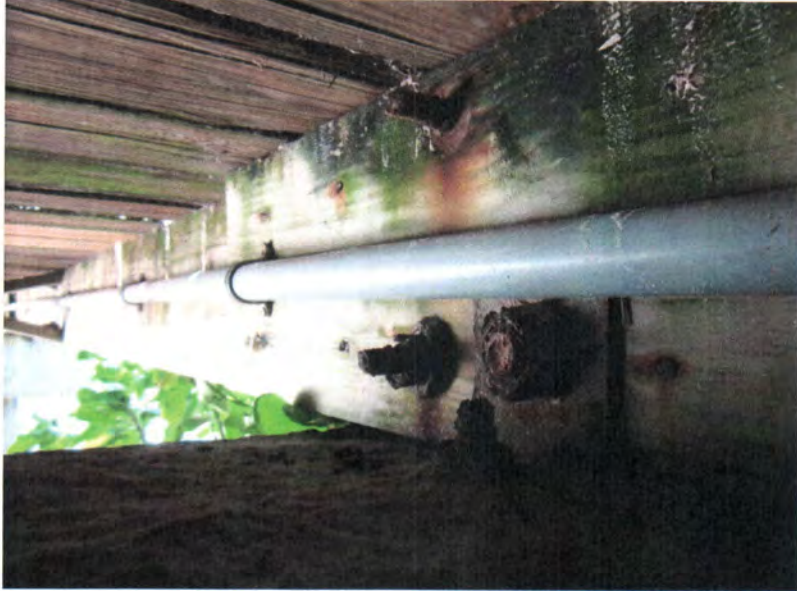
<p><u>Issue:</u> The rail post thru-bolt connectors and anchor bolt/ clip angle assembly on this side are undergoing severe corrosion as well. Note the top thru-bolt washer and hex-nut have been corroded away.</p> <p><u>Resolution:</u> Perform regular inspection and replace severely corroded washers and hex-nuts. In some case the galvanized clip angle may need replacement as well.</p>

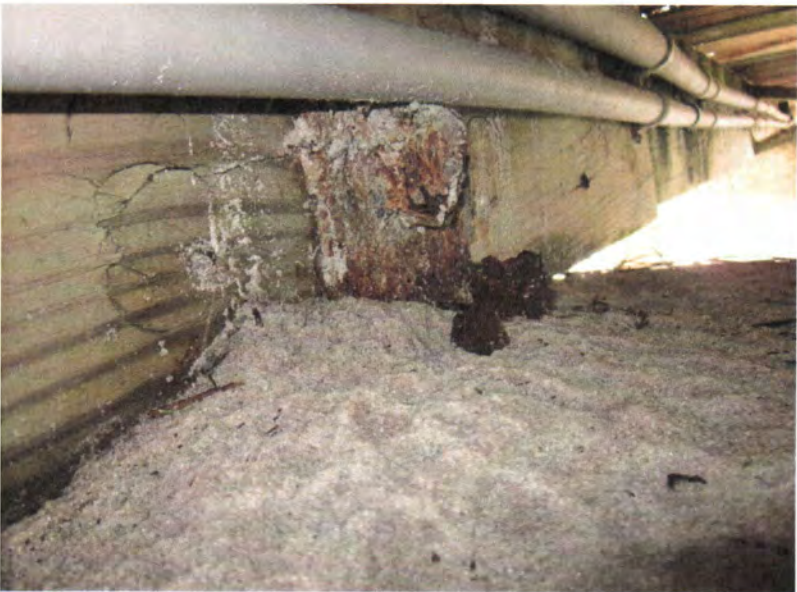
<p><u>Issue:</u> View of an inside stringer anchor bolt/clip angle assembly which is normally buried under the wet beach sand and debris causing accelerated corrosion of the metal hardware.</p> <p><u>Resolution:</u> Regular inspection and replacement of deteriorated hardware is required.</p>

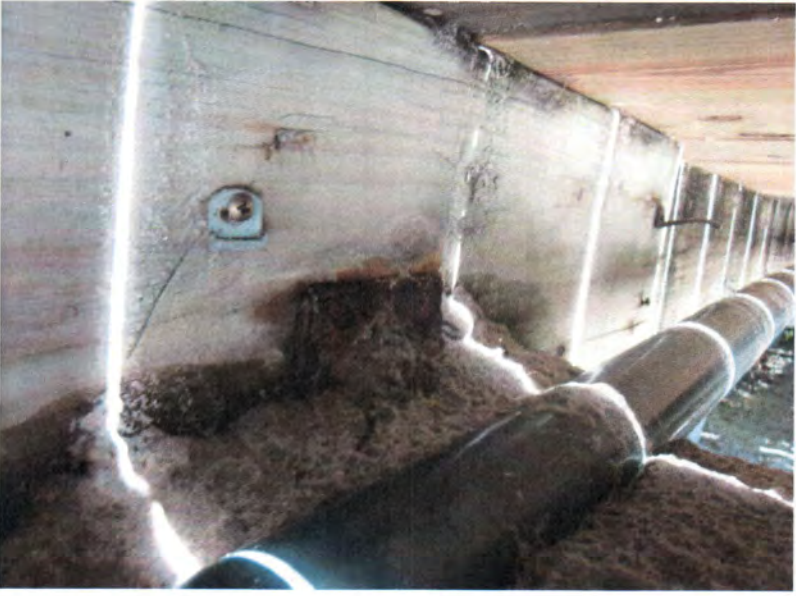
<p>Issue: See preceding issue. Note the broken pipe straps leaving the conduit/pipe unsupported.</p> <p>Resolution: Inspect and replace corroded metal hardware. Replace all broken plastic pipe straps and hangers to properly support the pipe/conduit.</p>

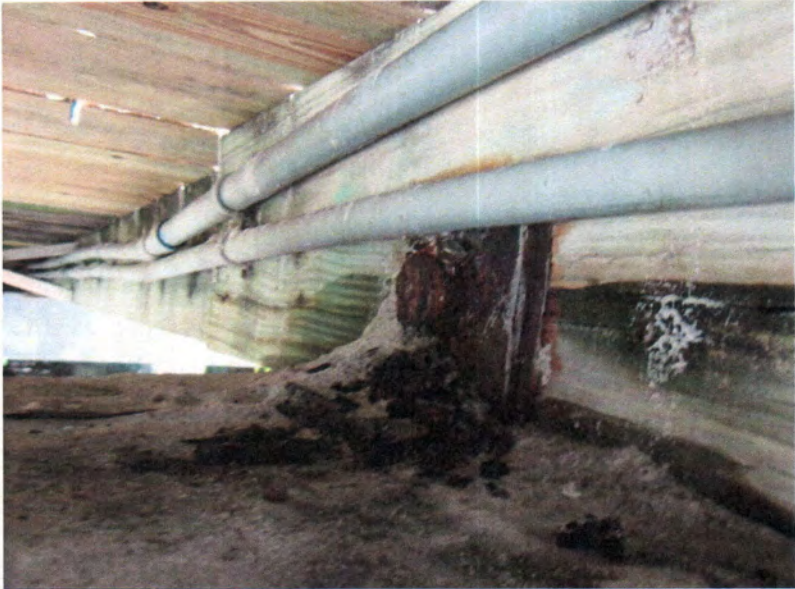
<p><i>Issue:</i> See preceding issue.</p> <p><i>Resolution:</i> Inspect and replace corroded metal hardware. Replace all broken plastic pipe straps and hangers to properly support the pipe/conduit.</p>

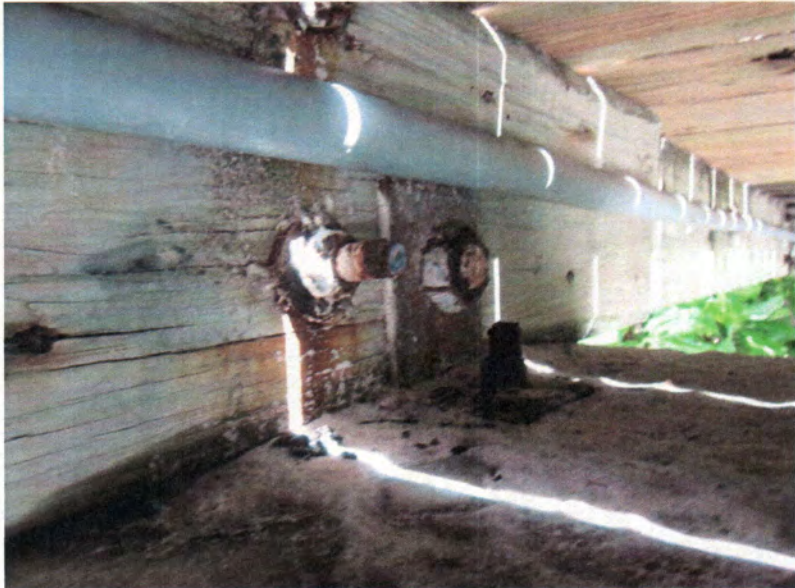
<p><i>Issue:</i> See preceding issue.</p> <p><i>Resolution:</i> Inspect and replace corroded metal hardware. Replace all broken plastic pipe straps and hangers to properly support the pipe/conduit.</p>

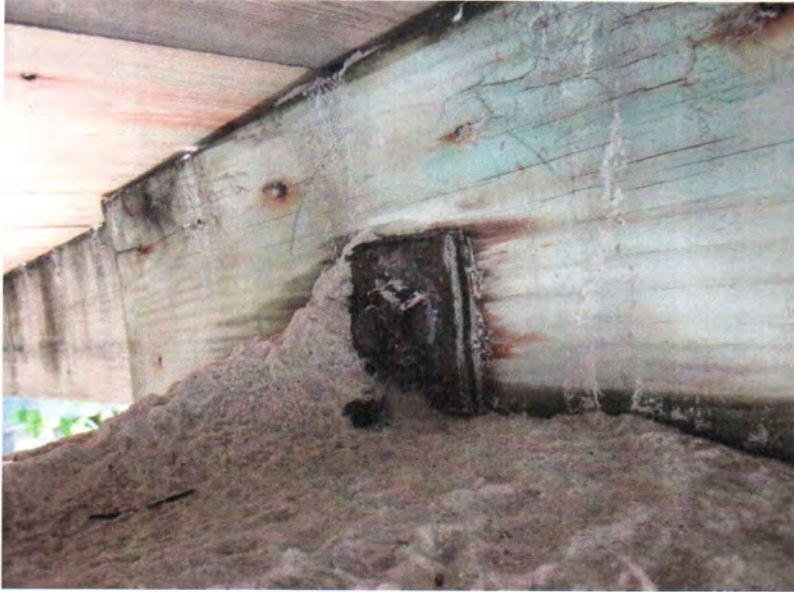
<p><u>Issue:</u> See preceding issue.</p> <p><u>Resolution:</u> See preceding resolution.</p>

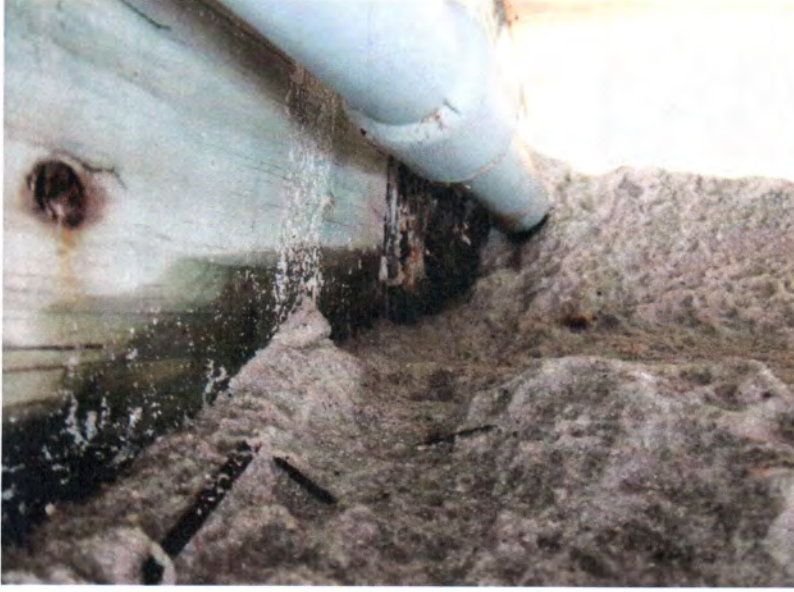
<p><u>Issue:</u> See preceding issue.</p> <p><u>Resolution:</u> Inspect and replace corroded metal hardware. Replace all broken plastic pipe straps and hangers to properly support the pipe/conduit.</p>

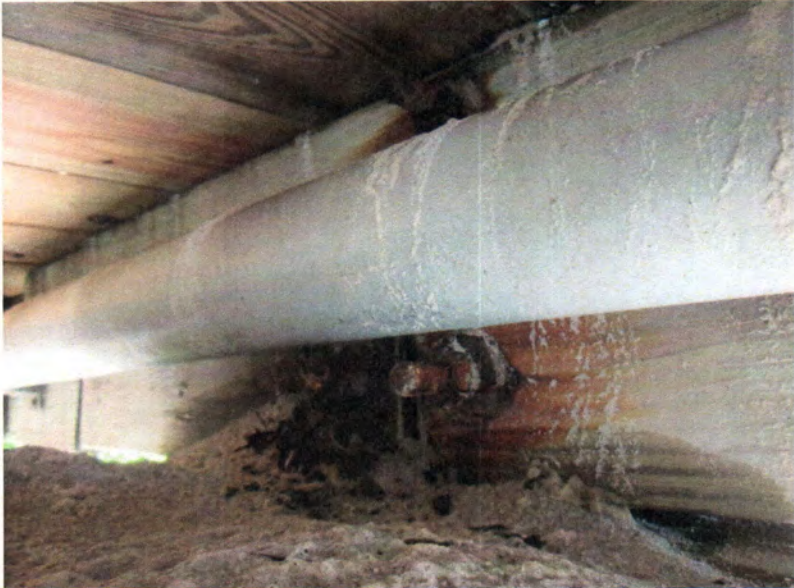
<p><i>Issue:</i> See preceding issue.</p> <p><i>Resolution:</i> Inspect and replace corroded metal hardware. Replace all broken plastic pipe straps and hangers to properly support the pipe/conduit.</p>

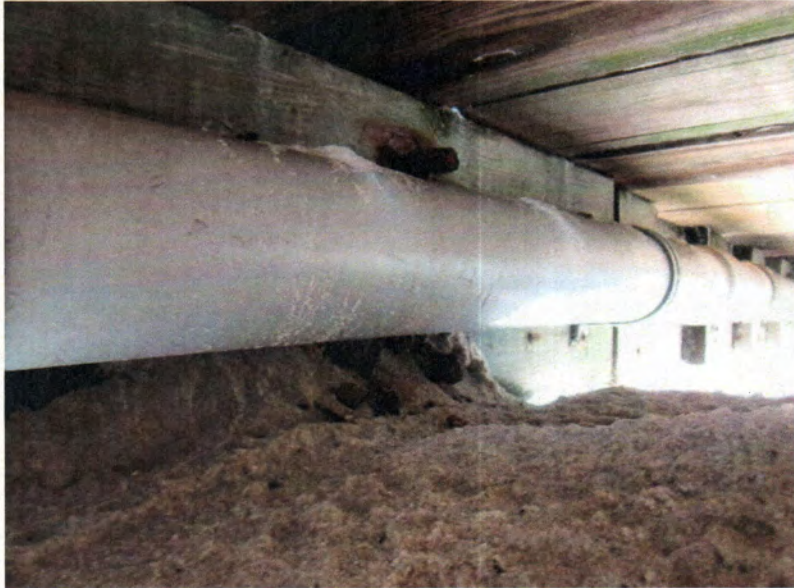
<p><i>Issue:</i> See preceding issue.</p> <p><i>Resolution:</i> Inspect and replace corroded metal hardware. Replace all broken plastic pipe straps and hangers to properly support the pipe/conduit.</p>

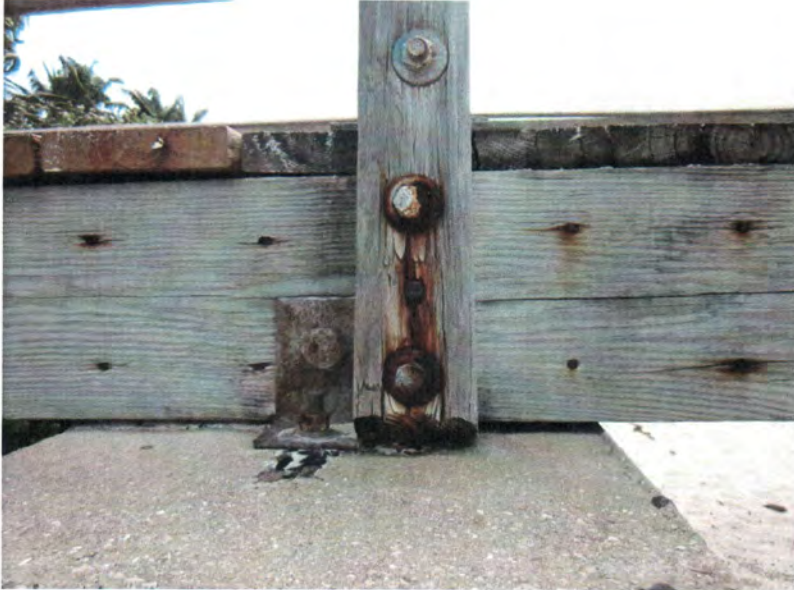
<p>Description: The rail post base thru-bolts display sign of corrosion which starts from the opposite side. The anchor bolt/clip angle assembly appears satisfactory.</p>

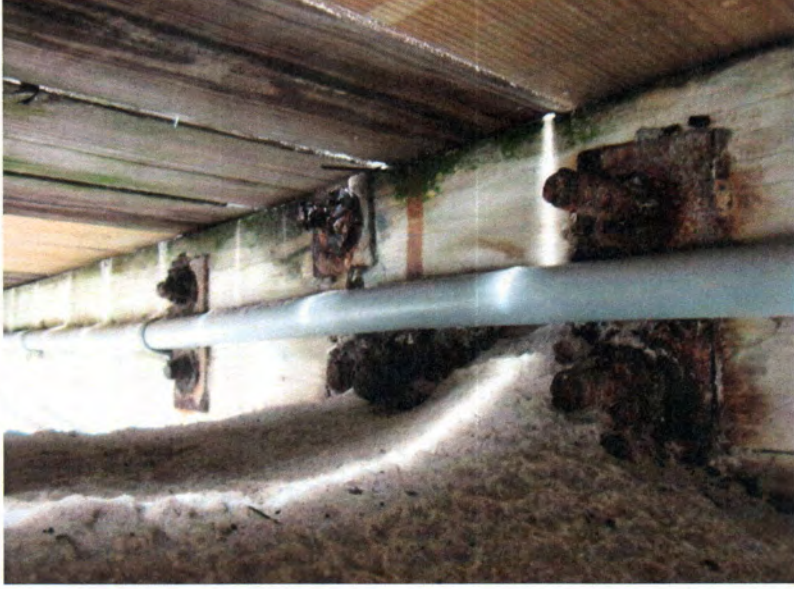
<p><i>Issue:</i> View of the same assembly on the interior face, which reveals severe corrosion of almost all the thru-bolts.</p> <p><i>Resolution:</i> Inspect and replace corroded metal hardware. Replace all broken plastic pipe straps and hangers to properly support the pipe/conduit.</p>

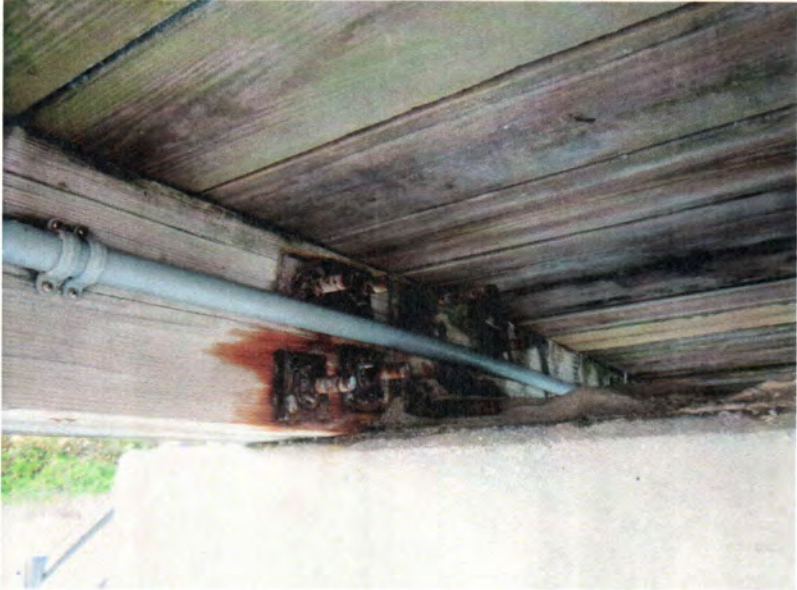
<p><u>Issue:</u> View of the same assembly on the inside face, which reveals severe corrosion of almost all the thru-bolts.</p> <p><u>Resolution:</u> Inspect and replace corroded metal hardware. Replace all broken plastic pipe straps and hangers to properly support the pipe/conduit.</p>

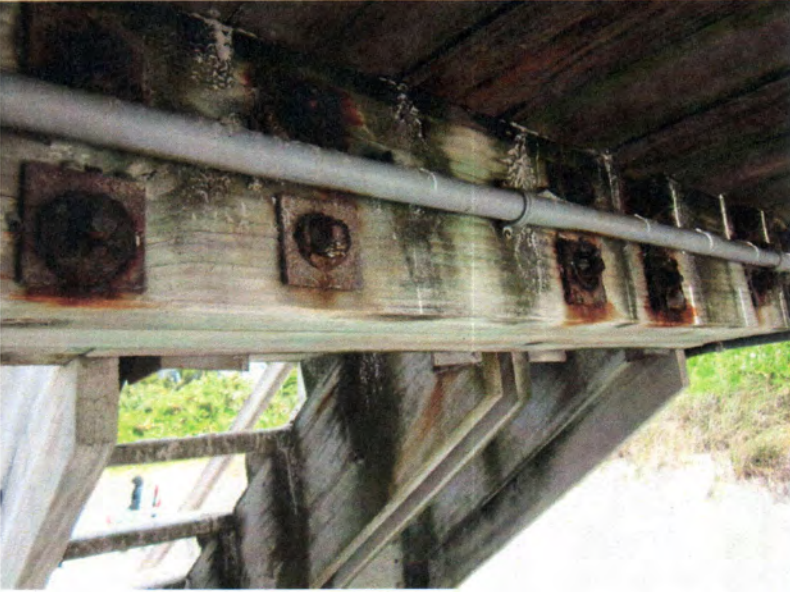
<p>Issue: View of the rail posts/stair stringer/deck stringer thru-bolt connections on the inside face of the deck stringer.</p> <p>Resolution: Inspect and replace corroded metal hardware.</p>

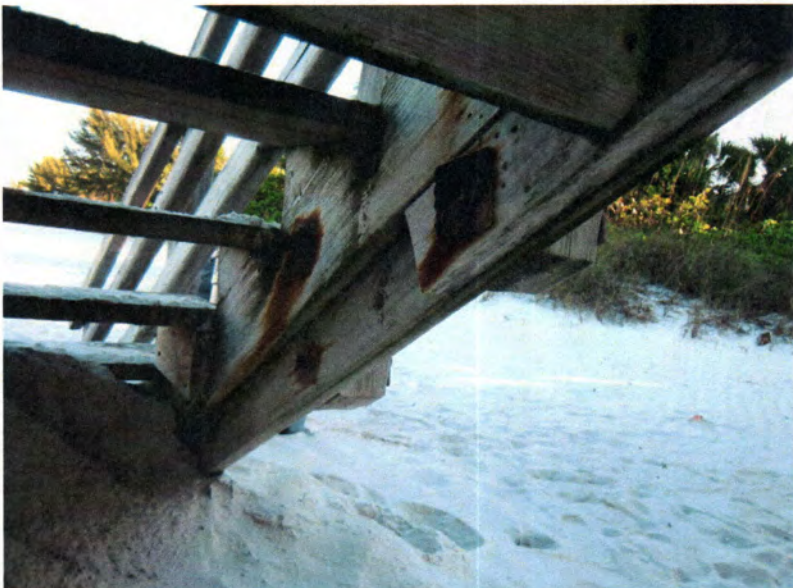
<p>Issue: Almost all of the stair assembly thru-bolt connections display severe corrosion of the metal hardware.</p> <p>Resolution: Inspect and replace corroded metal hardware.</p>

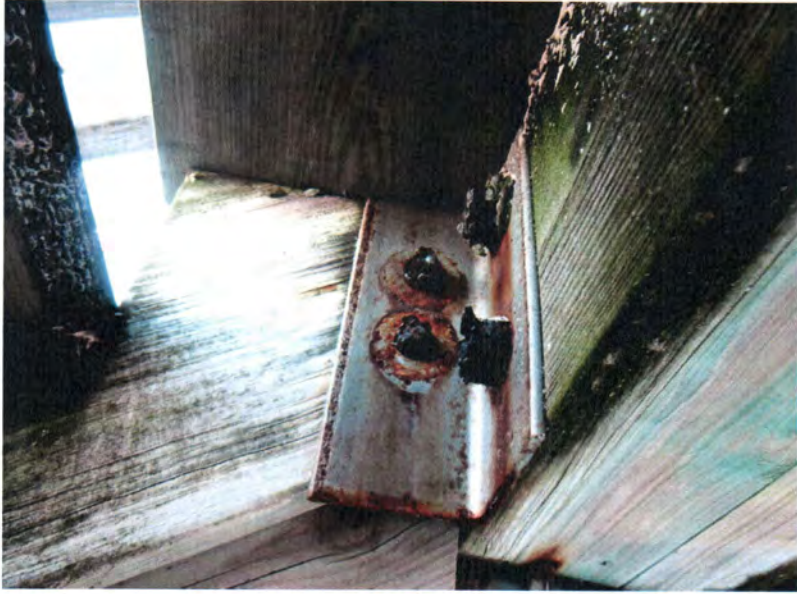
<p><u>Issue:</u> Stair stringer/deck stringer vertical connection assembly display severe corrosion of the metal hardware.</p> <p><u>Resolution:</u> Inspect and replace corroded metal hardware. To ensure structural soundness and durability, and to provide users a sense of safety and aesthetic, the entire stair may have to be rebuilt with better corrosion and weather resistant materials in near term.</p>

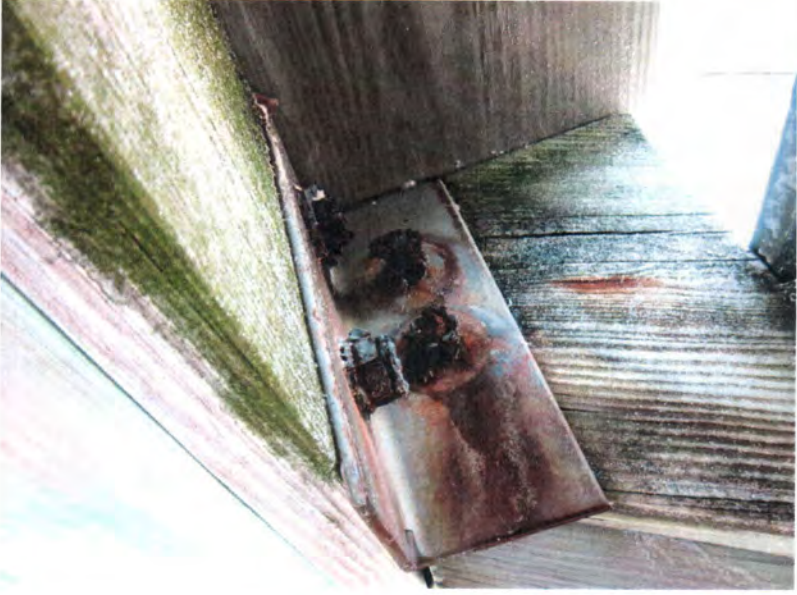
<p><u>Issue:</u> See preceding issue.</p> <p><u>Resolution:</u> See preceding resolution.</p>

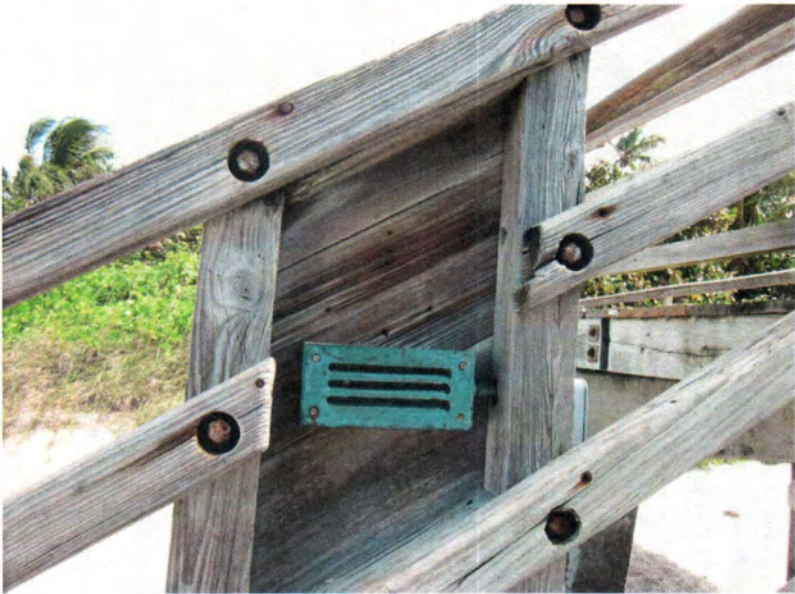
<p><u>Issue:</u> See preceding issue. Note the surface mount pedestrian louvered lighting fixture.</p> <p><u>Resolution:</u> See preceding resolution.</p>

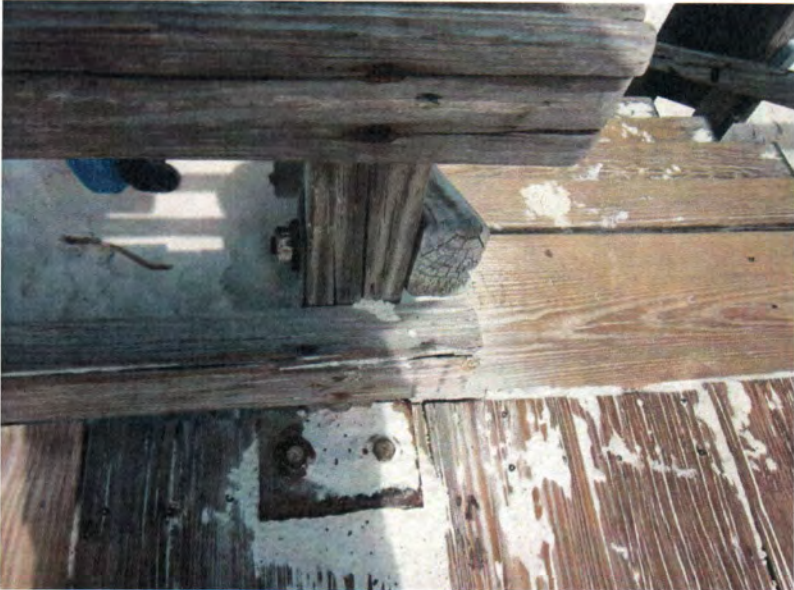
<p><i>Issue:</i> See preceding issue.</p> <p><i>Resolution:</i> See preceding resolution.</p>

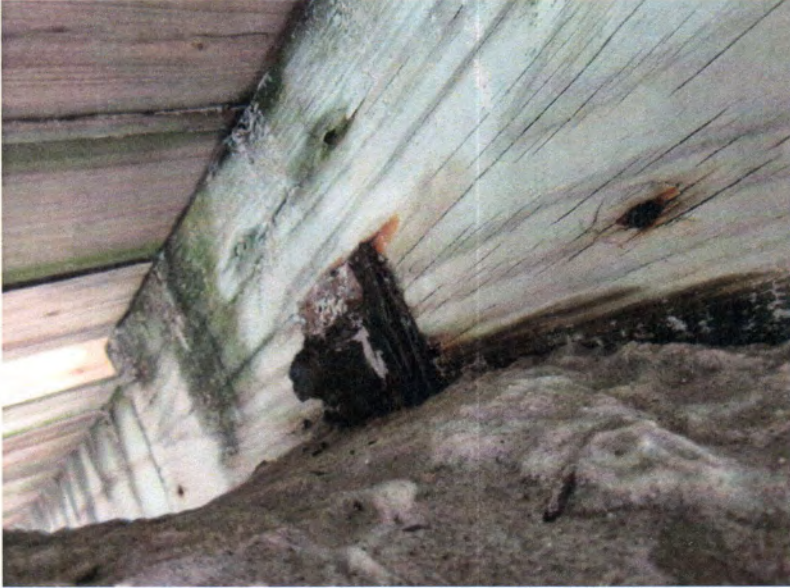
<p>Issue: View of repeated pattern of severe corrosion of thru-bolt and anchor bolt assembly due to near-constant wetness condition on top of the pile cap and the lack of direct sunlight and airflow to help accelerate drying of all components under the decking.</p> <p>Resolution: Remove and replace substructure connection metal hardware with better corrosion resistant metal hardware, preferably stainless steel type, when the deck boards are due for removal and replacement.</p>

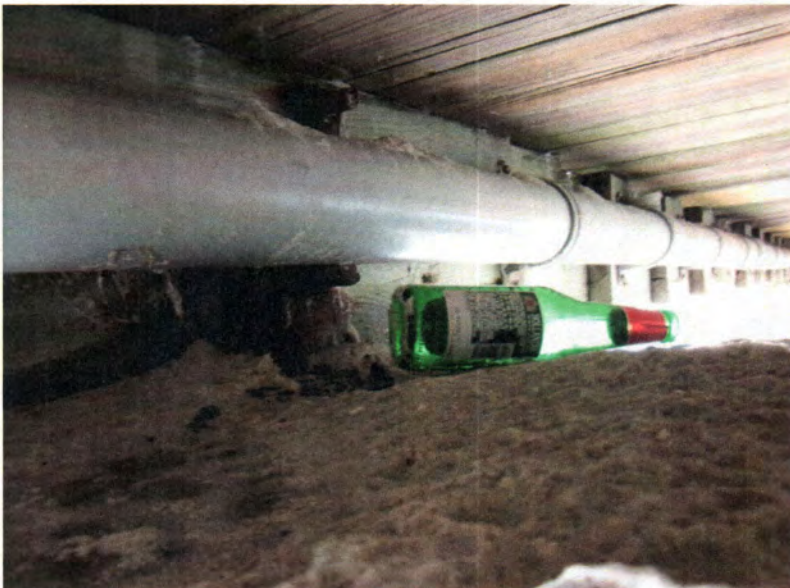
<p>Issue: See preceding issue.</p> <p>Resolution: See preceding resolution.</p>

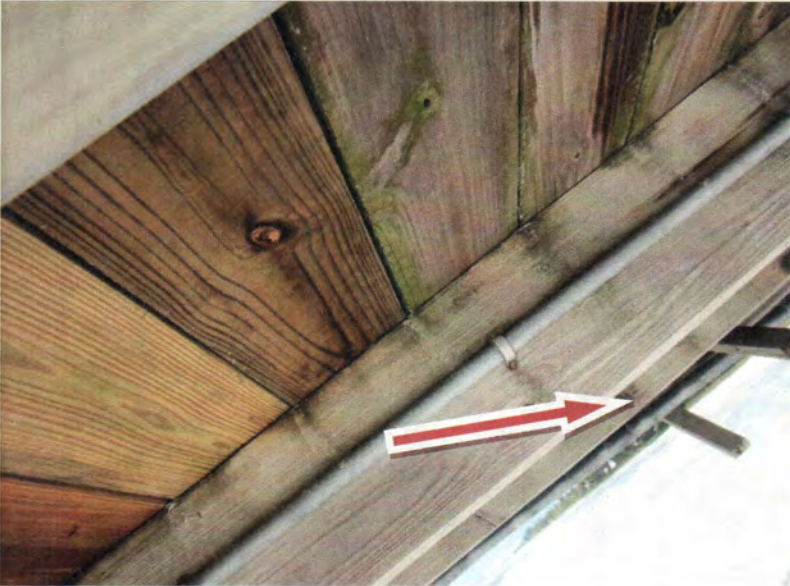
A close-up photograph of the underside of the pier decking. It shows the wooden framing and the gaps between the decking boards. A red arrow points to a specific area where a cross-brace is hanging loosely. There is visible algae growth in the gaps between the boards.	<p>Description: Typical view of the substructure framing and the condition of the decking underside from Pier #18. Note proliferation of algae between the gaps. Note multiple replacement boards. Also note some loose cross-bracing hanging beyond.</p>

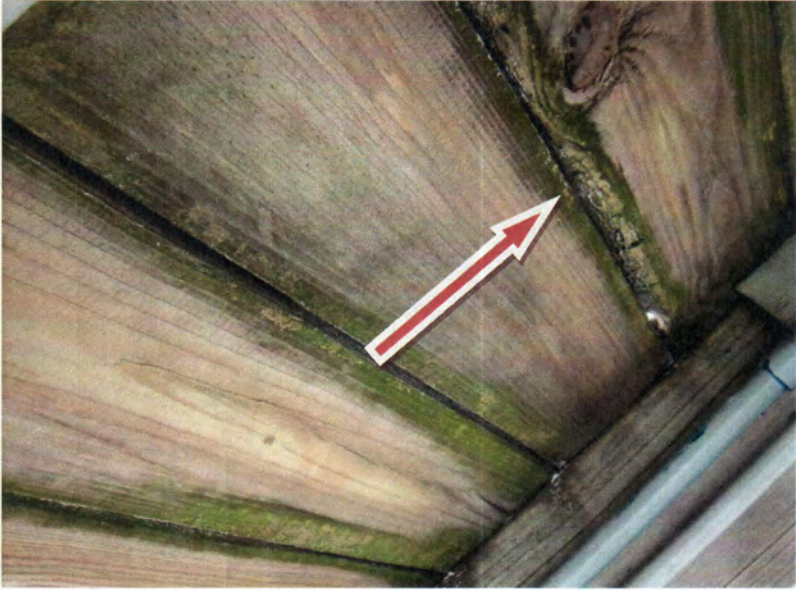
A close-up photograph of the substructure framing and decking underside from Pier #17. A red arrow points to a gap between the wooden boards, where there is a significant proliferation of green algae. The wood on the right side of the gap shows signs of decay and discoloration.	<p><i>Description:</i> Typical view of the substructure framing and the condition of the decking underside from Pier #17. Note proliferation of algae between the gaps. The board on the right is beginning to decay from the edge.</p>

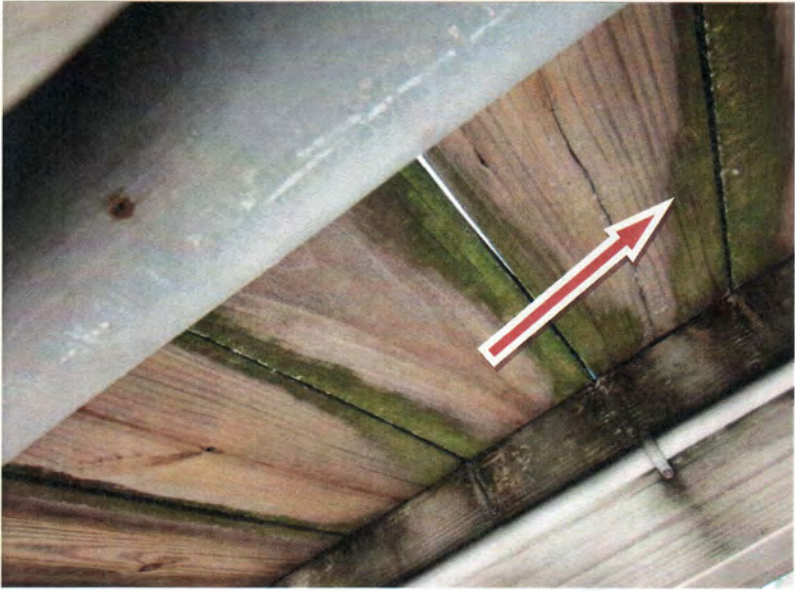
<p>Description: Typical view of the substructure framing and the condition of the decking underside from Pier #16. Note proliferation of algae between the gaps.</p>

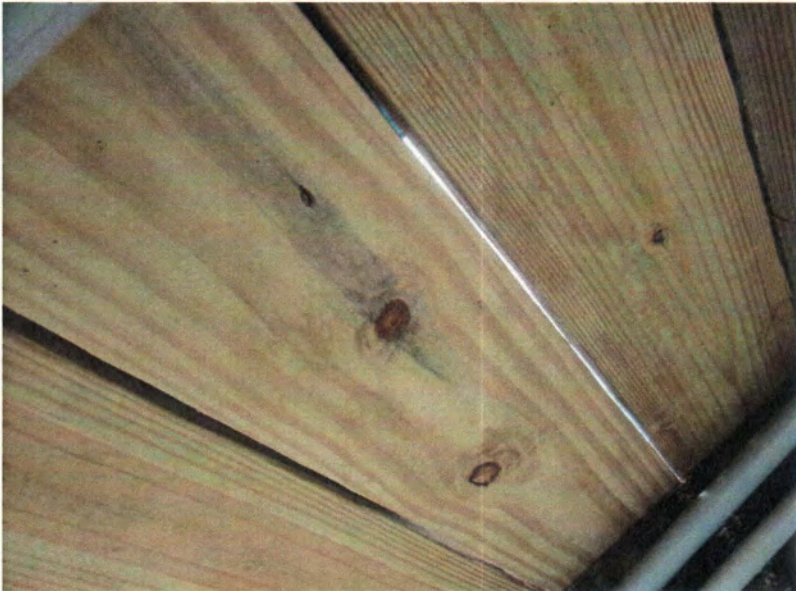
A close-up photograph of the substructure framing and decking underside from Pier #15. The image shows a diagonal wooden beam and several parallel decking boards. The wood is light-colored and shows signs of wear, including knots and discoloration. A metal fastener is visible on the diagonal beam.	<p>Description: Typical view of the substructure framing and the condition of the decking underside from Pier #15. Note multiple replacement boards.</p>

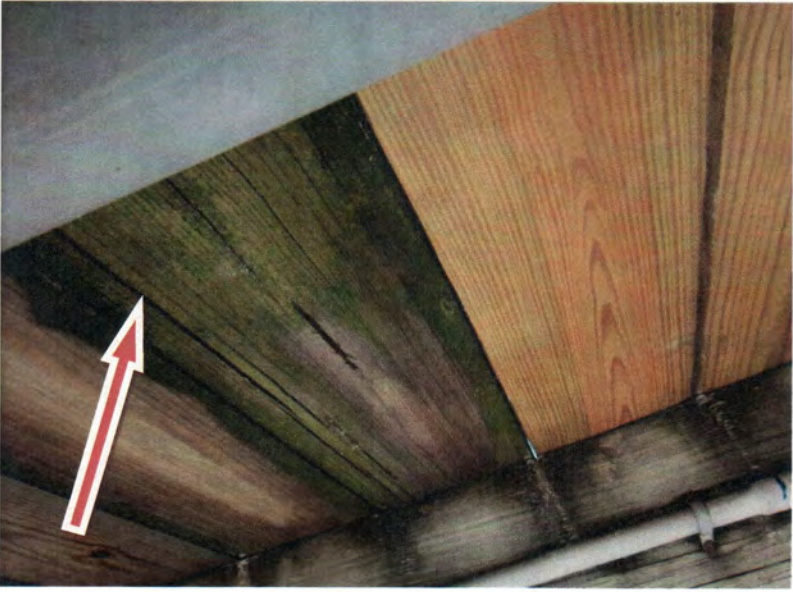
A photograph showing a close-up view of the wooden substructure framing. The image shows several wooden beams and planks. A red arrow points to a specific board that has a split fiber and is covered with green algae. A replacement board is also visible.	<p>Description: Typical view of the substructure framing and the condition of the decking underside from Pier #7. Note a board with split fiber and covered with algae which accelerates wood decay. Note replacement board.</p>

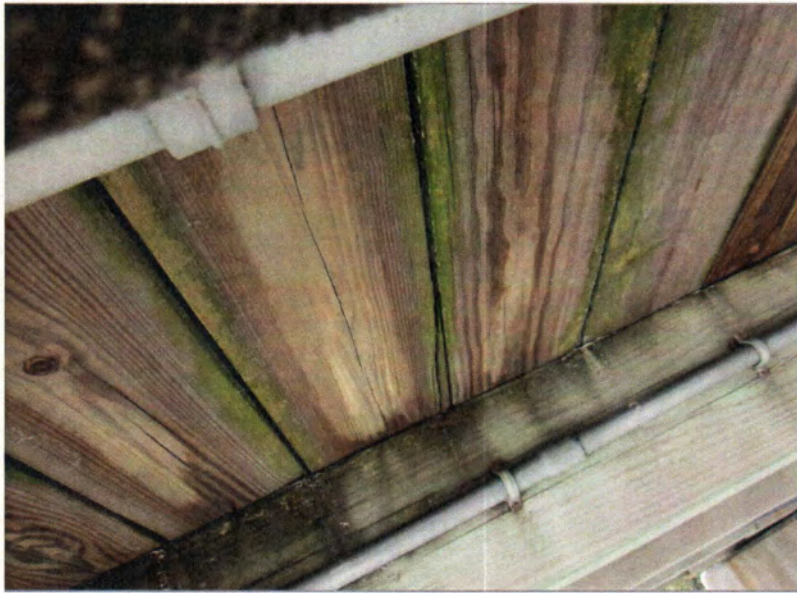
A close-up photograph of the underside of a wooden pier. It shows the substructure framing, including wooden beams and planks. There is significant green algae growth between the wooden boards.	<p>Description: Typical view of the substructure framing and the condition of the decking underside from Pier #7. Note algae growth between boards.</p>

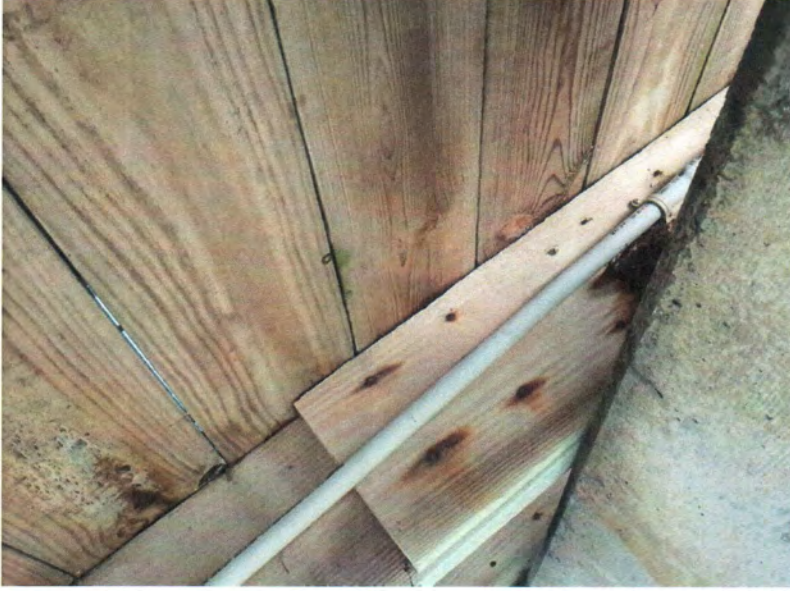
<p>Description: Typical view of the substructure framing and the condition of the decking underside at Pier #12. Note multiple replacement boards.</p>

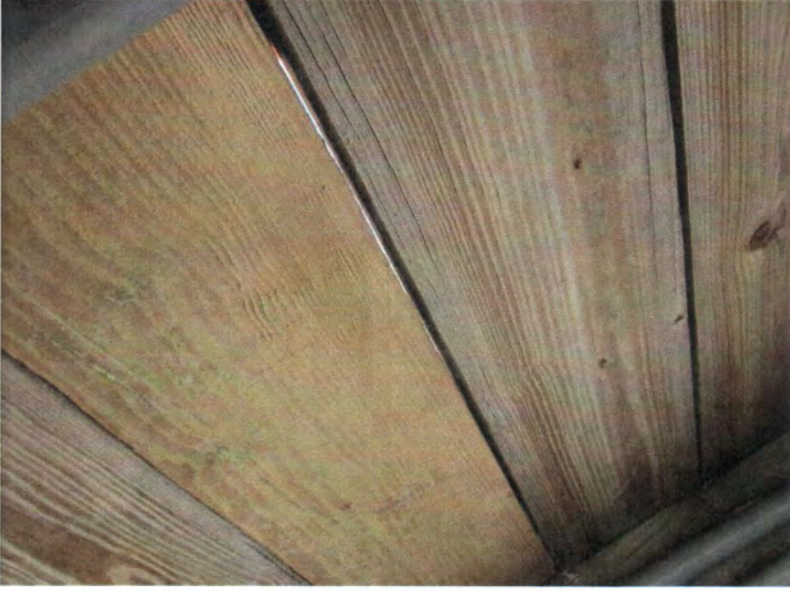
<p>Description: Typical view of the substructure framing and the condition of the decking underside from Pier #12. Note multiple replacement boards.</p>

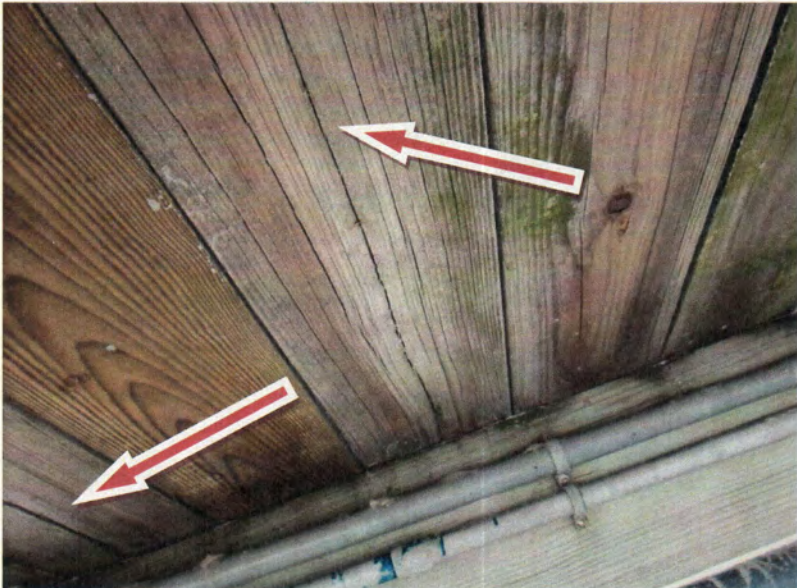
A close-up photograph of the substructure framing and decking. Two red arrows point to areas of wood with split fibers, indicating damage or decay. The wood is weathered and shows signs of mold or staining.	<p>Description: Typical view of the substructure framing and the condition of the decking underside from Pier #10. Note boards with split fiber.</p>

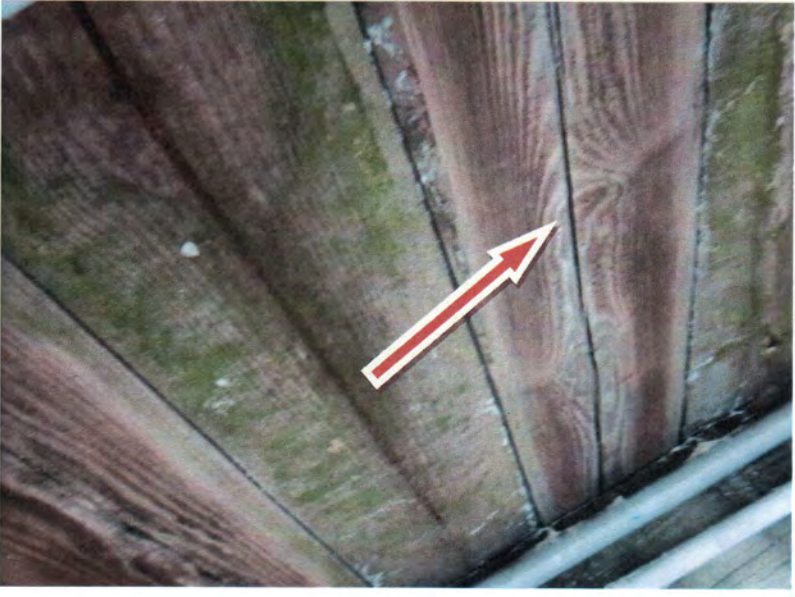
A close-up photograph of the wooden substructure framing and the underside of the decking from Pier #7. A red arrow with a white outline points to a specific board that exhibits split fiber, indicating a structural issue. The wood shows signs of weathering and moss growth.	<p><i>Description:</i> Typical view of the substructure framing and the condition of the decking underside from Pier #7. Note a board with split fiber.</p>

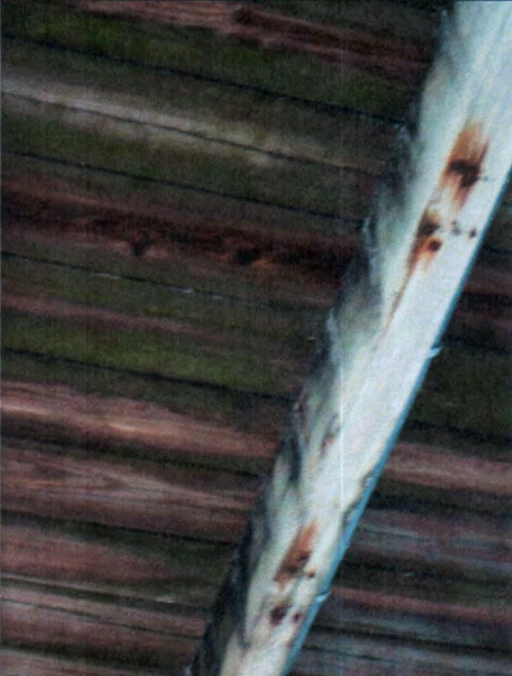
<p>Description: Typical view of the substructure framing and the condition of the decking between Pier #12 and Pier #13. The old deck boards display fiber splitting. The lack of direct sunlight and airflow in moisture rich deck underside proliferate algae growth.</p>

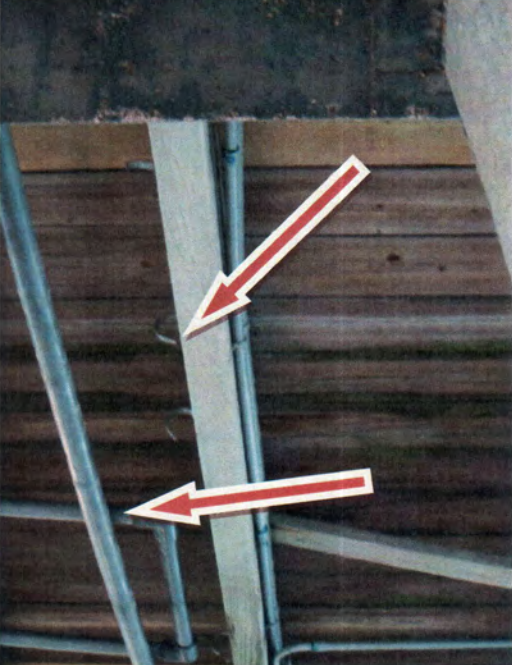
<p>Issue: View of the condition of the decking underside between Pier #12 and Pier #13. Note the main power conduit dropped away from its strapping along the inside stringer above.</p> <p>Resolution: Provide new plastic pipe straps with better working strength and durability (i.e. more material thickness/cross-section, mass, etc).</p>

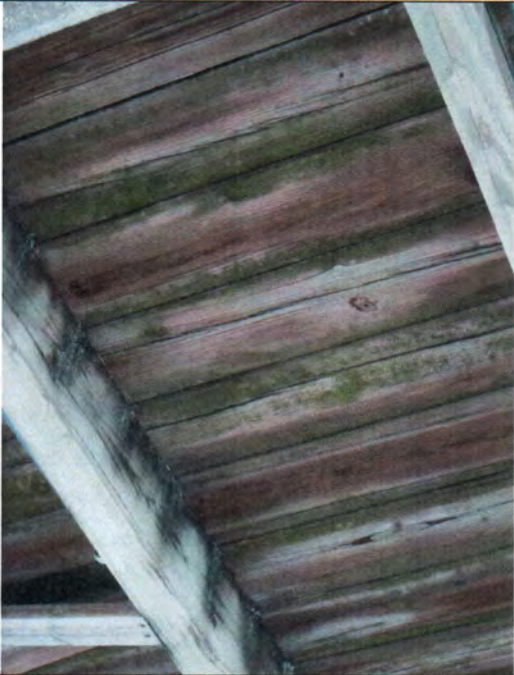
<p>Description: Typical view of the substructure framing and the condition of the decking between Pier #12 and Pier #13. The old deck boards display fiber splitting. The lack of direct sunlight and airflow in moisture rich environment cause the proliferation of algae below deck.</p>
