Project: LELY GOLF ESTATES BEAUTIFICATION, M.S.T.U.
Location: MSTU DISTRICT ROADWAYS
Project Manager: Darryl Richards, r.l.a., C.C.P.S.D. – A.T.M. Dept.
Consultant: McGee & Associates
Contractor: Commercial Land Maintenance
Report Date: FY14-15, 02/16/15

Landscape Observation Report: January 2015 - February 2015
Consultant's Representative: Michael A. McGee, rla, isa
Contractor's Representative: Robert Kindelan
Observation Date: 02/16/15

Report No. 5

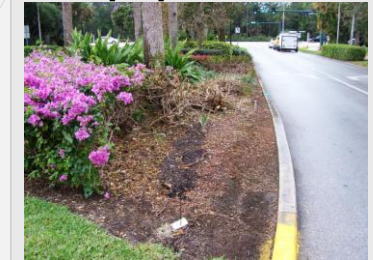
Comment [MM1]:

LOCATION/WORK AREA	S	C	R	OBSERVATION & RECOMMENDATIONS	RESPONSE or COMMENTS
					3. Remove existing plantings and install Coleus with two rows of Beckswiths Gem outside border and Burgundy Sun in the middle field.
		X		Auto accident outbound side of median. (photo)	Provide proposal.
		X	6	15' x 4' turf area located on the inbound side at light post needs to be replaced.	
Median #2		X	8	In the middle of the median at the Black olive tree there are two areas of declined Liriope plants. It is recommended to remove these plants and replace with 3 gal. size Variegated Arborcola shrubs. (11) on the south side and 19 on the north side.	Provide proposal.
Median #3		X		West end Crown of thorns were run over. Approx. 24 plants damaged.	Provide proposal.
		X	8	East end of median the Crown of thorn were run over. Remove damaged and provide replacements in 1 gal. size.	Provide proposal., M&A: 10-20-14 remove weeds.
