**Project:** LELY GOLF ESTATES BEAUTIFICATION, M.S.T.U.  
**Location:** MSTU DISTRICT ROADWAYS  
**Project Manager:** Darryl Richards, r.l.a., C.C.P.S.D. – A.T.M. Dept.  
**Consultant:** McGee & Associates  
**Contractor:** Commercial Land Maintenance  
**Report Date:** FY14-15, 03/23/15

**Landscape Observation Report:** February 2015 - March 2015

**Report No. 6**

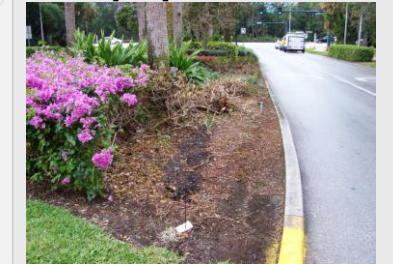
Comment [MM1]:

Median #3		X	2	West end Crown of thorns were run over. Approx. 24 plants damaged.	Provide proposal.
		X	9	East end of median the Crown of thorn were run over. Remove damaged and provide replacements in 1 gal. size.	Provide proposal., M&A: 10-20-14 remove weeds.
Median #4					
Median #5		X	3	Auto accident at light pole. (photo)	
Median #6		X	15	Replacement Holly tree at Plumbago bed has defoliated from water stress. Review and replace.	M&A: This tree is starting to regrow, but would be considered less than a number one grade tree. Replacement by the contractor is still recommended.
Median #7					
Median #8					
Median #8A					
Median #9					
		X	8	At Address 367: Auto accident on east end of median. Remove all Juniper and Bougainvillea up to damaged Foxtail palm and replant. Provide count for replacements.(Photo)	2/16/15 M&A: Small plants replaced palm needs to be removed and replaced.
Median #10
