McGee & Associates

Project:	GOLDEN GATE BEAUTIFICATION, M.S.T.U.	Location:	Collier Blvd. Part A & B	
Project Manager:	Harry Sells, MSTU Project Manager, C.C.P.S.D. – P.T.N.E. Dept.			
Consultant:	McGee & Associates	Consultant's Representative:	Michael A. McGee, rla, isa	
Contractor:	Hannula Landscaping & Irrigation Inc.	Contractor's Representative:	Dale Hannula	
Report Period:	FY 14-15, June 2015	Report No.:	Nine – FY 14-15	
<u>S</u> - Indicates items	to be addressed by staff.	<u>C</u> - Indicates items to be addressed by Contractor		
This was and is more a	and stated to the many data as a second state and the second terms are the second state as a second state of the	- include a second s	we also and the Orale Oraction at a set

LOCATION/WORK AREA	<u>S</u>	<u>C</u>	<u>R</u>	MAINTENANCE SERVICES OBSERVATIONS & RECOMMENDATIONS	RESPONSE or COMMENTS
Observation dates: 06/08-11/15				MONTHLY ADDRESSED	
Median# 8 - 12					
Part "A" - West R/W Sign Area		Х	15	Recommend removing Crown of thorn and mulch area.	
Median #3		Х	8	Recommend removing Thryallis shrubs and install Sand Cordgrass.	
Median #4		X	8	Recommend removing two remaining beds of Red Fountain grass and replant areas with Sil

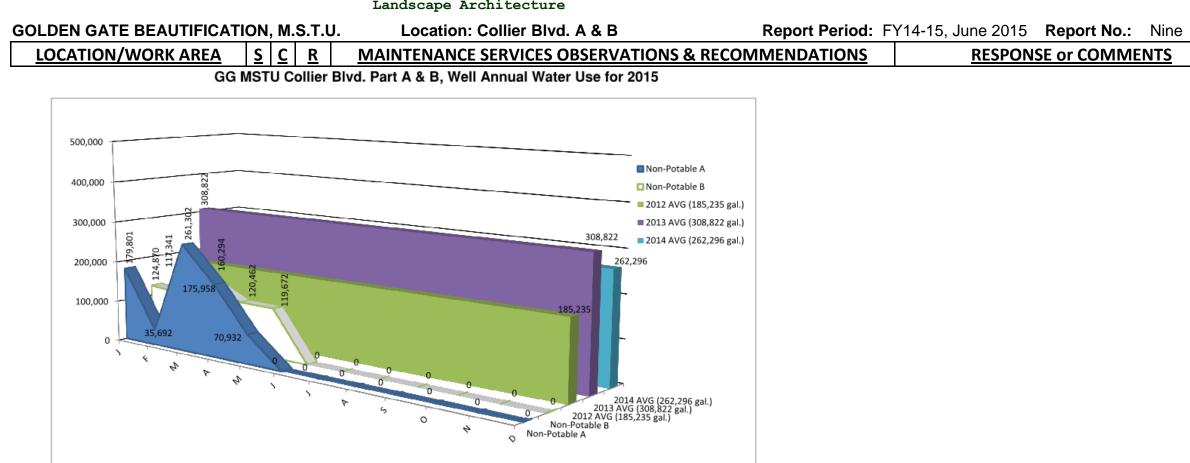
Water Use Goal:

(Original Part A =1.63 ac. of plants, Part B = 2.74 ac. of plants and turf, Revised Part B = 1.86, New Total Irrigated Area = 3.49 ac.)

Recommended: Supplemental watering rate of .5 to .75 inch per week.

Three-quarter inch per week equals 71,076 gallons per week or 284,305 gallons per month.

Combined 2012 total water use: 2,222,816 gallons or 18.73 inches of supplemental water pumped.

Combined 2013 total water use: 3,705,865 gallons or 31.23 inches of supplemental water pumped.

2014 Part B well & pump station relocated on 7/24/14. New well active 09/2014

Combined 2014 total water use: 3,147,554 gallons or 26.26 inches of supplemental water pumped.
