Project: GOLDEN GATE BEAUTIFICATION, M.S.T.U.
Project Manager: Harry Sells, MSTU Project Manager, C.C.P.S.D. – P.T.N.E. Dept.
Consultant: McGee & Associates
Contractor: Hannula Landscaping & Irrigation Inc.
Report Period: FY 14-15, June 2015

Location: Sunshine Blvd.
Consultant's Representative: Michael A. McGee, rla, isa
Contractor's Representative: Dale Hannula
Report No.: Nine - FY14-15

GOLDEN GATE BEAUTIFICATION, M.S.T.U.

Report No.: Nine

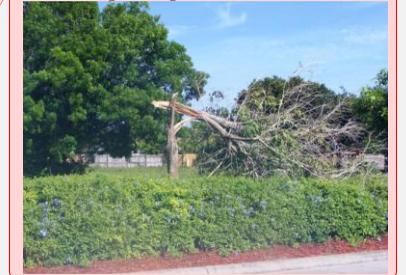
Comment [MAM1]:

LOCATION/WORK AREA	S	C	R	MAINTENANCE SERVICES OBSERVATIONS & RECOMMENDATIONS	RESPONSE or COMMENTS
Observation date: 06/08-11/15				MONTHLY ADDRESSED	Please provide responses as will review, ongoing, completed or proposal to be submitted. Once submitted provide proposal number and date and any notation deemed important.
Median 2, 3, & 6		X	3	It is recommended to apply to all dwarf Bougainvillea and any remaining Indian hawthorn beds Ferromec AC15-0-0 plus 6% iron & 3% sulfur @ 1.5 gal. per 100 gal. of water and root drench with Cleary's 3336 per manufacturer's recommended rate.	
Median #1		X	7	Two Juniper plants have been damaged and need to be replaced with 3 gal. size plants.	
Median #2		X		Yellow Alder tree has broken in half from heavy wind. (Photo)	It is recommended to remove and replace the tree location with a Tabebuia 'Ipe', 12'-14' oa. Ht.
		X	3	See above for Bougainvillea shrubs.	
		X	17	At address 2274: Replace auto accident damaged Juniper on south end of median.	M&A: Appears 3-3 gal. plants will be needed. M&A: 7/8/14 another accident has occurred in same location. Approx. 50 L.F. of Juniper damaged. Review and remove damaged and provide count for replacements. (photo)

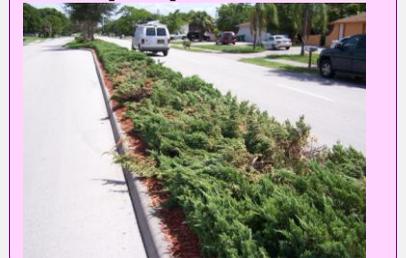
Comment [MAM2]:

Median #3		X	9	Light pole accident on south end of median. Multiple Juniper have been run over and are damaged and broken. Prune out damaged foliage and branches and review in 30 days for replacements.	M&A: 12-12-14 Damaged plants have been removed.
Median #4					
Median #5					
Median #6		X	3	See above for Bougainvillea and Indian hawthorn shrubs.	
18 th Place SW Median		X		Remove large weeds in pavers and Bougainvillea.	
		X	3	Remove damaged Bougainvillea branches and review for replacements. 3 gal. size.	
18th Ave. S.W. Median		X	14	Auto accident has removed 6 to 8 Bougainvillea plants on northwest side. Review and provide count for replacements.	M&A: 4/14/15 This location will now be listed in this report and not the Collier Blvd. Part B report.

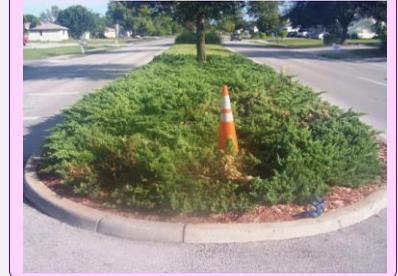
Comment [MAM3]:

LOCATION/WORK AREA	S	C	R	MAINTENANCE SERVICES OBSERVATIONS & RECOMMENDATIONS	RESPONSE or COMMENTS
<u>QUARTERLY ADDRESSED</u>					
Accent/Street Lighting	X		7	In north end of median 3 light pole B-2 has been removed do to an accident. (photo)	M&A:06/11/15 Light pole debris is still in median.
Pump Station-Median #3, 5 hp , 6" well, VFD					
Lighting Electric Meter 2271 Sunshine Blvd., 1 SUN, Alley off 23rd Ave. SW					
Lighting Electric Meter & Irrigation Controller Electric , 1995 Sunshine Blvd., 2 SUN, Alley off 20th PL. SW					
Lighting Electric Meter 4642 18th Pl. SW, 3 SUN, North R/W					
Fertilizations:		X	2	Please update status of April's requirements and submit for May's requirements per schedule below.	
Irrigation:		X		Please perform a controller program review and complete check of the main line and zones to see if there are any leaks occurring during operations.	
	X	X	7	The water use for November was extremely high. Review system and controller for issues. If the Bermad pulse counter is working then request from Darryl's office to contact the County Irrigation Project Manager to set the maximum flow per week at 45,000 gallons at which time an alarm will be sent to Hannula Landscaping.	M&A: 4/15/15 Please update status.
