Project: GOLDEN GATE BEAUTIFICATION, M.S.T.U.
Project Manager: Harry Sells, MSTU Project Manager, C.C.P.S.D. – P.T.N.E. Dept.
Consultant: McGee & Associates
Contractor: Hannula Landscaping & Irrigation Inc.
Report Period: FY 14-15, August 2015

Location: Sunshine Blvd.
Consultant's Representative: Michael A. McGee, rla, isa
Contractor's Representative: Dale Hannula
Report No.: **Eleven** - FY14-15

GOLDEN GATE BEAUTIFICATION, M.S.T.U.

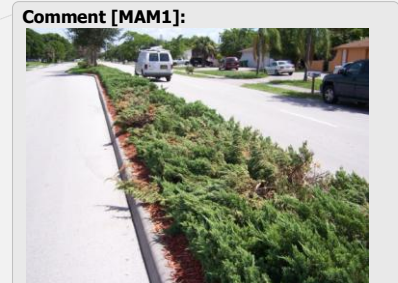
<u>LOCATION/WORK AREA</u>	<u>S</u>	<u>C</u>	<u>R</u>	<u>MAINTENANCE SERVICES OBSERVATIONS & RECOMMENDATIONS</u>	<u>RESPONSE or COMMENTS</u>
Observation date: 08/10-13/15				<u>MONTHLY ADDRESSED</u>	Please provide responses as will review, ongoing, completed or proposal to be submitted. Once submitted provide proposal number and date and any notation deemed important.
Median 1, 2, 3, & 6		X		There exist multiple small areas of turf that have declined and thinned to the point that replacement is recommended. The decline would be due to previous water stress from sprinkler issues, chinch bug insects, and/or broadleaf weed control that removed the weeds. Also broadleaf weed control is needed.	
Median #1		X	9	Two Juniper plants have been damaged and need to be replaced with 3 gal. size plants.	
Median #2		X	2	At address 20th Ct. SW: 3' x 30' turf area is in decline with dead areas. Review for replacement.

X	2	Yellow Alder tree has broken in half from heavy wind.	It is recommended to remove and replace the tree location with a Tabebuia 'Ipe', 12'-14' oa. Ht.
		X	19	At address 2274: Replace auto accident damaged Juniper on south end of median.	M&A: Appears 3-3 gal. plants will be needed. M&A: 7/8/14 another accident has occurred in same location. Approx. 50 L.F. of Juniper damaged. Review and remove damaged and provide count for replacements.(photo)
Median #3		X	2	At address 1900: 10' x 15' turf area is in decline with dead areas. Review for replacement.	
		X	11	Light pole accident on south end of median. Multiple Juniper have been run over and are damaged and broken. Prune out damaged foliage and branches and review in 30 days for replacements.	M&A: 12-12-14 Damaged plants have been removed.
Median #4					
Median #5					
Median #6		X		At address 1740: On both sides of the Live Oak tree the turf areas are stressed and in decline, as well as broadleaf weeds are present.

X	2	Prune out dead and damaged Juniper plant foliage on north end of median related to	M&A: 8/13/15 Review and remove additional plants and

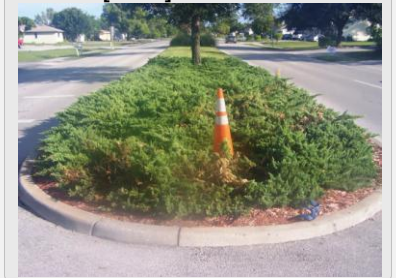
Comment [MAM2]:

LOCATION/WORK AREA	S	C	R	MAINTENANCE SERVICES OBSERVATIONS & RECOMMENDATIONS	RESPONSE or COMMENTS
				previous auto accident at light pole.	foliage.
18 th Place SW Median		X		(2) dwarf Bougainvilleas 'Helen Johnson", 3 gal. size need to be replaced on east side of median at back of pavers.	
18th Ave. S.W. Median		X	16	Auto accident has removed 6 to 8 Bougainvillea plants on northwest side. Review and provide count for replacements.	M&A: 4/14/15 This location will now be listed in this report and not the Collier Blvd. Part B report.
<u>QUARTERLY ADDRESSED</u>					
Accent/Street Lighting	X		2	On south end of median 3 light pole has been removed do to an accident.(photo)	
	X		2	On north end of median 6 light pole has been removed do to an accident.	
Pump Station-Median #3, 5 hp , 6" well, VFD					
Lighting Electric Meter 2271 Sunshine Blvd., 1 SUN, Alley off 23 rd Ave. SW					
Lighting Electric Meter & Irrigation Controller Electric , 1995 Sunshine Blvd., 2 SUN, Alley off 20 th PL. SW

Lighting Electric Meter 4642 18 th Pl. SW, 3 SUN, North R/W					
Fertilizations:		X		Review fertilization schedule below for August requirements.	
Irrigation:		X		July monthly water use is within previous three years records.	
	X	X	8	The water use for November was extremely high. Review system and controller for issues. If the Bermad pulse counter is working then request from Darryl's office to contact the County Irrigation Project Manager to set the maximum flow per week at 45,000 gallons at which time an alarm will be sent to Hannula Landscaping.	M&A: 4/15/15 Please update status. M&A: 8/13/15 Based upon our current understanding of the County's Irrigation Central Control System upgrades and reprogramming we recommend this request be put on hold. Comment will be removed from future reports.

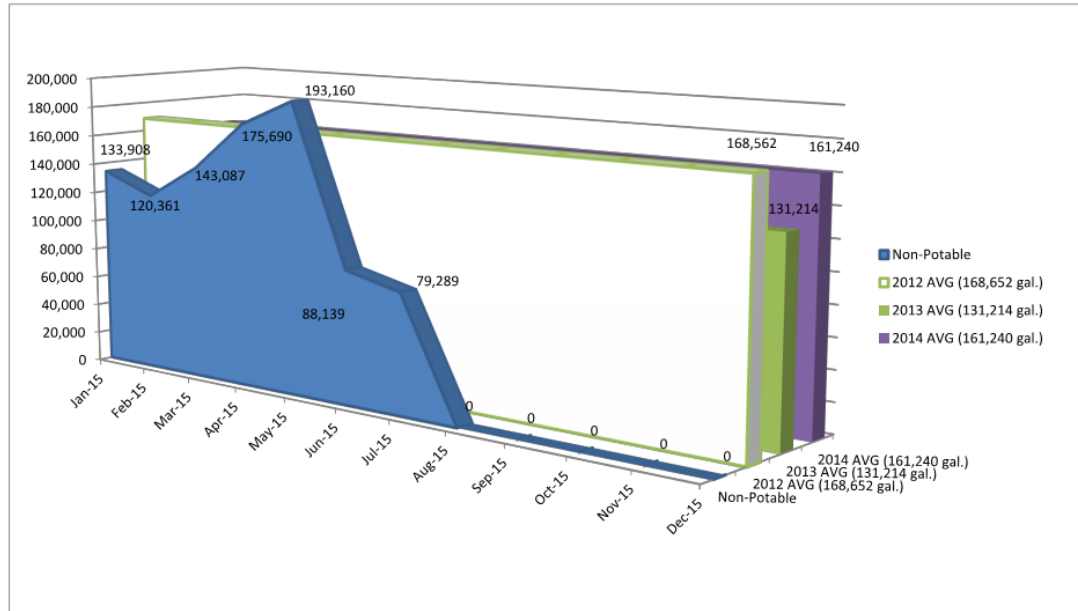
GG MSTU Sunshine Blvd. Well Annual Water Use for 2015

Recommended: Supplemental watering rate of .75 to 1 inch per week. One inch per week equals 39,917 gallons per week or 159,668 gallons per month.

2012 total water use: 2,022,743 gallons or 50.67 inches of supplemental water pumped.

2013 total water use: 1,574,562 gallons or 39.45 inches of supplemental water pumped.

2014 total water use: 1,954,877 gallons or 48.97 inches of supplemental water pumped.
