Project: GOLDEN GATE BEAUTIFICATION, M.S.T.U.

Report Period: FY 14-15, September 2015

Location: Collier Blvd. Part A & B

Report No.: Twelve – FY 14-15

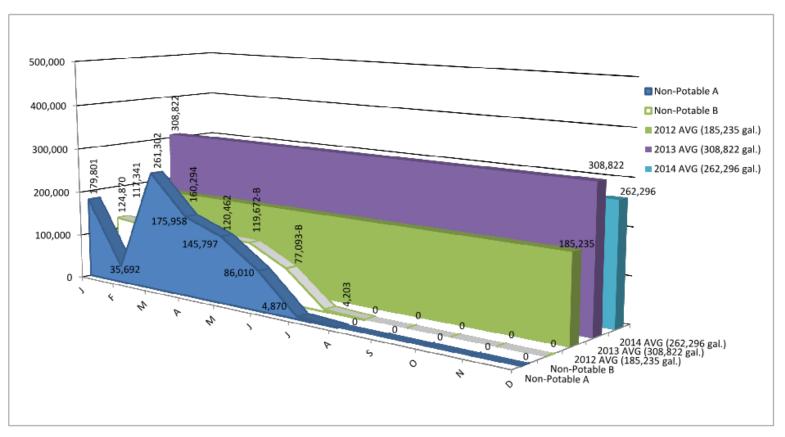
GG MSTU Collier Blvd. Part A & B, Well Annual Water Use for 2015

(Original Part A = 1.63 ac. of plants, Part B = 2.74 ac. of plants and turf, Revised Part B = 1.86, New Total Irrigated Area = 3.49 ac.)

Recommended: Supplemental watering rate of .5 to .75 inch per week.

Three-quarter inch per week equals 71,076 gallons per week or 284,305 gallons per month.

Combined 2012 total water use: 2,222,816 gallons or 18.73 inches of supplemental water pumped.

Combined 2013 total water use: 3,705,865 gallons or 31.23 inches of supplemental water pumped.

2014 Part B well & pump station relocated on 7/24/14. New well active 09/2014

Combined 2014 total water use: 3,147,554 gallons or 26.26 inches of supplemental water pumped.
