FLOOD PROOFING TESTS

Tests of Materials and
Systems for Flood
Proofing Structures

August 1988

Structures Laboratory
US Army Engineer Waterways Experiment Station

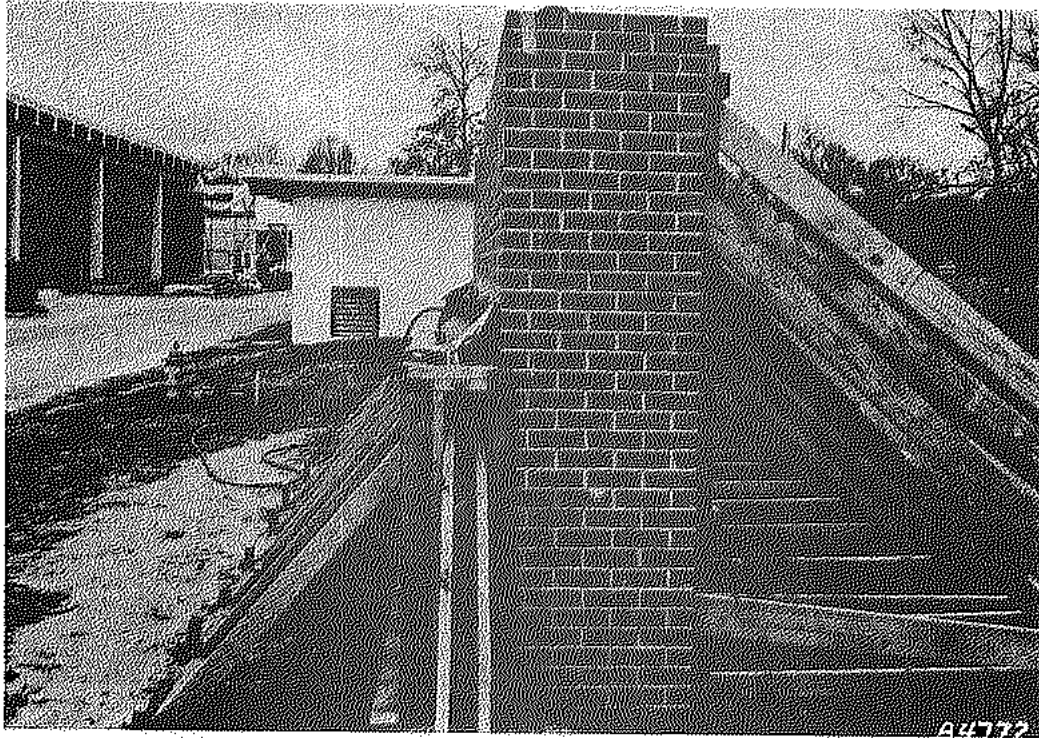
even a slight deflection (Figure 9). This means that the wall itself was seriously damaged at relatively small deflections. To be conservative, the wall deflection should be kept below approximately 0.01 in. in the direction of the water loading. The deflection of the wall is mentioned because it is probably a more reliable guide for general wall configurations than the water depth. For example, the same water depth might produce less deflection or damage on a short wall than on a longer wall. Similar damage would more than likely occur around the same wall deflection than the same water depth. If the wall deflects more than 0.01 in., there is damage and a chance that it will not support service loads or vibrations during normal operation. The deflection criteria will be practicable only after further study and failure charts are developed by computer solutions.

Figure 9. Wall 1. Wall deflection

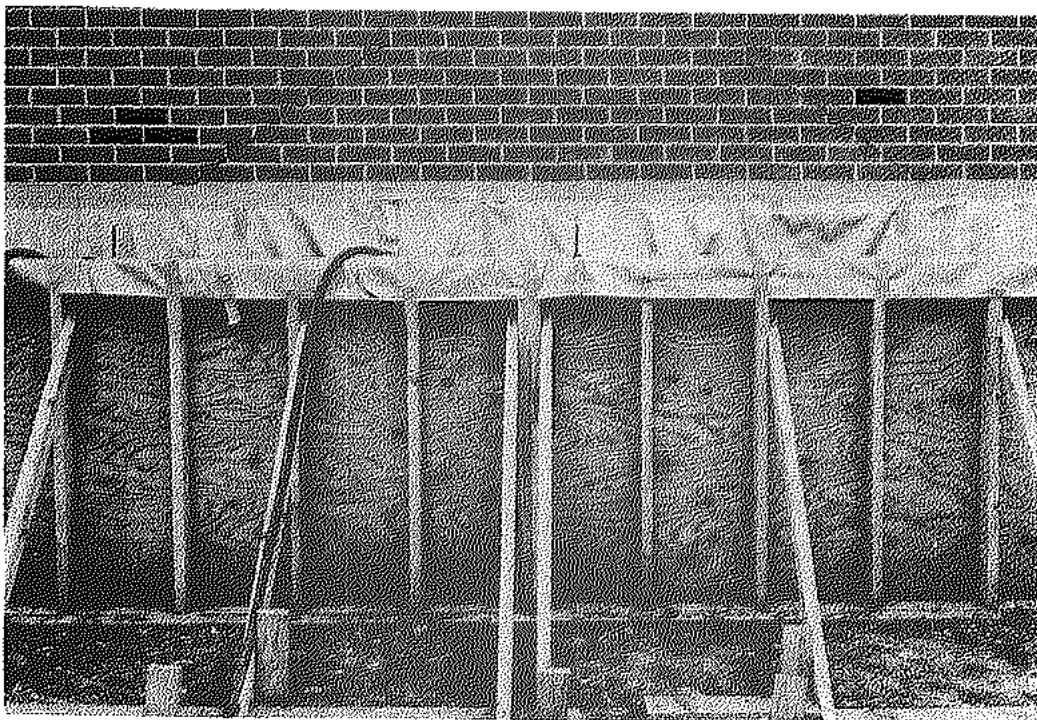
A severe loss of integrity began at 2 ft of water with complete loss occurring at 2.4 ft (Figure 8). The failure at 2.4 ft of water is presented in Figures 10 and 11.

Figure 10. Wall 1. Failure pattern of wall

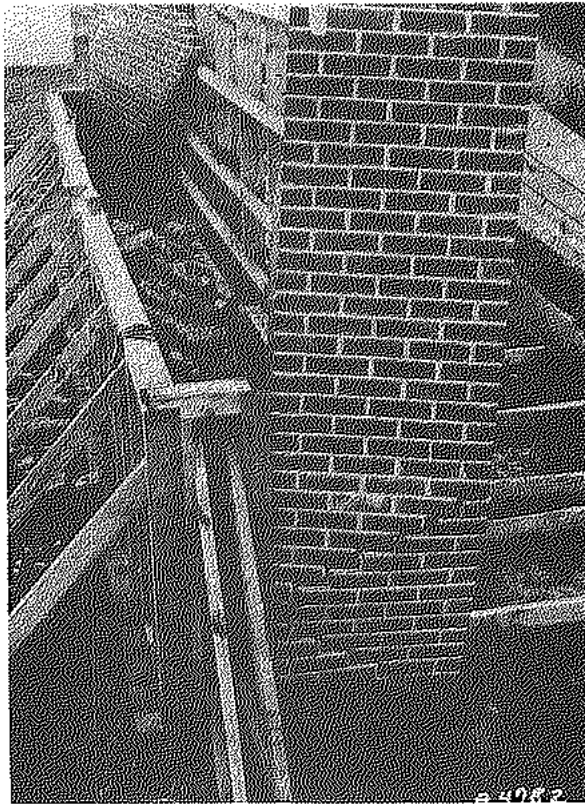
Figure 11. Wall 1. Wall failure

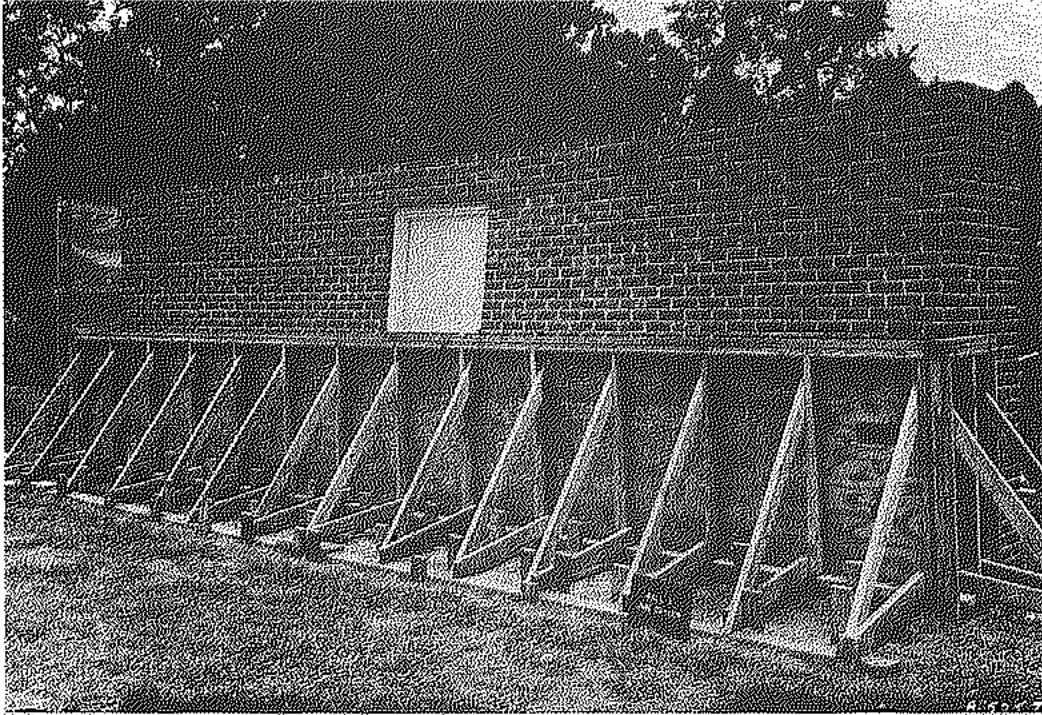
The wall deflected forward for low water loads because cord lengthening in the vicinity of the loading caused the upper part of the wall to cup forward. In an actual home, the finishing materials on the inside of the studs will give support to the wall and allow it to experience a deeper water loading than indicated by these tests. Computer solutions could be used to determine the effect of such restraints. The significant point is that the deflections recorded for Wall 2 at a given water depth should be an upper bound of deflections experienced in an actual brick-veneer house under the same loading. The failure of Wall 2 is shown in Figures 13 and 14.

Figure 13. Wall 2. Wall failure, front view

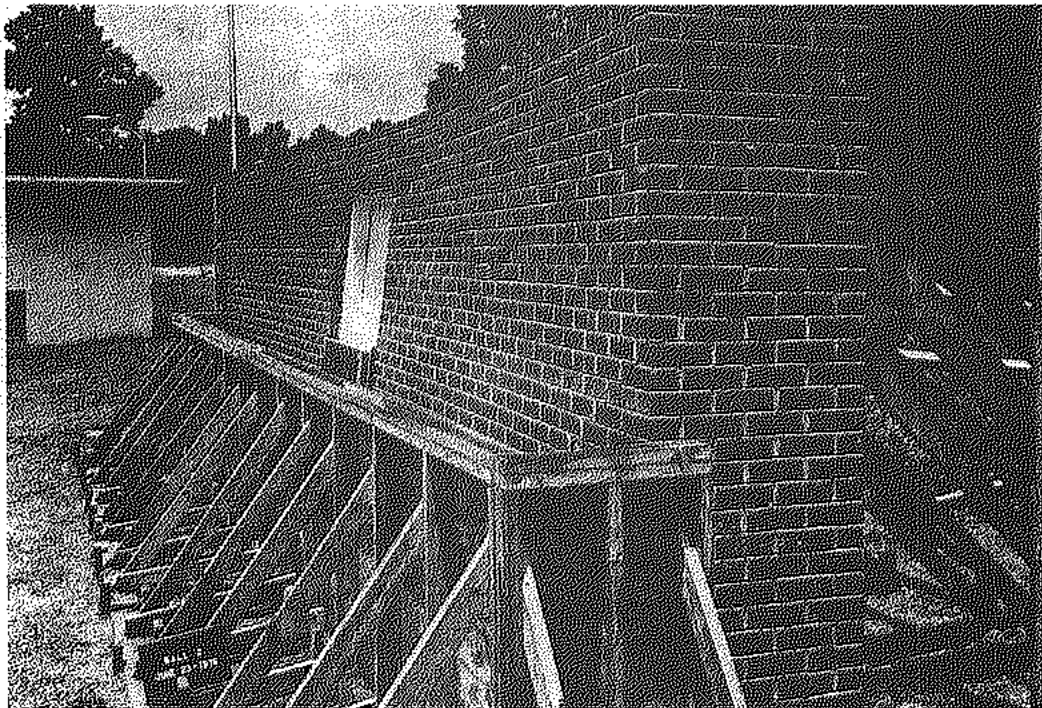
Figure 14. Wall 2. Wall failure, side view

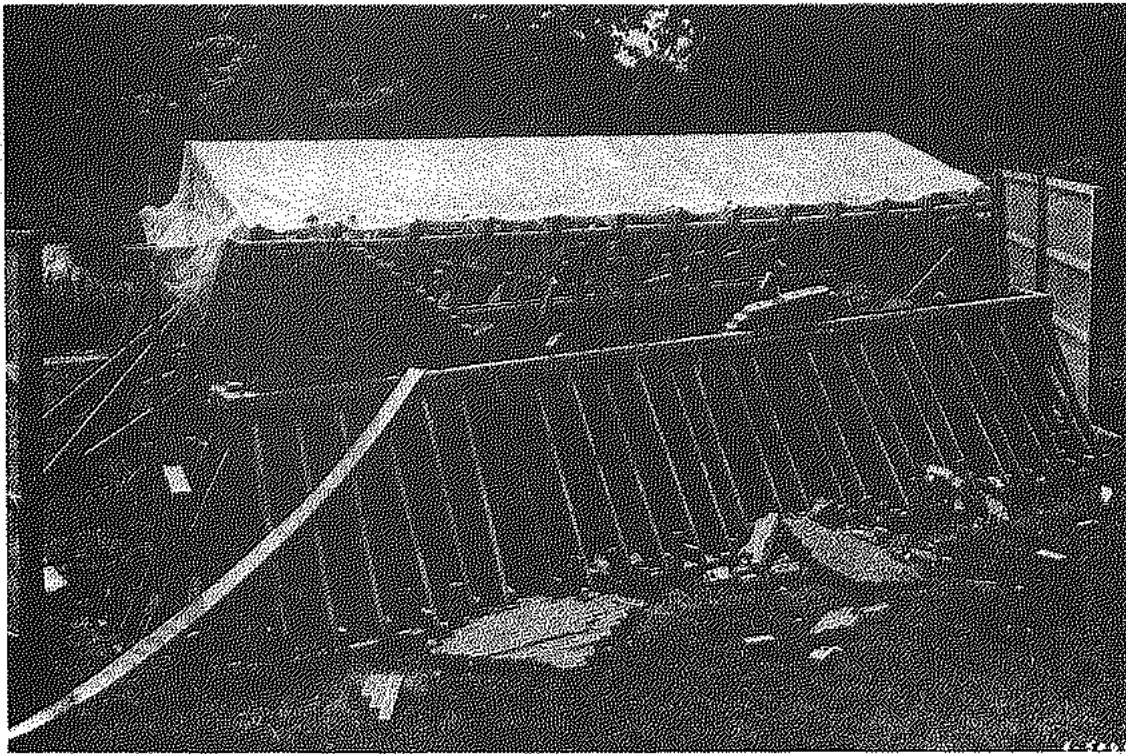
Total collapse of the brick-veneer wall occurred at a depth of 57 in. and at a total applied force of 18,300 lb. This failure was sudden and resulted from the failure of the supporting studs. The remains of the brick-veneer wall after failure are presented in Figures 16 and 17.

Figure 16. Wall 3. Wall failure, front view

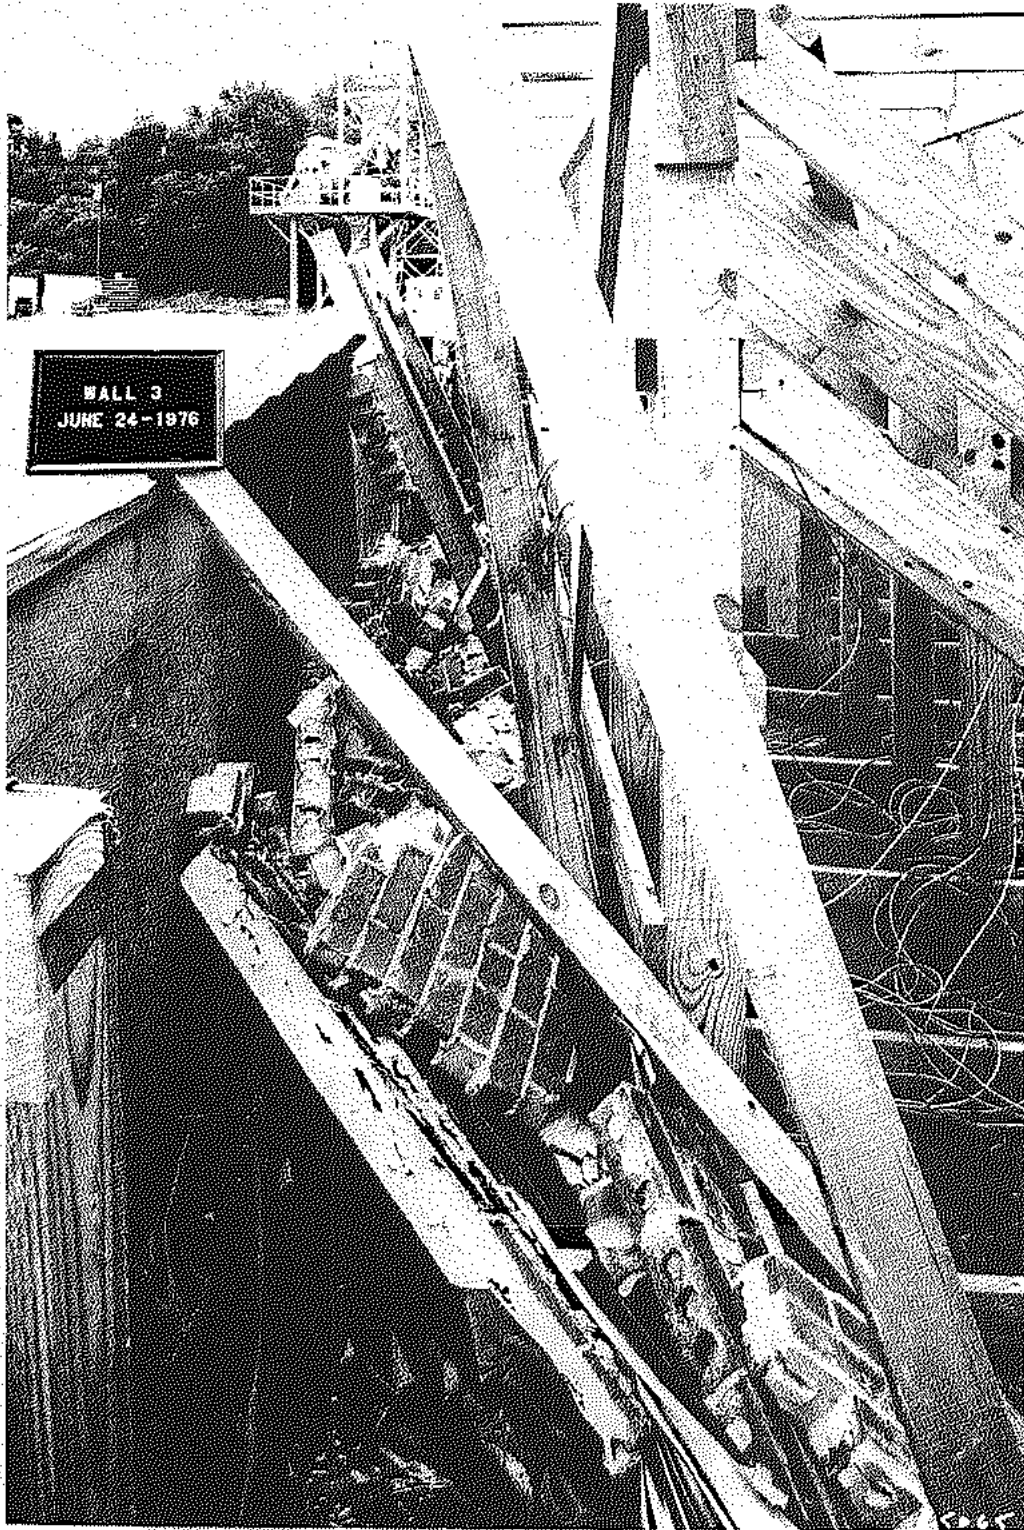
Figure 17. Wall 3. Wall failure, side view

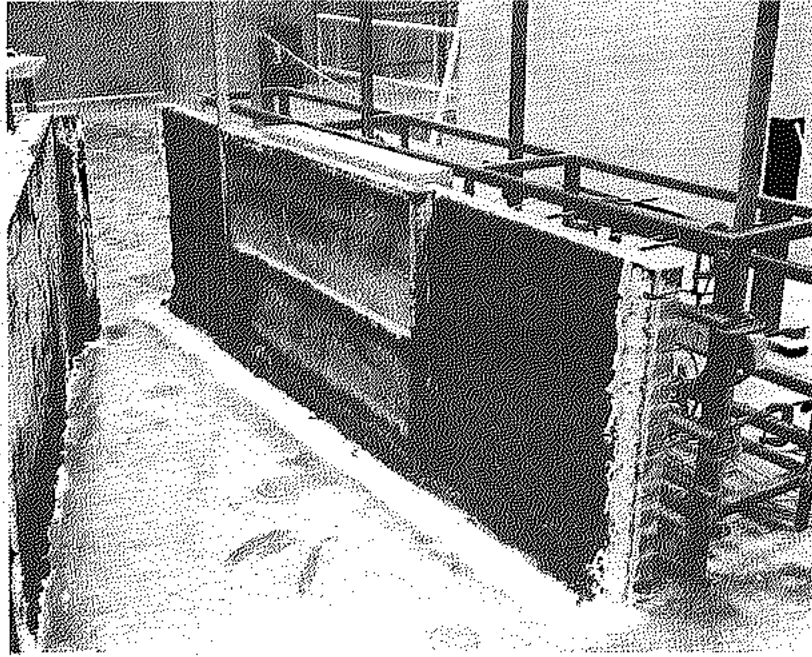
3	Same as Tests 1 and 2.	Coated with asphalt cement. Figure 37 shows the wall after the test.	The wall continued to leak in a couple of places. After the bulk-head was removed, no flaws could be observed in the asphalt cement coating in areas where the wall leaked. This implies that great care must be exercised, even if asphalt cement is put on the wall, or water will penetrate the house. The wall leaked so badly that the closure was not tested for water.

Figure 37. Brick walls coated with asphalt cement

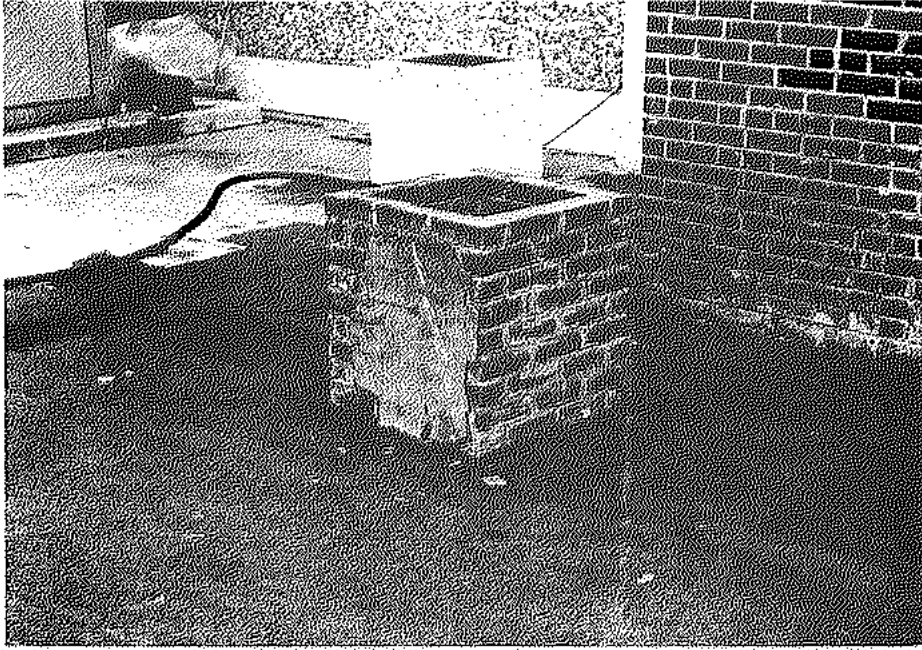
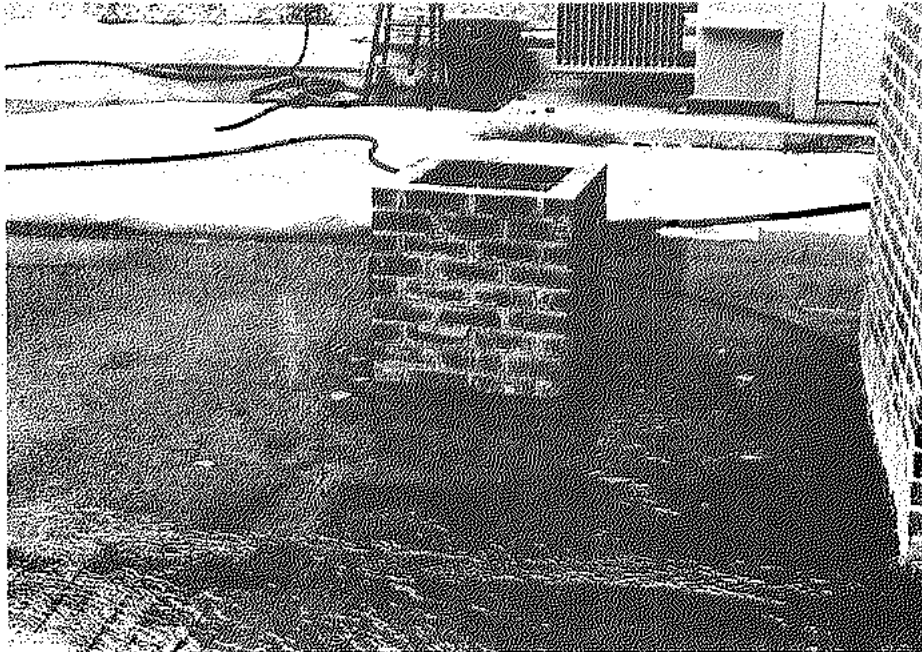
Figure 46. Failure of coating 4

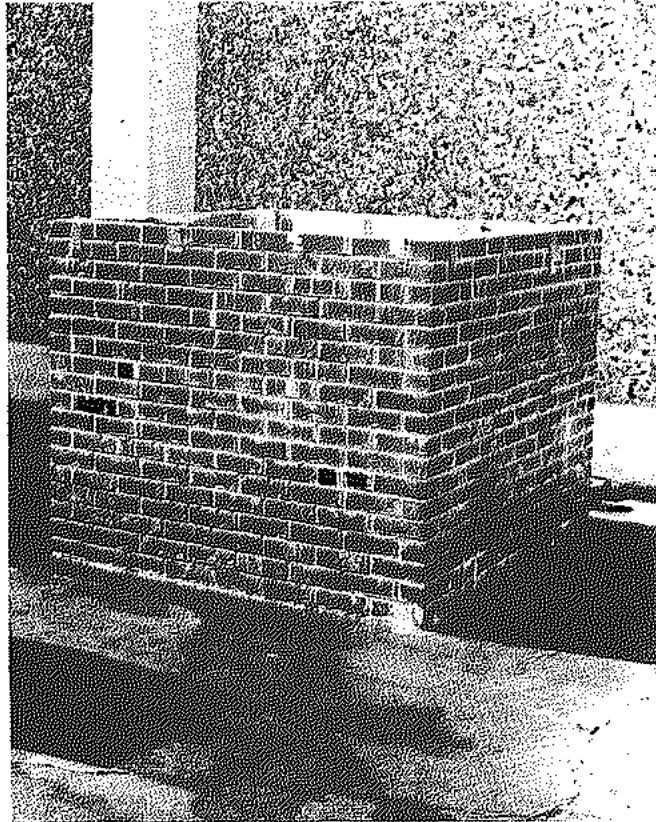
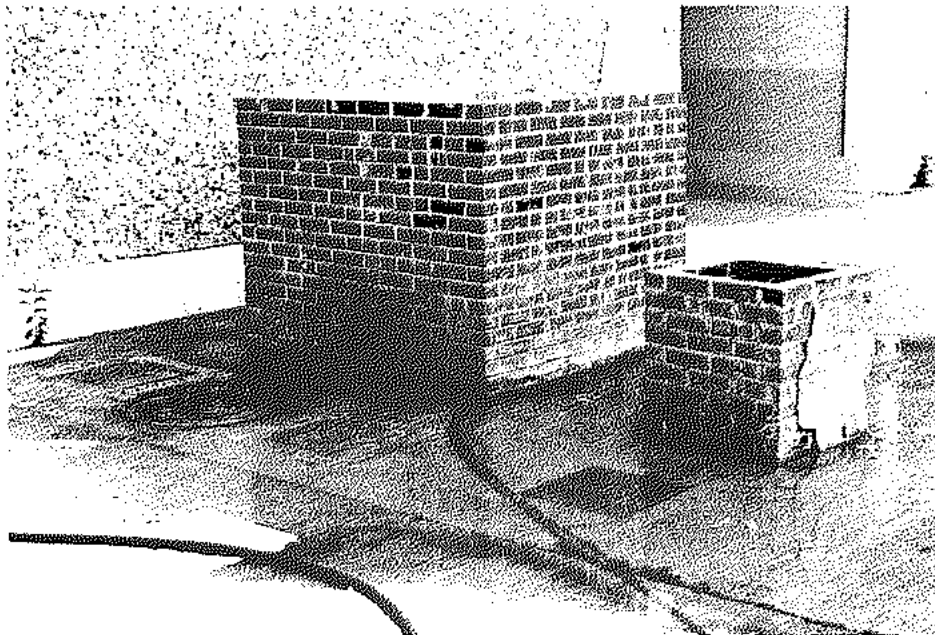
Figure 52. Dye in water leaking from large brick cube

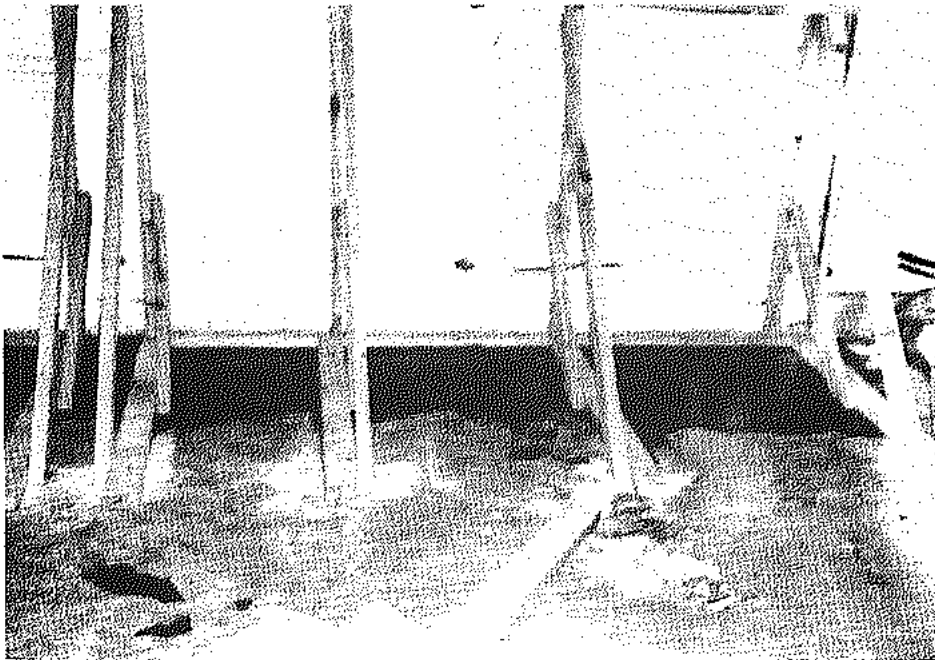
Figure 73. Water seeping under garage door due to excessive water height in sump

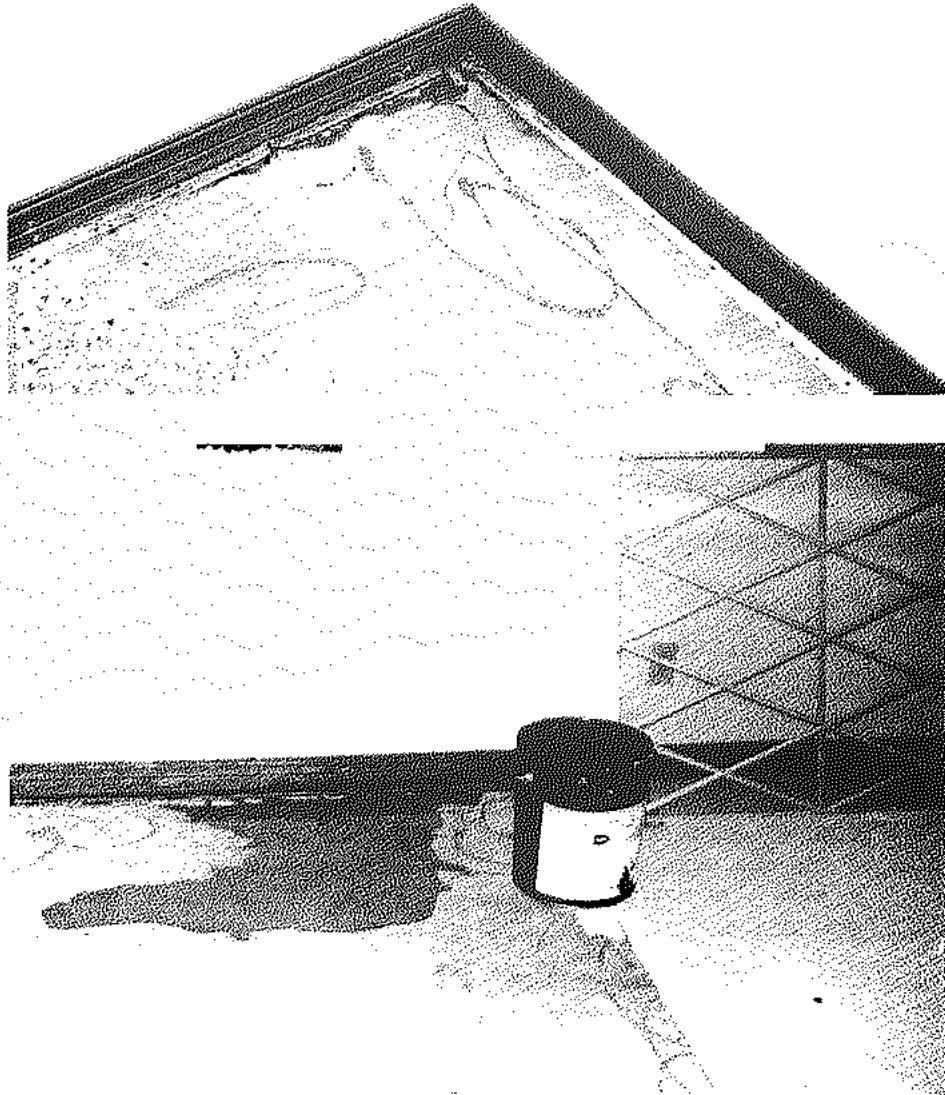
Figure 74. Seepage along baseboard due to leak in lap of fabric
