PROJECT: RADIO ROAD EAST MSTU MAINTENANCE

FIELD REPORT 2016 -3

CONTRACT: LANDSCAPE & IRRIGATION MAINTENANCE - COMMERCIAL LAND MAINTENANCE

MAINTENANCE FIELD VISITS PERFORMED ON 2/19/16, 2/22/16 and 3/06/16

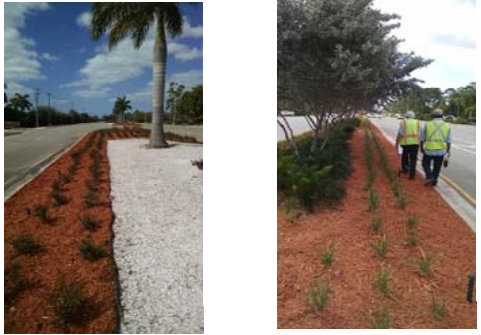
<p>6. There were some weeds starting to emerge in the new planting areas; Amado has treated the weeds that emerged during their contract, and CLM will continue to treat the weeds now that the project has been turned over to them. CLM is now responsible for the new planting areas.</p>

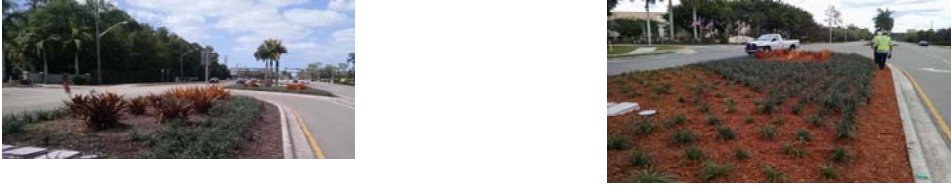
<p><i>Liriope & Bromeliads on Median #32</i> <i>Different sizes of Liriope, from different suppliers</i></p>	
		<p><i>Edging put back in place</i> <i>Society Garlic installed</i></p>	
OBSERVATIONS & RECOMMENDATIONS THROUGHOUT MEDIANS	ACTION REQUIRED	STATUS

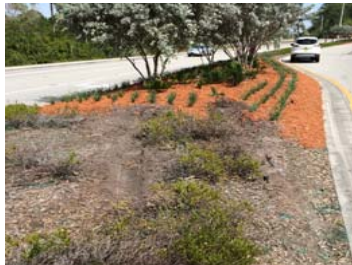
<p><i>Repair ruts from car damage in Median #35</i></p>
<p>17. Fire ants are still apparent throughout, treat as necessary. Several mounds were noted on Medians #31 and 39</p>	<p><i>CLM to treat for fire ants</i></p>	<p>ONGOING</p>	
<p>18. Weed growth has been removed in most of the shell areas. Rake or blow off leaf litter and debris from shell areas to keep a neat appearance.</p>	<p><i>CLM to rake or blow off leaf debris from shell areas, and where the leaves collect against Muhly Grass.</i></p>	<p>ONGOING</p>	
<p>19. There is damage from an errant vehicle in the shell area on Median # 35 .</p>	<p><i>CLM to rake out ruts and repair damaged edging</i></p>	<p>NO</p>

<p><i>Repair ruts from car damage in Median #39</i></p>
<p>21. There was car damage on Medians #39 and 38, caused by two separate incidents. On the east end of Median #38, CLM is to repair the damage, replant the liriopie and replace 2 irrigation heads. On the west end of Median #39, replace 2 Society Garlic, rake out the ruts and check for irrigation damage.</p>	<p><i>CLM to repair damage on Medians #38 and 39</i></p>	<p>NEW 3/6/16</p>	
<p>22. The spring fertilizer application should be done this month - early April.</p>	<p><i>CLM to do spring fertilization</i></p>	<p>NEW 3/6/16</p>	
<p>IRRIGATION ISSUES</p>
