Project: GOLDEN GATE BEAUTIFICATION, M.S.T.U. Location: Sunshine Blvd.

Project Manager: Collier County Public Services Division, Public Transportation & Neighborhood Enhancements Department

FY 16-17, June 2017 Report No.: Eight

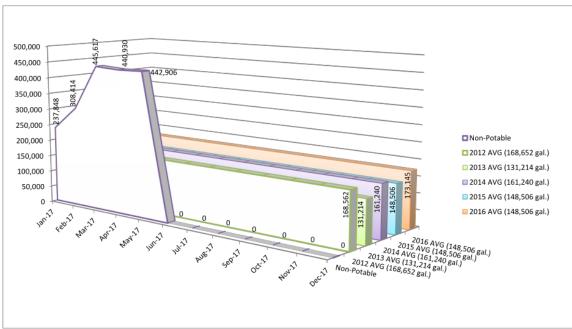
GG MSTU Sunshine Blvd. Well Annual Water Use for 2017

Recommended: Supplemental watering rate of .75 to 1 inch per week. One inch per week equals 39,917 gallons per week or 159,668 gallons per month.

2012 total water use: 2,022,743 gallons or 50.67 inches of supplemental water pumped 2013 total water use: 1,574,562 gallons or 39.45 inches of supplemental water pumped 2014 total water use: 1,954,877 gallons or 48.97 inches of supplemental water pumped 2015 total water use: 1,782,067 gallons or 44.64 inches of supplemental water pumped 2016 total water use: 2,077,734 gallons or 52.05 inches of supplemental water pumped
