Project: GOLDEN GATE BEAUTIFICATION, M.S.T.U. Location: Coronado Pkwy. and Hunter Blvd. Project Manager: Collier County Public Services Division, Public Transportation & Neighborhood Enhancements Department Consultant's Representative: Consultant: McGee & Associates Michael A. McGee, rla, isa Hannula Landscaping & Irrigation Contractor: Contractor's Representative: Dale Hannula FY 16-17, June 2017 Report Period: Report No.: Eight AC - Indicates major items recommended to be discussed by Advisory Committee, S - Indicates items recommended to be addressed by staff, C - Indicates items recommended to be addressed by Contractor

GOLDEN GATE BEAUTIFICATION, M.S.T.U. Location: Coronado Pkwy. & Hunter Blvd. Report Period: FY 16-17, June 2017 Report No.: Eight

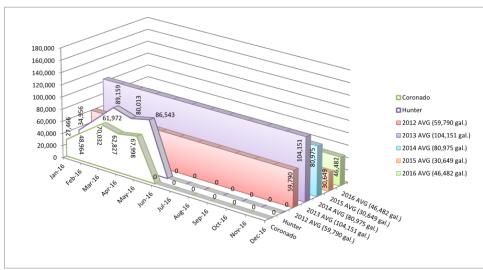
GG MSTU Coronado - Hunter, Well Annual Water Use for 2017

LOCATION/WORK AREA	<u>AC</u>	<u>S</u>	<u>C</u>	<u>R</u>	MAINTENANCE SERVICES OBSERVATIONS & RECOMMENDATIONS	RESPONSE or COMMENTS
Median #12			Х		Remove dead foliage out of Flax lily plants.	
			Х	19	(1) Flax Lily and (1) Alexander palm is missing from west end of median.	
					QUARTERLY ADDRESSED	
Fertilization:						
General Irrigation:			Х		May water use meter readings indicate 154,541 gallons used for both roadways.

Recommended: Supplemental watering rate of .5 or less inches per week. One half inch per week equals 24,846 gallons per week or 99,384 gallons per month.
