Project: GOLDEN GATE BEAUTIFICATION, M.S.T.U. Collier Blvd. Part A & B Location:

Consultant: McGee & Associates **Consultant's Representative:** Michael A. McGee, rla, isa

Report Period: FY 16-17, June 2017 Report No.: Eight

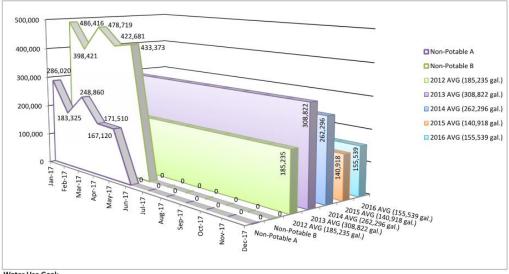
GG MSTU Collier Blvd. Part A & B, Well Annual Water Use for 2017 (Meter Data not Accurate due to Meters Malfunctioning)

## Water Use Goal:

(Original Part A = 1.63 ac. of plants, Part B = 2.74 ac. of plants and turf, Revised Part B = 1.86, New Total Irrigated Area = 3.49 ac.)

Recommended: Supplemental watering rate of .5 to .75 inch per week.

Three-quarter inch per week equals 71,076 gallons per week or 284,305 gallons per month.

Combined 2012 total water use: 2,222,816 gallons or 18.73 inches of supplemental water pumped.

Combined 2013 total water use: 3,705,865 gallons or 31.23 inches of supplemental water pumped.

2014 Part B well & pump station relocated on 7/24/14. New well active 09/2014

Combined 2014 total water use: 3,147,554 gallons or 26.26 inches of supplemental water pumped.

Combined 2015 total water use: 1,691,015 gallons or 5.95 inches of supplemental water pumped, data not fully accurate, meter malfunctions A & B

Combined 2016 total water use: 1,866,471 gallons or 26.26 95 inches of supplemental water pumped, data not fully accurate, meter malfunctions A & B
