Project: GOLDEN GATE BEAUTIFICATION, M.S.T.U.

Location: Sunshine Blvd.

Report No.: One

Report Period: FY 17-18, December 2017

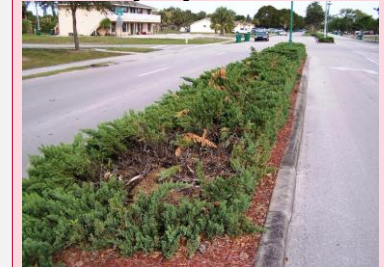
X	X			At address 2101: (1) Golden Tabebuia damaged. Remove and replace.
