GOLDEN GATE BEAUTIFICATION, M.S.T.U.

Location: Collier Blvd. A & B

Report Period: FY17-18, December 2017

Report No.: One

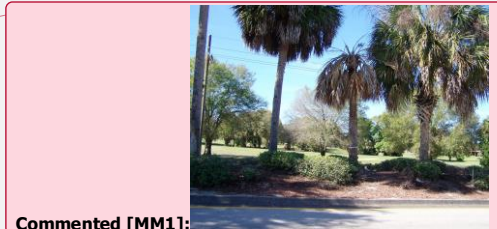
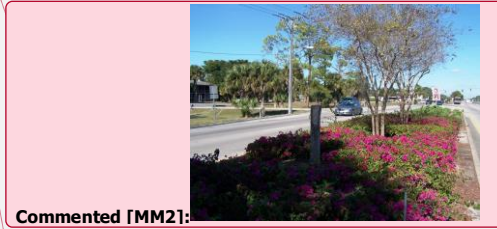
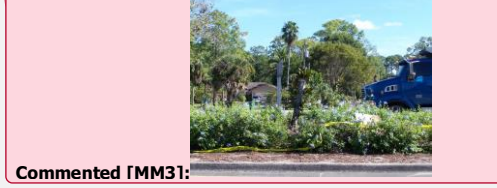
X	X		Understory plantings need to be reviewed for replacements. On south end Flax lily and Plumbago shrubs could be removed and the areas replanted with yellow African iris.	
		X	X		Planting beds could use mulch. Bare ground is present along perimeter of many planting beds.	
			X	38	Juniper bed on south end of median contains dead plants and brown foliage. Remove both and provide count for replacements.	
Median #71 (M.P. #8)		X	X		At address 11845: Add (2) Crape myrtles.	
		X	X		Understory plantings need to be reviewed for replacements. Flax lily, Plumbago and Thryallis shrubs could be removed and the areas replanted with yellow African iris.	
		X	X	39	Juniper bed on south end of median contains dead plants and brown foliage. Remove both and provide count for replacements.	
		X	X	42	Plant replacements are needed in multiple areas.	Hannula 12/20/13: An estimate cannot be submitted without

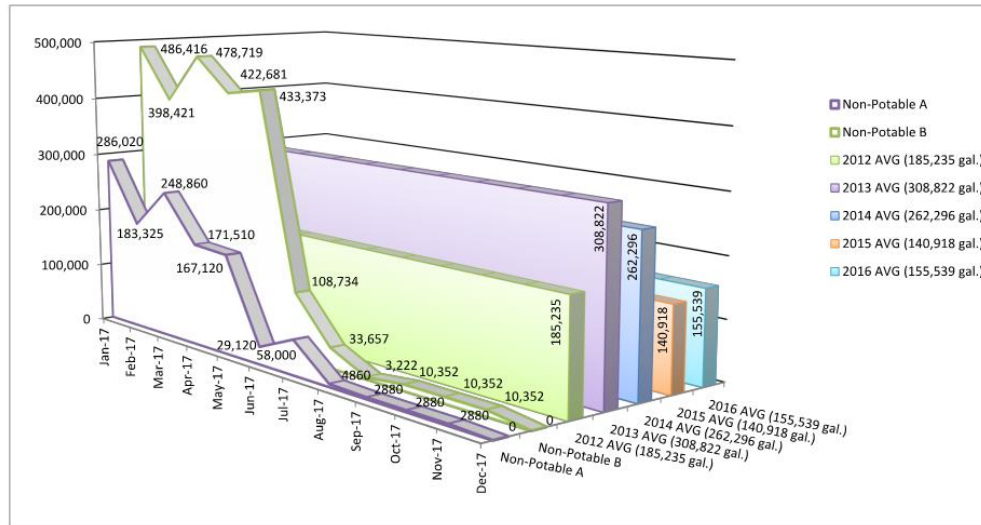
GG MSTU Collier Blvd. Part A & B, Well Annual Water Use for 2017
(Meter Data not Accurate due to Meters Malfunctioning)

(Original Part A = 1.63 ac. of plants, Part B = 2.74 ac. of plants and turf, Revised Part B = 1.86, New Total Irrigated Area = 3.49 ac.)
 Recommended: Supplemental watering rate of .5 to .75 inch per week.
 Three-quarter inch per week equals 71,076 gallons per week or 284,305 gallons per month.
 Combined 2012 total water use: 2,222,816 gallons or 18.73 inches of supplemental water pumped.
 Combined 2013 total water use: 3,705,865 gallons or 31.23 inches of supplemental water pumped.
 2014 Part B well & pump station relocated on 7/24/14. New well active 09/2014
 Combined 2014 total water use: 3,147,554 gallons or 26.26 inches of supplemental water pumped.
 Combined 2015 total water use: 1,691,015 gallons or 5.95 inches of supplemental water pumped, data not fully accurate, meter malfunctions A & B
 Combined 2016 total water use: 1,866,471 gallons or 26.26 95 inches of supplemental water pumped, data not fully accurate, meter malfunctions A & B

2017: Hurricane Irma delayed readings from 09/17 to 12/17, readings are average over 3 months.
