McGee & Associates
Landscape Architecture

Project: LELY GOLF ESTATES BEAUTIFICATION, M.S.T.U. **Landscape Observation Report:** May 2019
Location: MSTU DISTRICT ROADWAYS
Project Manager: Dan Schumacher, Collier County Public Services Division, Public Transportation & Neighborhood Enhancements Department
Consultant: McGee & Associates **Consultant's Representative:** Michael A. McGee, rla, isa
Contractor: Commercial Land Maintenance **Contractor's Representative:** Robert Kindelan, Gary Gorden
Report Date: FY18-19, 5/7/19 **Observation Date:** 5/7/19

Report No. 8

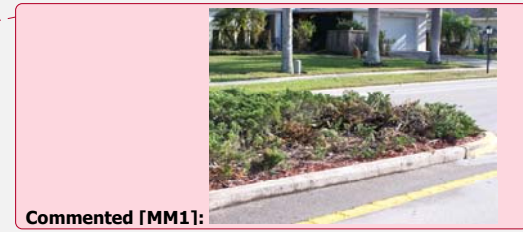
4	Auto accident on east end of median in Juniper plants. (6-7) plants damaged and need to be removed. Recommend removing Juniper back to light pole and install Perennial Peanut on end. (45-50) 1 gal. plants required. (photo)	
<u>Median #5</u>			X	19	At address 164: (2) Queen's crape myrtle leaning.	Reset and stake.
<u>Median #6</u>	X	X	X	6	At address 228: Recommend installing (3) Alexander palms, Add (2) between existing Washingtonia palms and (1) west of westernmost Washingtonia palm. Field grown B & B with double 10 ft. clear trunks. Align trunks with median. Will require (3) bubblers locations with (2) adjustable flood bubblers per tree.	Committee Approved: _____
	X	X	X	7	At address 246: Recommend installing (3) Alexander palms, Add (2) between existing and removed Washingtonia palms and (1) east of easternmost Washingtonia palm. Field grown B & B with double 10 ft. clear trunks. Align trunks with median. Will require (3) bubblers locations with (2) adjustable flood bubblers per tree.
