Project: GOLDEN GATE BEAUTIFICATION, M.S.T.U.
Location: Collier Blvd. Part A & B
Project Manager: Dan Schumacher, Collier County Public Services Department, Public Transportation & Neighborhood Enhancements Division.
Consultant: McGee & Associates
Contractor: Superb Landscaping
Observation Date: 11/04/19

Landscape Architect Report: December 2019

Report No.: 3 (FY20)

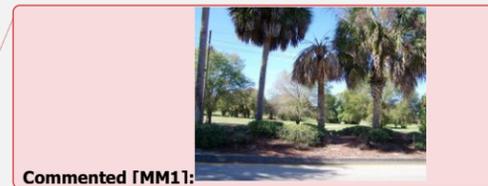
X	X	25	Multiple Juniper plants on the north median end are missing.	
		X	X	58	Recommend removing two remaining beds of Red Fountain grass and replant areas with Silver Saw palmetto's.	
Median #68 (M.P. #5)		X	X	11	Auto accident on north end east side that damaged Plumbago, Bougainvillea and crown of thorn plants. Review and replace as required.	
		X	X	25	Multiple Juniper plants on the south median end are missing.	
		X	X	25	(3) Oak trees damaged. Remove and replace.	
		X	X	26	(3) Magnolia trees damaged. Remove and replace.	M&A: 12/11/17 Consider replacement with alternative tree such as Crape myrtle.
		X	X	31	Dead Sabal needs to be removed. (photo)	M&A: 2/14/17 Tree removed and location staked.

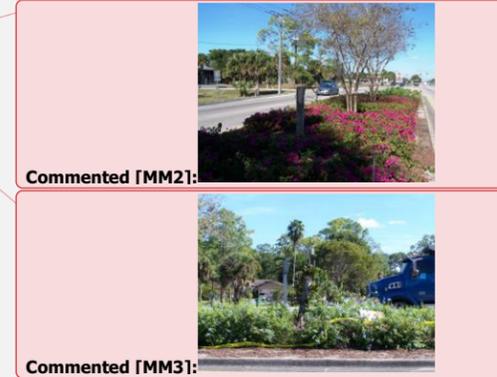
25	At address 12045: (1) Tabebuia tree damaged. Remove and replace.	M&A: 12/11/17 Consider replacement with alternative tree such as Crape myrtle.
		X	X	72	Review Juniper on north and south end for replacements due to auto damaged.	Hannula 12/20/13: Plant count is needed by next drive through
Median #73 (M.P. #10)		X	X	24	At address 12135: (1) Oak tree damaged. Remove and replace.	
				24	At address 12125: (1) Oak trees damaged. Remove and replace.	
		X	X	66	Review south end Juniper bed for replacements.

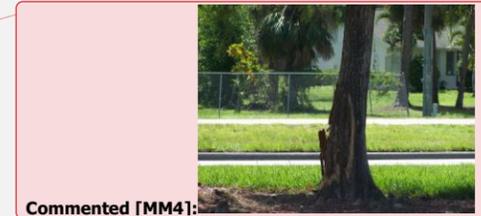
X	X	39	Median turf areas have dead spots from previous water stressed.	
		X	X	62	Remove dead Indian hawthorn plants and replace. (8) 3 gal. size.	
		X	X	66	Turf areas need to be reviewed for dead areas that need to be replaced.	Provide proposal with square footages per median.
West R/W		X	X	41	Tree branches are below ten feet over sidewalks.	
Irrigation:					Previous month water use: Part A – 81,771 gallons, Part B – 167,955 gallons.	
Part A Pump Station- Median 67 (M.P.#4), New pump station installed 1/18, 5 hp, 6" well, VFD, Motorola controller Electric meter on west R/W at pump station						
Part B Pump Station-Median 74 (M.P. #11), New pump station installed 1/18, 7.5 hp, 6" well, VFD, Motorola controller, Electric Meter West R/W adjacent to Median #9 Address #12225						
<u>QUARTERLY ADDRESSED</u>						
Part "A" - West R/W Sign Area						
Part "A" Medians #66 thru 68		X	X	65	These medians need to have renovation plantings. The future roadway construction appears to be more than 10 years out.	Hannula 12/20/13: An estimate cannot be submitted without knowing the recommended species for replacement and a plant count, Area(s) must be white lined during drive-through upon acceptance of estimate. M&A 1-15-14: Please call our office to schedule an on-site meeting to review medians.
