PELICAN BAY SERVICES DIVISION
Municipal Services Taxing & Benefit Unit

NOTICE OF PUBLIC MEETING

PELICAN BAY

Lake 4-1 Analysis

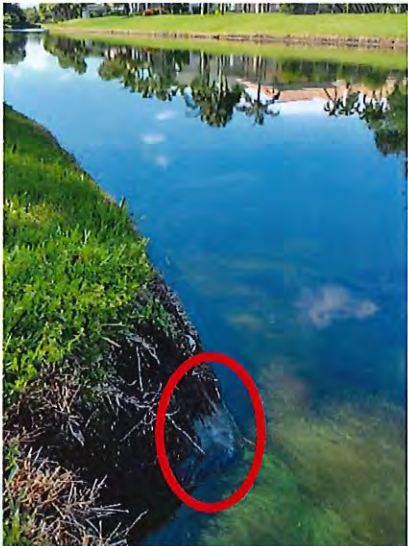
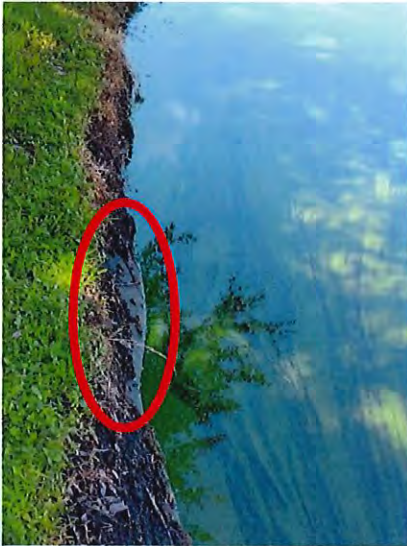
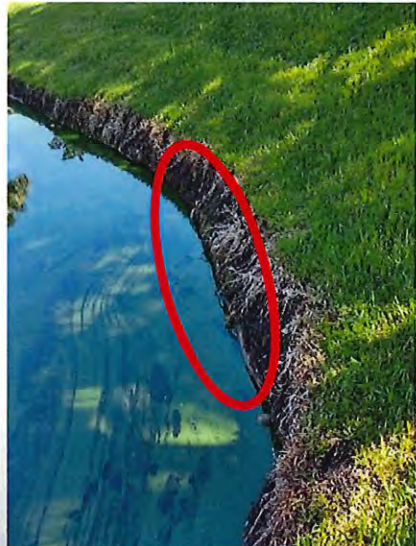
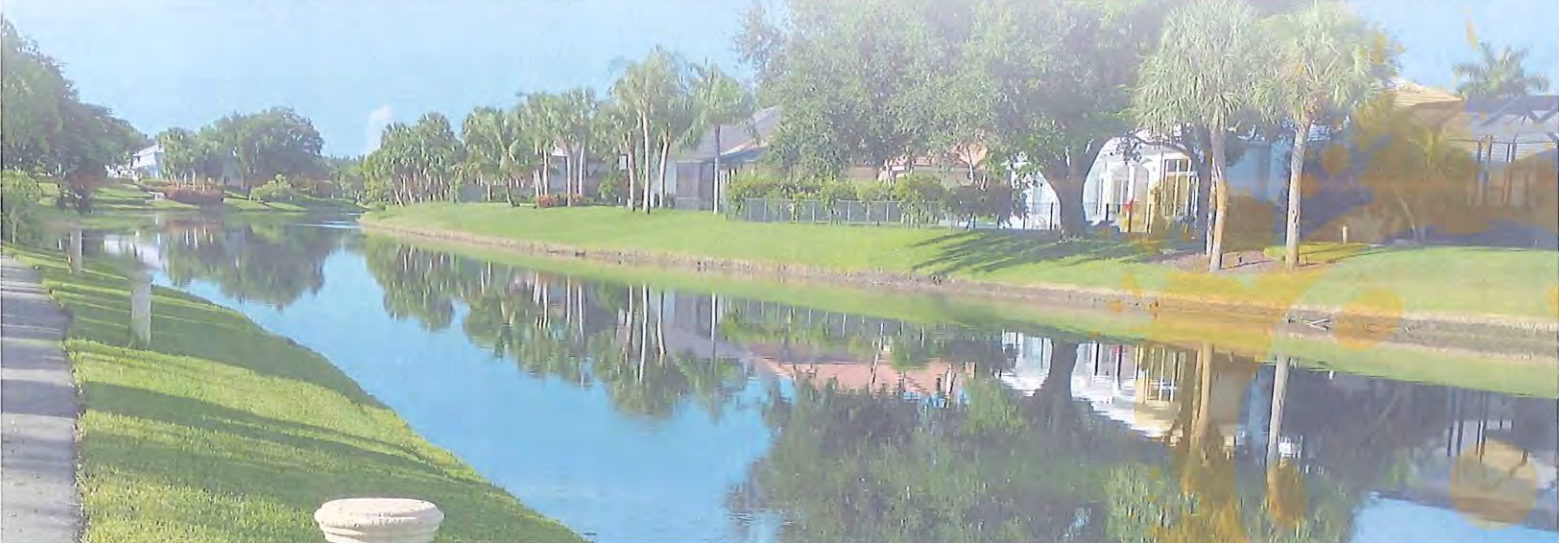
Some of the depth found around the lake banks during inspection can be attributed to geo-tube put in place from previous erosion prevention effort. This geo-tube anchors much of the soil to the bank and holds the soil in place as water runs over it. This allows the part of the bank not held in place by the fabric sock to be pushed farther into the lake. The geo-tube then begins to fail and slide into the lake itself, no longer serving its purpose.

The escarpment height around much of the lake was higher than the 9-inch limit for the SFWMD permit showing critical signs of erosion along the bank, reaching depths of up to 30 inches in some places. It was most critical along the east side of the lake where you can see exposed geo-tube from previous erosion prevention efforts. However, this fabric has begun to fail and is now sliding into the water no longer preventing erosion along the bank.

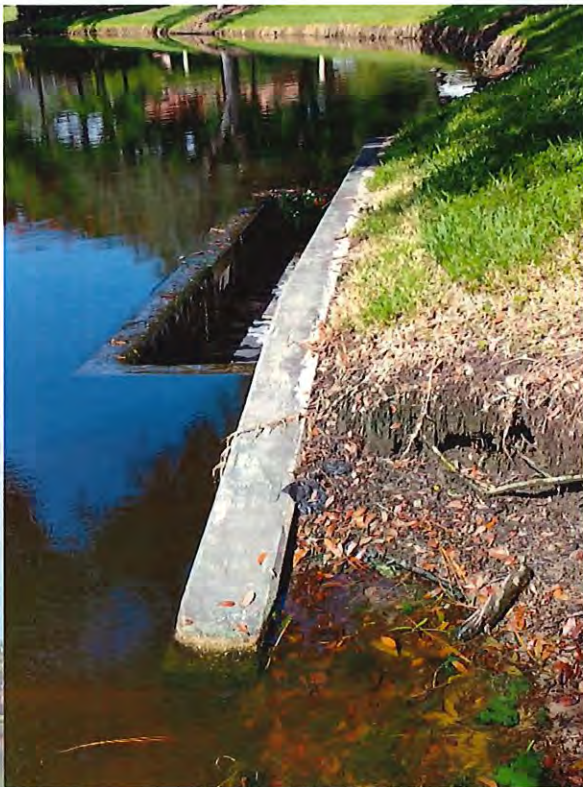
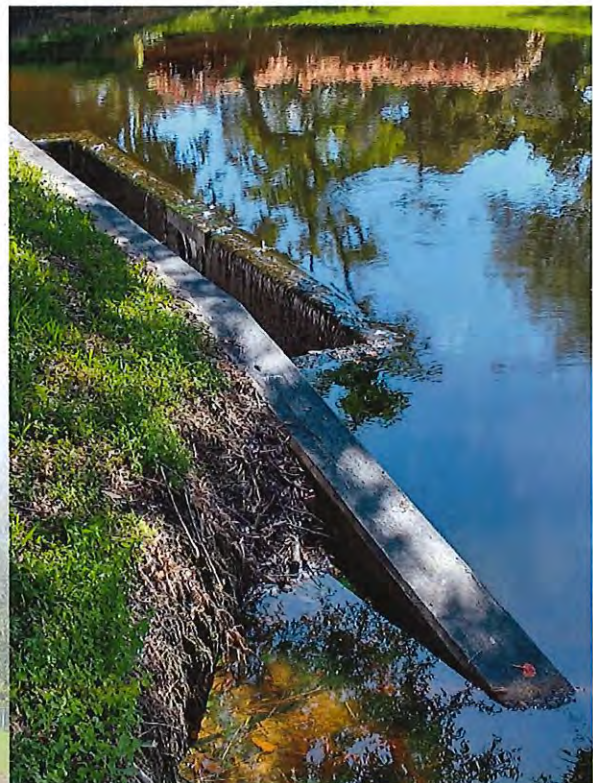
There is an outfall structure on the north side of the lake bank that showed signs of erosion behind the headwall. Typically, headwall is used to stabilize the soil around drainage structures to prevent the structure from falling into the water. In the picture below, the headwall has been exposed due to the receding lake bank. This presents not only a problem of erosion but may put the structure at risk in the long-term.

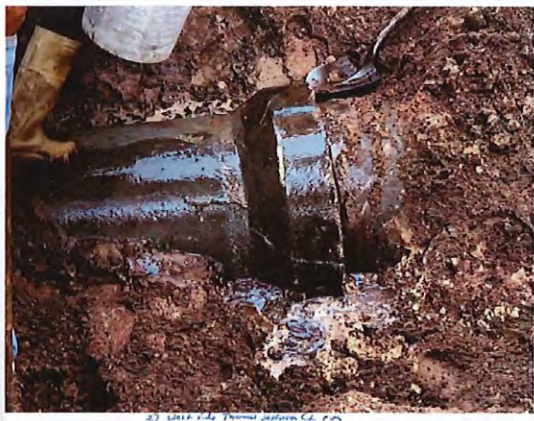
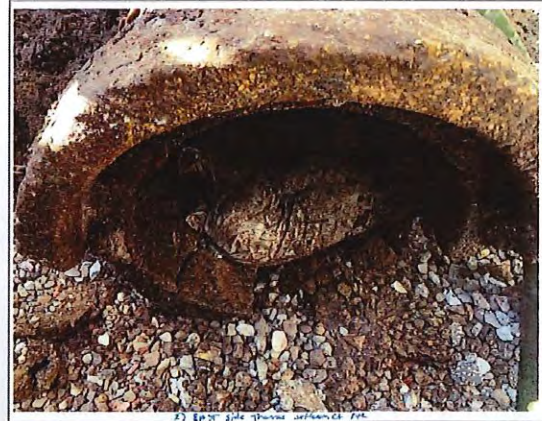
Damaged 24' stormwater pipe

Bid award for repairs:
Quality Enterprises

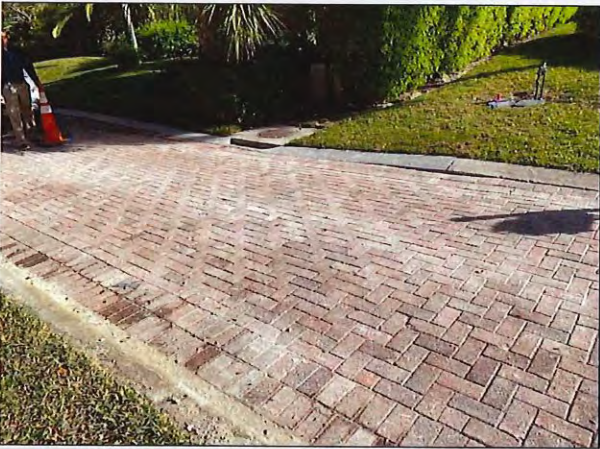
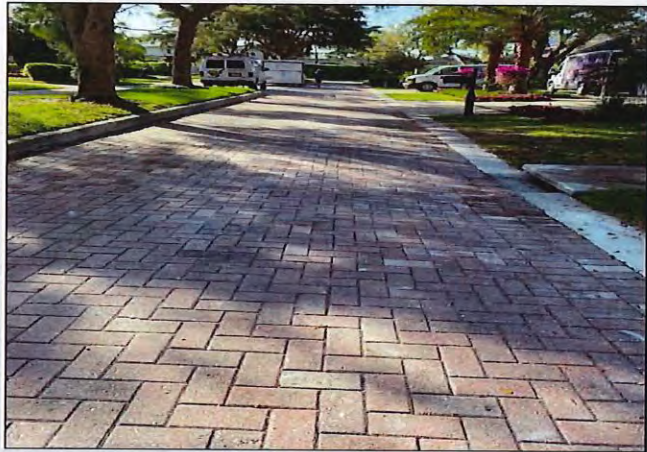
Job complete 02/2020
