CLAM PASS

2019 Review of Inlet Management

Prepared for
Pelican Bay Services Division
Collier County, Florida

Prepared by
Humiston & Moore Engineers
md@humistonandmoore.com

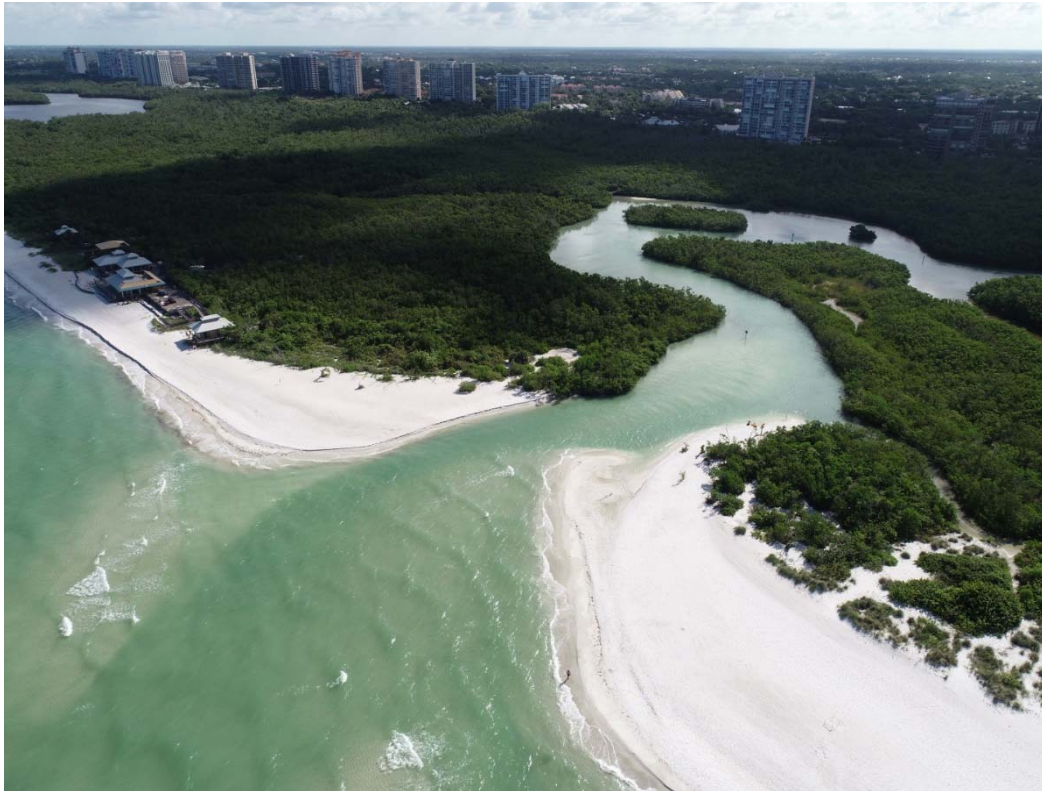
Figure 6 . Clam Pass aerial in July 2019, one year post 2018 maintenance dredging

Figure 6 shows recent aerial photo taken in July 2019 of Clam Pass. The aerial photos and survey data of May 2019 indicate the stable inlet conditions 1 year post 2018 maintenance dredging. **Appendix A** includes summary of the 2019 inlet condition survey showing cross section plots of existing conditions at various locations within the inlet sections. Review and analysis of all available data over the past 20 years were completed as part of this study. **Appendix B** includes plots of changes in inlet geometry and inlet cross sections based on available data over the past 20 years. The inlet morphology data analysis indicated

- Dredging the authorized template increases flow areas and sand holding capacity in the flood shoal areas.
- Rapid shoaling typically occurs in the first year post dredging and evolves towards equilibrium conditions of flow area and sand accumulation within the template.

- Cumulative shoaling rates vary over years between dredging events depending on wave events, frequency, intensity and duration of storms.
- Increased shoaling in Section B of the flood shoal area since 2010 forced the flow to channelize along the south bank of the flood shoal area. This resulted in significant erosion of the mangrove shoreline and expansion of the width of Section B.

- The change in the geometry of Section B since 2010 increased the inlet channel meander towards the north and reduced inlet stability potential.
- Blocking the channel meander as part of the south bank grading during the 2018 maintenance dredging helped reduce the channel meander and increase stability of the inlet.

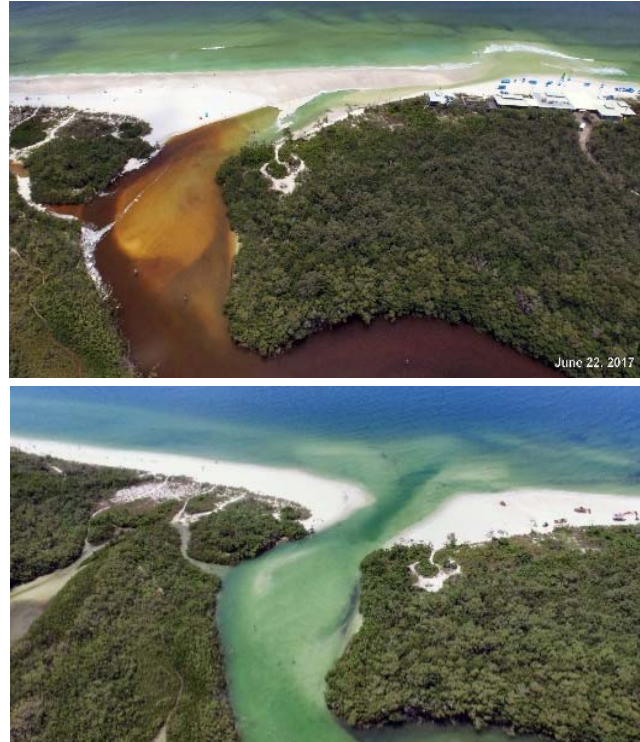
Figure 12 . Pre and Post construction for the 2017 Clam Pass inlet channel restoration

The sand placement south of the inlet and sequence of wave events pushed sand towards the inlet causing significant inlet migration northward and sand spit growth across the inlet mouth. Emergency maintenance excavation of the inlet channel and grading of the inlet banks was completed in July 2017 to restore the inlet stability and avoid potential of inlet closure. **Figure 12** shows pre and post inlet channel restoration in July 2017.

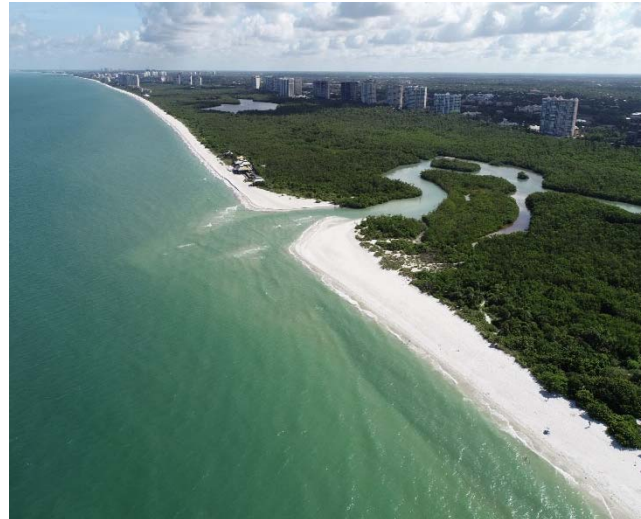
Figure 13 . July 2019 conditions at Clam Pass (1-year Post construction of the 2018 Clam Pass maintenance dredging)

The 2018 wave energy also indicated increased energy from the south than average such that the net transport was relatively small due to the similar magnitude of north and south transport in 2018. Maintenance dredging in 2018 was completed to restore the inlet to design template including hydraulic dredging of the interior flood shoal areas and correct the inlet channel meander. The 1-year post dredging survey indicated the inlet remains in stable conditions. **Appendix A** includes the 2019 monitoring data and comparative plots at various monitoring stations. **Figure 13** is an aerial photo of July 2019 showing the condition of the inlet and adjacent beaches 1 year post the 2018 maintenance dredging.

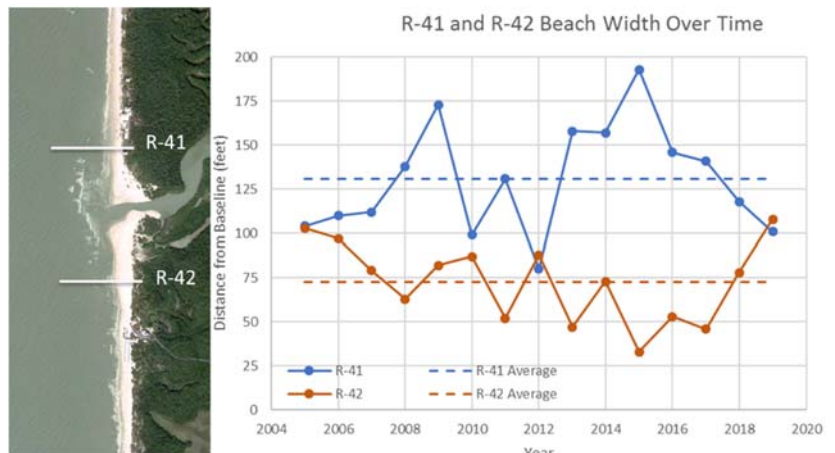
Figure 18 . Beach width north and south of Clam Pass (2005-2019)

A review of beach width north and south of the inlet indicated that in general the beach width north of the inlet is significantly wider than the beach south of the inlet. This in part in response to the effect of the typically predominant transport in this region from north to south and the active beach nourishment program. **Figure 18** shows the beach width north and south of Clam Pass between 2005 and 2019. The figure indicates that on average the beach north of Clam Pass is approximately 50 feet wider than the beach south of the inlet. This offset in beach width makes the inlet more

resilient to storms originating from the north than storms originating from the south. This offset in beach width and shoreline position across the inlet is among the reasons why the inlet was impacted significantly in years with tropical storm activities from the south such as 2016/2017 season. Sand placement from the inlet maintenance in 2016 and beach nourishment later the same year south of the pass were followed by very active wave events driving sand northward towards the inlet and forming large sand spit across the inlet mouth. Emergency restoration of the inlet channel was done following tropical storm Cindy in the summer of 2017.

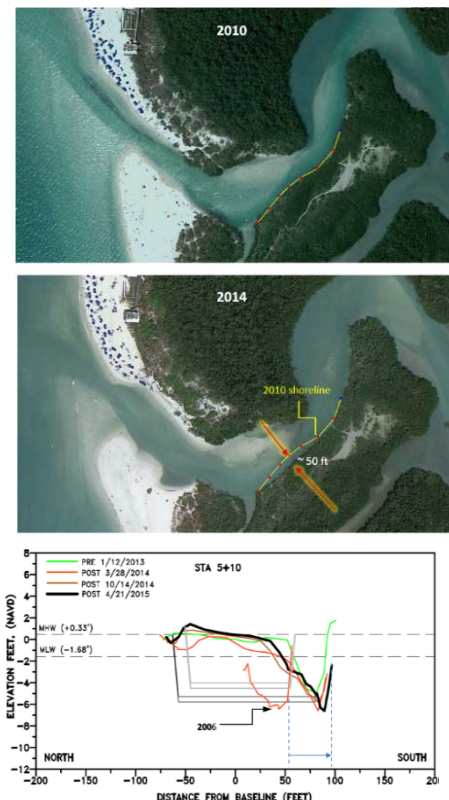
Figure 19 . Long term changes in flood shoal area (section B) 210-2014

- The south bank erosion became more progressive in the flood shoal in section B due to lack of dredging between 2007 and 2013 and wave events of 2010 and 2012. This resulted in change in flow patterns within the flood shoal area and increased meandering of the inlet channel. **Figure 19** shows the change in cross section area and southward migration of flood shoal channel between 2010 and 2014.

The widening of section B of the flood shoal due to the south bank mangrove erosion altered the geometry and flow patterns in the

flood shoal. This resulted in rapid shoaling in the central area of section B following maintenance dredging and sharp meander of the channel along the north inlet bank.

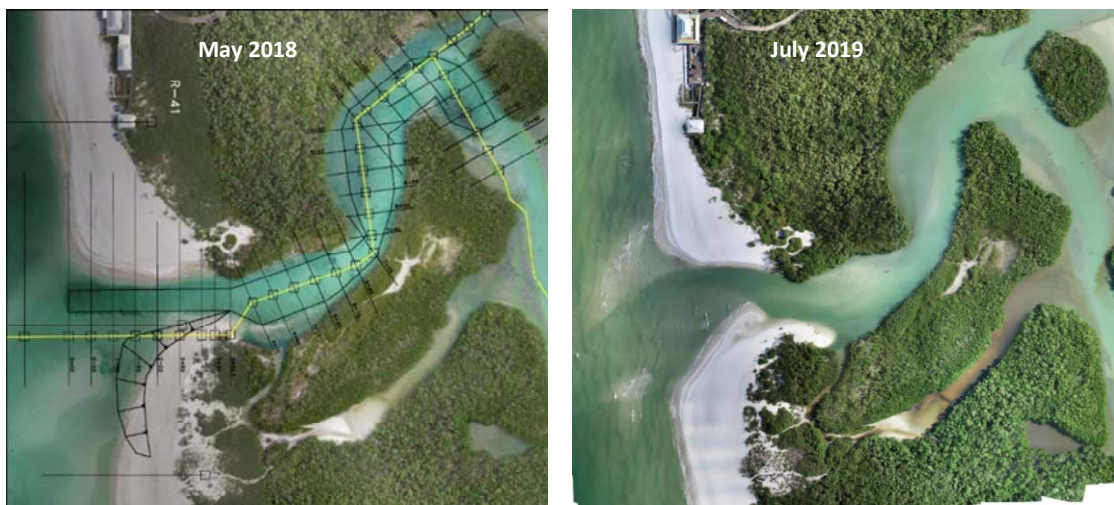
Figure 20. Clam Pass immediately post 2018 maintenance dredging and 1 year post construction conditions

The impacts of Hurricane Irma on Clam Pass accentuated the trend discussed in the above section of the widening of section B and flow channelization along the south bank resulting in increased inlet channel meander and reduced inlet stability. During the 2018 maintenance dredging sand was placed with the south bank grading area to dyke the channel meander on the south bank. This allowed the flow to remain within the design template area and reduced the potential for inlet channel meandering. The 2019 monitoring survey indicated improved flow and reduced shoaling in section B of the flood shoal and improved sand bypassing patterns across the inlet. **Figure 20** show aerial photos of the May 2018 immediately post dredging conditions and July 2019 conditions 1 year post construction. The figure shows the stability of the inlet channel and inlet morphologic features and response to the adaption measures allowed by the inlet bank grading zone.
