PELICAN BAY SERVICES DIVISION
Municipal Services Taxing & Benefit Unit

NOTICE OF PUBLIC MEETING

**AGNOLI
BARBER &
BRUNDAGE, INC.**
Professional Engineers, Planners, Surveyors & Landscape Architects

PELICAN BAY

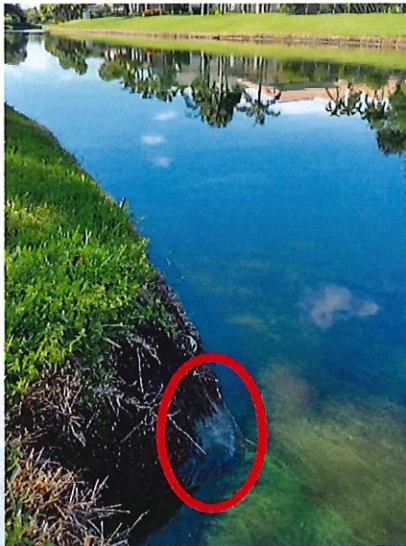
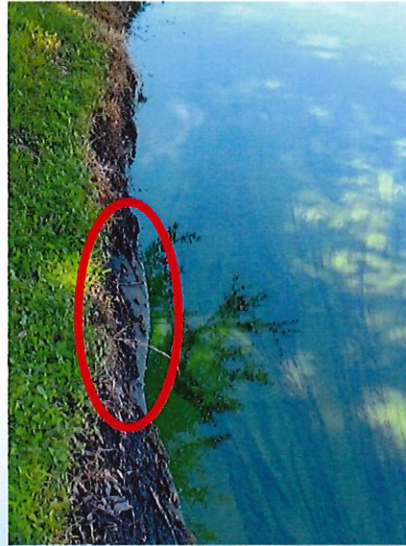
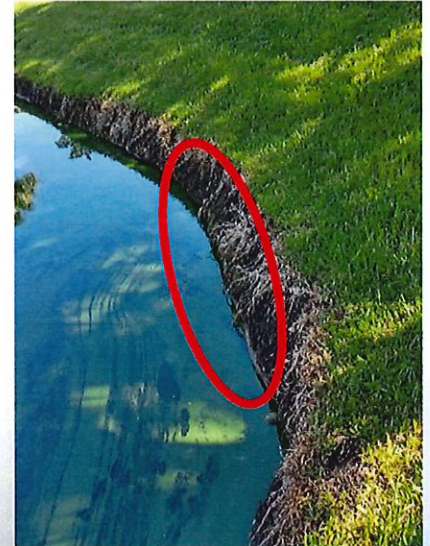
Some of the depth found around the lake banks during inspection can be attributed to geo-tube put in place from previous erosion prevention effort. This geo-tube anchors much of the soil to the bank and holds the soil in place as water runs over it. This allows the part of the bank not held in place by the fabric sock to be pushed farther into the lake. The geo-tube then begins to fail and slide into the lake itself, no longer serving its purpose.

The pedestrian side has some steep side slopes abutting the lake bank that need to be remediated to meet the 4:1 slope requirement. Excess runoff produced by the roofs of the homes may contribute to this issue however the homes on the east side, abutting the pathway, should have downspouts connected into the storm water system along the roads in front of the homes.

The escarpment height around much of the lake reaches depths of up to 30 inches in some places, falling out of compliance with the SFWMD permit. It was most critical along the east side of the lake where you can see exposed geo-tube from previous erosion prevention efforts. However, this fabric has begun to fail and is now sliding into the water no longer preventing erosion along the bank.

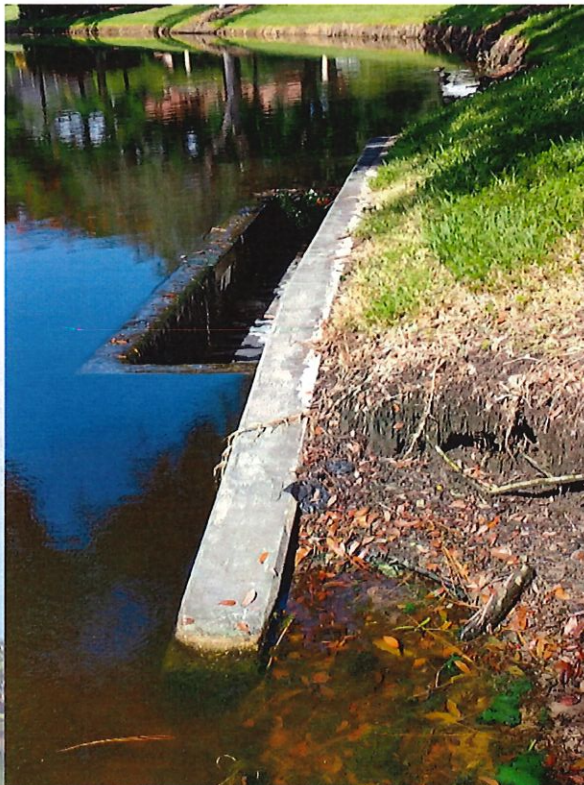
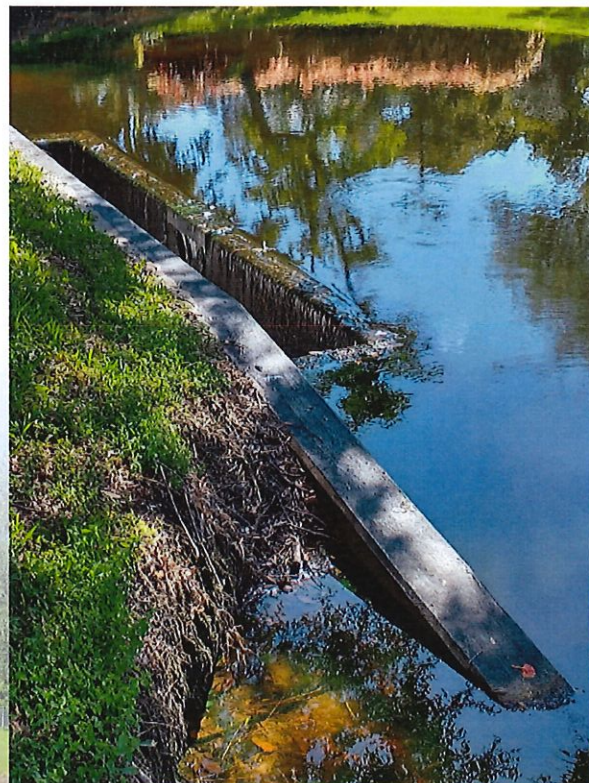
There is an outfall structure on the north side of the lake bank that showed signs of erosion behind the headwall. Typically, headwall is used to stabilize the soil around drainage structures to prevent the structure from falling into the water. In the picture below, the headwall has been exposed due to the receding lake bank. This presents not only a problem of erosion but may put the structure at risk in the long-term.

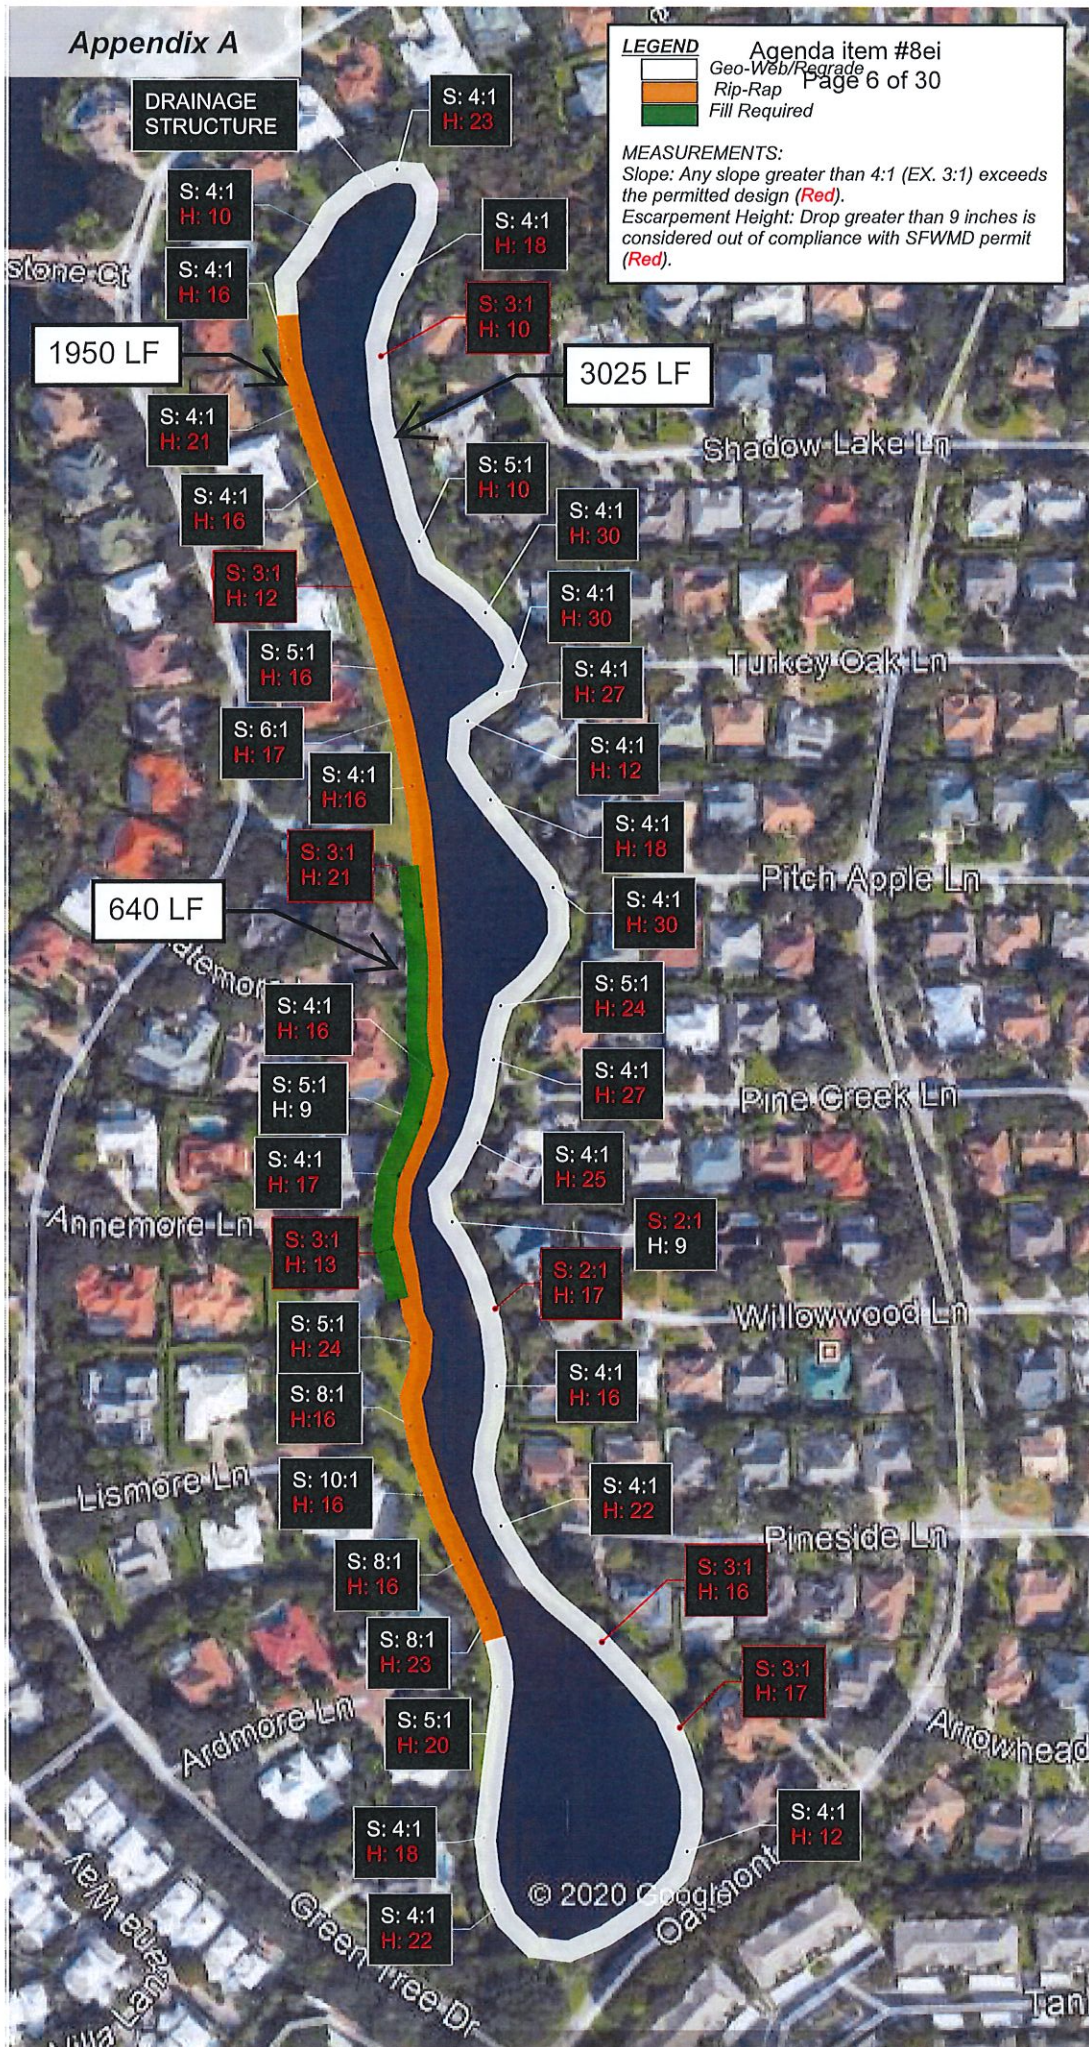
The field data collected in Appendix A determined that there are areas that are considered more severe than others. Therefore, different options regarding the extent of restoration has been provided below. For further financial information, refer to the tables in Appendix B.

Slope: Any slope greater than 4:1 (EX. 3:1) exceeds the permitted design (Red).
 Escarpment Height: Drop greater than 9 inches is considered out of compliance with SFWMD permit (Red).

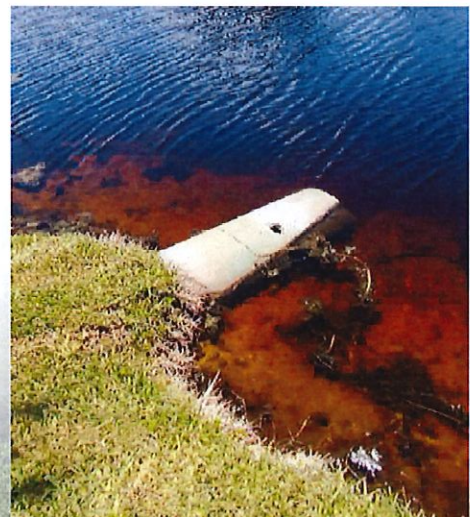
In this case, the drainage structures are exposed or even damaged (see above). The exposure of drainage pipe is an indicator that the lake bank is receding or falling into the water, which can create a significant amount of issues.

Figure 4: Exposed & damaged drainage pipe depicting the receding lake bank.

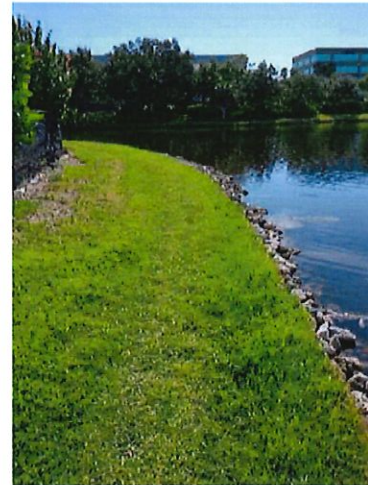
Lake 1-3 has approximately 3250 linear feet of lake bank however about half of it has had riprap installed. Due to this, there were only 12 lake-data points taken, primarily on the east side of the lake. The data shows that erosion does not seem to be a significant issue here, however it will be in the future. While the existing slopes satisfy requirements, the escarpment height does exceed the permitted amount. Generally, the height only falls within 6 inches of the permitted amount except for two points that are over 20 inches in height. If any restoration were to occur, it is recommended that this area be prioritized. The structures around this lake are in good condition.

Figure 2: Rip-rap has been installed around approximately half of the existing lake bank on Lake 1-3.

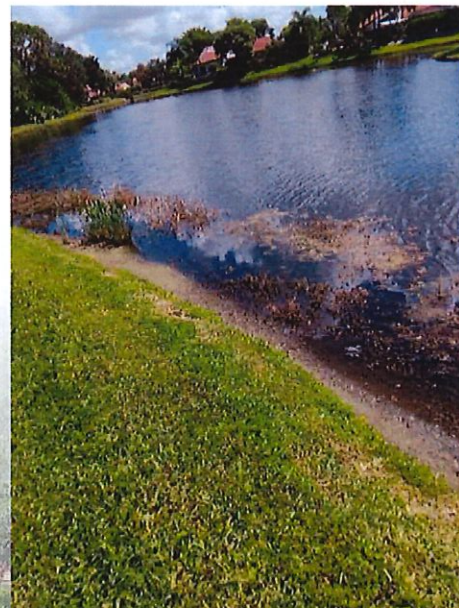
As seen in many of the other lakes throughout this observation, the escarpment height is typically the primary sign of erosion. While this is true for Lake 1-6 as well, a combination of both the escarpment height and the slope highlights points of critical erosion, specifically on the southwest side of the lake. This side is adjacent to Crayton Road which most likely contributes to much of these characteristics. Lake 1-6 also offers a large fetch which, as previously stated, speeds up the erosion process. The lake stretches approximately 1,500 linear feet from north to south however due to the lake following the bend in Crayton Road, this length is broken in about half which prevents significantly more damage from the wind and waves. Nevertheless, the bend in the middle of the lake still suffers from these factors. Referring to Appendix C, there is approximately 160 linear feet of lake bank that is "sliding" towards the water's edge. The picture below depicts a distinct line where the bank looks to be flattening out, where water can sit and saturate the soil, ultimately making it fall into the water (right). It should also be noted that there was a portion of the lake bank around Lake 1-6 that could not be measured due to not having access.

Figure 3: Erosion causing the lake bank to "slide".
