**PELICAN BAY SERVICES DIVISION**  
**Municipal Services Taxing & Benefit Unit**

**NOTICE OF PUBLIC MEETING**

# PELICAN BAY

# Lake 4-1 Analysis

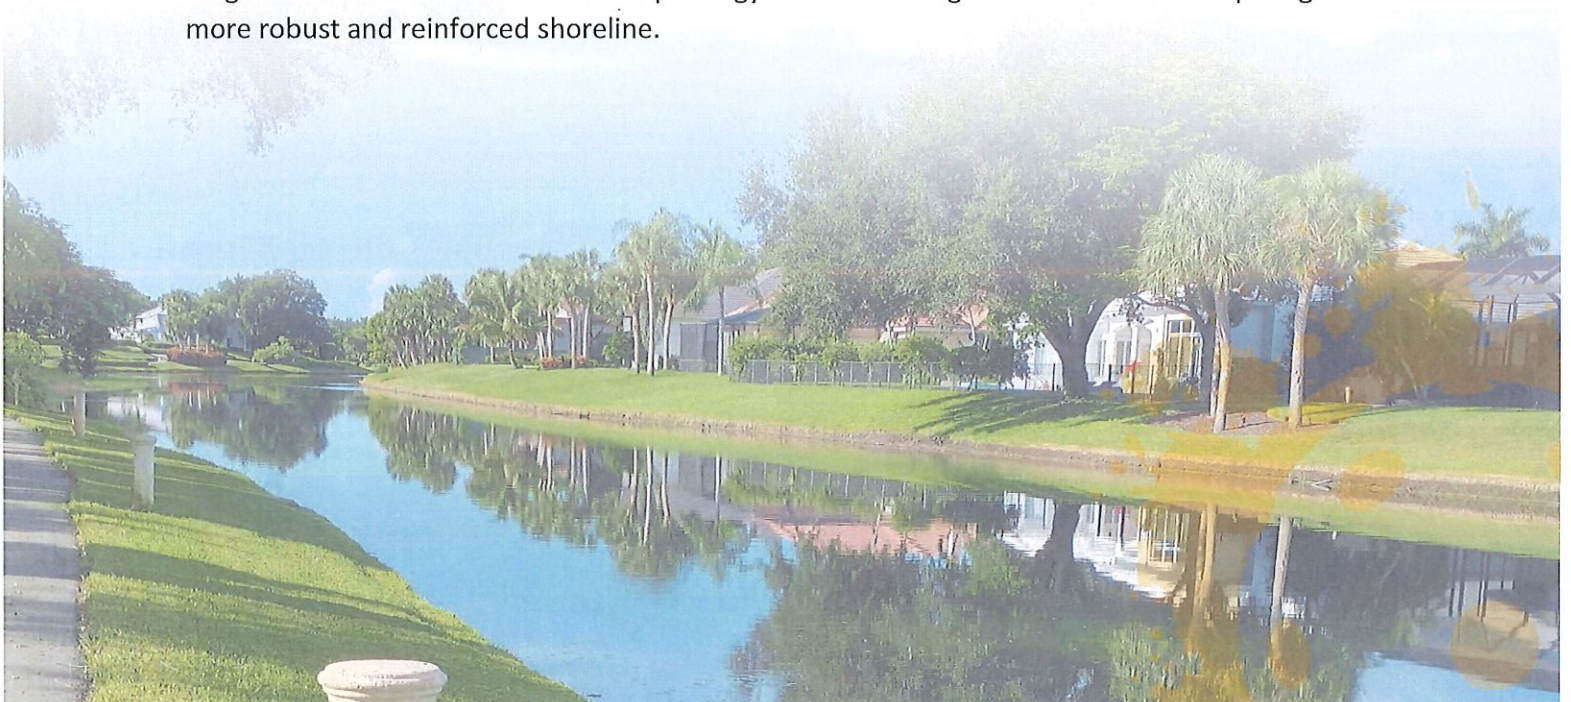
Wind is a major factor in creating waves, fortunately for Lake 4-1 the longest distance from the east to the west side of the lake is about 260 linear feet however the length from north to south is quite significant. Approximately 2600 linear feet separates the north and south sides of the lake, leaving it prone to erosion. Incoming cold fronts and increased wind from storms can create waves that worsen the condition of the lake banks and create additional problems. The long fetch allows the waves to build up energy before crashing into the lake bank requiring a more robust and reinforced shoreline.

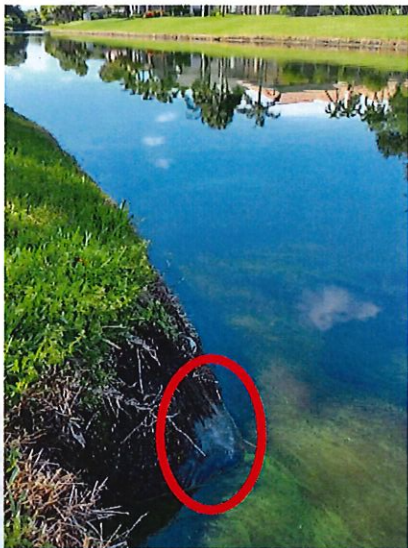
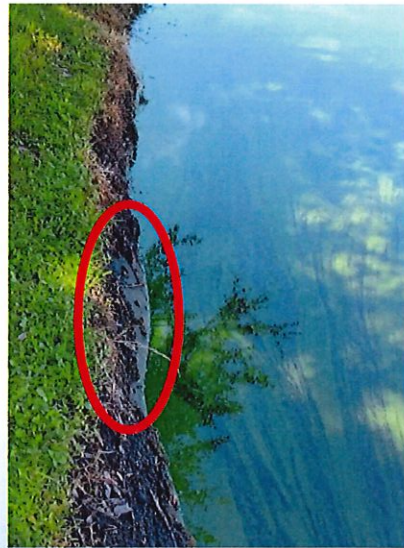
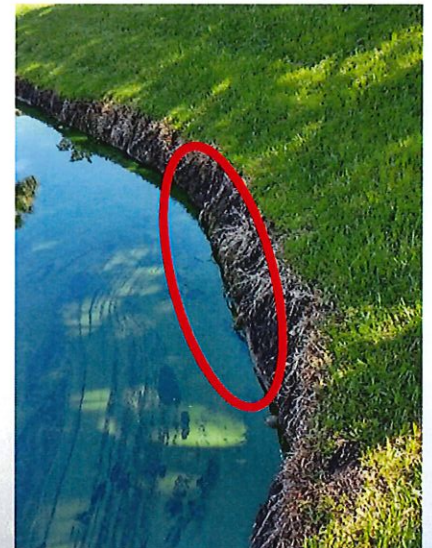
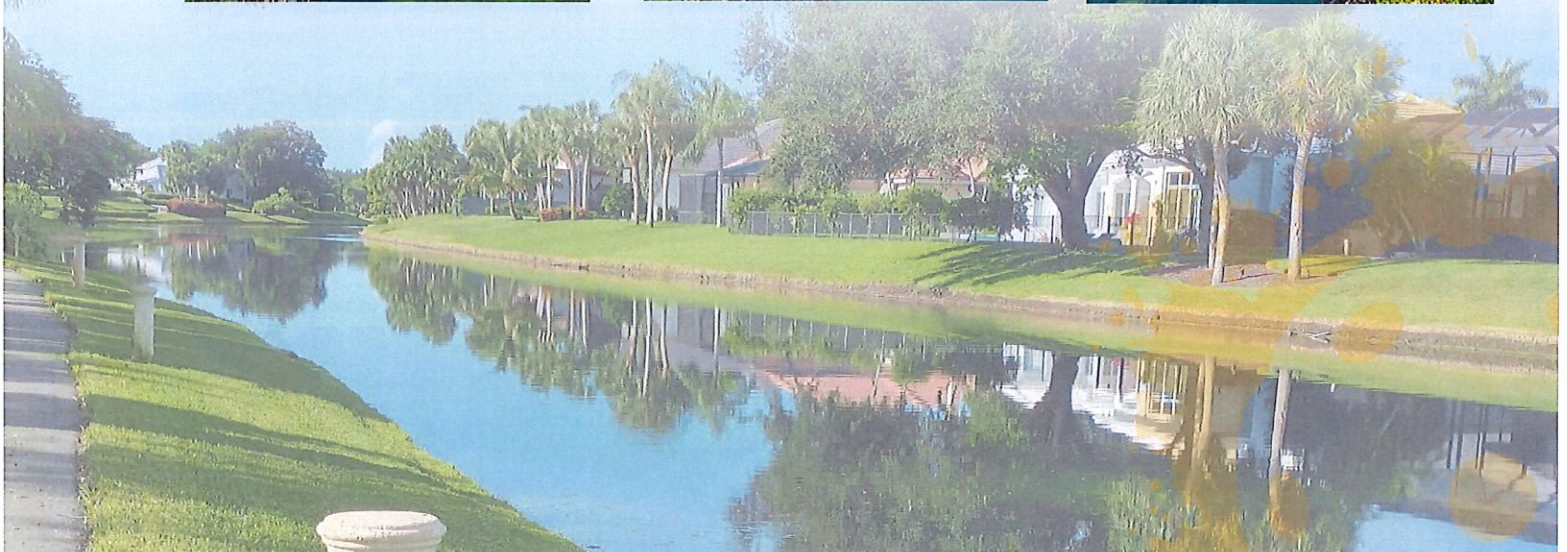
Some of the depth found around the lake banks during inspection can be attributed to geo-tube put in place from previous erosion prevention effort. This geo-tube anchors much of the soil to the bank and holds the soil in place as water runs over it. This allows the part of the bank not held in place by the fabric sock to be pushed farther into the lake. The geo-tube then begins to fail and slide into the lake itself, no longer serving its purpose.

The escarpment height around much of the lake reaches depths of up to 30 inches in some places, falling out of compliance with the SFWMD permit. It was most critical along the east side of the lake where you can see exposed geo-tube from previous erosion prevention efforts. However, this fabric has begun to fail and is now sliding into the water no longer preventing erosion along the bank.

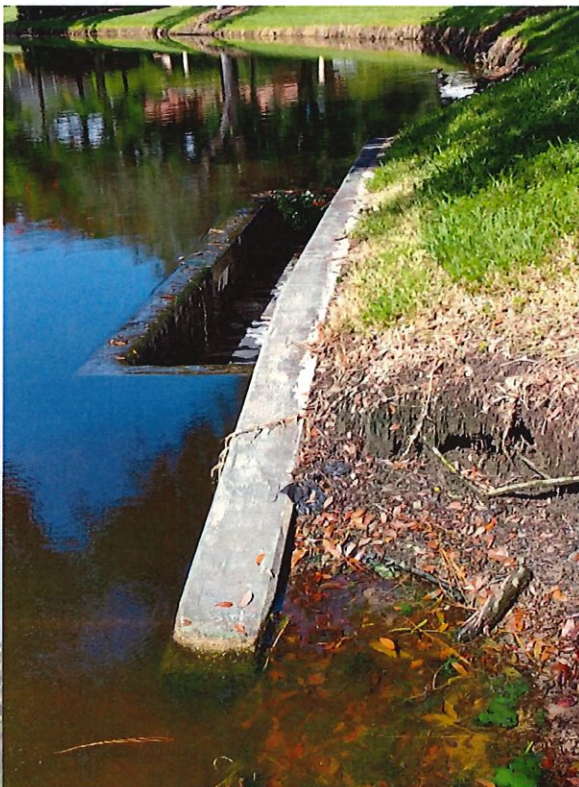
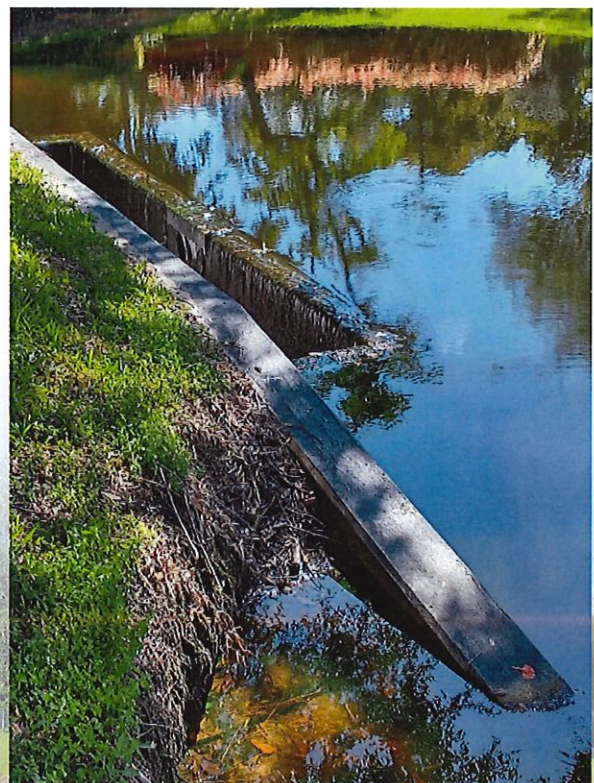
There is an outfall structure on the north side of the lake bank that showed signs of erosion behind the headwall. Typically, headwall is used to stabilize the soil around drainage structures to prevent the structure from falling into the water. In the picture below, the headwall has been exposed due to the receding lake bank. This presents not only a problem of erosion but may put the structure at risk in the long-term.

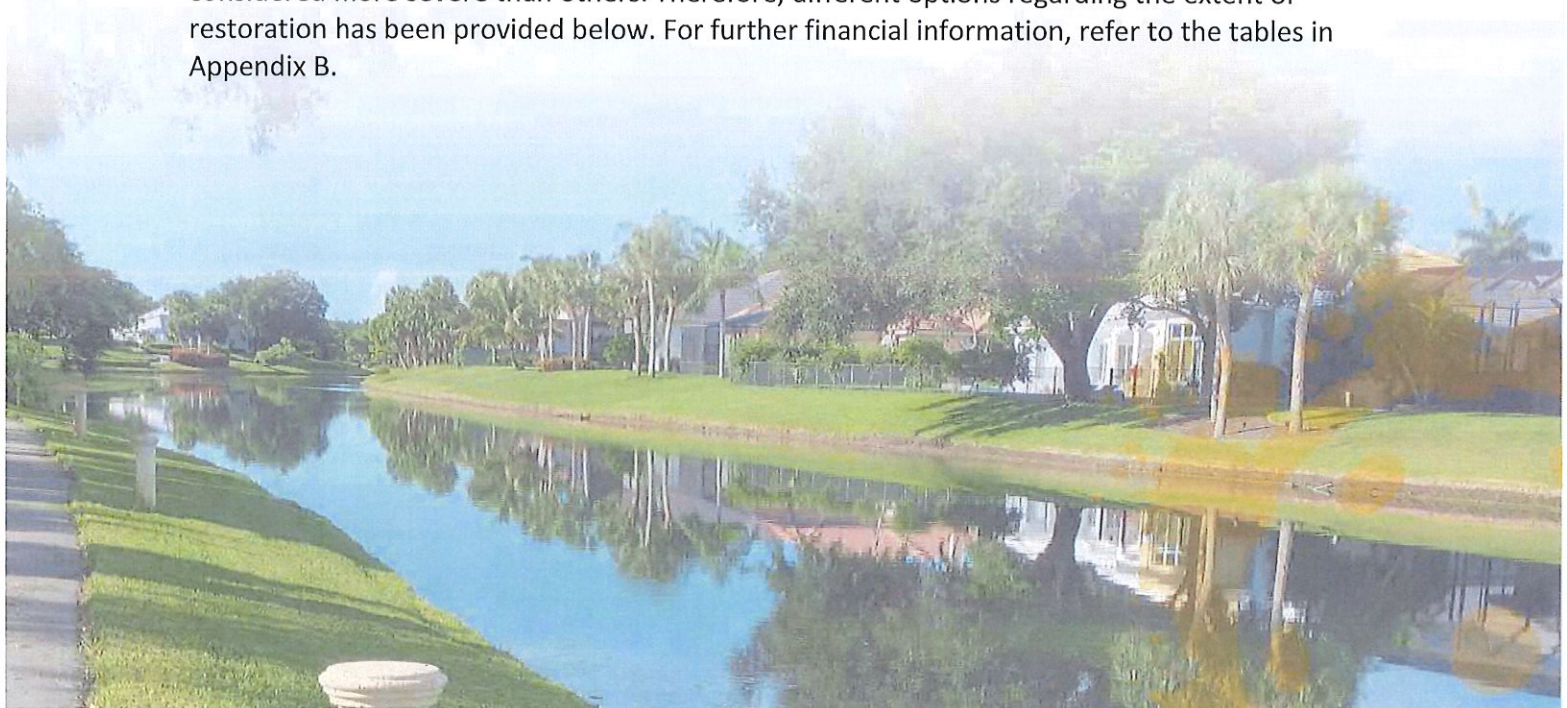
The field data collected in Appendix A determined that there are areas that are considered more severe than others. Therefore, different options regarding the extent of restoration has been provided below. For further financial information, refer to the tables in Appendix B.

Slope: Any slope greater than 4:1 (EX. 3:1) exceeds the permitted design (Red).

Escarpement Height: Drop greater than 9 inches is considered out of compliance with SFWMD permit (Red).

Given the amount of lake bank Lake 4-1 provides, there are different restoration options depending on expenses and degree of erosion. Generally, there are three methods of restoration, installing rip-rap, a geoweb system or simply regrading the existing lake bank to comply with the standards.
