Clam Pass Physical and Tidal Monitoring Report 2020

March, 2021

Prepared for
Pelican Bay Services Division

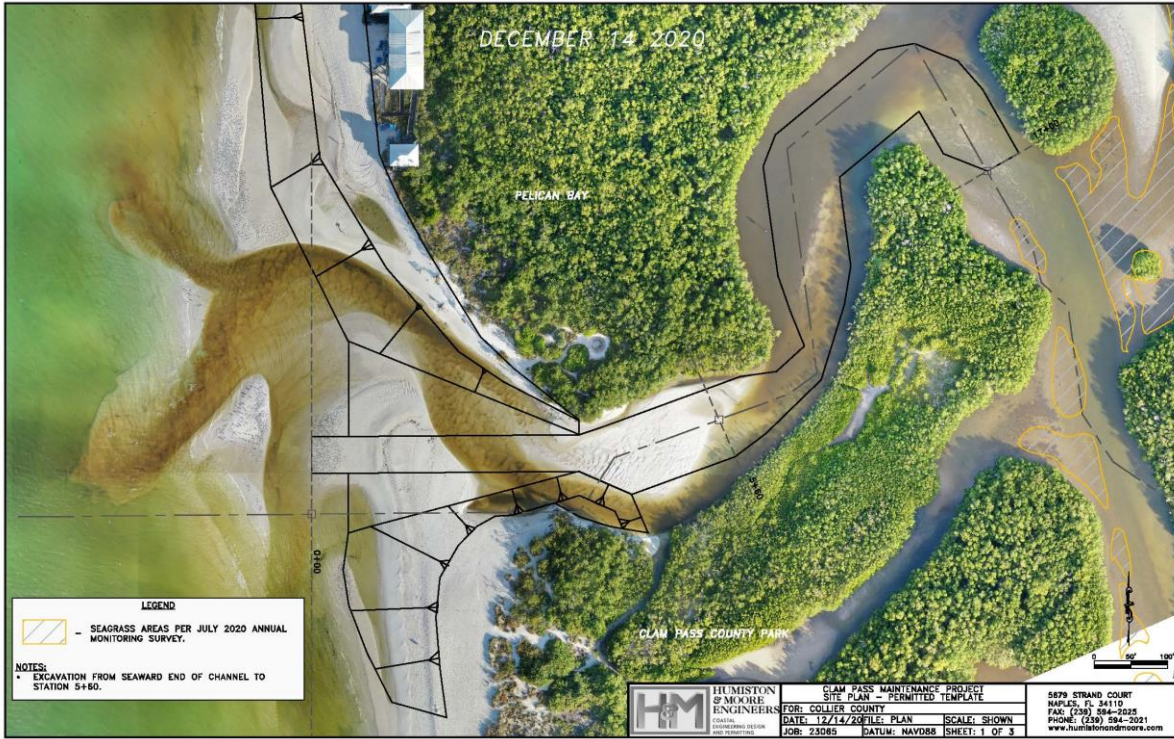
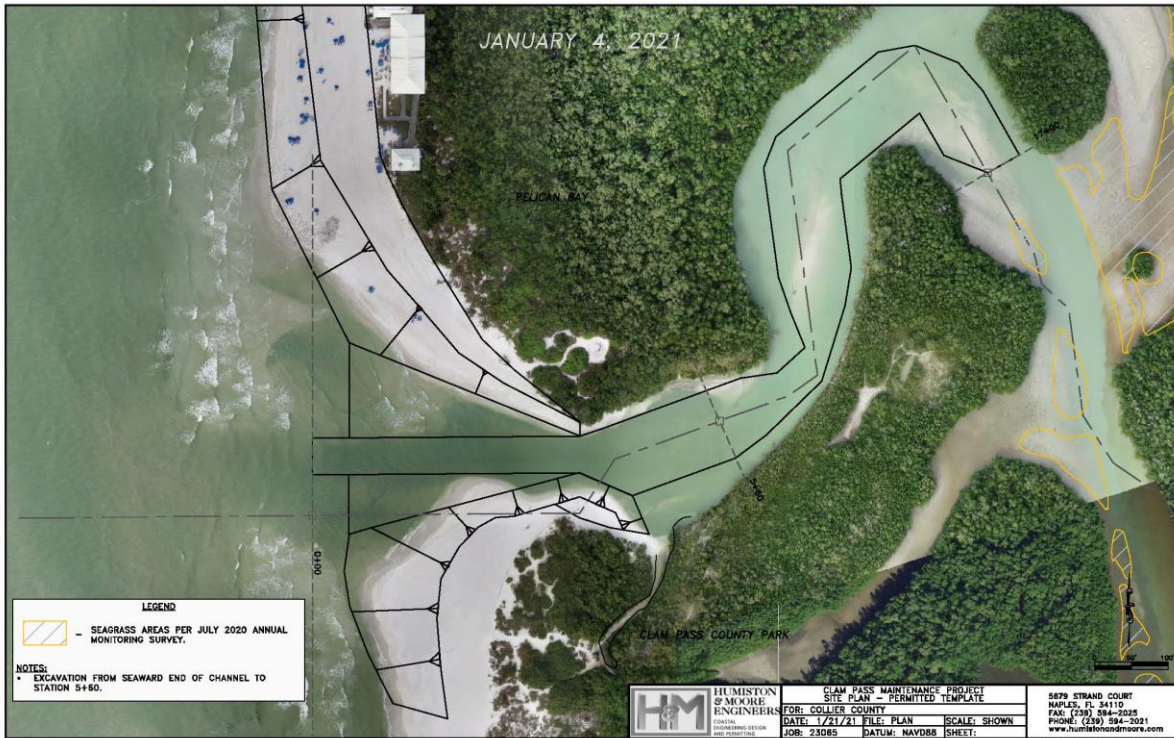
A second limited maintenance work included removal of the sand spit formed from the south bank across the inlet entrance and re-grading the inlet banks using mechanical equipment. The December 2020 also included excavation of sand accumulated in the flood shoal area in section B. The project removed approximately 10,300 cy from the permitted template and grading areas between Station 0+00 and Station 5+50. Approximately 3,900 cubic yards were removed mechanically from the inlet and 6,400 cubic yards were regraded; the excavated material was placed on the adjacent banks and in the vicinity of R-41.

This project was substantially completed on January 4, 2021 and surveys were completed on January 5, 2021. Aerial photos for condition pre and post the December 2020 dredging event are shown below.

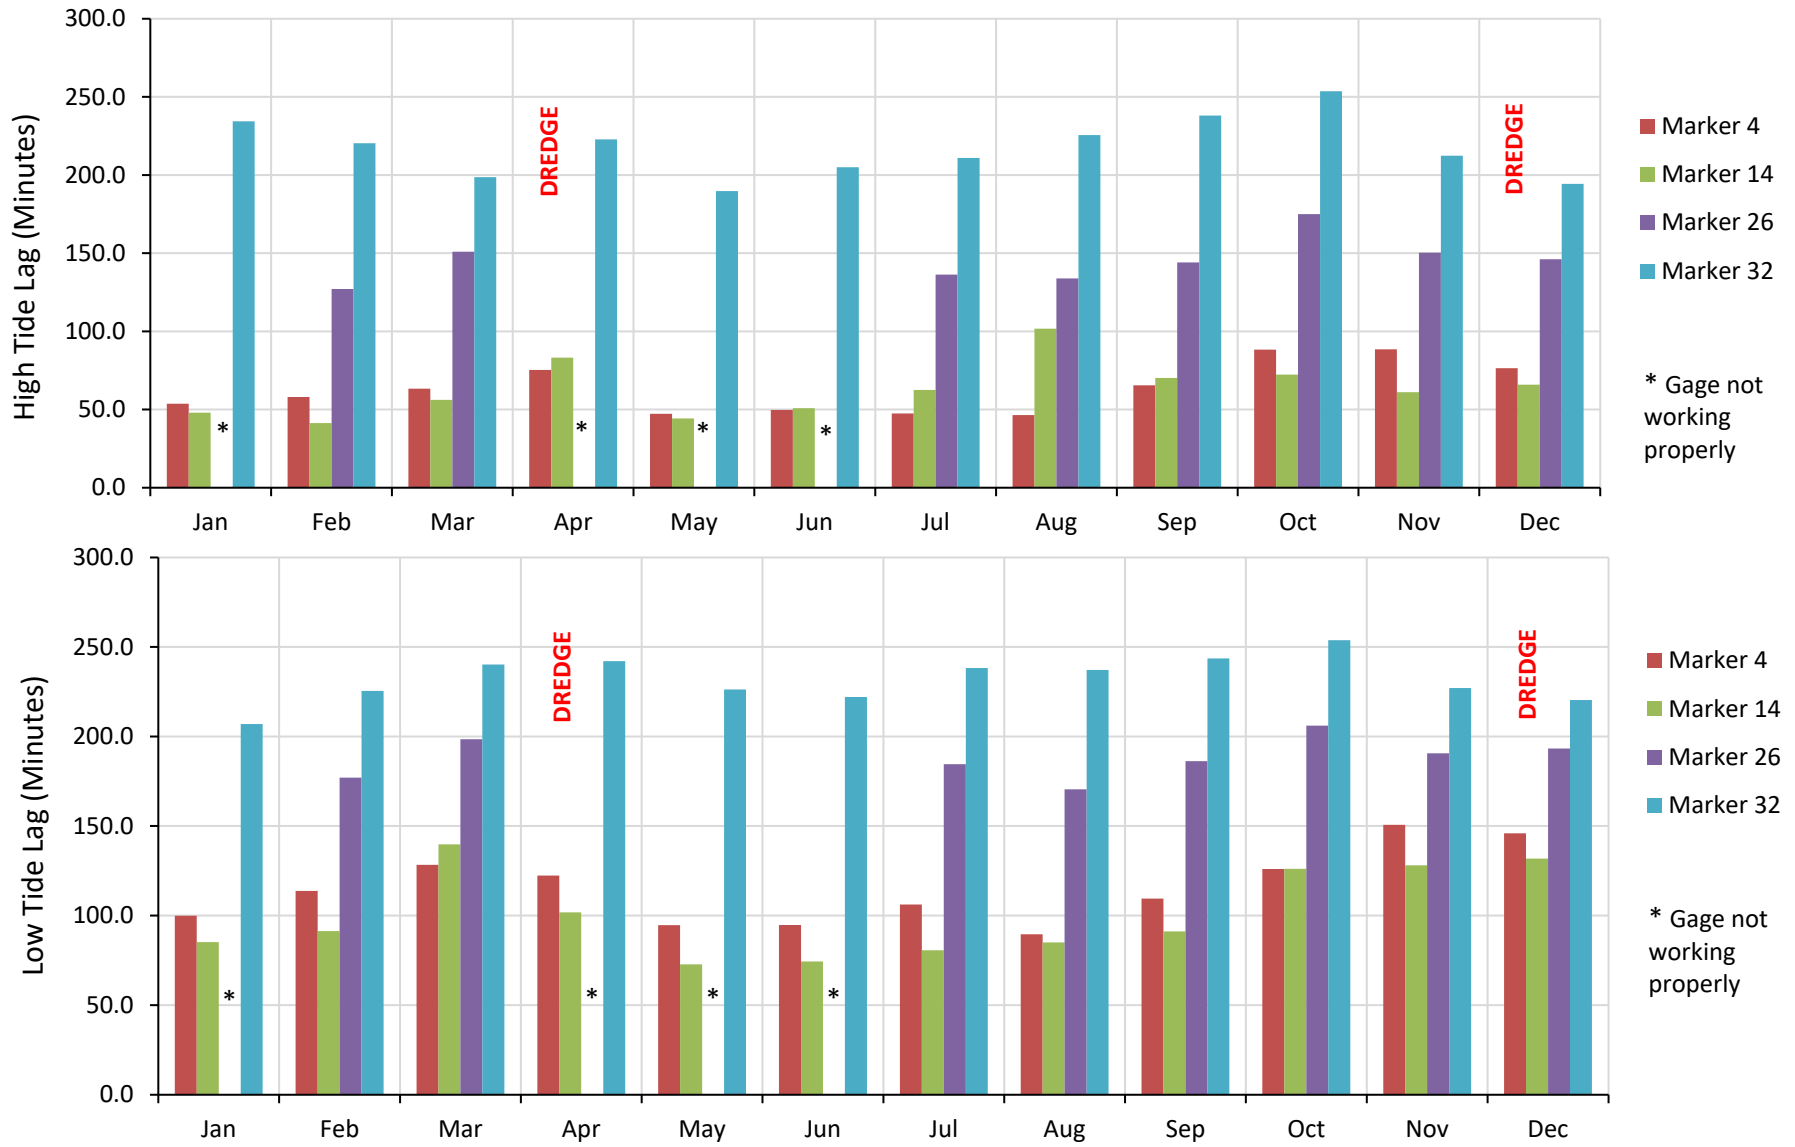
Figure 4 – Monthly Low & High Tide Time Lag Averages – 2020

Figure 4 presents a monthly average of the low tide and high phase lags over the monitoring period of 2020. Monthly high and low tide lags decreased at Marker 4 and 14 directly after the April 2020 maintenance dredging of the Pass showing improved efficiency and then gradually increased until December 2020. A second maintenance dredging was subsequently implemented during the month of December 2020 and January 2021. Monthly time lags at Marker 32 remained the same suggesting no shoaling of the connector channels.

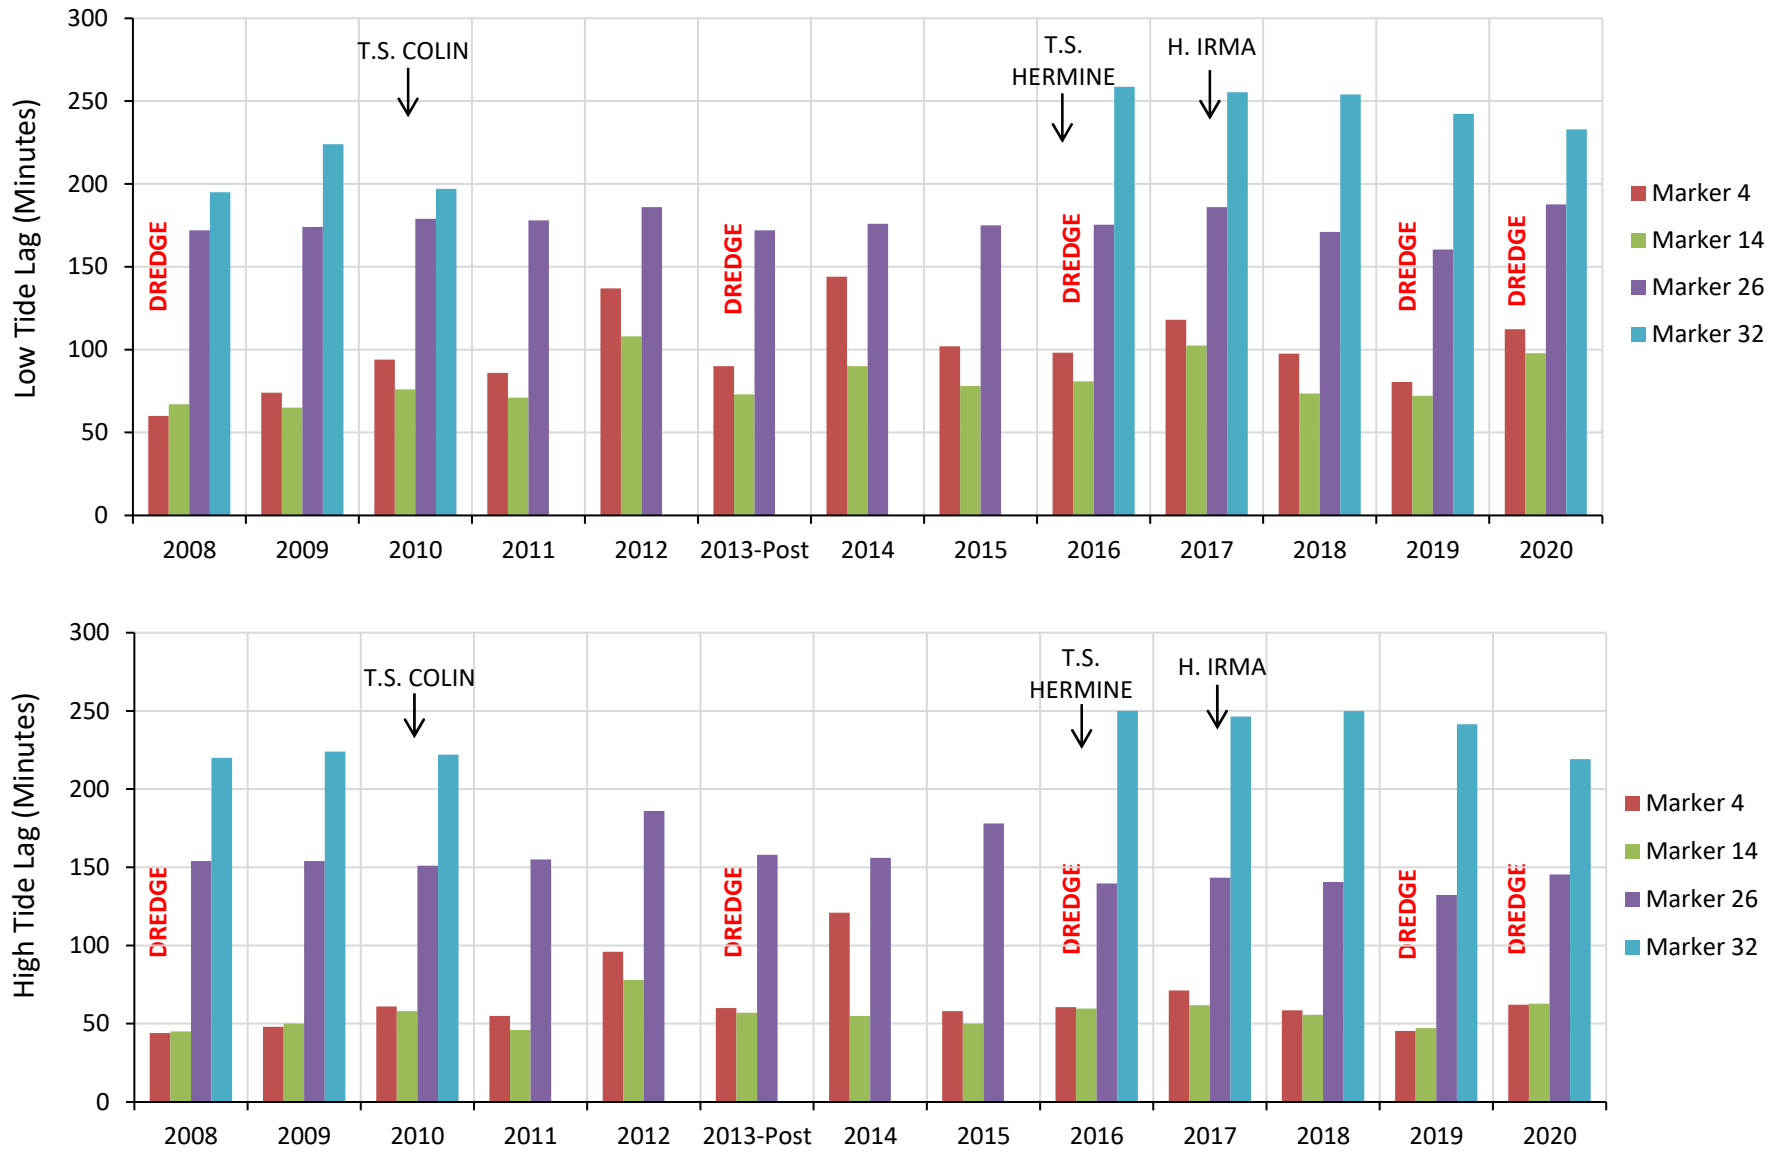
Figure 5 – Yearly Low & High Tide Time Lag Averages – 2008 to 2020

Figure 5 shows the annual averages of low tide and high tide phase lags from 2008 to 2020. The data indicates that the annual time lags for 2020 were slightly higher at Marker 4 and 14 than during 2019, this was the result of sand accumulation in the Pass entrance which resulted in two maintenance dredging events. The time lag at Marker 32 was on average slightly lower than for 2019 suggesting that the lower bay performed more efficiently than previous years.

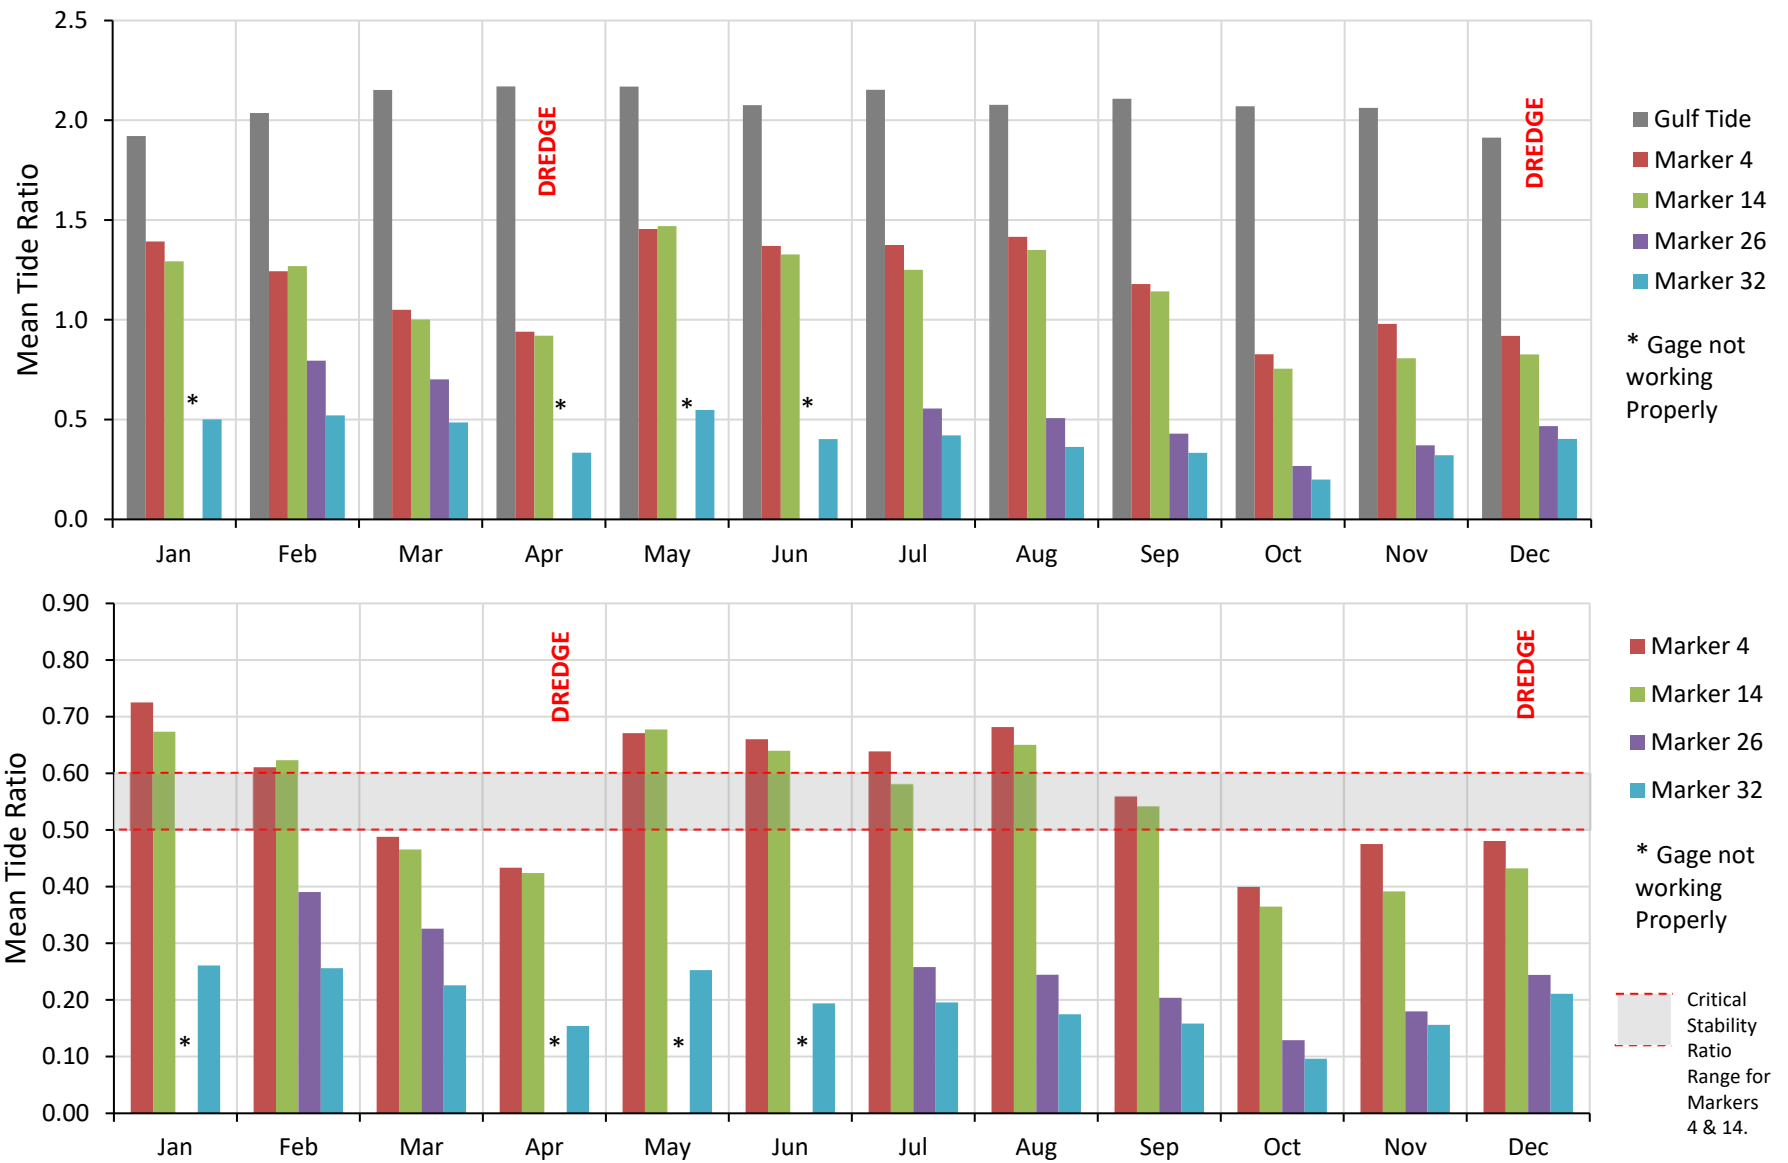
Figure 7 – Monthly Average Tide Range and Tide Range Ratio - 2020

Figure 7 shows both the monthly average tidal ranges and tide ratios for the monitoring period of 2019. The Gulf tide range was around 2 feet, while the Marker 4 & 14 gauges (near the pass) tide ranges were near 1.5 feet. The tidal ranges at Marker 26 and 32 were consistent at around 0.5 feet and 0.2 feet respectively.

The plot of the monthly mean tide ratios shows ratios at Markers 4 & 14 dropped below the critical 0.5 ratio in March 2020 and October 2020, both events prompted maintenance dredging of the pass. The latest maintenance dredging event occurred during December 2020 and January 2021, subsequent monitoring indicates that the ratio went back above the critical threshold in 2021.

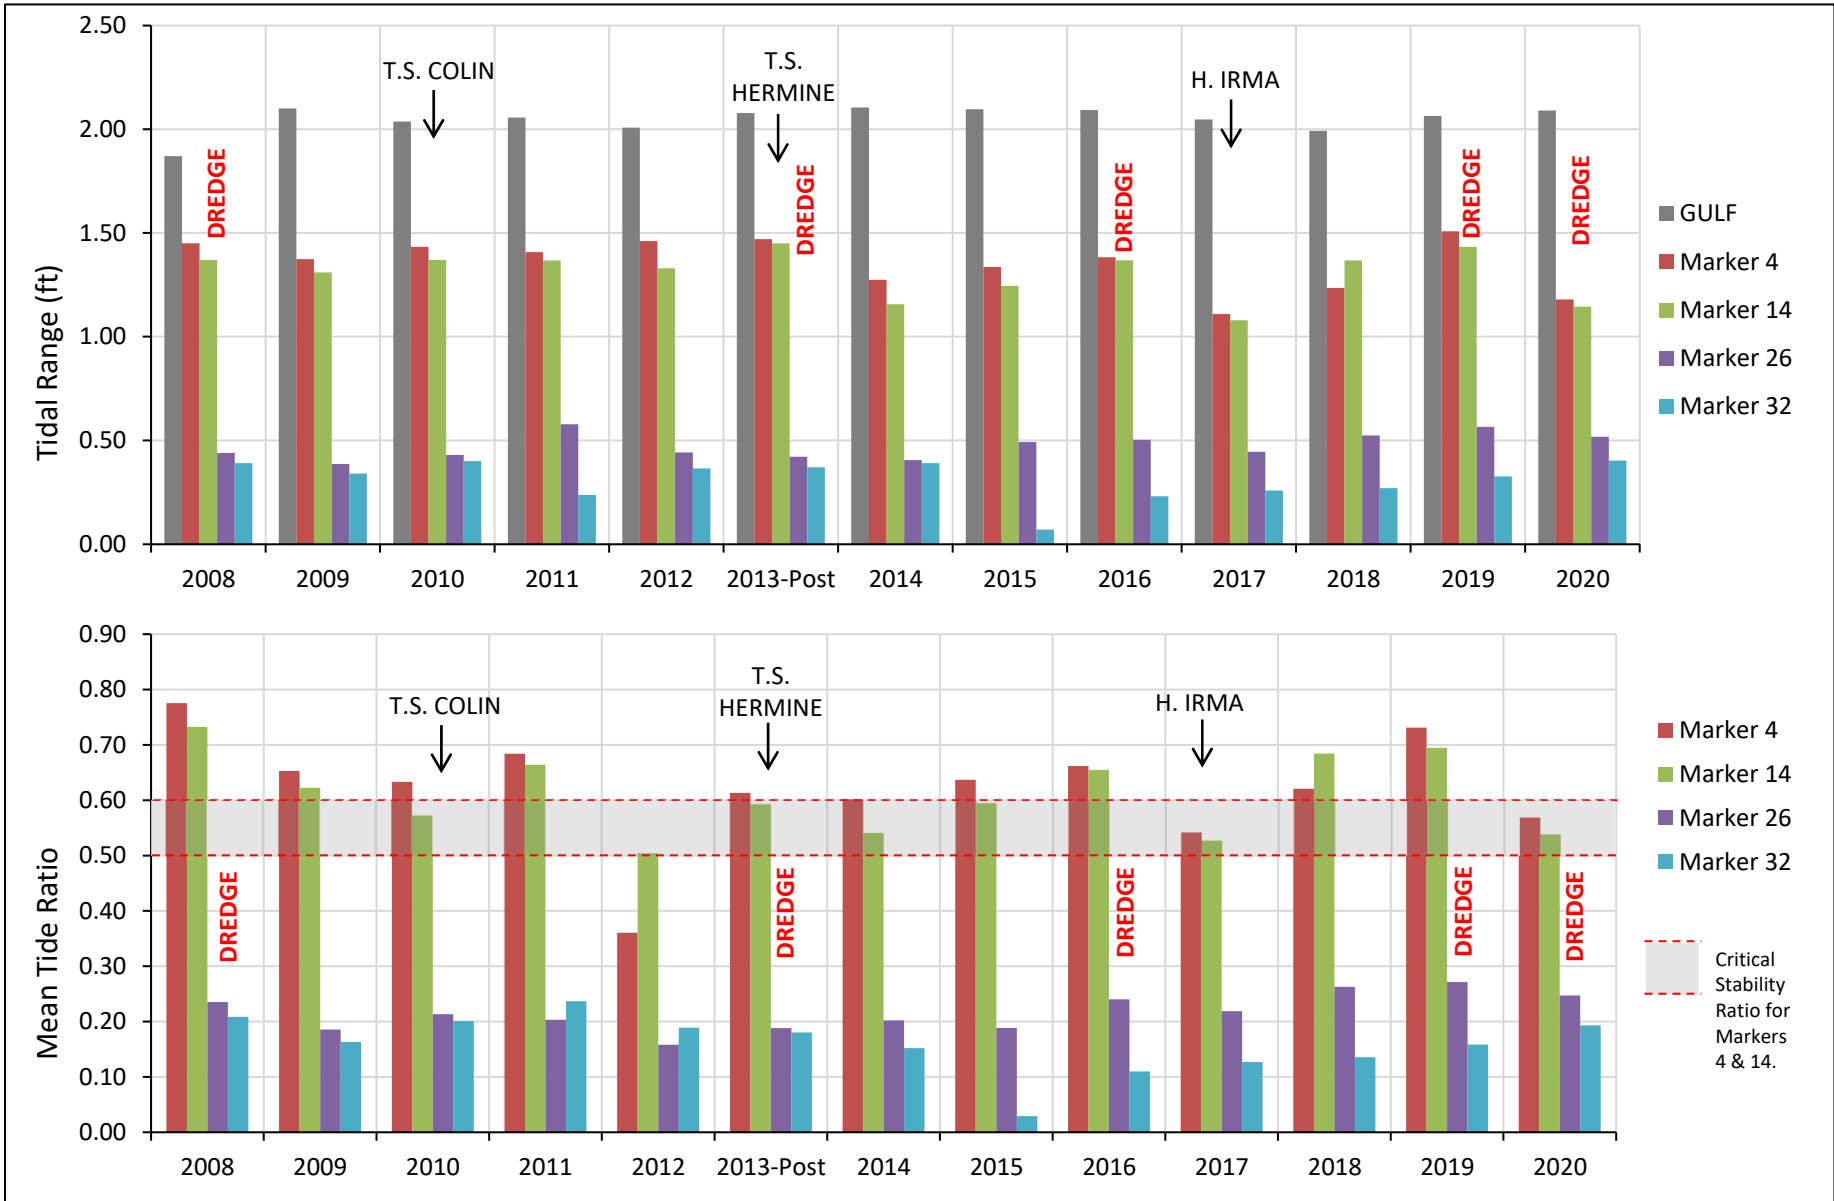
Figure 8 – Annual Average Tide Range and Tide Range Ratio – 2008 to 2020

Average annual tidal ranges and ratios for Clam Pass are presented in **Figure 8** for the time period between 2008 and 2020. The average annual tidal ranges remain within the range of typical values. The average ratios for 2020 at Marker 4 and 14, were within the critical range of 0.5 to 0.6 and lower than the previous year, this is due to the nearshore sand movement which resulted in the maintenance dredging of the entrance of the pass in April and December 2020.

Overall, monthly and annual tide ranges and range ratios indicated a critically stable inlet requiring observation. Two maintenance grading operations were required to maintain the pass open due to shoaling at the mouth.
