Above the Flood: Elevating Your Floodprone House

FEMA 347/ May 2000

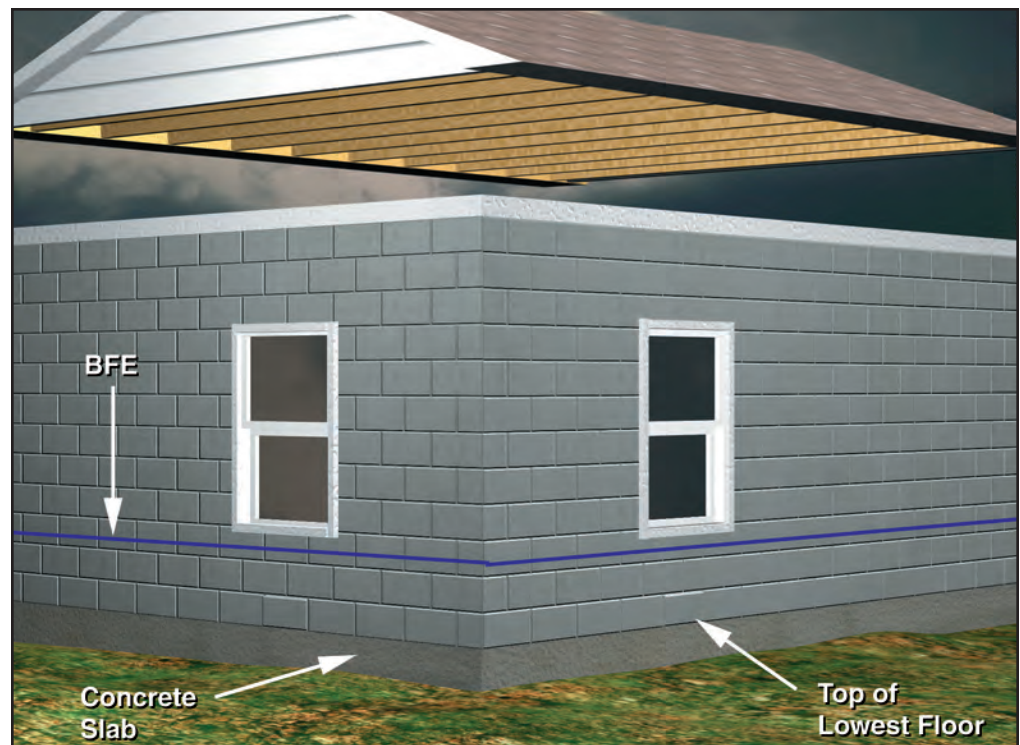
Figure 10
The first step in Technique 1 is removing the roof.

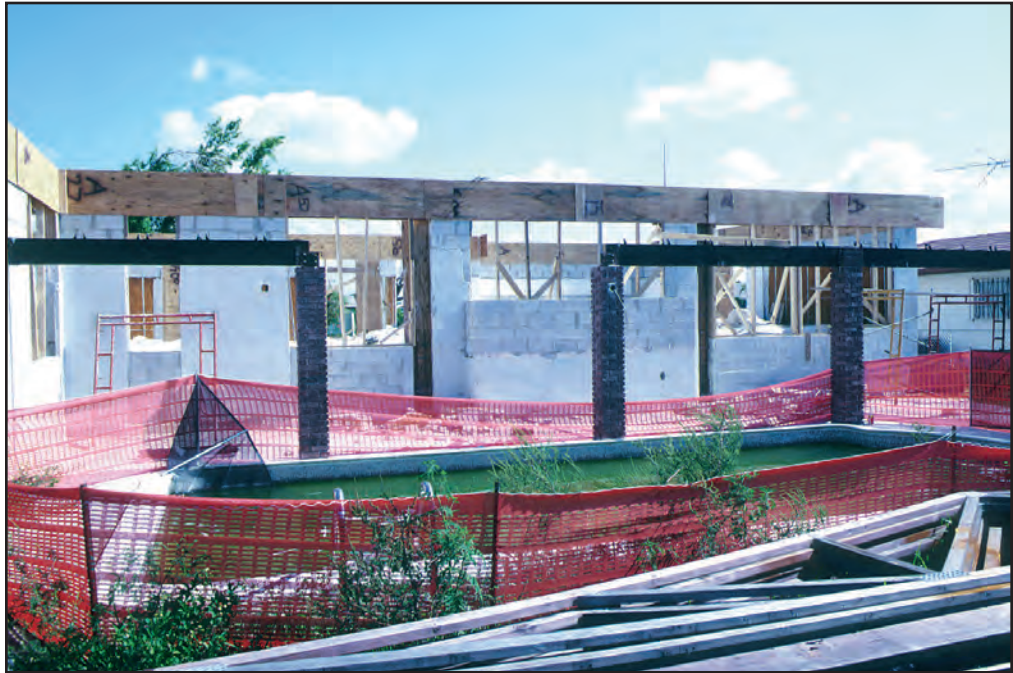
Figure 23
View from the back of the house. The walls have been extended upward with concrete blocks. The plywood visible at the tops of the walls is used to form cast-in-place concrete bond beams that will strengthen the extended walls. The roof trusses shown in the foreground were salvaged for reinstallation. The owner of this house decided to replace the original roof sheathing and shingles with new materials.

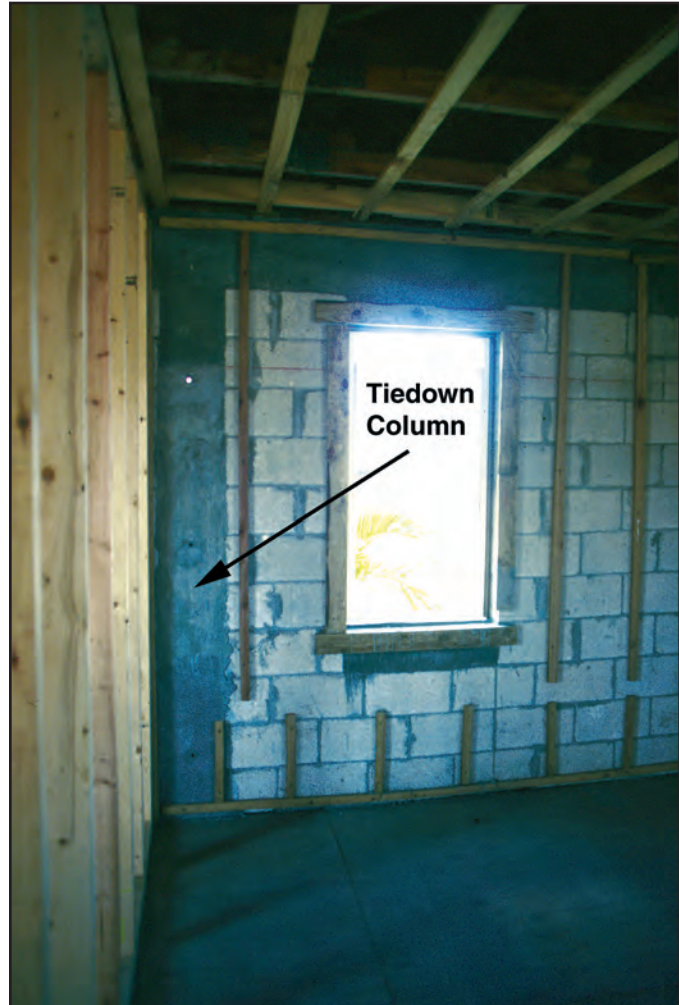
Figure 46
Concrete tiedown columns, such as the one to the left of the window in this photograph, were also used in this house.

Concrete bond beams similar to those shown earlier were used in this house, but here they were installed on the tops of both the original first-story walls and the new reinforced concrete block second-story walls.

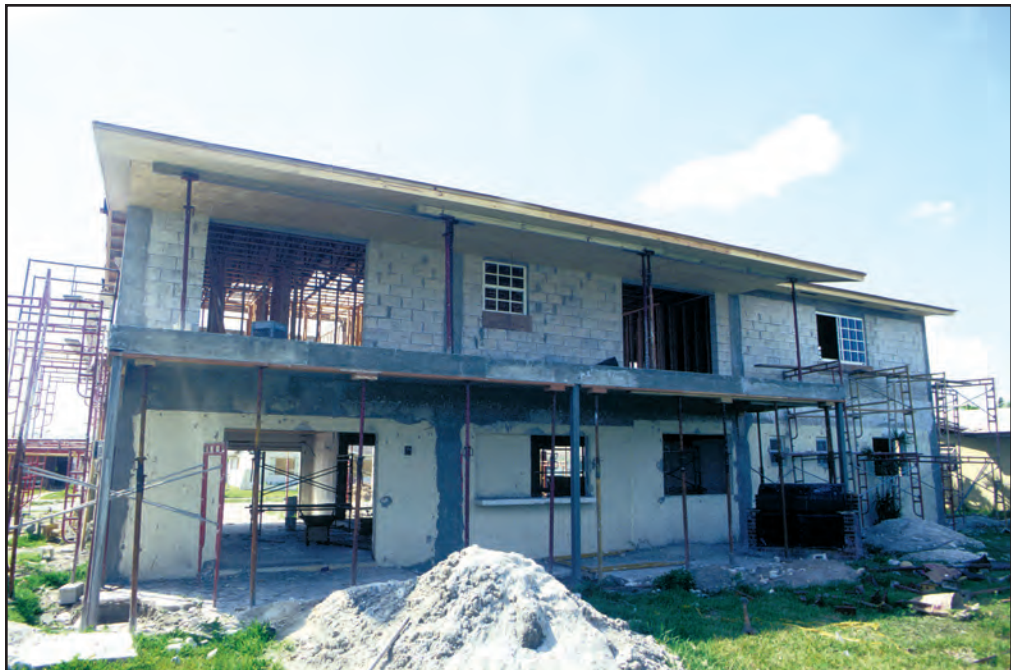
Figure 47
The tiedown columns extend down from the new second-story walls and into the original first-floor walls. The columns tie the first and second stories together and provide a continuous load path that helps the house resist the forces of high winds.

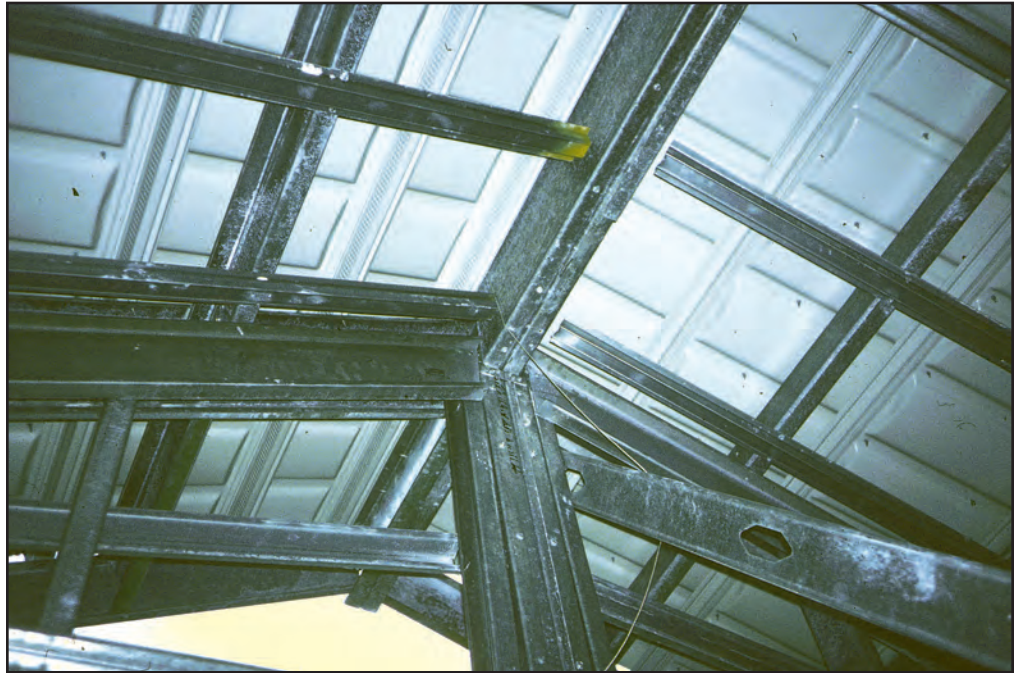
One advantage of metal framing is its relatively light weight. An additional advantage is that the screws used to attach metal-frame components provide strong connections.

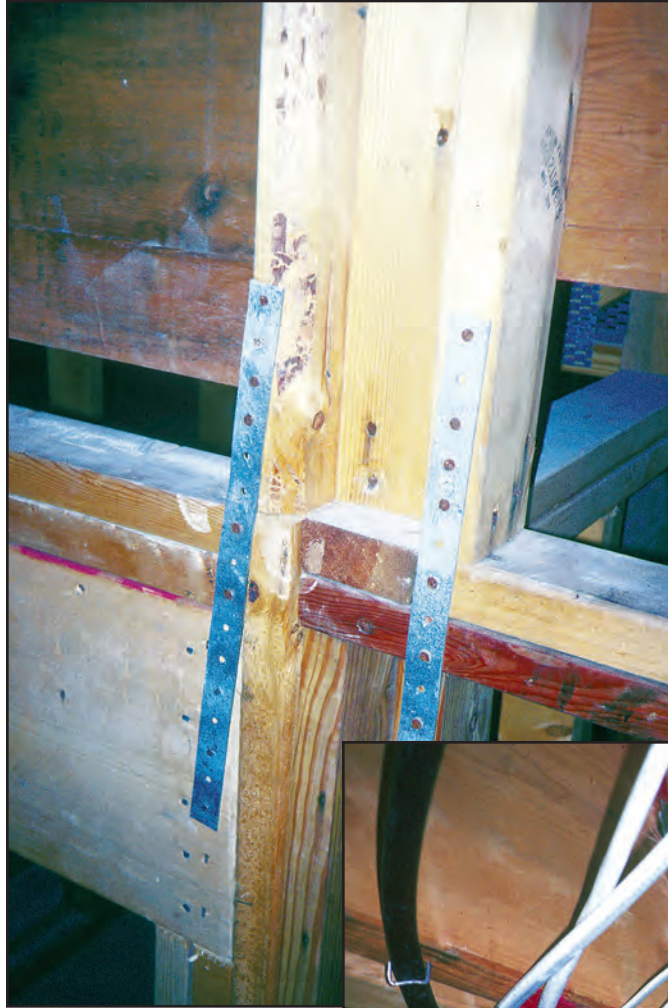
Figure 70

Metal hurricane straps are used to tie the structural members together and create a continuous load path from the roof to the foundation.

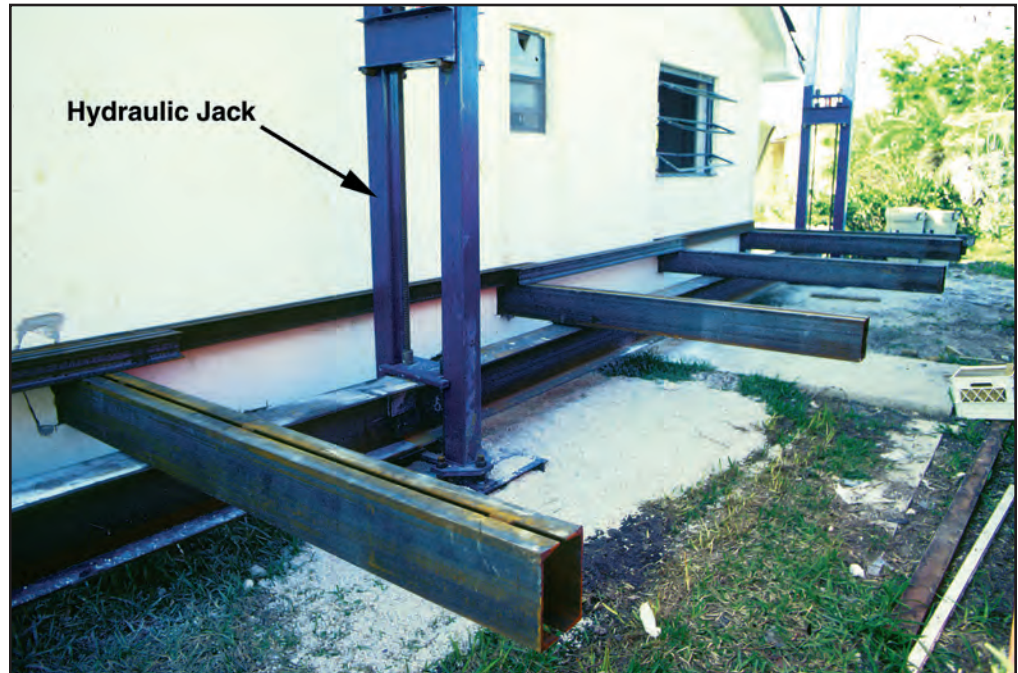
Figure 74

In this variation of Technique 3, steel beams are inserted through the walls of the house rather than under the slab. The beams span the length and width of the house and cross one another inside to create a grid. Outside the house, the beams rest on larger beams that will be raised with hydraulic jacks.

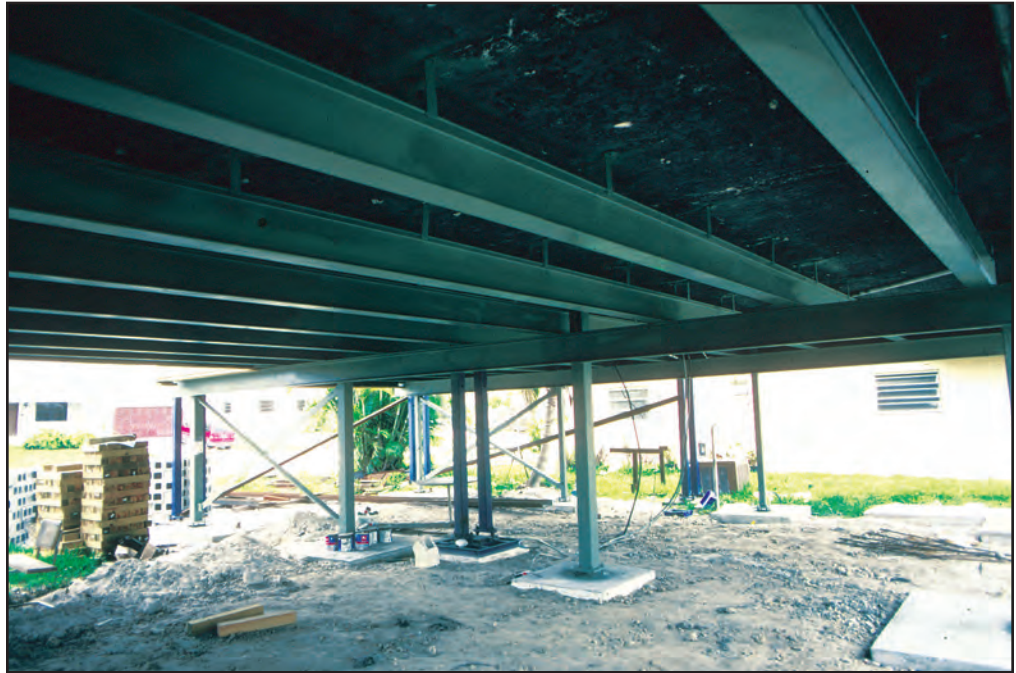
Figure 82

While the jacks and beams supported the house, new steel foundation members were installed below.
