# Conservation Collier Initial Criteria Screening Report Gore TPMA

Target Protection Area Parcels and Acreage: 167 parcels (424.18 ac)
Application Parcel Owner: Berman Trust (41508680004), Trigoura (41507440009), Perez
(415606000006), Mack (415057560002)

Staff Report: August 3, 2022

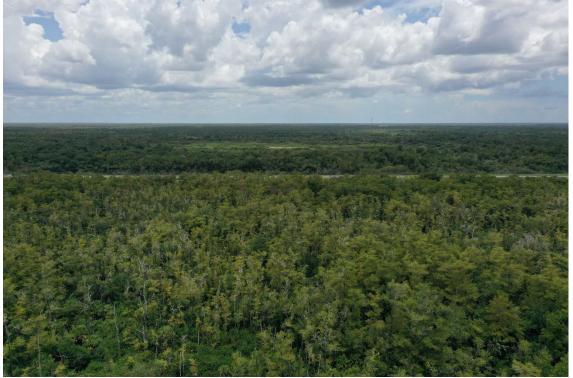
Figure 6 – Cypress/Tupelo

Native plant communities that make up the TPA parcels as indicated through the Cooperative Land Cover Classification System and ground and aerial observations include: Cypress, Cypress- Mixed Hardwoods, Mixed Wetland Hardwoods, Mixed Scrub-Shrub Wetland, Pine Flatwood.

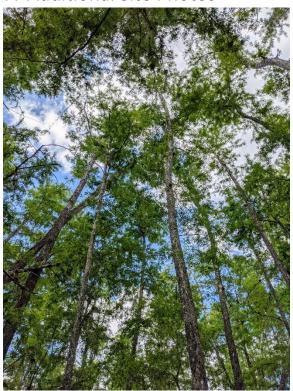
Mature Cypress within Gore TPA

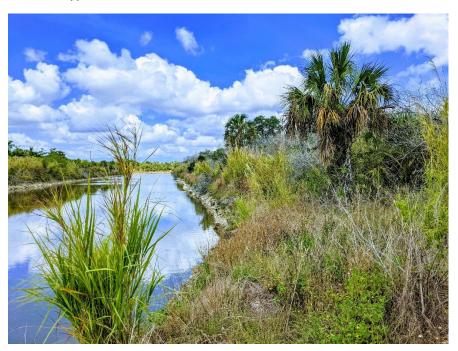
Faka-Union canal with opportunities for enhance public access amenities

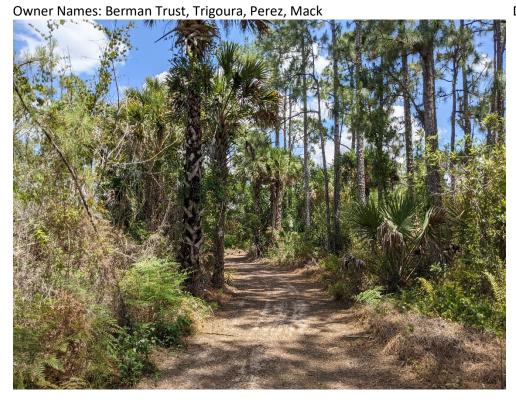
As a result of historic efforts to develop the Golden Gate Estates and habitat alterations that reduced the hydroperiod, some parcels within the TPA have transitioned to pine flatwoods with upland vegetation in the understory.

Typical site conditions of wetland hardwood communities that have transitioned to mesic flatwood.
