COLLIER COUNTY BEACH NOURISHMENT PROJECT 2023 POST-CONSTRUCTION ANNUAL MONITORING SUMMARY

August 2023

DEP PERMIT 0331817-005-JC
USACOE PERMIT SAJ-2003-12405 MOD (MOD-KS)

PREPARED BY
HUMISTON & MOORE ENGINEERS
HM File No. 28019

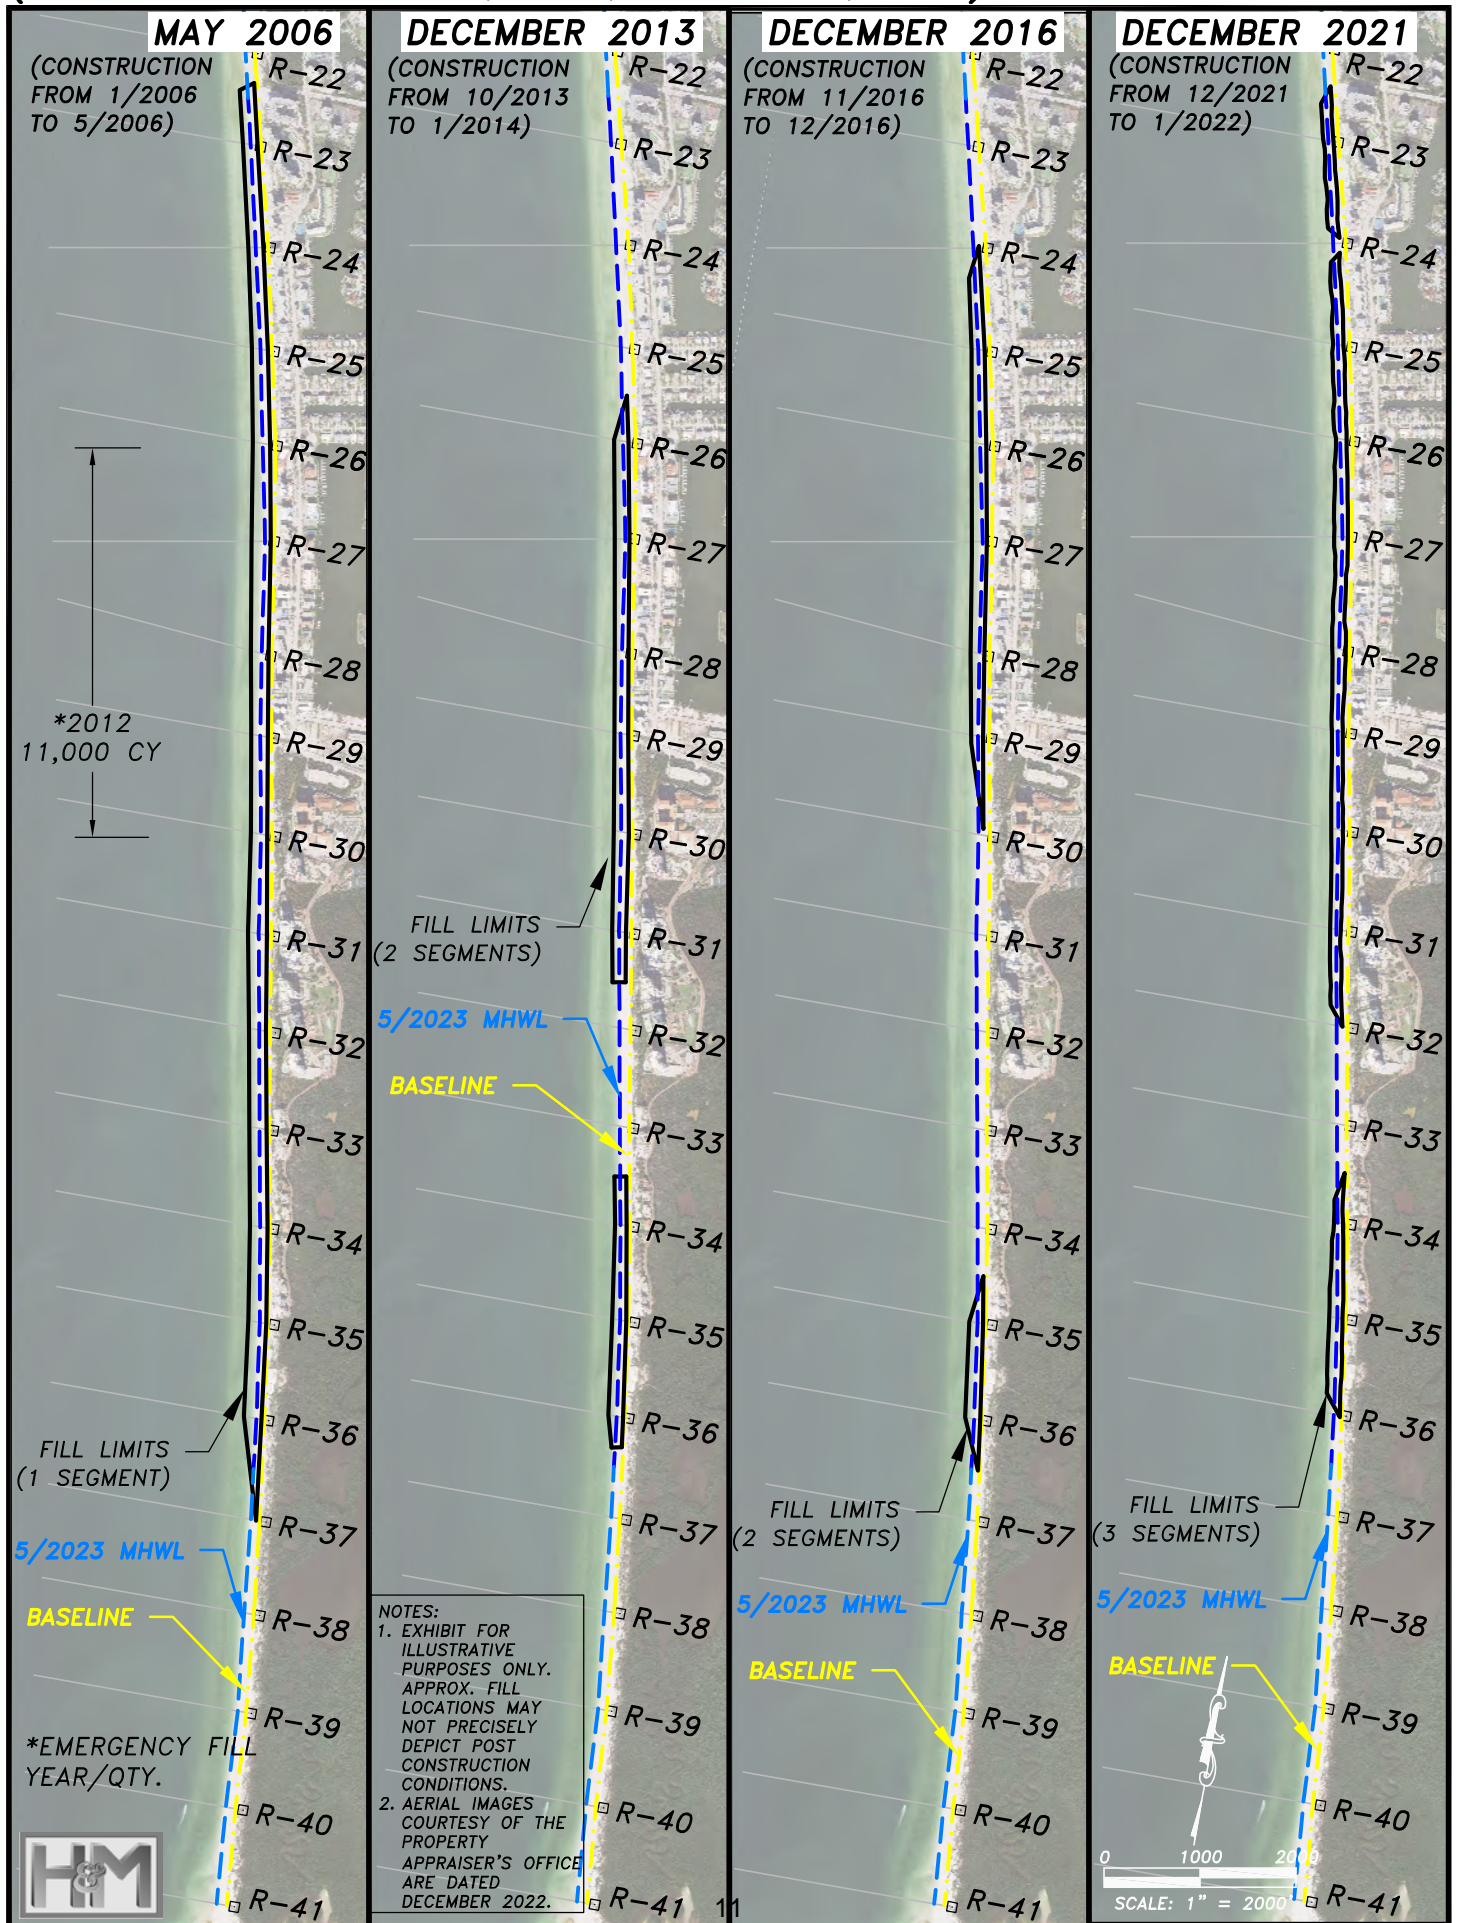
**FIGURE 3a: FILL LIMITS FOR VANDERBILT & PELICAN BAY BEACH
(NO FILL PLACED IN 2014, 2015, 2017-2020, 2022)**

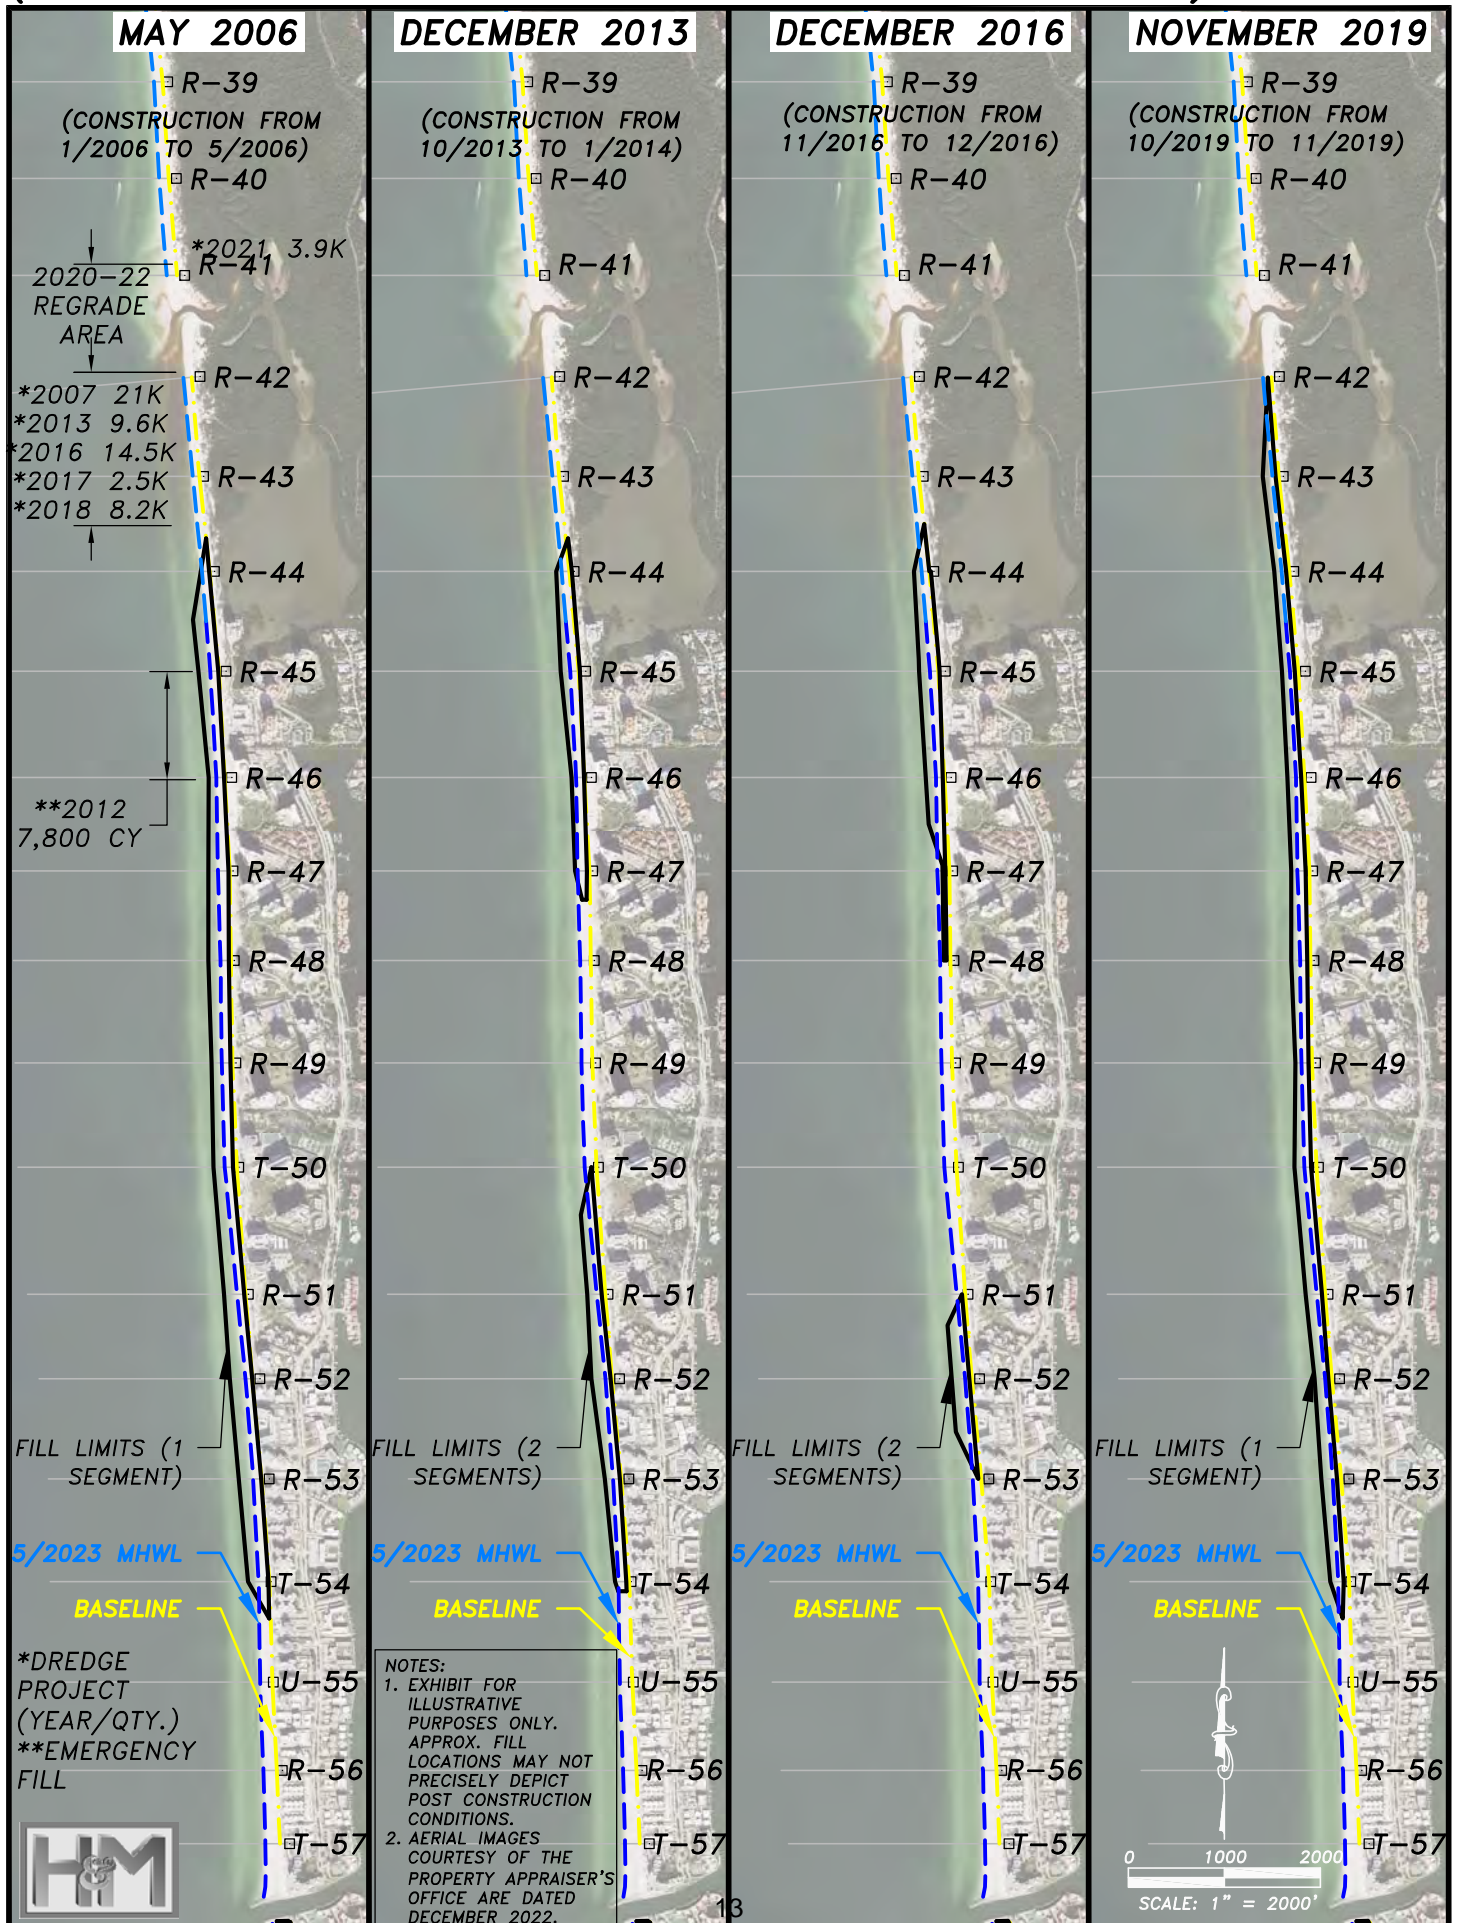
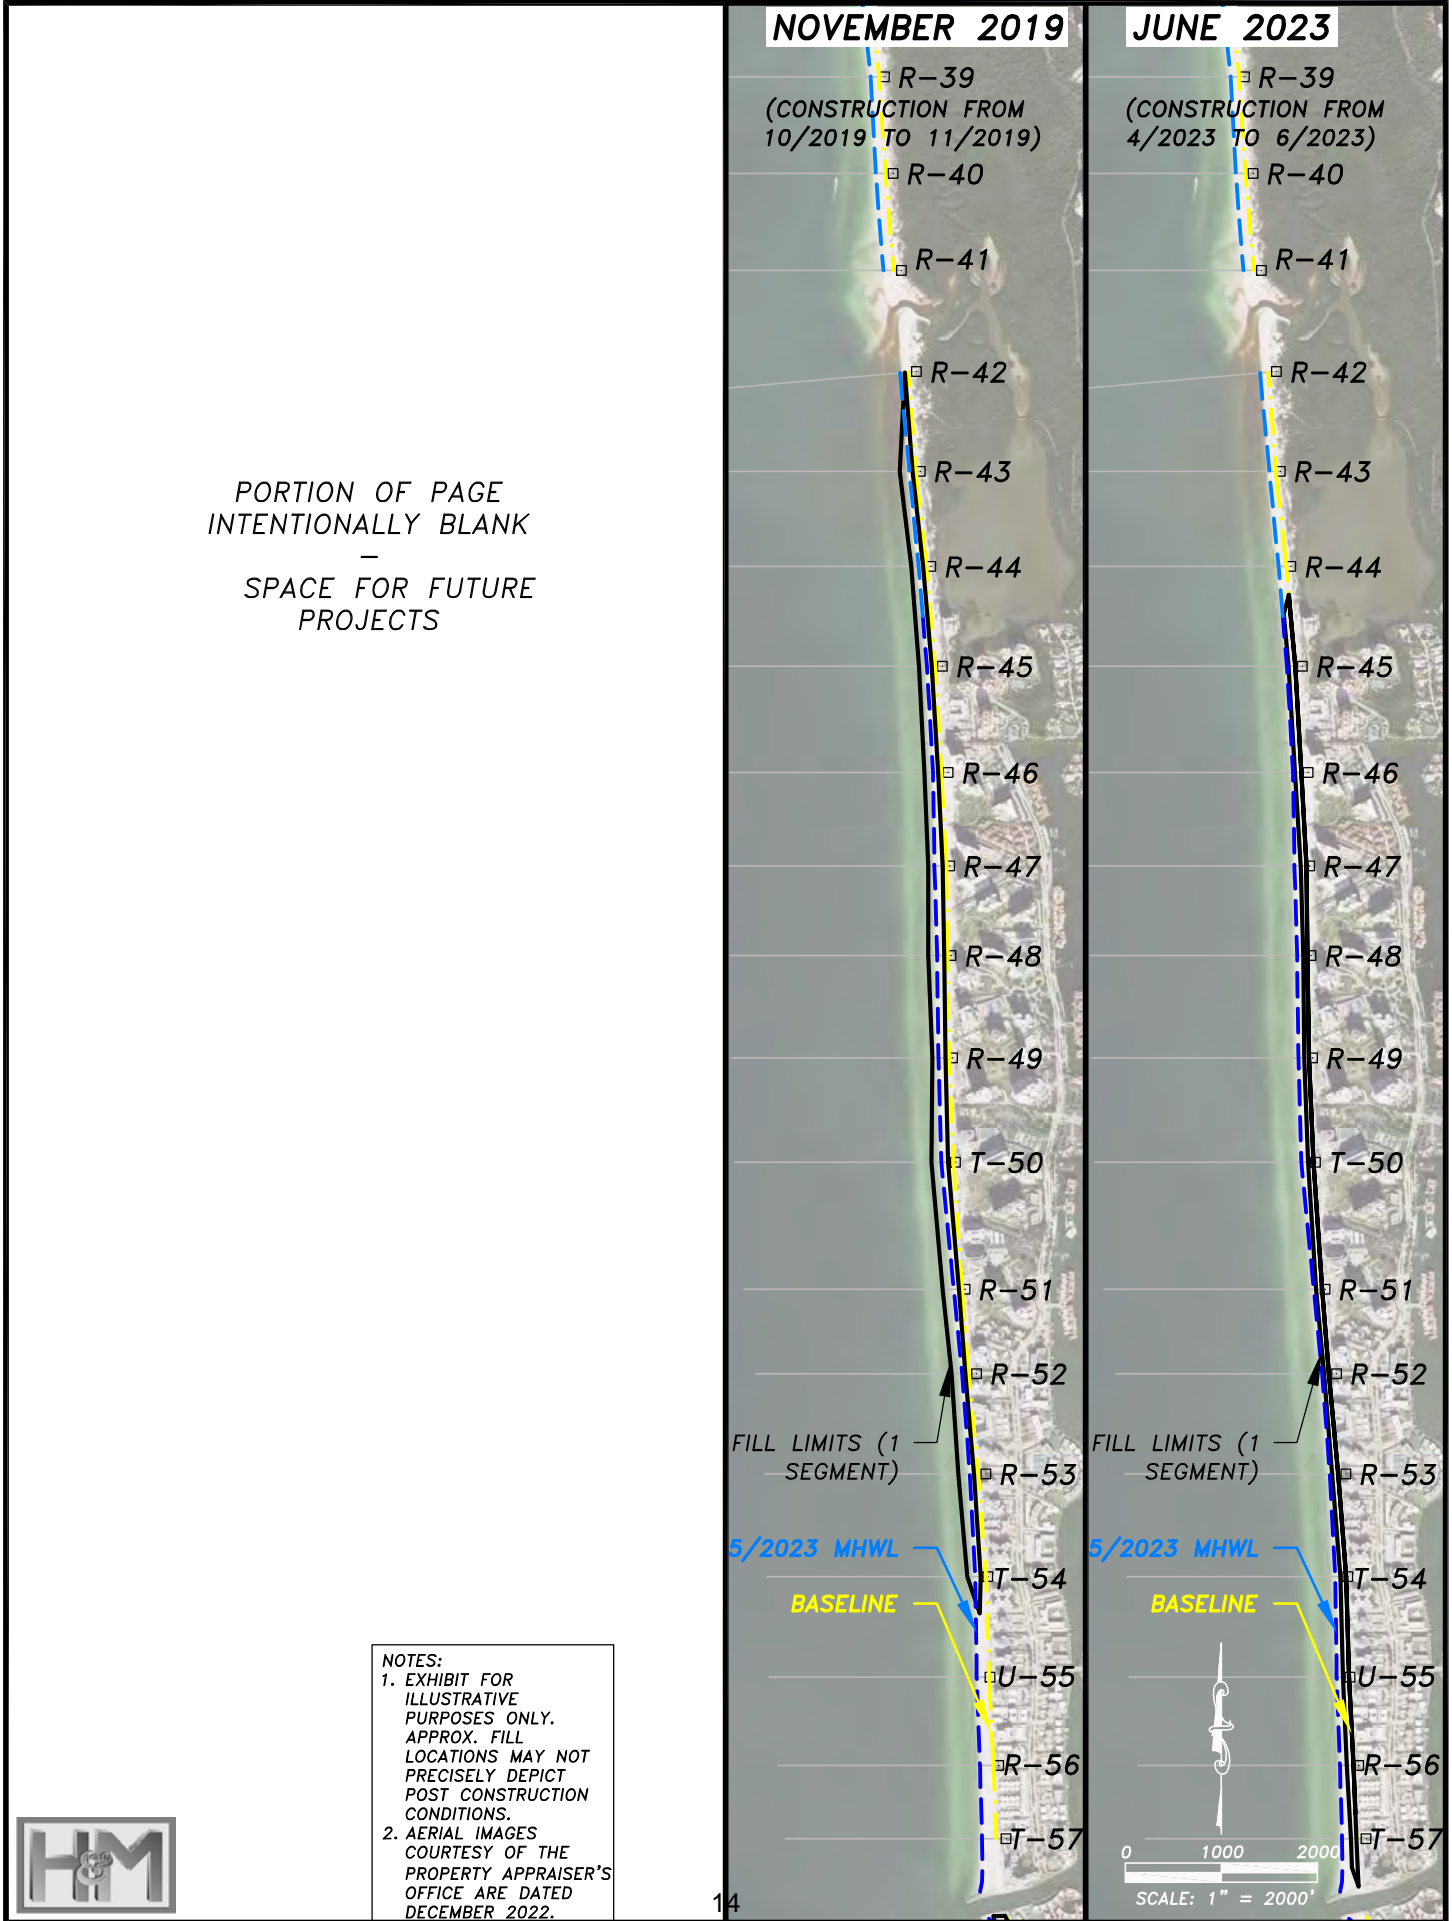
**FIGURE 3b: FILL LIMITS FOR PARK SHORE BEACH
(NO FILL PLACED IN 2014-2015 OR 2017-2018 OR 2020-2022)**

**FIGURE 3b: FILL LIMITS FOR PARK SHORE BEACH
(NO FILL PLACED IN 2014–2015 OR 2017–2018 OR 2020–2022)**

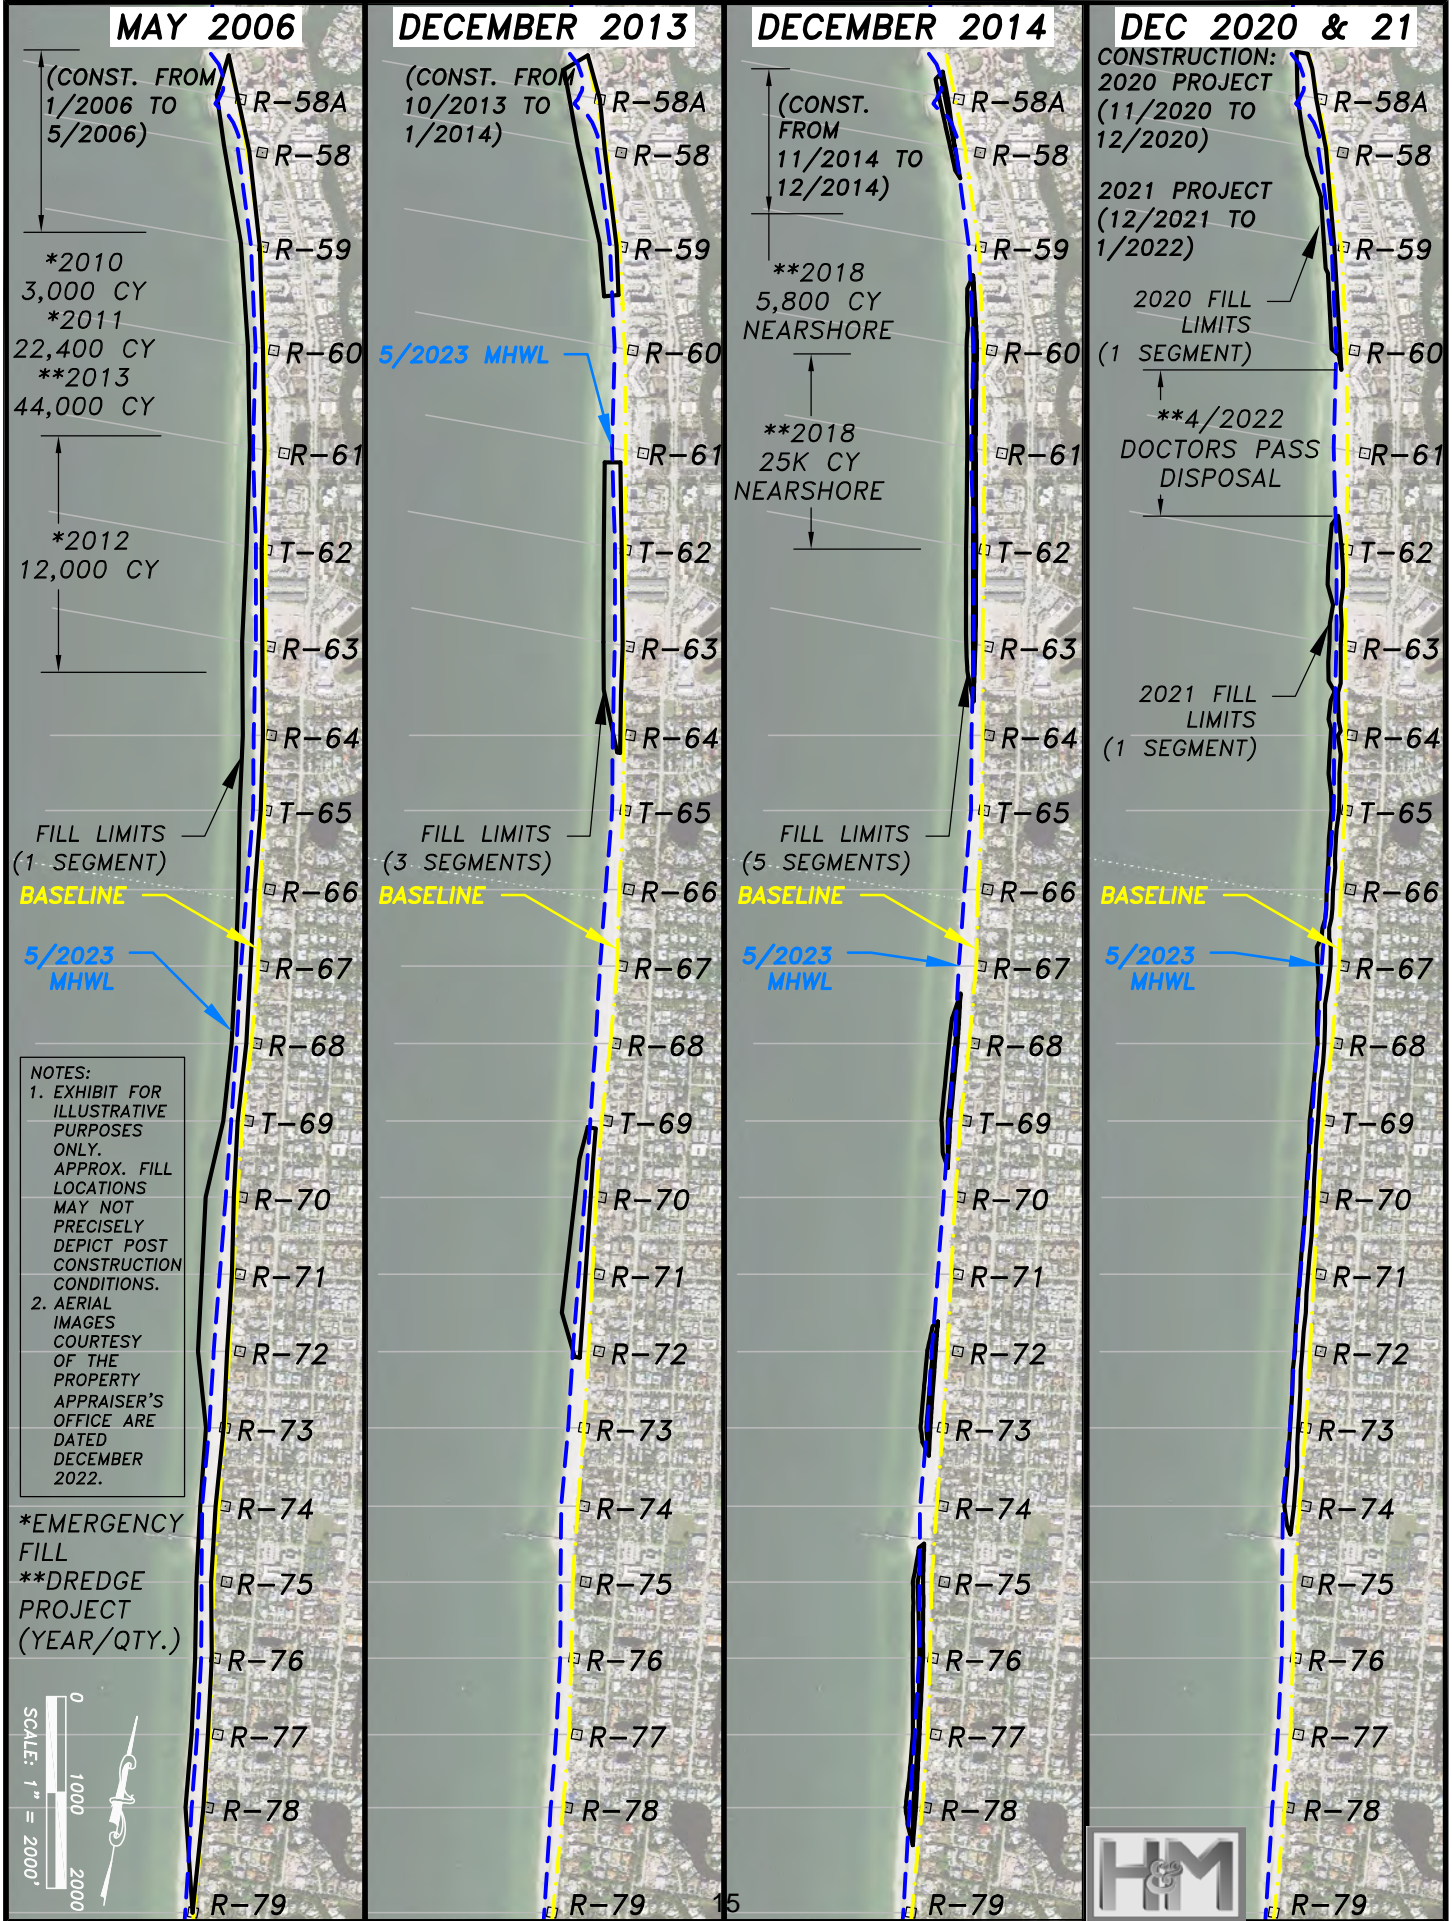
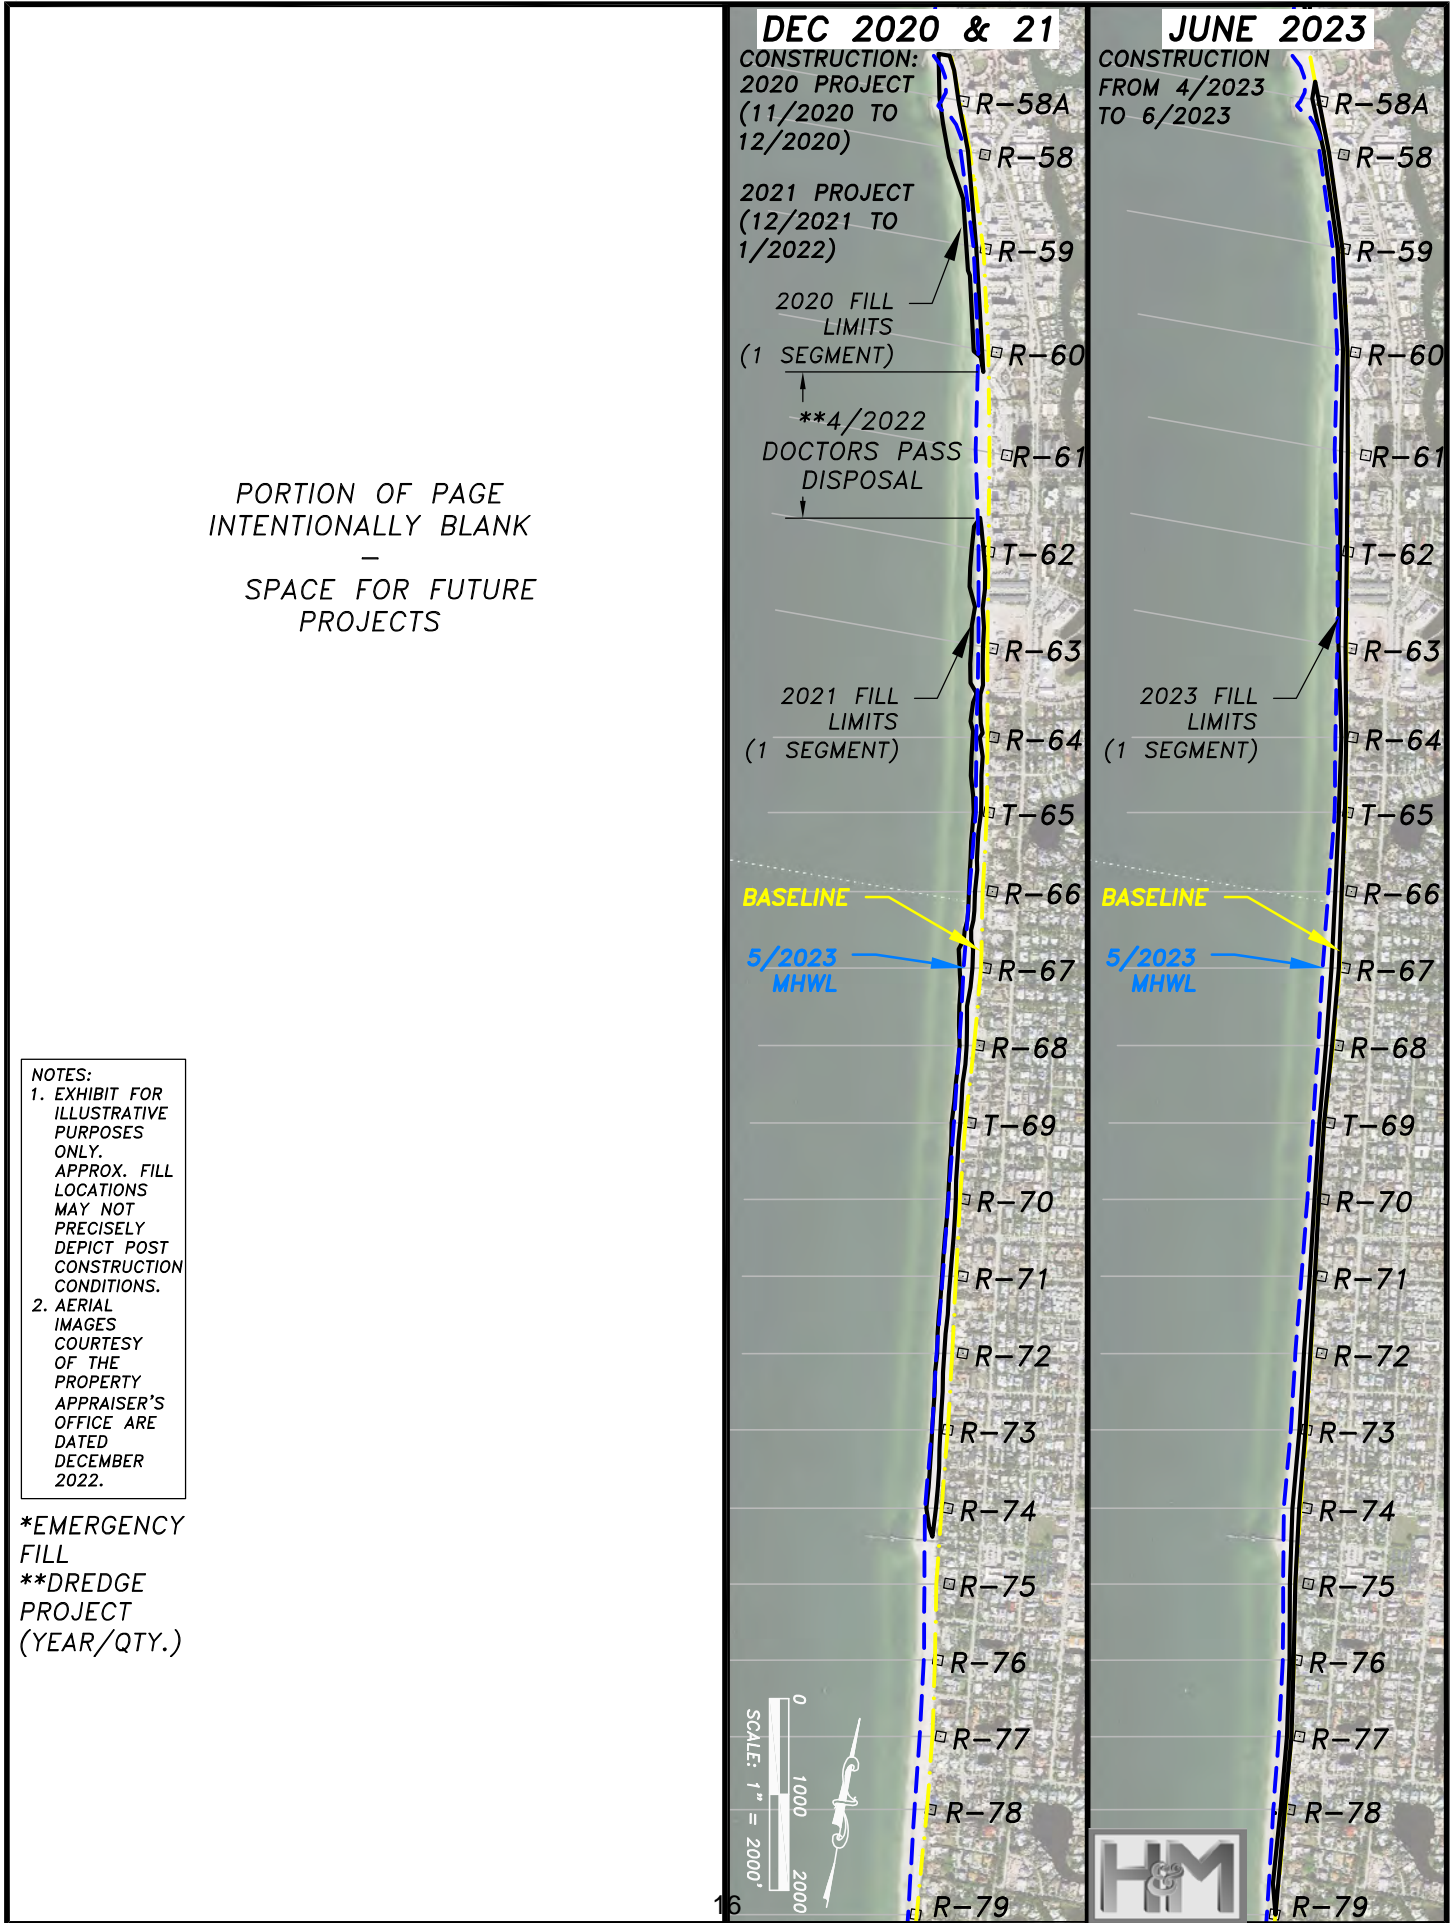
**FIGURE 3c: FILL LIMITS FOR NAPLES BEACH
(NO FILL PLACED ON THE BEACH FROM 2015 TO 2019)**

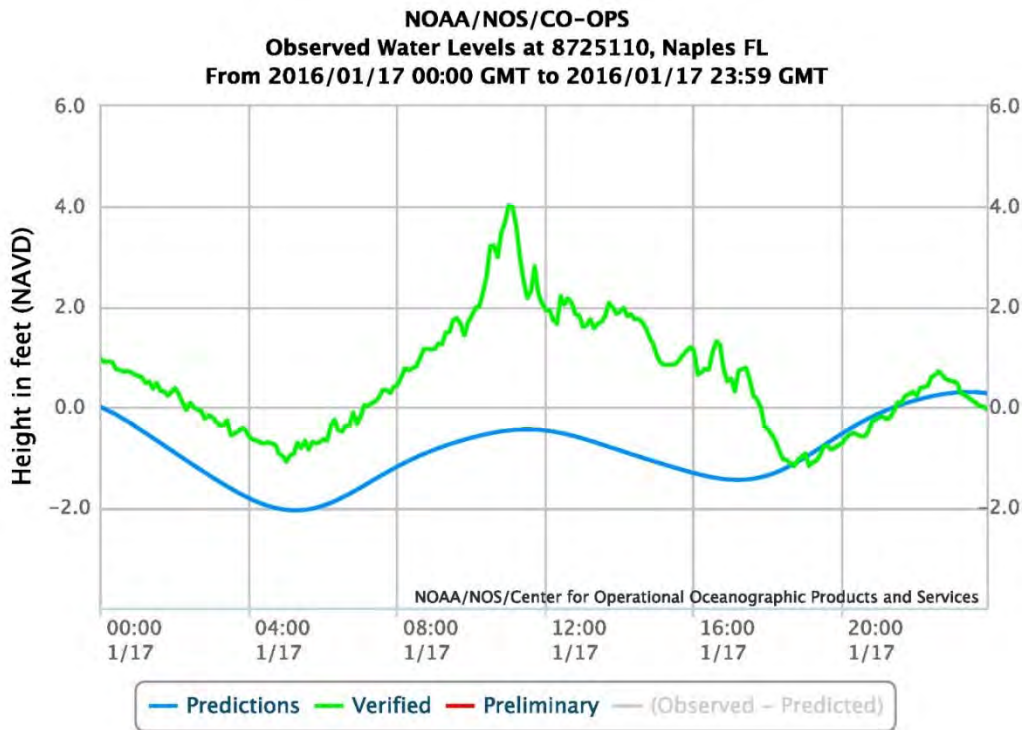
Figure 2. Observed Water Level in Naples Florida on January 17, 2016.

The City of Naples experienced a meteotsunami¹ in January 2016. A graph of the observed water levels at the Naples Tide Station on January 17, 2016 documenting the meteotsunami is shown in **Figure 2**.

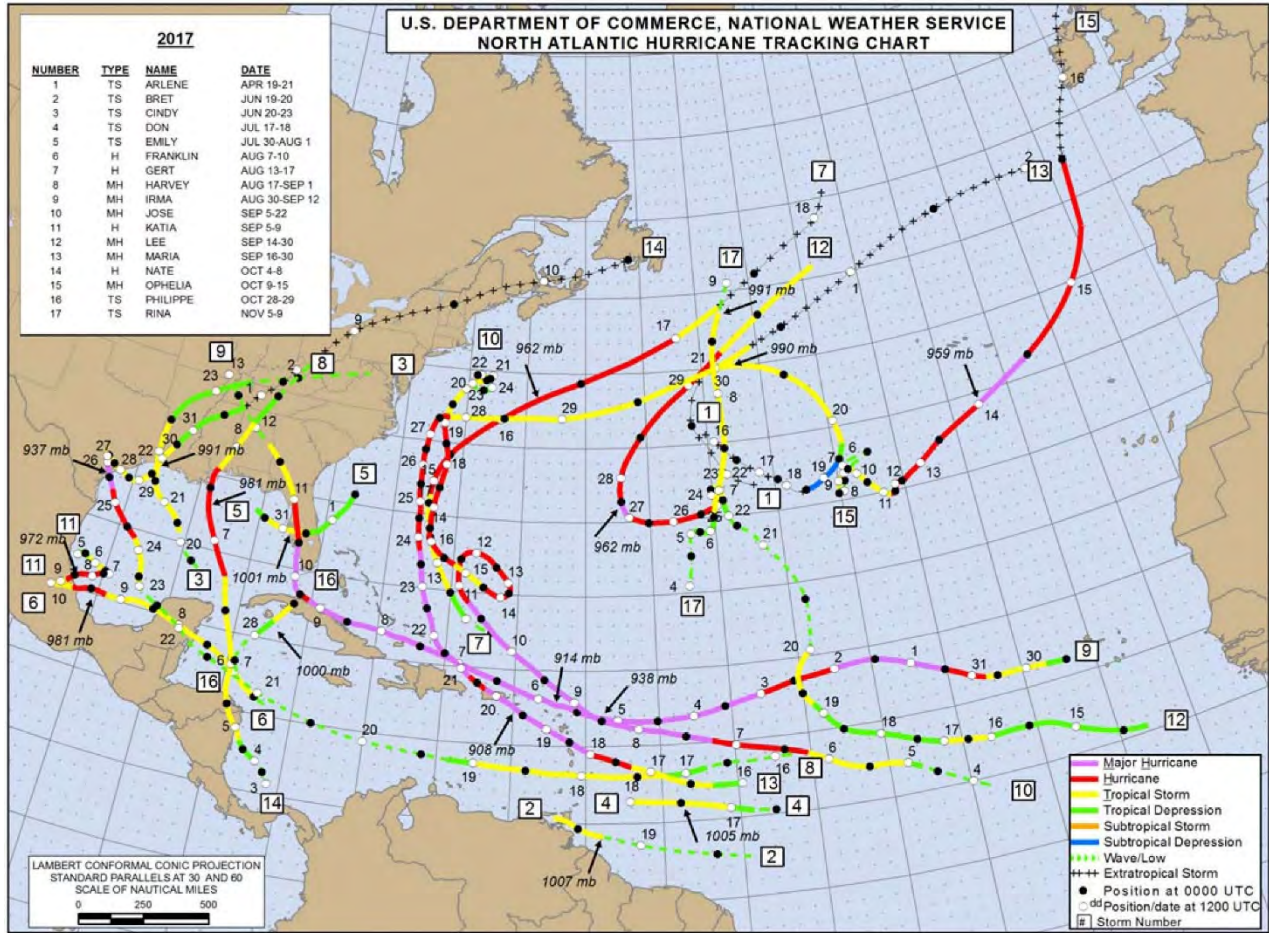
Figure 3. Hurricane Tracking Chart for 2017.

By the time the minimal hurricane reached northwest Florida (on the morning of September 11th), the wind gusts across south Georgia and northwest Florida were generally in the 45 to 60 MPH range (Fig. 8). Conditions improved rapidly once the storm center passed by as strong, dry southwest winds aloft made the system asymmetric, with nearly all of the rain and most of the strongest winds being along and north of the poorly-defined center. Irma weakened to a tropical storm in south Georgia in the afternoon, and further into a tropical depression while moving north across central Georgia in the evening. See the **Figure 3** in this section showing the 2017 storm tracks.
