DOCTORS PASS MAINTENANCE DREDGING 2023 POST-CONSTRUCTION MONITORING SUMMARY

August 2023

DEP PERMIT 0331817-005-JC
USACOE PERMIT SAJ-2004-8754

PREPARED BY
HUMISTON & MOORE ENGINEERS
HM File No. 29018

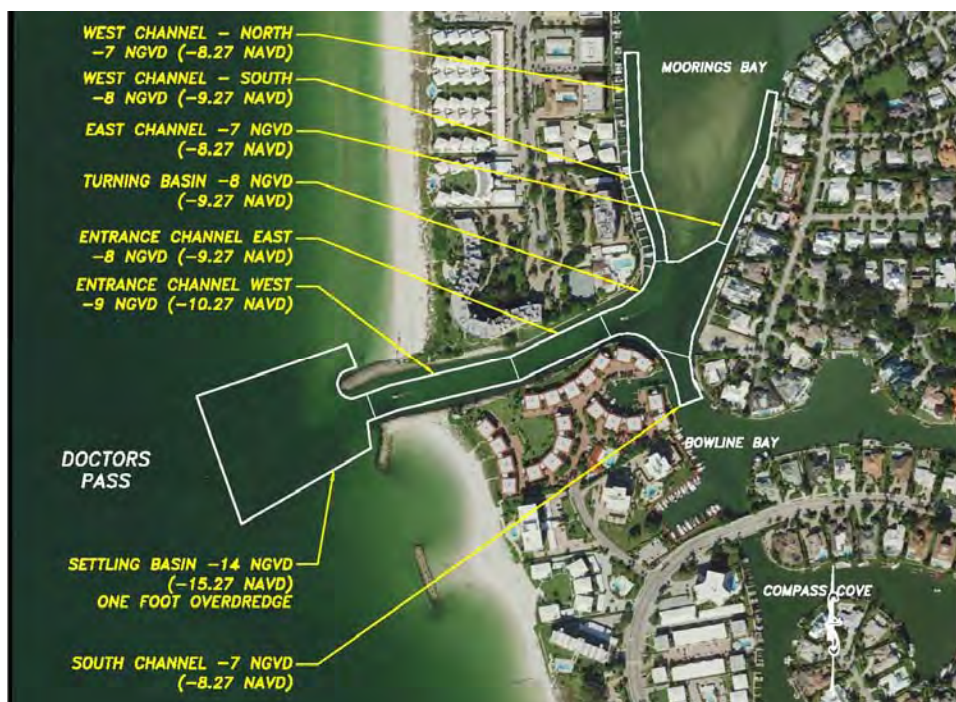
<i>Dredge Template Section</i>	<i>Permitted Dredge Depth</i>	
	<i>(Feet NGVD)</i>	<i>(Feet NAVD)</i>
<i>*Settling Basin</i>	-14.0	-15.3
<i>Entrance Channel - West</i>	-9.0	-10.3
<i>Entrance Channel - East</i>	-8.0	-9.3
<i>Turning Basin</i>	-8.0	-9.3
<i>West Channel - South</i>	-8.0	-9.3
<i>West Channel - North</i>	-7.0	-8.3
<i>East Channel</i>	-7.0	-8.3
<i>South Channel</i>	-7.0	-8.3

*Settling Basin is permitted with a one-foot over-dredge allowance to -16.3 NAVD.

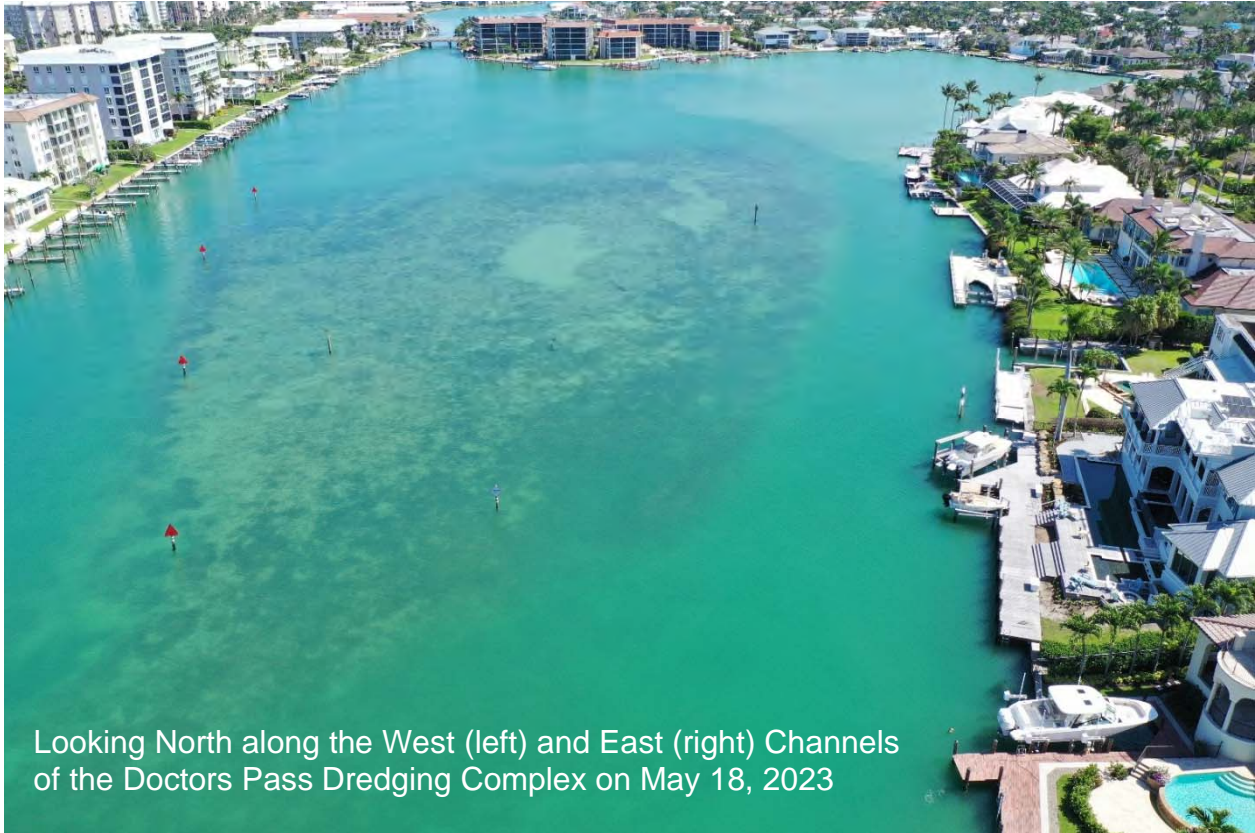
Looking North along the West (left) and East (right) Channels of the Doctors Pass Dredging Complex on May 18, 2023

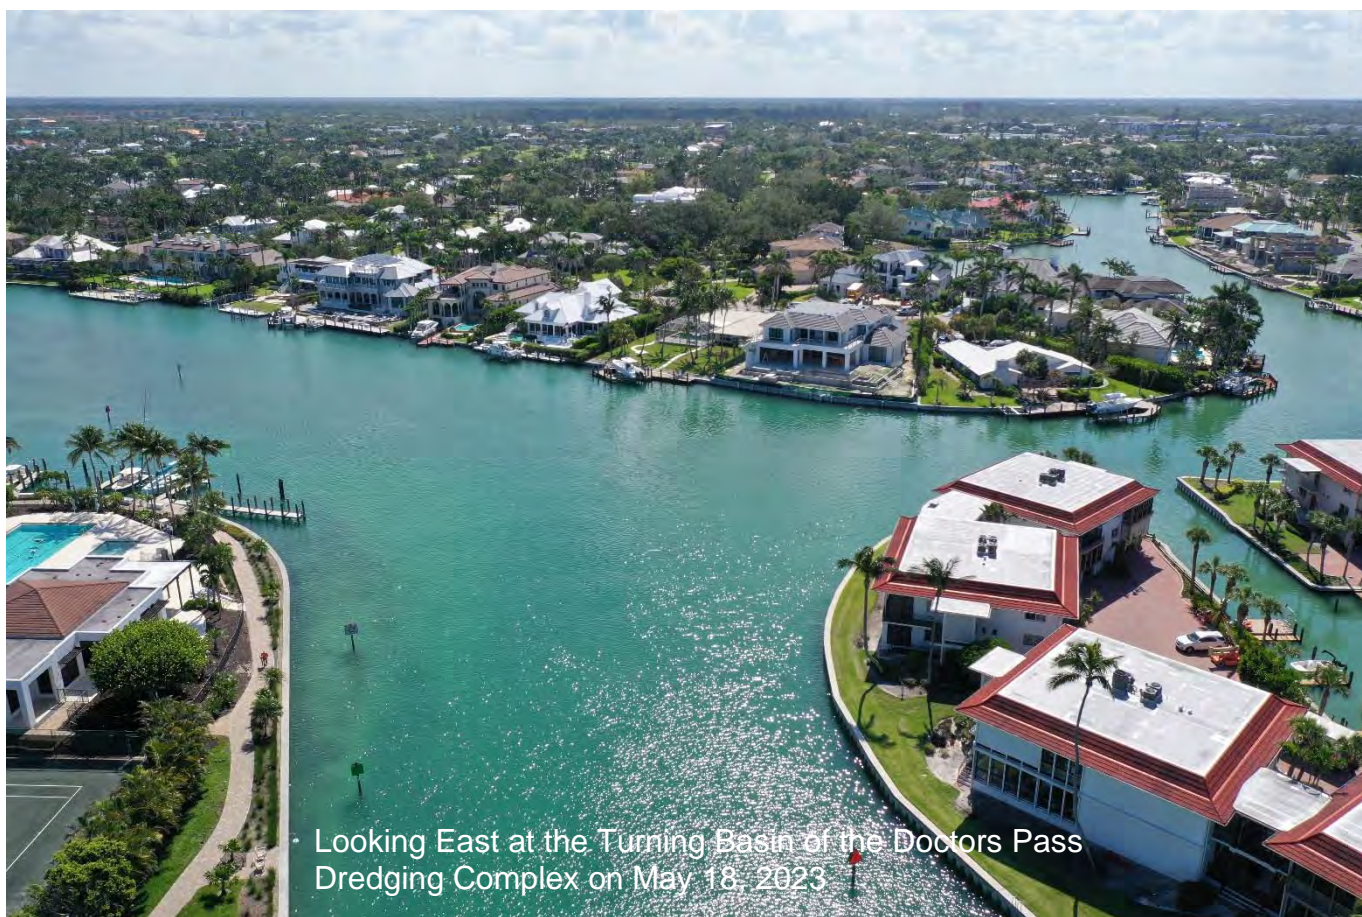
Figure 6a is a contour change map illustrating volumetric gain from sand accumulation shown ranging from dark blue to brown, within the Settling Basin and Entrance Channel (extent of the post-construction survey) for the most recent monitoring period from April 2022 to November 2022. (Note: elevation changes of less than one foot are not shown). The largest changes in elevation occurred in the Settling Basin southwest of the north jetty. Changes within the Entrance Channel show accumulation at the west end and loss of sand at the east end near the Turning Basin. The accumulation shown at the west end of the Entrance Channel indicates elevation change since the post-construction condition and does not necessarily represent material within the dredge template as can be seen on the profiles provided in **Appendix D-2**. Due to the availability of survey data for the Turning Basin, east and West Channel, **Figure 6b**, another contour change map, shows changes from the previous monitoring survey in February 2021 to November 2022. This portion of the monitoring area was not dredged in 2022. Although not significant, accumulation can be seen at the northern portion of the Turning Basin and in the northern portion of the East Channel.

FIGURE 6a. DOCTORS PASS INLET MONITORING AREA SETTLING BASIN & ENTRANCE CHANNEL CONTOUR CHANGE MAP APRIL 2022 TO NOVEMBER 2022 (POST-CONSTRUCTION TO POST-IAN SURVEY)

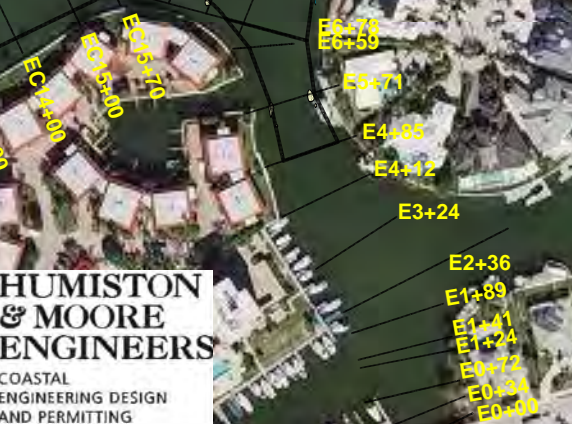
Figures 7. Settling Basin and Entrance Channel Cross Section

Figure 7 depicts the location of a centerline profile through the Settling Basin and Entrance Channel in plan view and the associated cross-section. The rectified image shown in **Figure 7**, acquired on December 2022, shows the approximate location of shoals near the mouth of the inlet, outlined for clarity. The March 2022 pre-construction, April 2022 post-construction, and the November 2022 post-Ian monitoring survey profiles are shown on the cross-section as well as the 2013 and 2018 post-construction profiles to indicate the location of rock. This profile extends from the west edge of the Settling Basin to the northeast end of the Entrance Channel. Accumulation of material is evident in the Settling Basin from Station EC3+00 to EC4+00, and the scouring effects of Hurricane Ian are visible at the east end of the Entrance Channel.

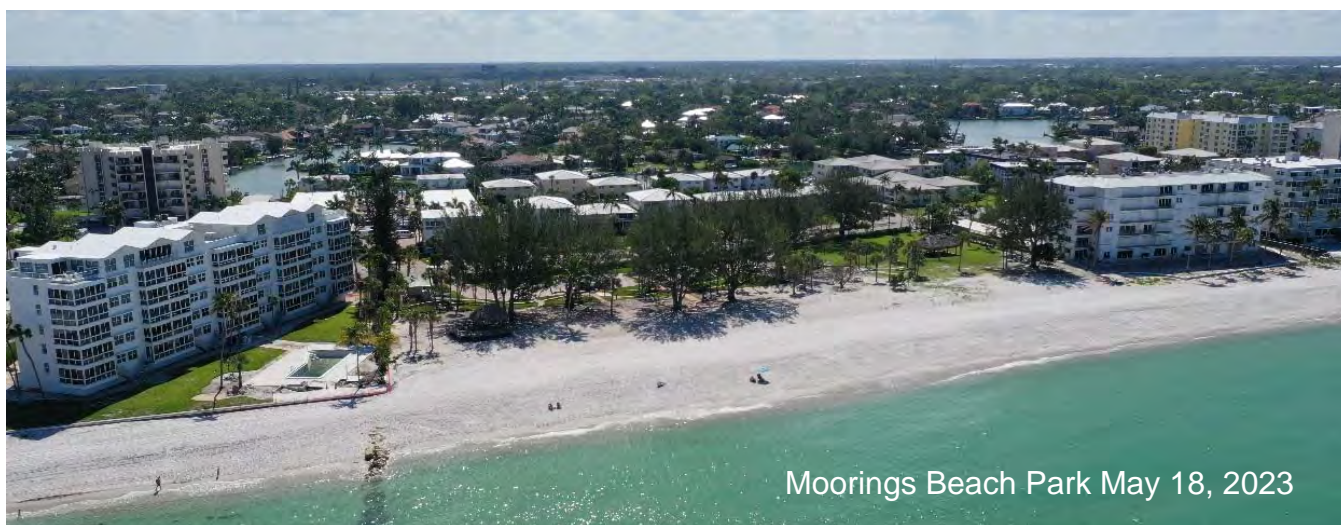
Figure 9. Schematic Diagram for Typical Shoreline and Volumetric Change Analysis

Figure 9 is a schematic depiction of the elements involved in the analysis of shoreline and volume change in this report for beach profiles R-58A to R-62. (This case shows a beach width greater than the *Design Standard*.) Two adjacent DEP reference monuments and associated monitoring azimuths are shown along with the baseline, *Design Standard* width (100 feet), mean high water line (MHWL), and approximate depth of closure⁵ (DOC). Also shown are comparative beach profiles at the adjacent monuments and the associated area change between the monitoring surveys to be compared. Shoreline change is the difference in the “Distance from the Baseline to MHWL” for different monitoring surveys. Volumetric change, determined by the formula shown (at the bottom of the figure) for the average end area method, utilizes the cross-sectional area change for different monitoring surveys at adjacent monuments and the length of beach between those monument profiles.

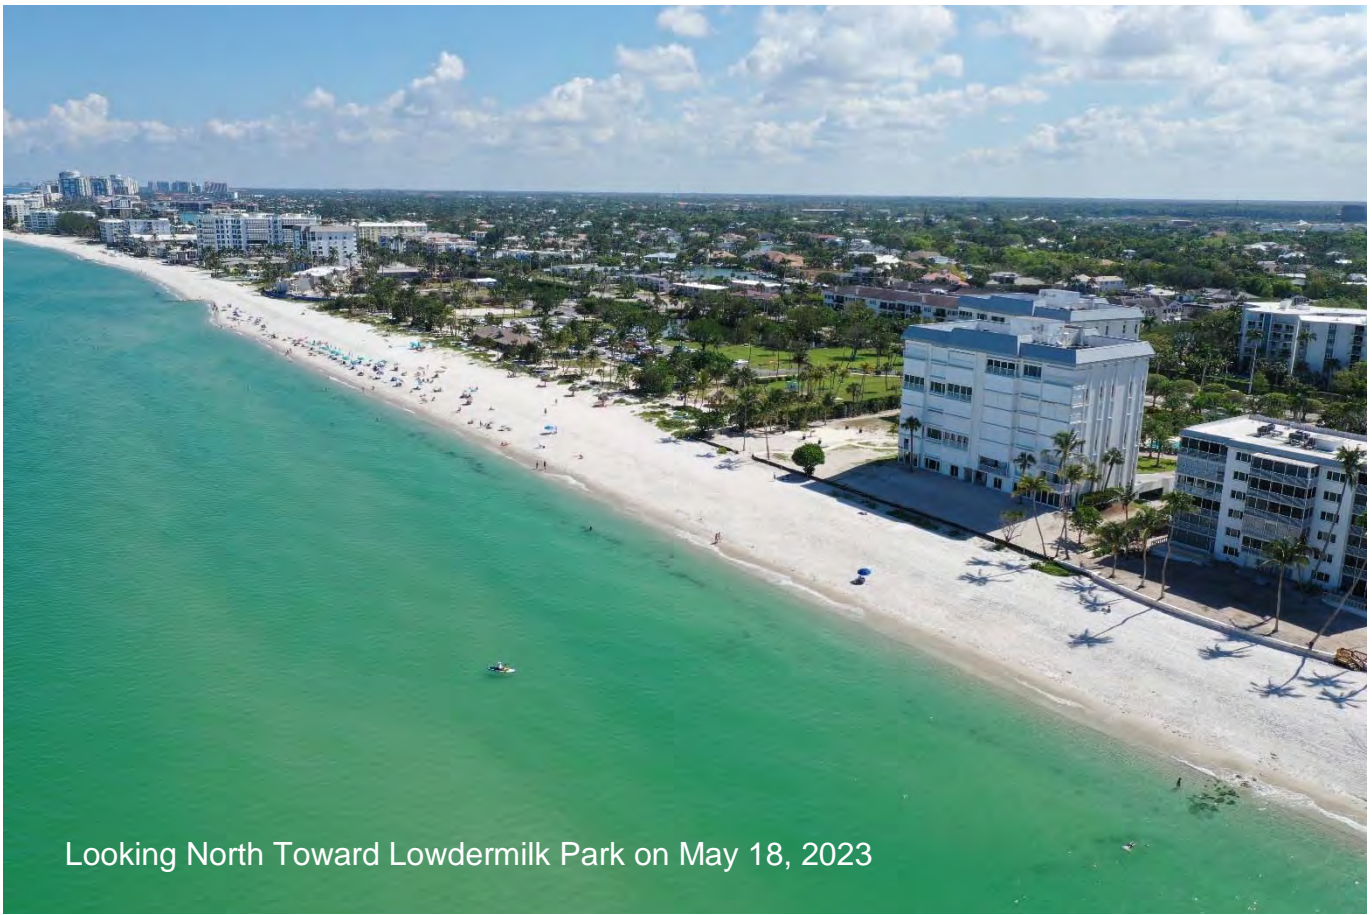
Looking North Toward Lowdermilk Park on May 18, 2023

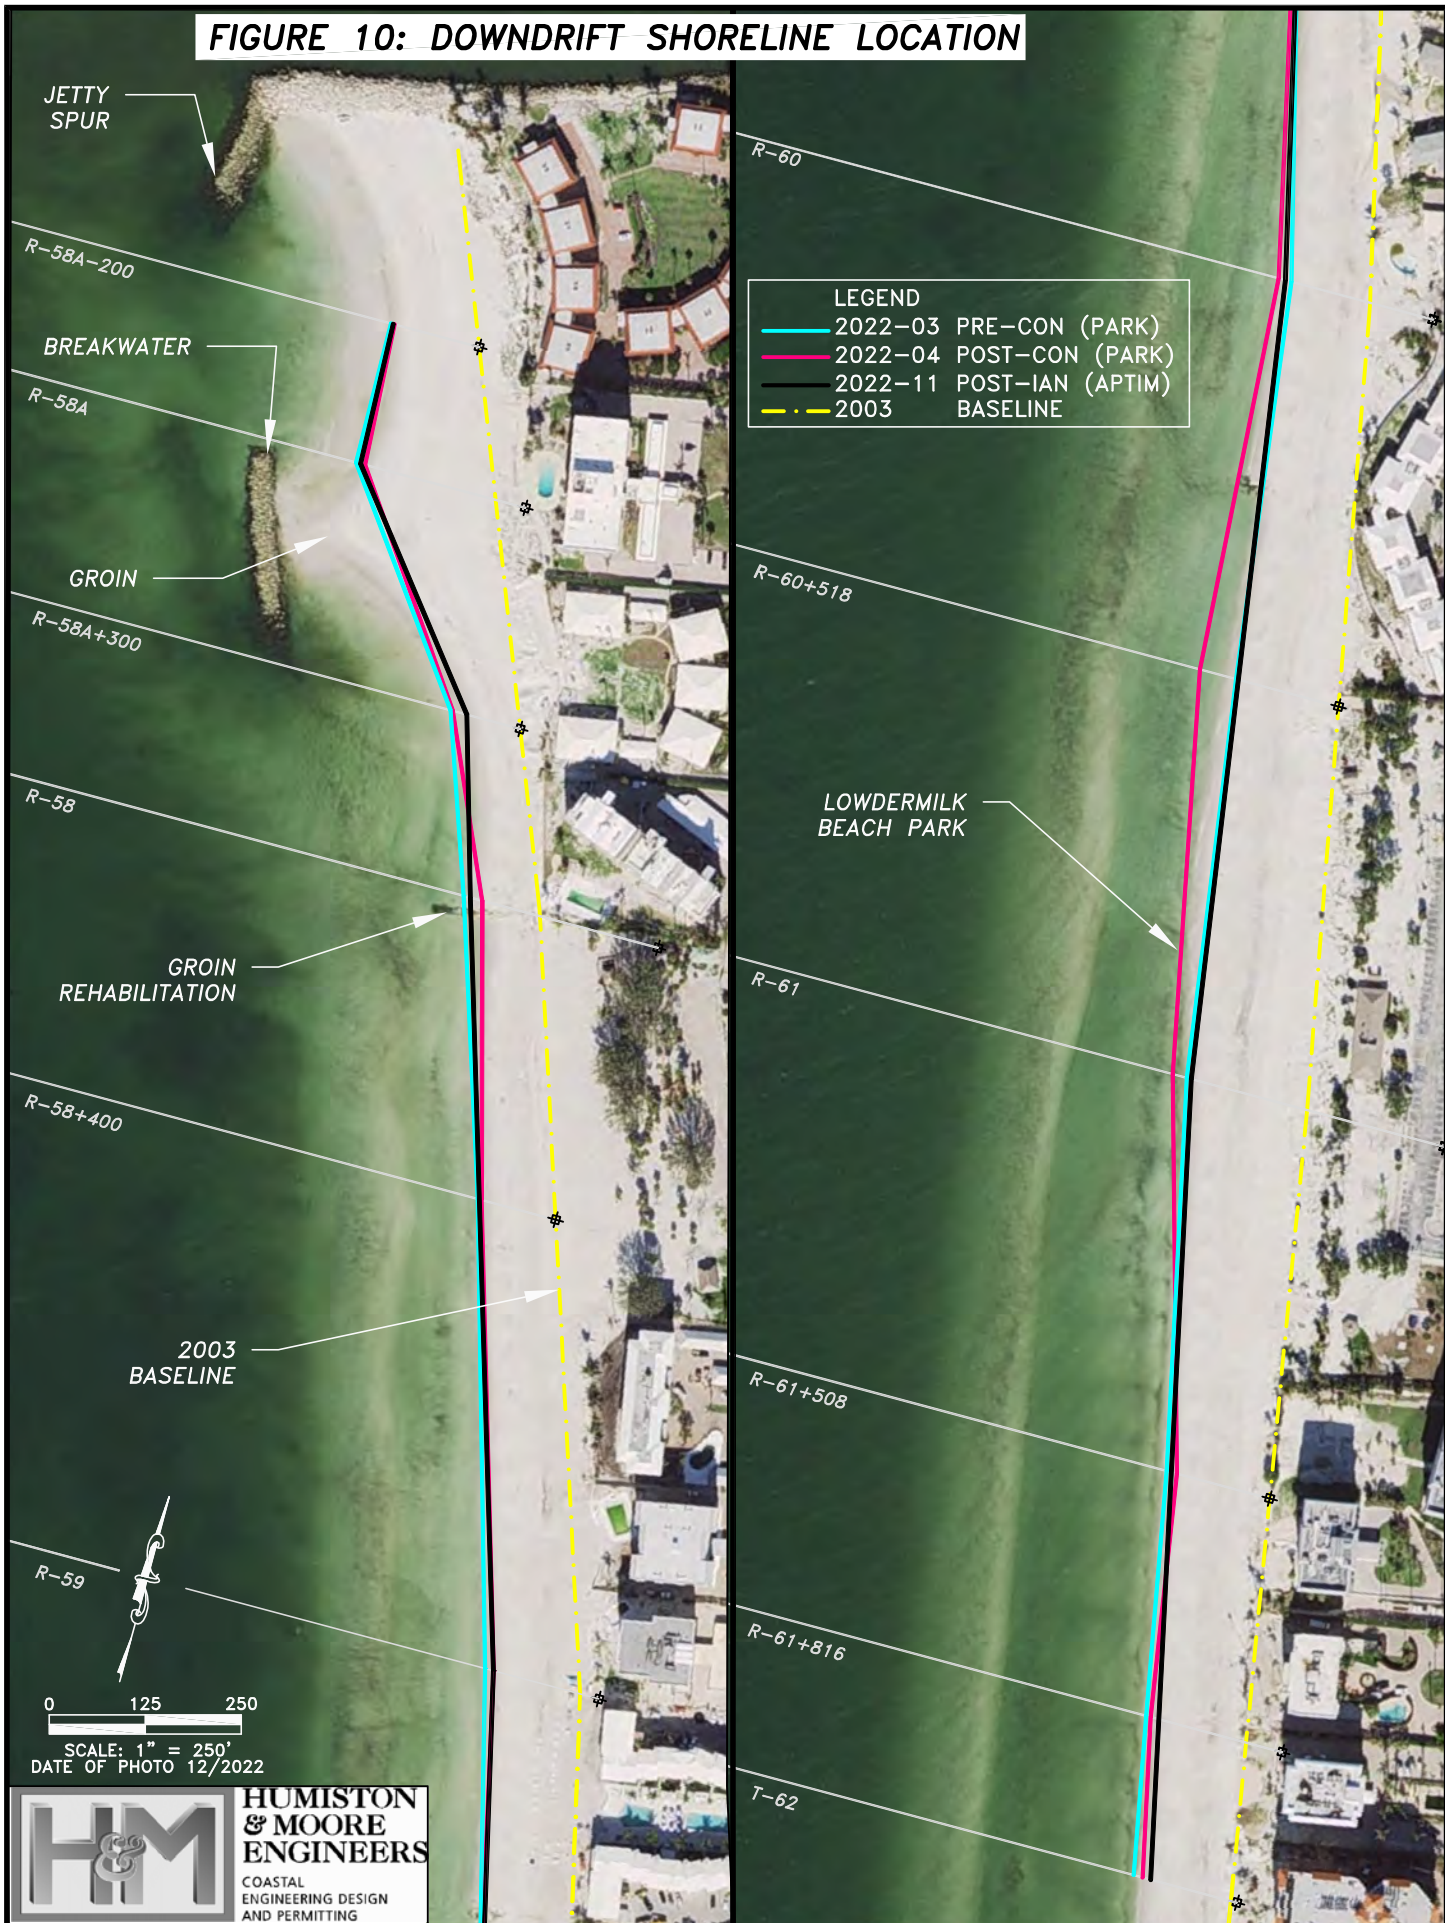
FIGURE 10: DOWNDRIFT SHORELINE LOCATION

Figure 10 shows the location of the MHWL for the pre-construction, post-construction, and post-Ian monitoring surveys, as well as the location of the 2003 Baseline. The gain in beach width from R-60 south due to the 2022 dredging project and the subsequent accelerated equilibration due to Hurricane Ian is evident. It should also be noted; the 2003 baseline was established in approximately 1,000-foot increments without consideration to changes between monuments therefore comparisons to the *Design Standard* at intermediate monuments could be misleading. Design quantities for fill projects consider other factors as well as erosion or accretion including the existing beach width, advance nourishment requirements, predicted erosion prior to construction, storm losses, tapers, gaps, berm height, design life, and estimated end losses.
