**WIGGINS PASS MONITORING REPORT
MAY 2004 SURVEY DATA**

**COLLIER COUNTY
AND
THE STATE OF FLORIDA
DEPARTMENT OF ENVIRONMENTAL PROTECTION**

PERMIT NO. 0142538-001-JC

Wiggins Pass Monitoring Report
 May 2004 Monitoring Data
 July 2004

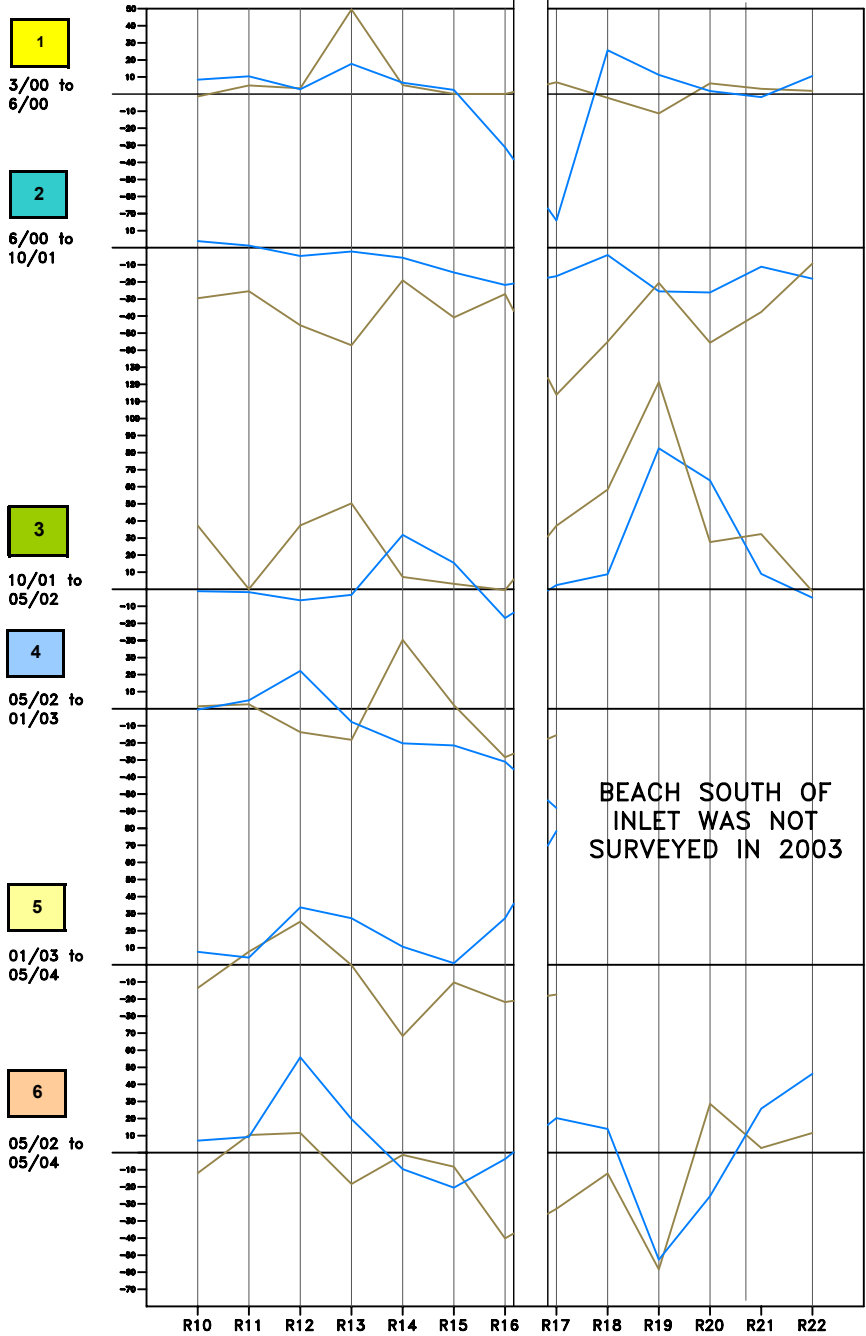
Figure 5 is a stack plot which shows the changes in shoreline position between the pre (March) and post- (June) construction surveys of 2000, the October 2001 county-wide survey, the May 2002 monitoring survey, the January 2003 post dredging survey and the May 2004 monitoring survey. The shoreline changes are illustrated at +1.5 ft NGVD (Mean High Water) and at +4 ft NGVD which approximately corresponds to the beach berm elevation. Shoreline change in the +4 ft NGVD contour is also shown because it illustrates the continued recession of the escarpment due to the erosion that has occurred on the north side of the inlet. Additionally, a color coded time scale is represented at the bottom; each color represents a different survey period between March 2000 and May 2004. Storm and dredging events are also represented. This is included in order to provide the reader with a quantitative time sequence of the erosion that has been reported by many eye witnesses.

This exhibit shows that the edge of the berm and mean high water line do not always follow the same accretion and erosion trend. Disparities between the two illustrate that at times, the berm was eroding while the mean high water was accreting and vice versa. The shoreline generally advanced seaward in both the north and south beach fill sites, as a result of the beach disposal from the dredging between 2000 and 2002. The exception to this general accretion has been significant shoreline recession immediately adjacent to the inlet, at DEP reference monument R-16 and R-17. See Figure 2 for the locations of the monuments.

Averaged shoreline changes and rates are provided in Table 1 and Table 2 for the shoreline north and south of the inlet at +1.5 ft and +4 ft NGVD, respectively. The shoreline change and shoreline rates are averaged by monitoring period and by location as well. As indicated, these local averages were computed both with and without the changes adjacent to the inlet at R-16 and R-17 (highlighted in gray in the tables) in order to illustrate the influence of the inlet on the overall average changes in the study area.

The high erosion at the monuments adjacent to the inlet may be indicative of a localized response to the expanded dredging limits in 2000, and the maintenance of the modified dredging limits in 2002 through 2004. This localized effect is probably due to readjustment of the side-slopes of the larger dredged channel, and therefore would not be representative of general shoreline trends further from the immediate influence of the inlet. The high rates of shoreline recession adjacent to the inlet are discussed in more detail in Section 6 of this report.

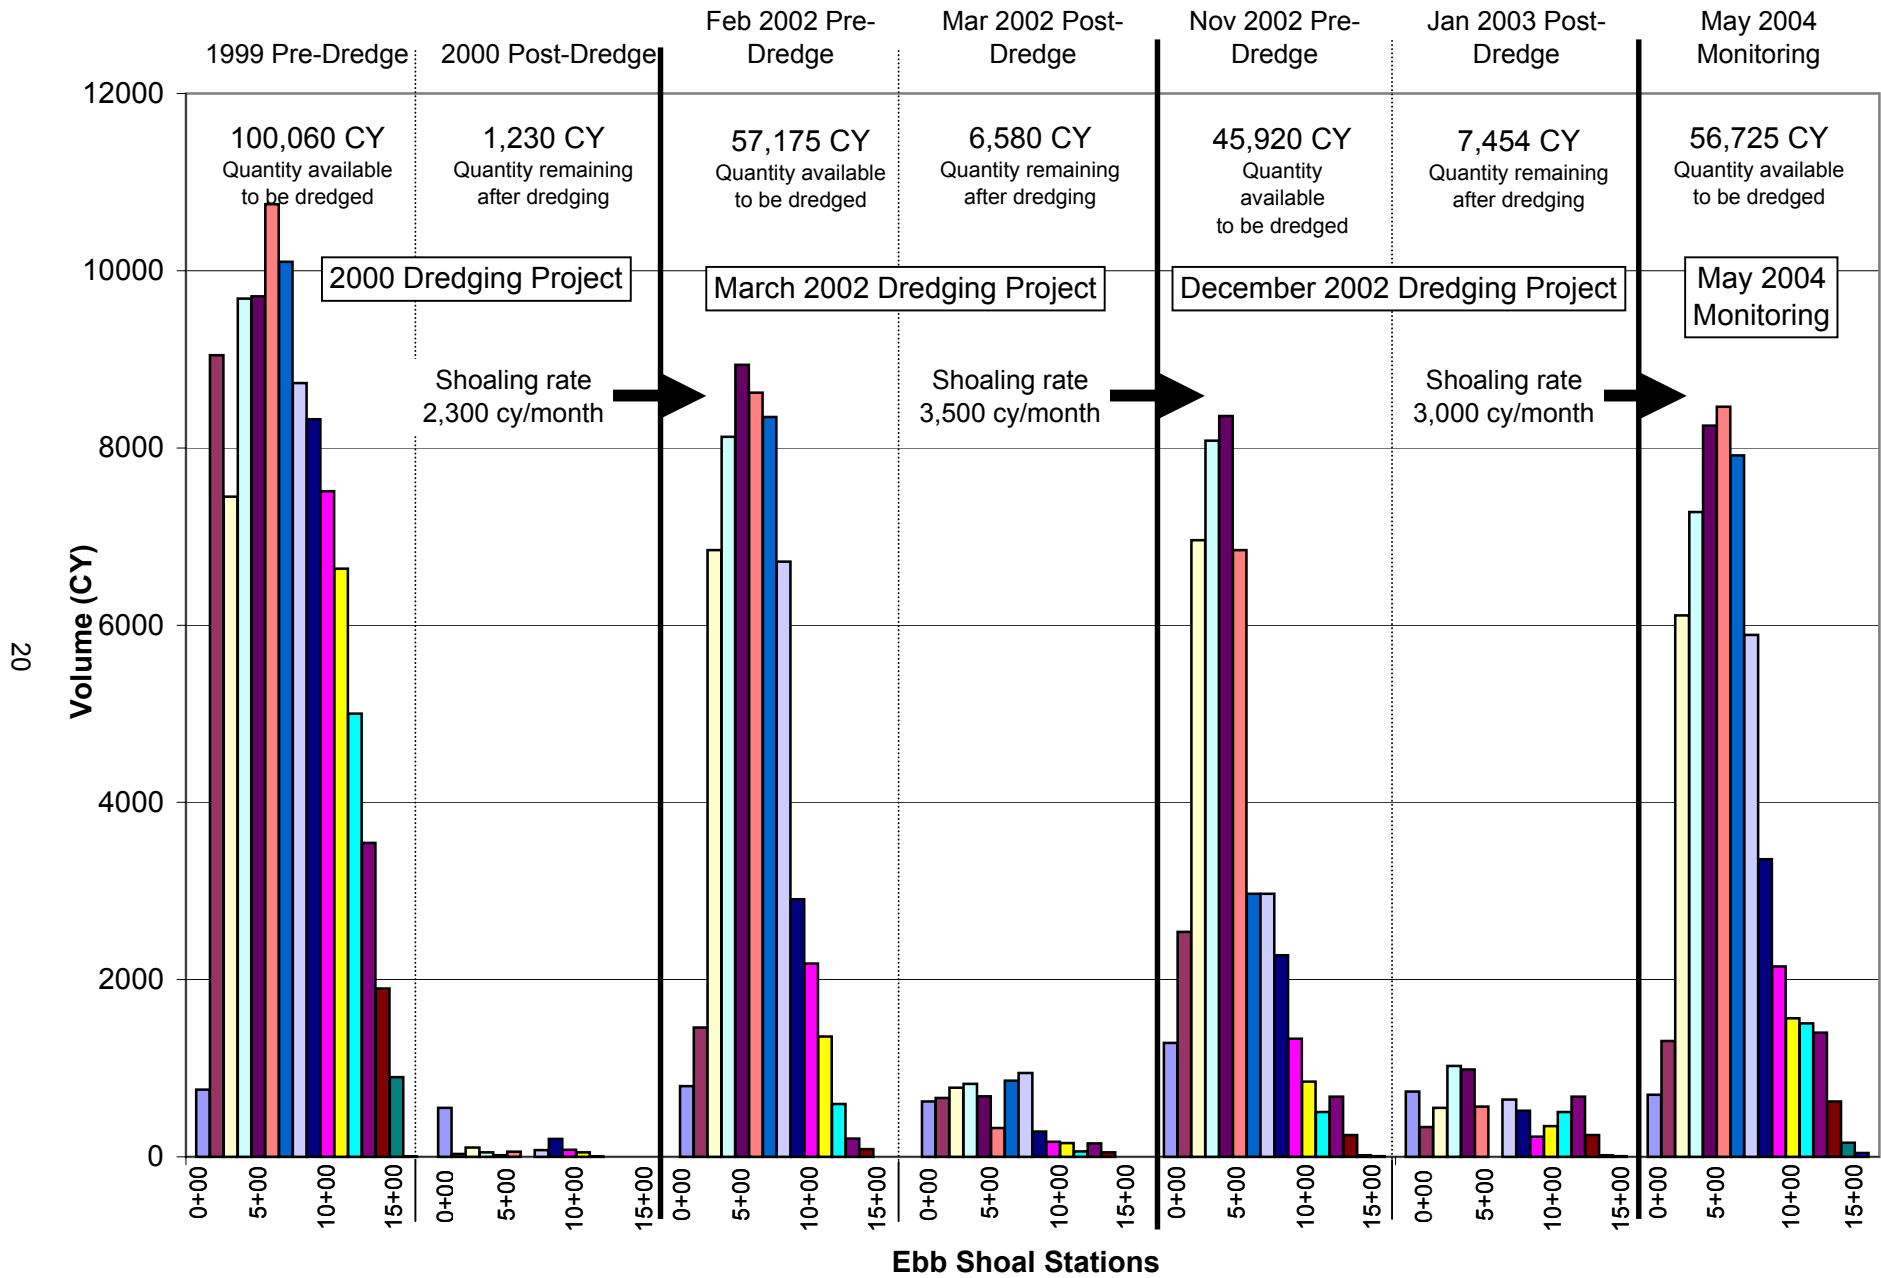
Figure 10 is a bar chart which shows the amount of material at each station within the channel limits for each survey since the dredging was completed in 2000. Data from the 1999 pre-dredge survey indicate that there were approximately 100,060 cubic yards available to be dredged from within the channel limits. The post dredge survey shows that all but approximately 1,230 cubic yards were removed during the dredging. It should be noted that the available quantity includes overdepth. This is the material at the bottom of the channel that the contractor is not required to remove, but will be paid for any portion of it that is removed. The purpose of this is to consider the inaccuracies in the dredging process and to provide incentive for the contractor to achieve the design depth at a minimum. The 2002 pre-construction survey shows approximately 57,175 cubic yards to be dredged from within the channel limits. The 2002 post dredge survey shows that all but approximately 6,580 cubic yards were removed during the dredging.

Comparison of Volume Within Dredge Limits for the 2000 through May 2004 Monitoring (Volumes Include Overdepth)

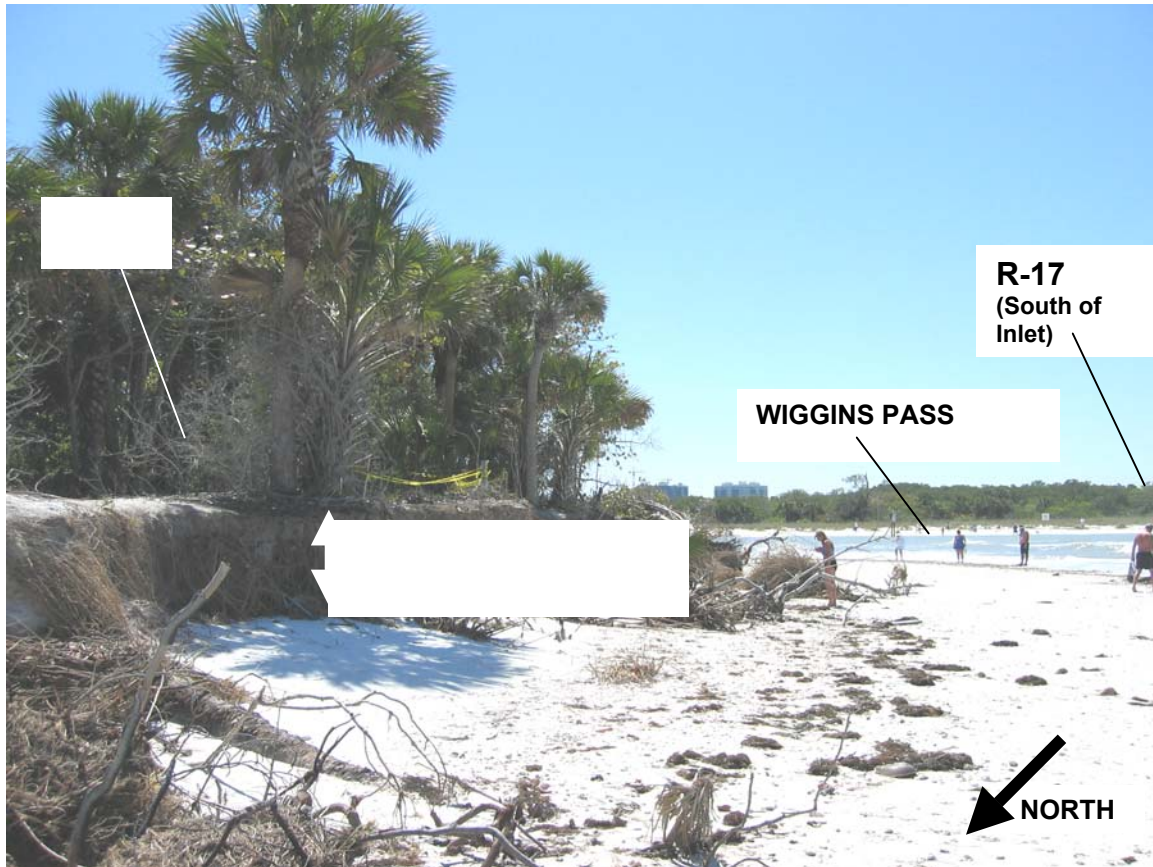
Figure 11 – Escarpment formation at R-16 (Photograph taken April 2004)

The latest survey showed that the Mean High Water (MHW) line both north and south of the inlet at R-16 and R-17 had been accreting between January 2003 and May 2004 (+8.2 feet). This observation does not reflect the volumetric loss of material that occurred at the berm elevation with an escarpment recession of -24 feet and a total volume loss close to -41 cubic yard per foot of beach (Tables 1, 3 and 4). Some of the sand which eroded from the upland may have moved seaward resulting in shoreline accretion at MHW during the same time period. This significant berm (+4 ft NGVD) recession was observed by many eyewitnesses as formation of an escarpment (Figure 11), approximately 5 feet high which undermined trees and other vegetation. This is probably related to a

Concern has been expressed by the County Parks Department about the stability of the beach at R-16, which is located on the north shore of the inlet. Since the pre-construction survey of March 2000, the shoreline at R-16 has receded approximately -73.6 feet, or -17.7 feet per year, and lost approximately -59.6 cubic yards per foot, or -14.3 cubic yards per foot per year. It is likely that much of this material ended up in the dredged channel as a result of a natural adjustment to the expanded dredging limits, as discussed in Section 2.

4. The severe erosion of the south end of Barefoot Beach Park could be diminished by modifying the recommended dredging plans of the 1995 IMP by reducing the dredging depth at the east end of the dredge cut from -13 feet the original depth of -8.8 feet. Establishing the limits of the portion of the channel where the dredging depth should be reduced is a design function which would need to be evaluated and was not part of the Feasibility Study.

5. The severe erosion at the south end of Barefoot Beach Park could be addressed with erosion control structures. The Feasibility Study recommended this as a potential phase II alternative to be considered only if other measures to control the erosion prove to be insufficient.
