**APPENDIX I**

**Wiggins Pass Resource Investigation Report**

**WIGGINS PASS, COLLIER COUNTY  
2008 RESOURCE INVESTIGATION REPORT**

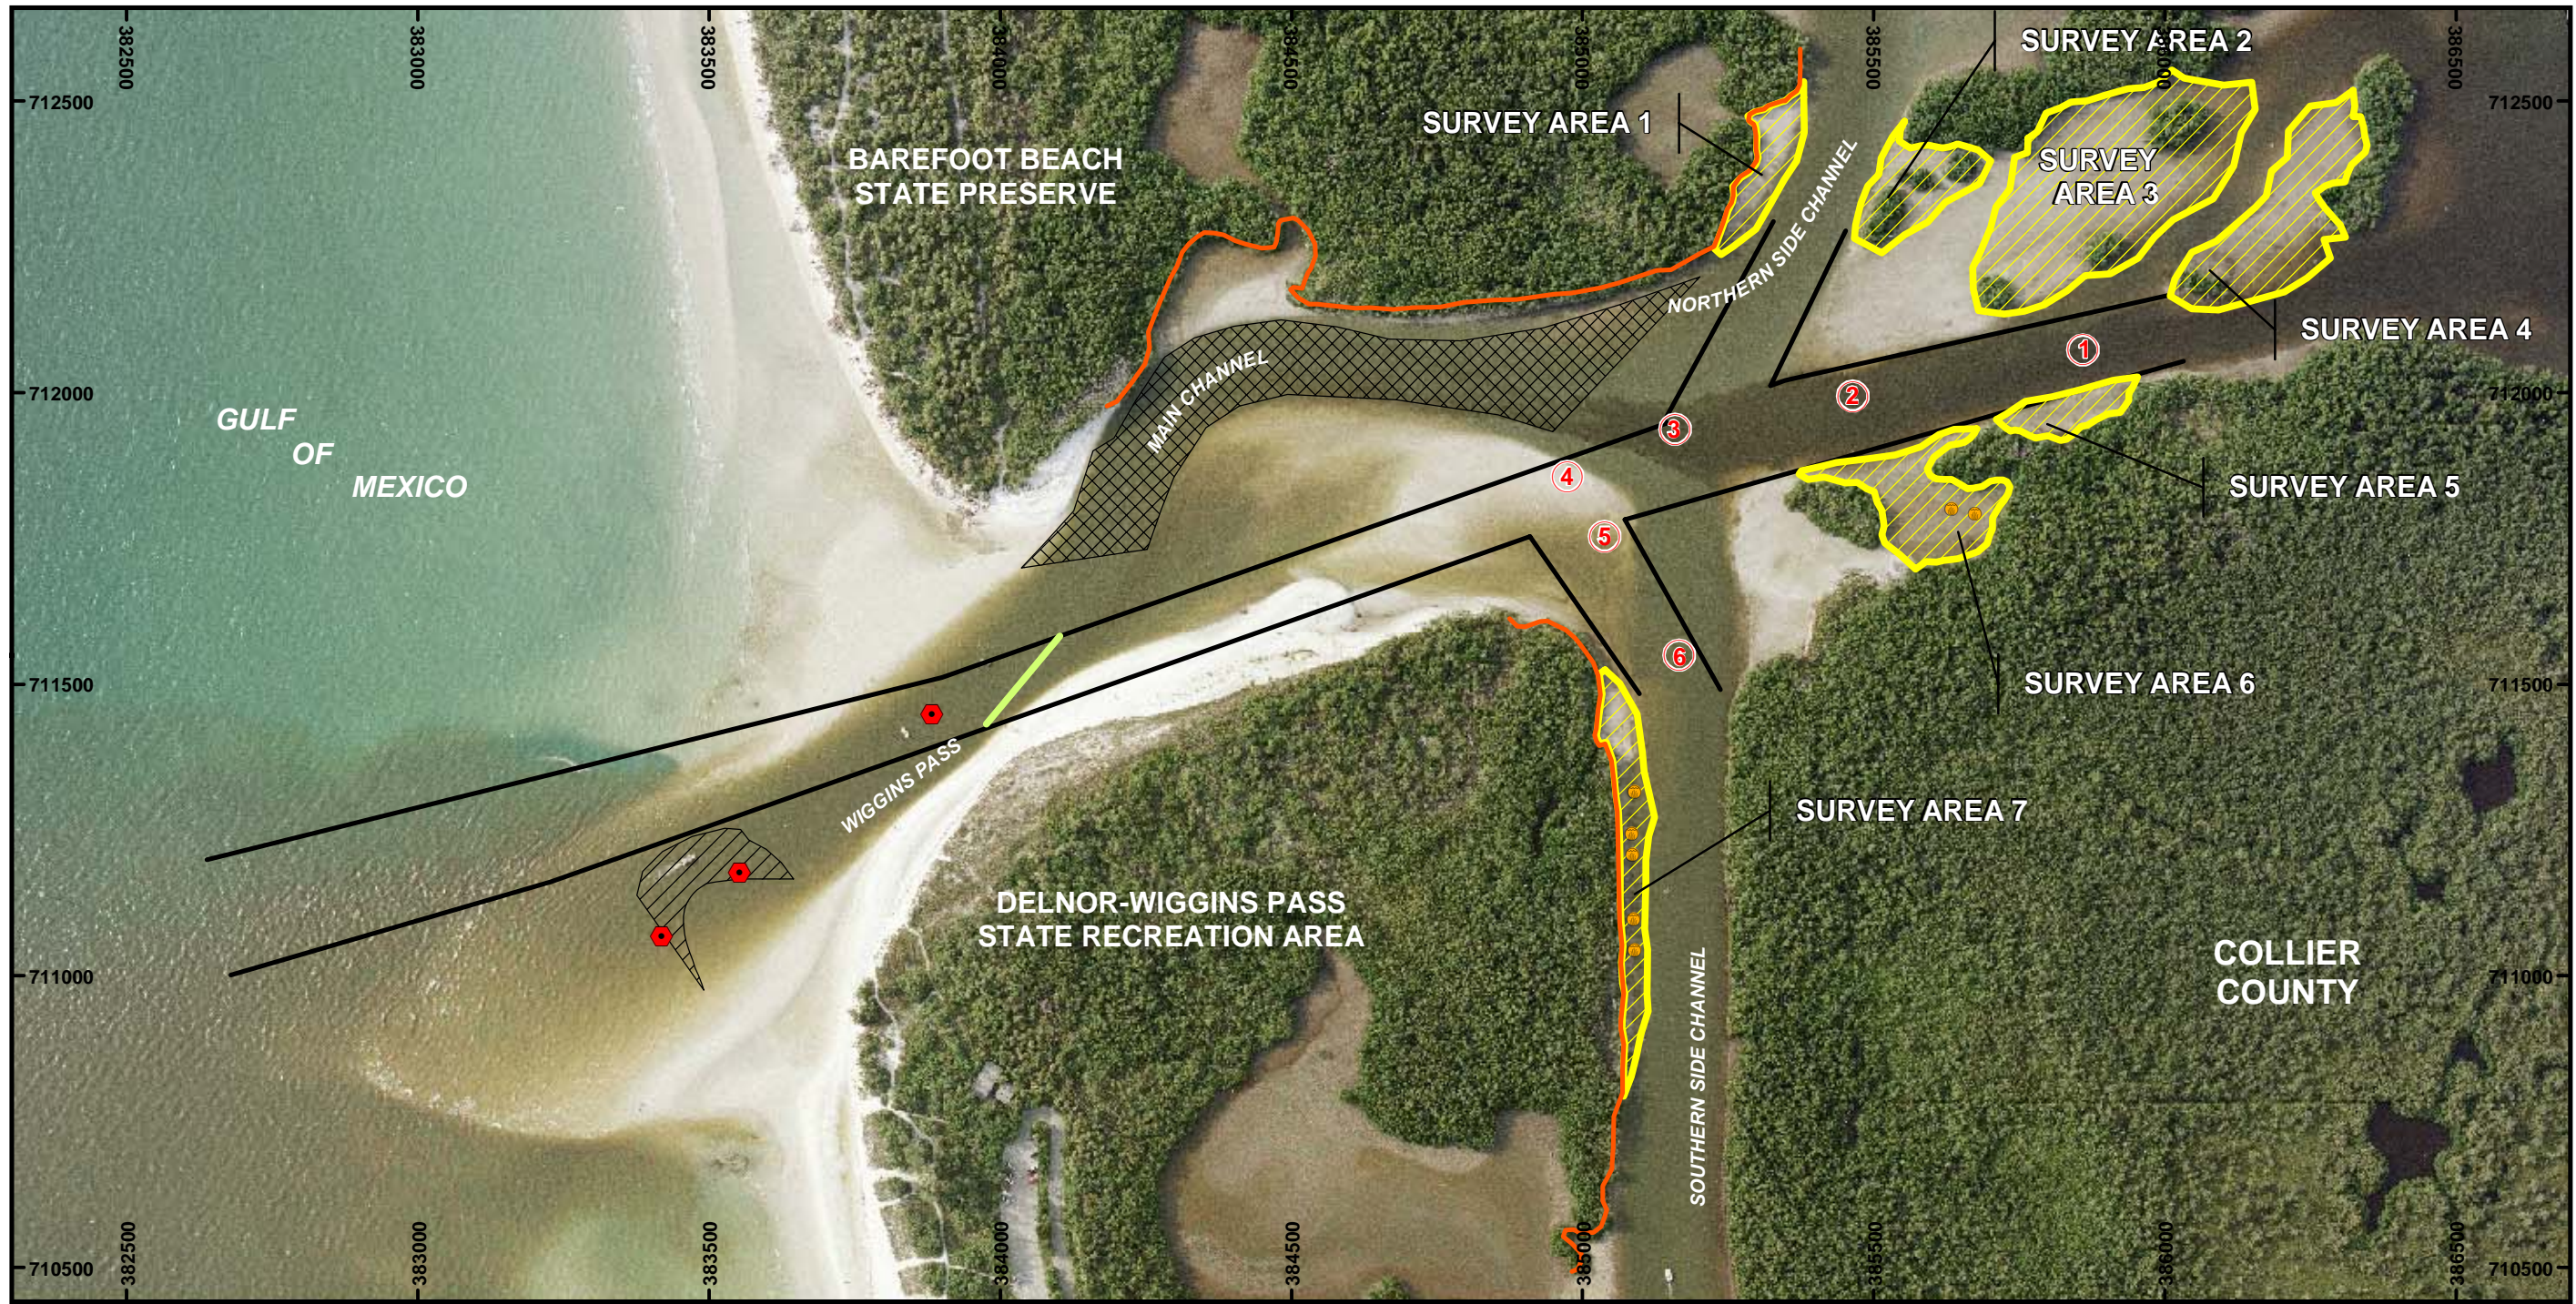
Various substrate cores were taken within Wiggins Pass to record specific geologic features and as a prelude to dredging. The U.S. Army Corps of Engineers (USACE) conducted borings in the Wiggins Pass channel area in 1979 (USACE, 1980). The USACE did not discover a nearshore subsurface rock ledge, but did discover a hard, grey limestone layer located further offshore. The USACE defined the limits of the limestone layer with core and wash borings. The subsurface rock appears to be discontinuous and of limited size. The limits of the subsurface rock were between channel stations 2+00 and

Conversely, back in 1990, Coastal Engineering Consultants (CEC) identified a rock ledge located on an elevation between -7 and -10 ft NGVD at the entrance of the inlet. This ledge was considered a significant geological feature in 1990, and was used to restrict dredging and the channel location for the inlet. However, based on our 2008 survey investigations, this ledge is believed to be a soft feature, as described below.

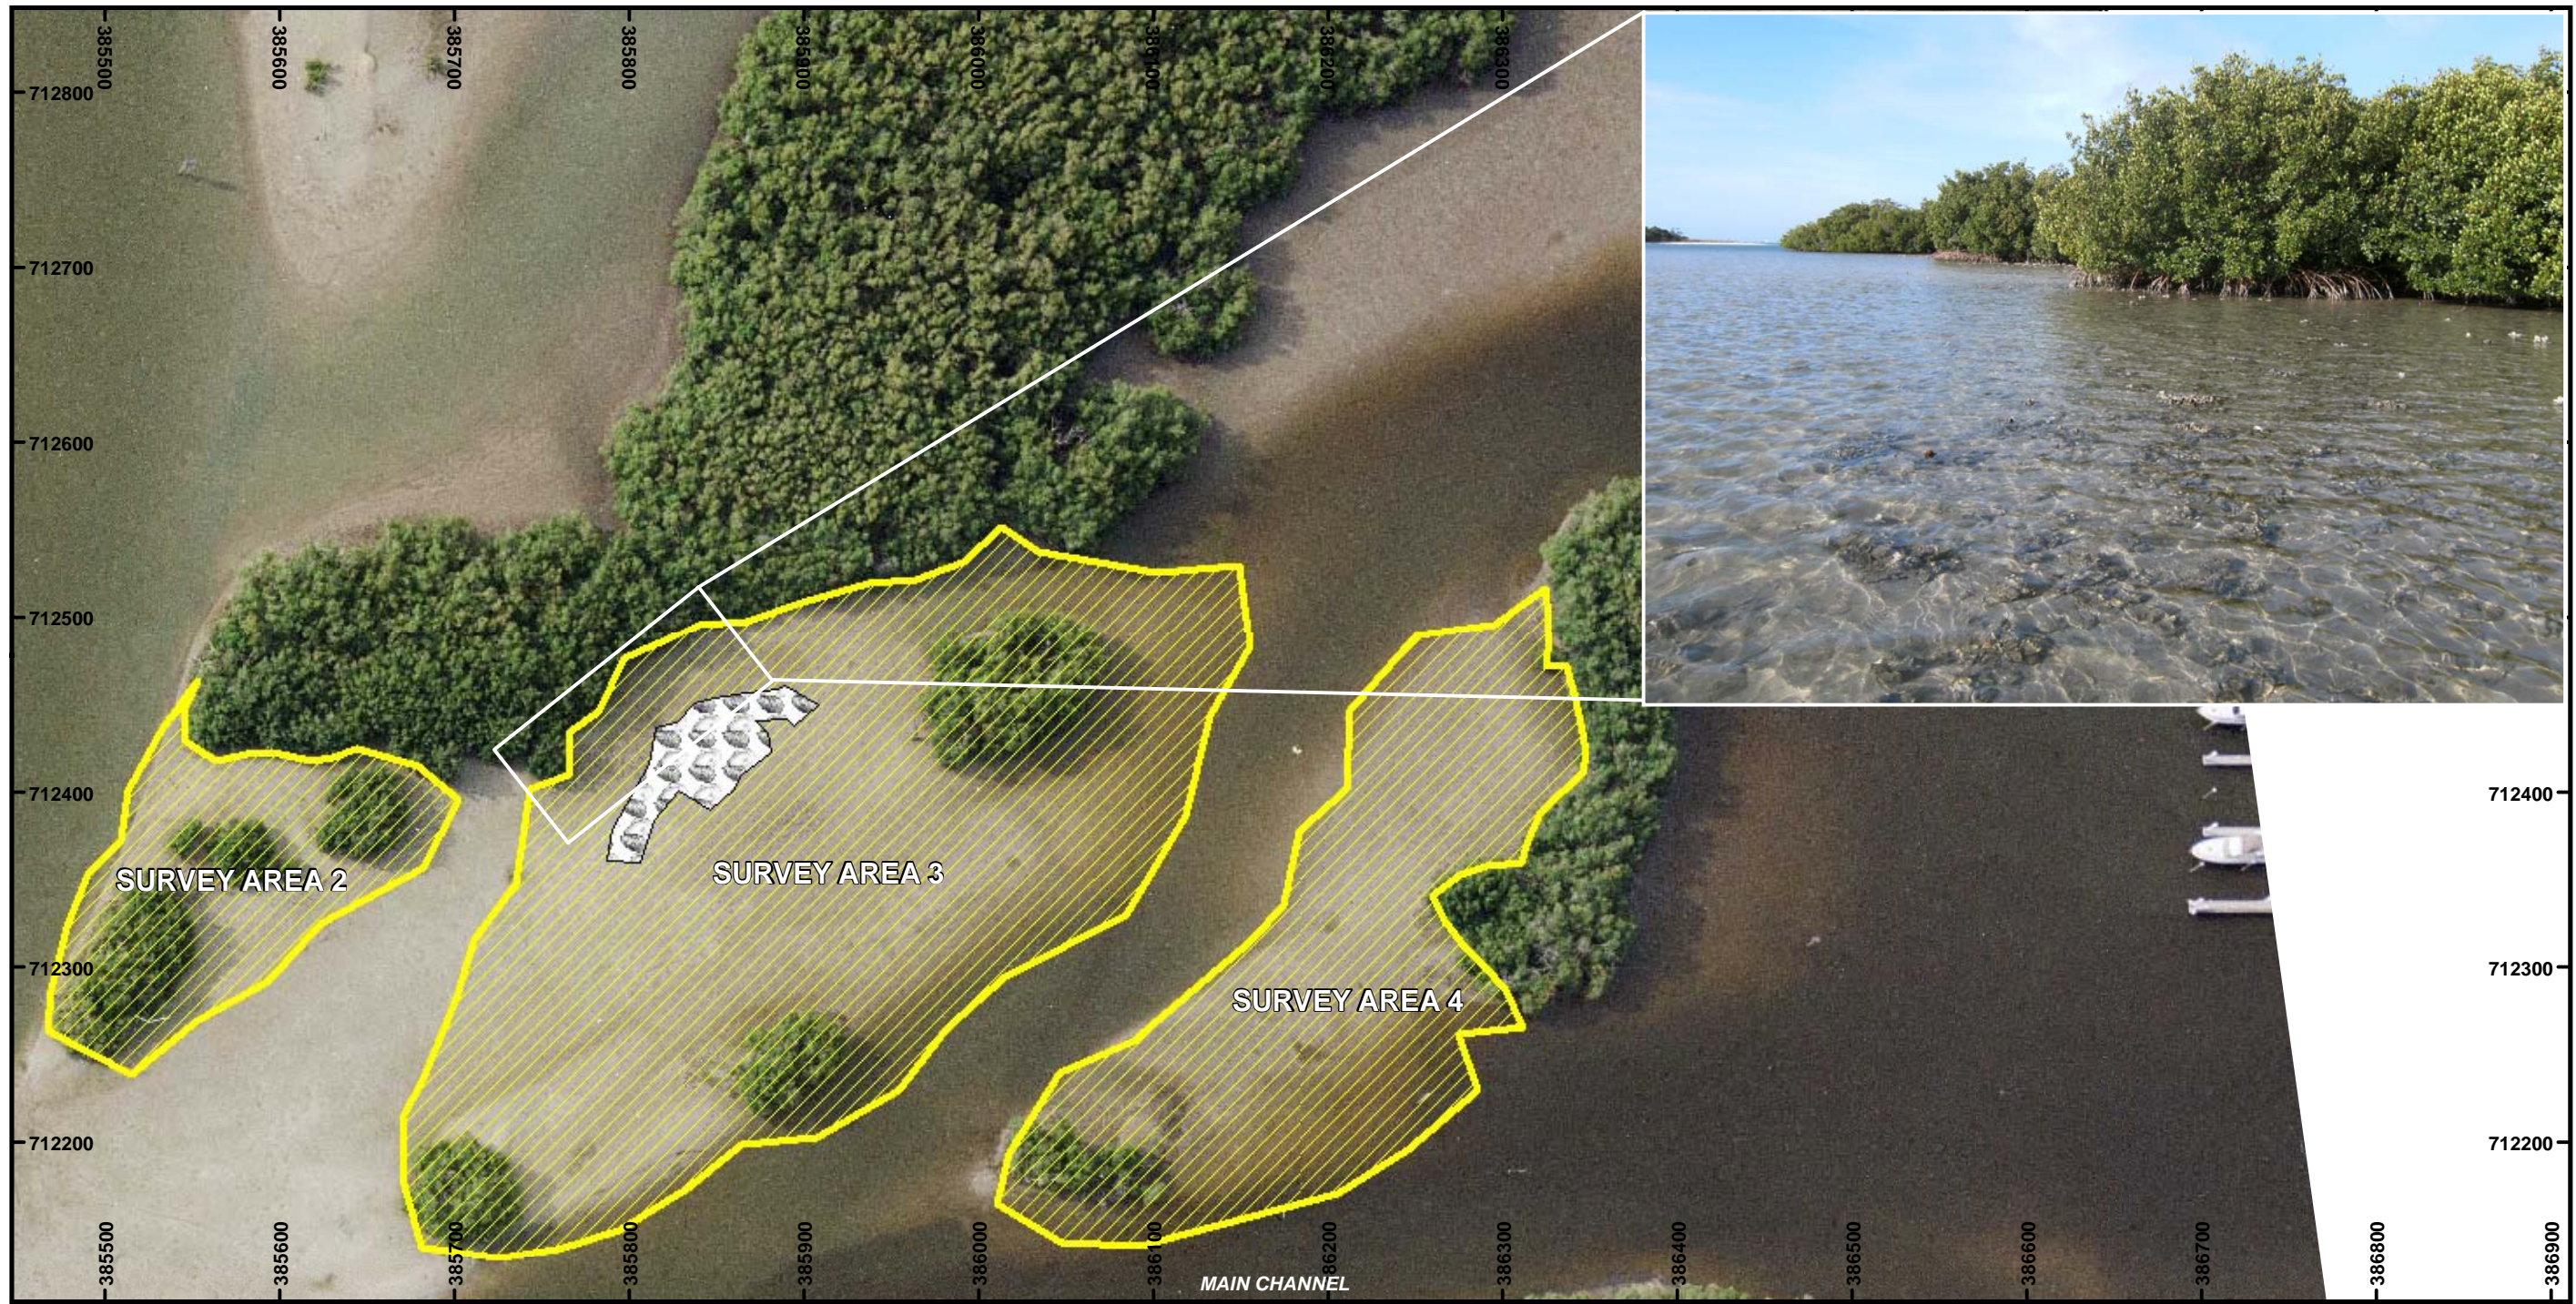
**FIGURE 3**

Survey Areas #2, 3, & 4 were located to the east of Survey Area #1, adjacent to the northern edge of the main channel in Wiggins Pass (Figure 3). The survey areas varied (~0.58, 2.52, and 1.24 acres, respectively), but the water depth at low tide remained less than one foot. In all three of these survey areas, no seagrass or hardbottom substrates were found. A large bed of *C. virginica* was recorded in Survey Area #3 (Photograph 5), along with a submerged concrete pipe (Photograph 6). The bottom substrate was consistent with a mixture of coarse sand, fine sediment, and shell hash.

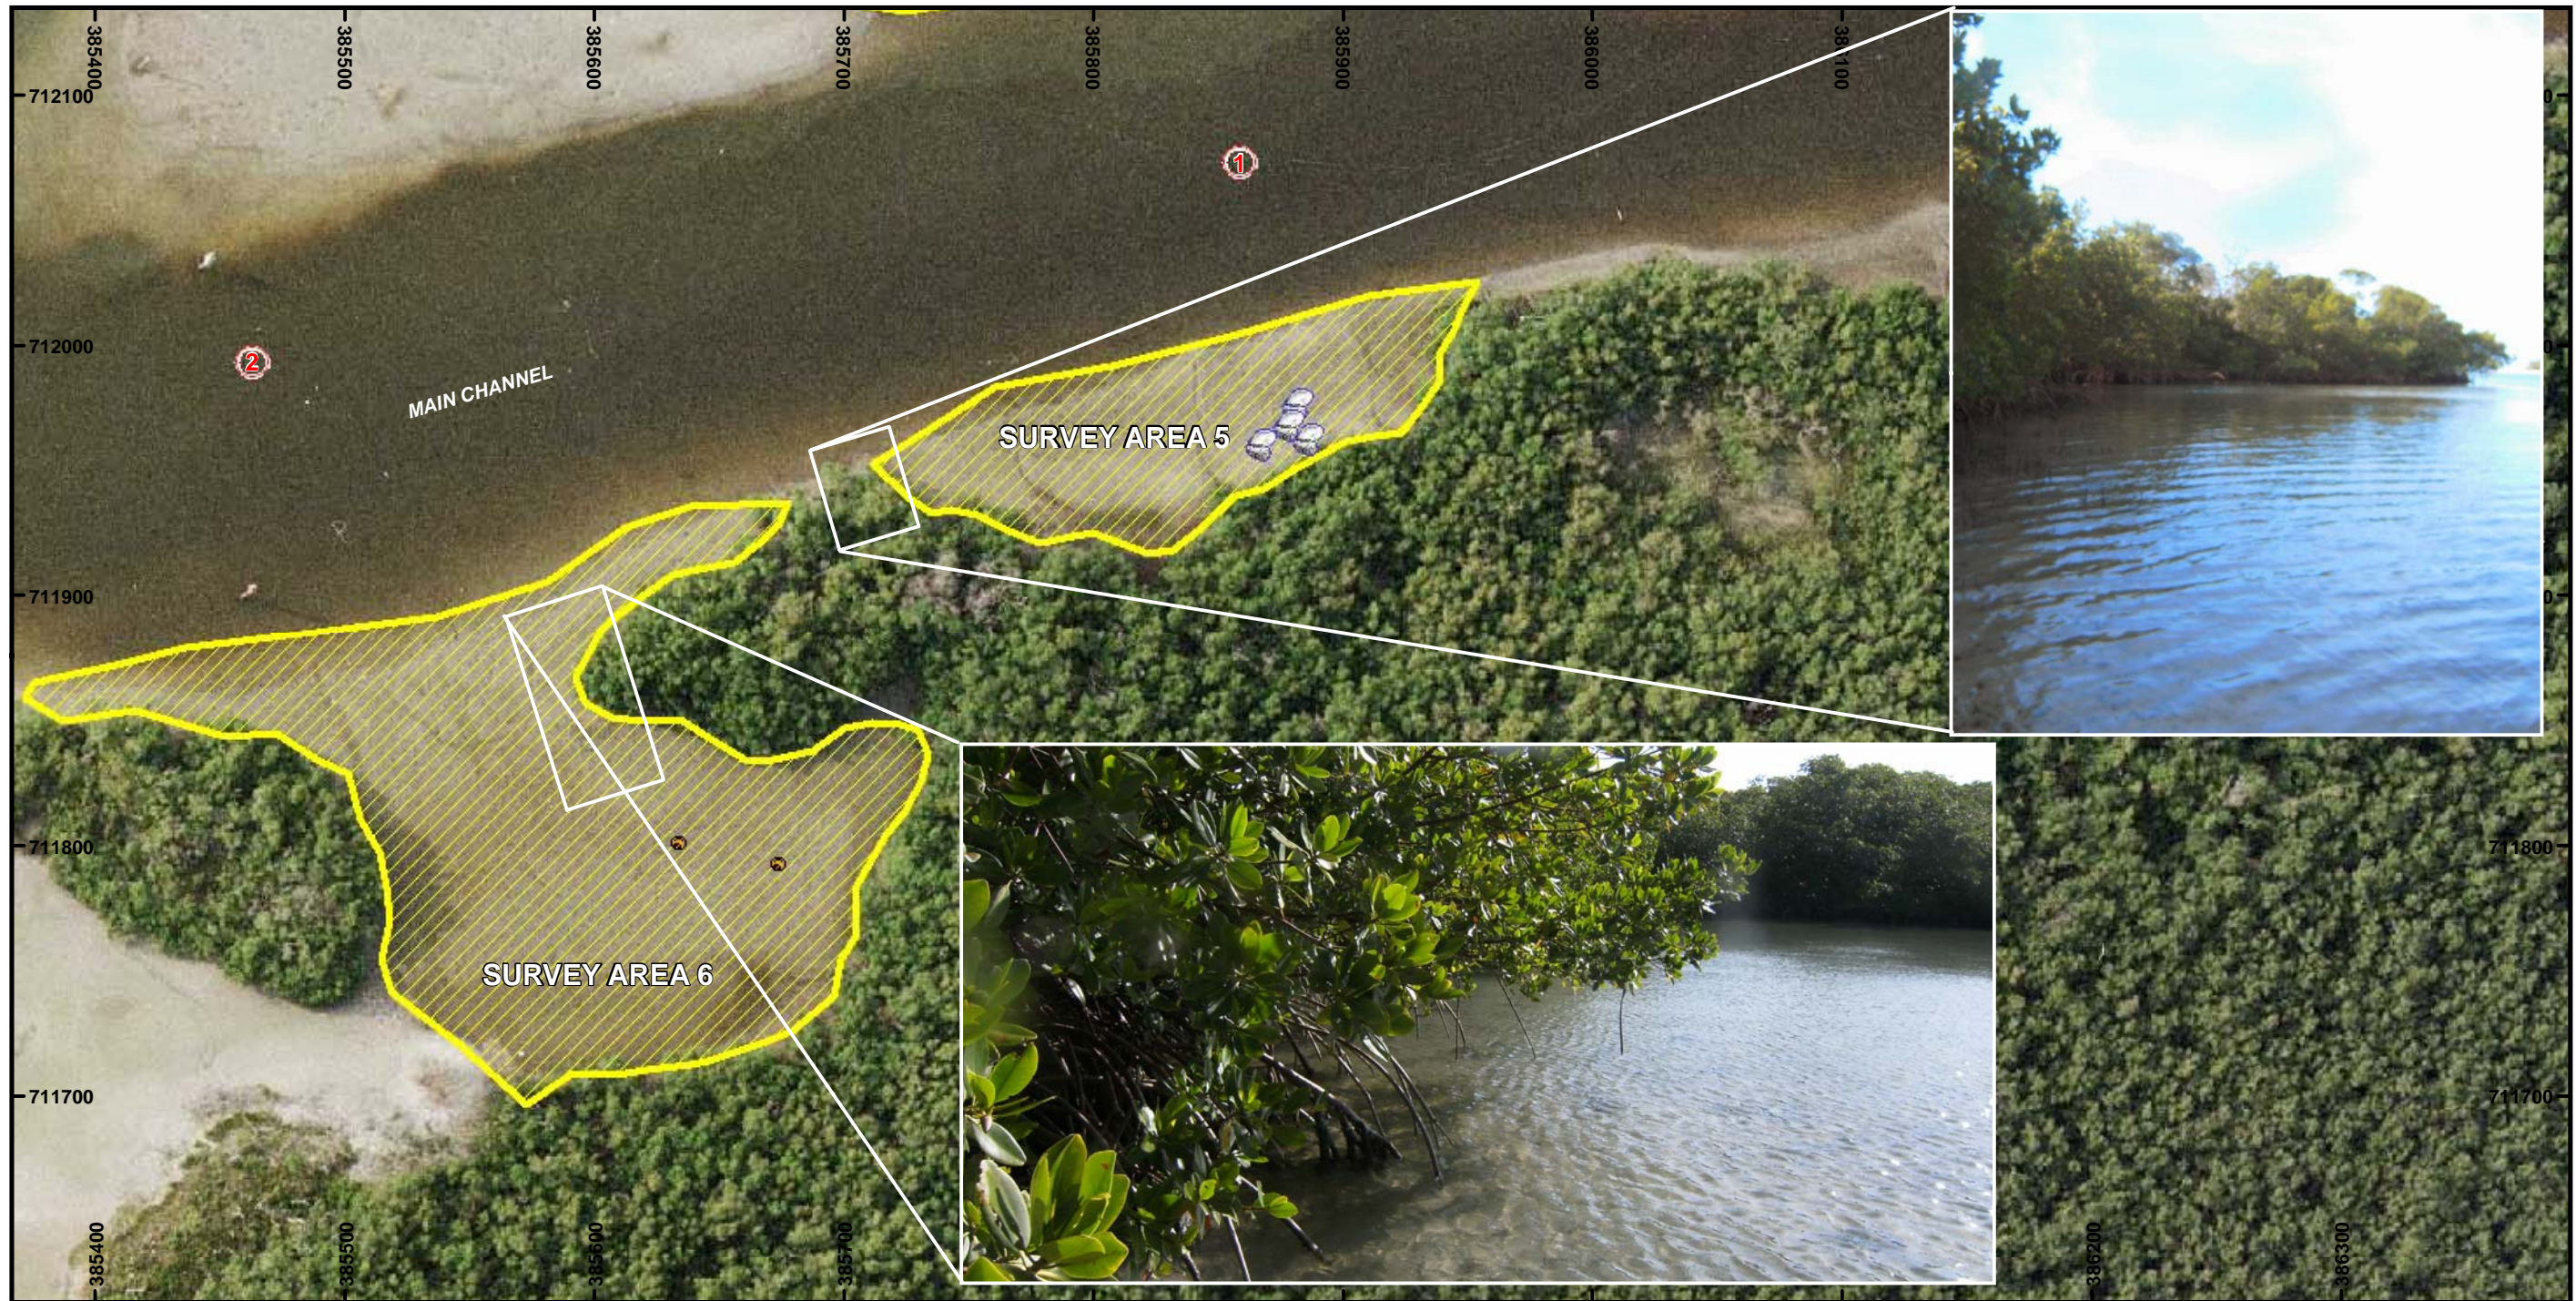
**FIGURE 4**

Survey Areas #5 & #6 were located directly opposite of the previously surveyed areas, positioning them along the southern edge of the main channel (Figure 4). While Survey Area #5 (~0.30 acres; 1-3 ft deep) found only a small oyster bed, Survey Area #6 (~0.83 acres; 1-3 ft deep) recorded a few flat, narrow blades of *Halodule wrightii* (shoal grass). These blades of seagrass were very sparse, with a total density less than 1 cm<sup>2</sup> (Photograph 7).

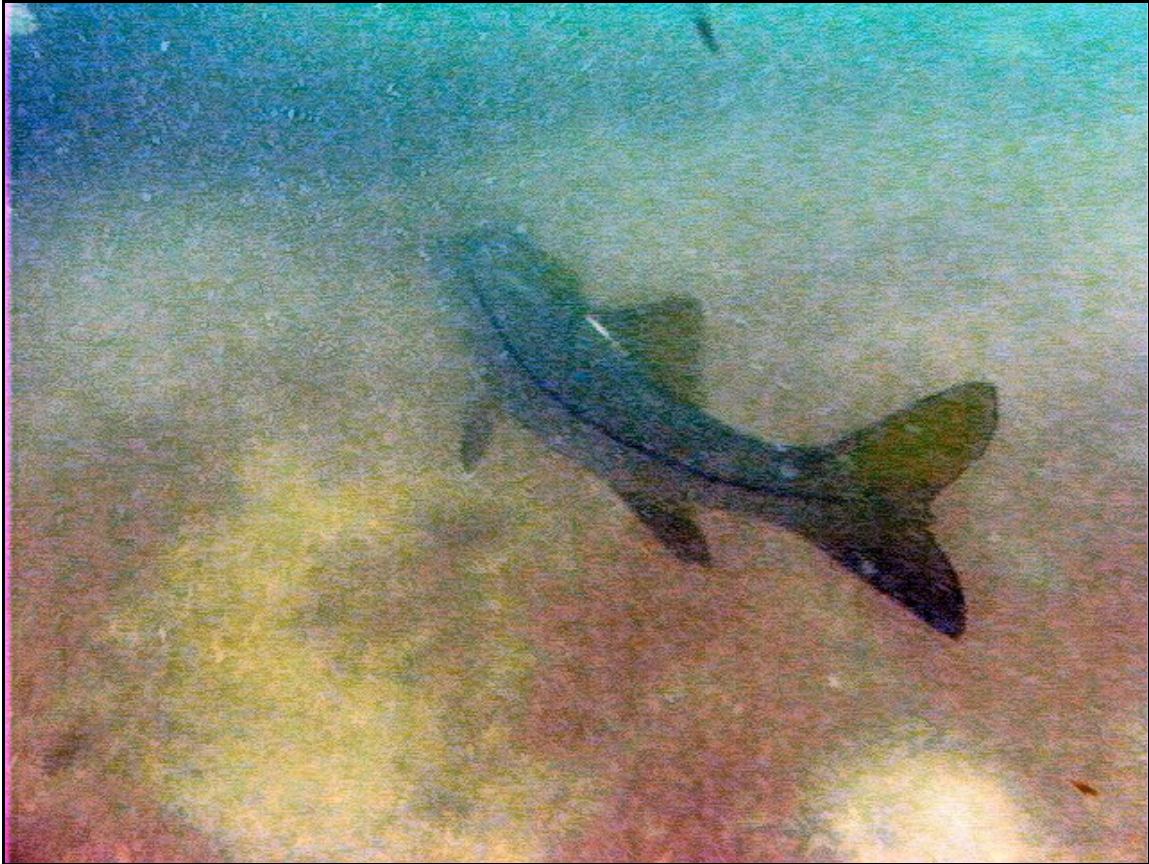
Photograph 1. Common snook, *Centropomus undecimalis*, are known as a euryhaline species of fish, which gives them a preference towards the mangrove-fringed estuarine waters within Wiggins Pass. This adult, photographed along the southern side channel, is easily identified by its well-defined black lateral line and yellowish fins. Currently, there is no designated critical habitat for snook in the State of Florida.

While various fish use the estuary system of Wiggins Pass as either developmental or feeding grounds, one species in particular has raised concern. The common snook, *Centropomus undecimalis*, are mostly found in mangrove fringed coastal waters, such as those within Wiggins Pass (Photograph 1). The inlet improvement can be made without displacement or impacts to mangroves. As juveniles utilize the back estuary as a developmental habitat, the adults congregate to the inlet opening to initiate spawning; male snook require a certain salinity within the water column for fertilization to occur. The Florida Wildlife Conservation Commission's designation for the common snook is a 'protected species of concern'. And while this designation is listed for the purposes of public awareness and commercial fishing, the listing does not carry any specific conservation regulations in regard to dredging activities. Furthermore, no critical habitat has been designated for snook, especially not within Wiggins Pass. In the Gulf region, closed season for snook occur during the months of December, January, February, May, June, July, and August.

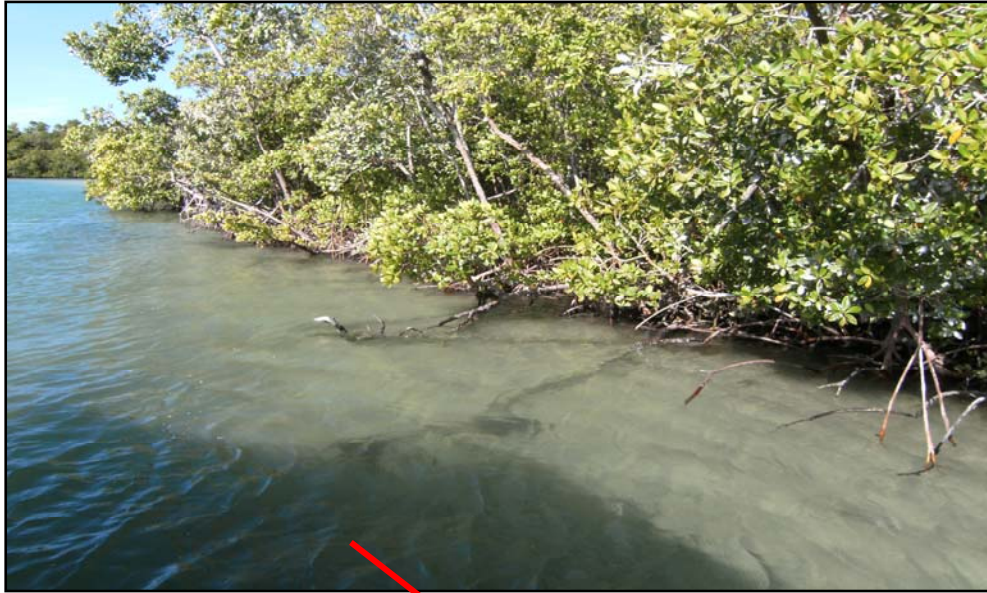
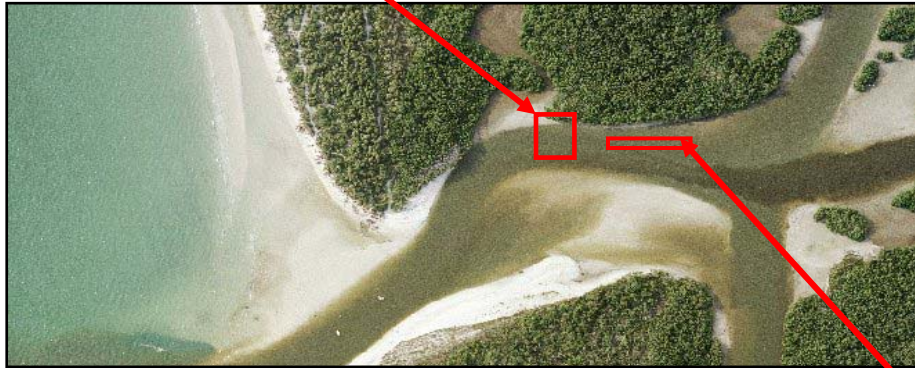
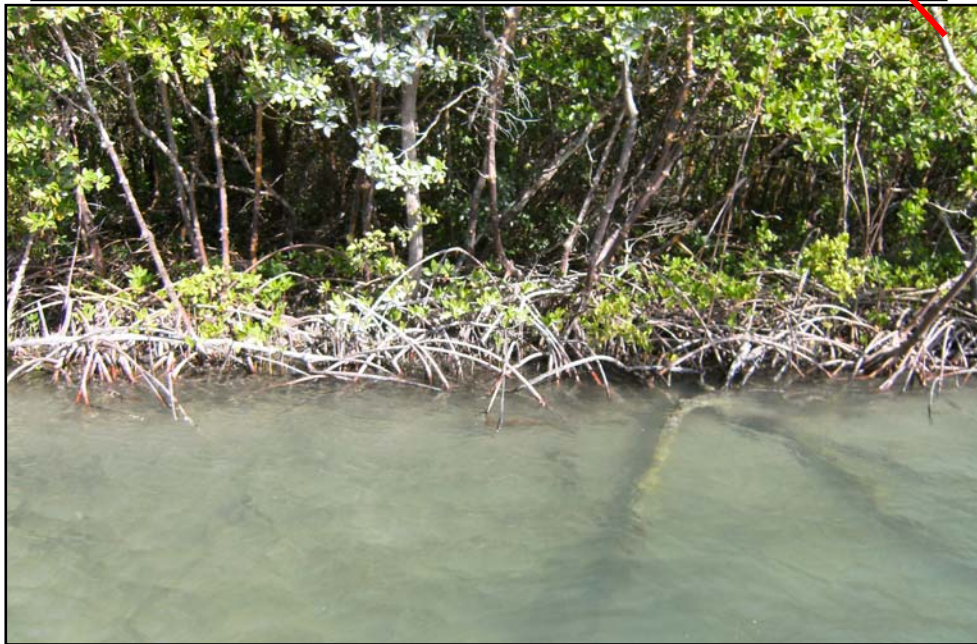
Photograph 2. Close-up view of the northern main channel of Wiggins Pass. The top picture shows the profile of red mangrove trees fringing the channel, while the bottom picture distinctly shows how the mangrove roots become submerged with the high tide.

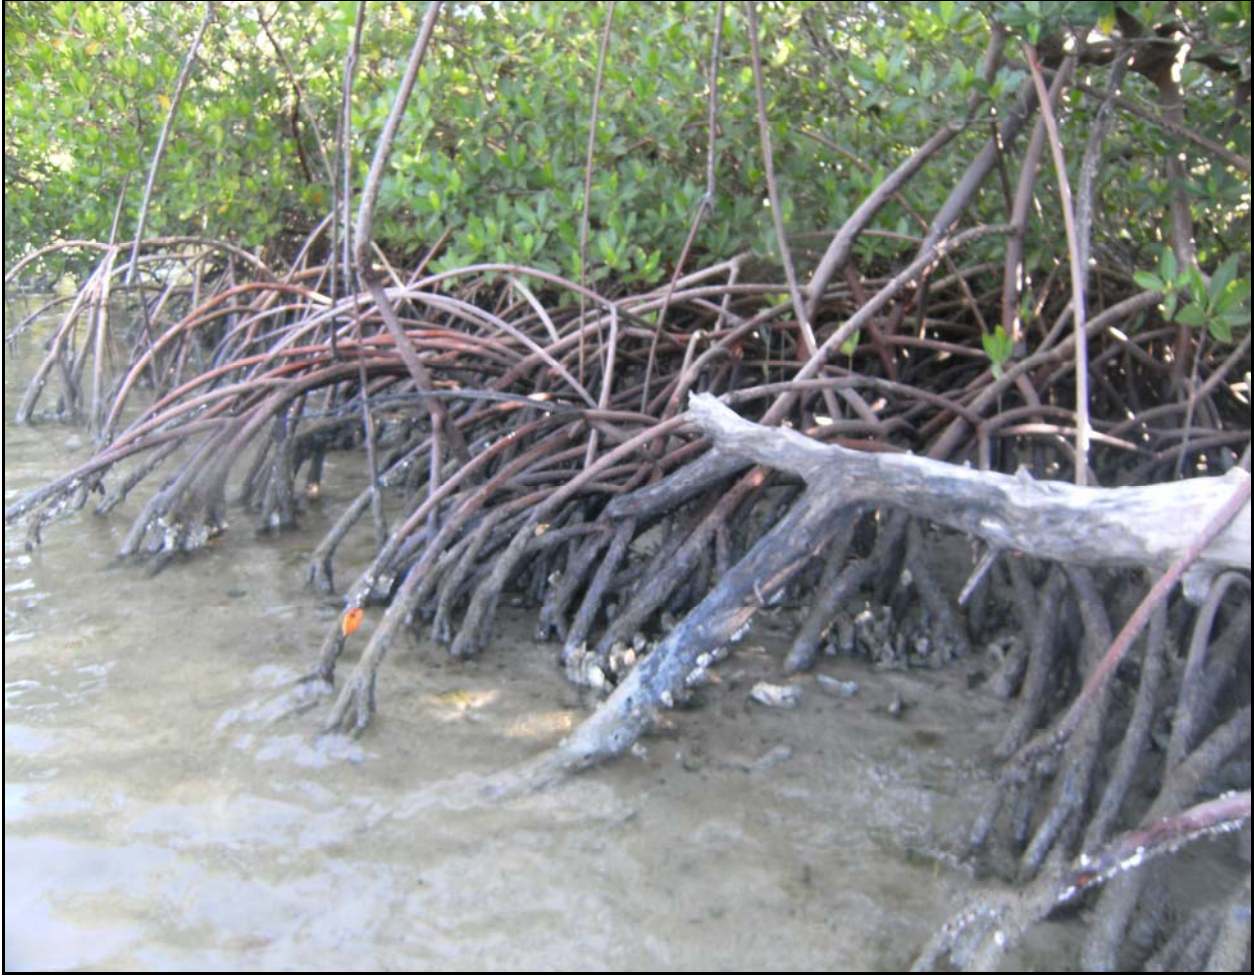
Photograph 3. The main and side channels of Wiggins Pass are lined with red mangrove trees (*Rhizophora mangle*). Their tall arching roots, also called prop roots, are distinct to this species and are continuously being inundated and exposed with the cyclic tides.

Red mangroves line the main and side channels of Wiggins Pass, with their roots having cyclic access to tidal waters. In the State of Florida, mangroves are protected, thus, prohibiting their trimming or altering of any kind without specialized permits. The Mangrove Trimming and Preservation Act (2006) is enforced by the Florida Department of Environmental Protection and mandates that an individual permit must be applied for in order to conduct mangrove alteration or trimming. The term 'trimming' refers to the cutting of mangrove branches, twigs, limbs, and foliage, whereas, 'altering' means to

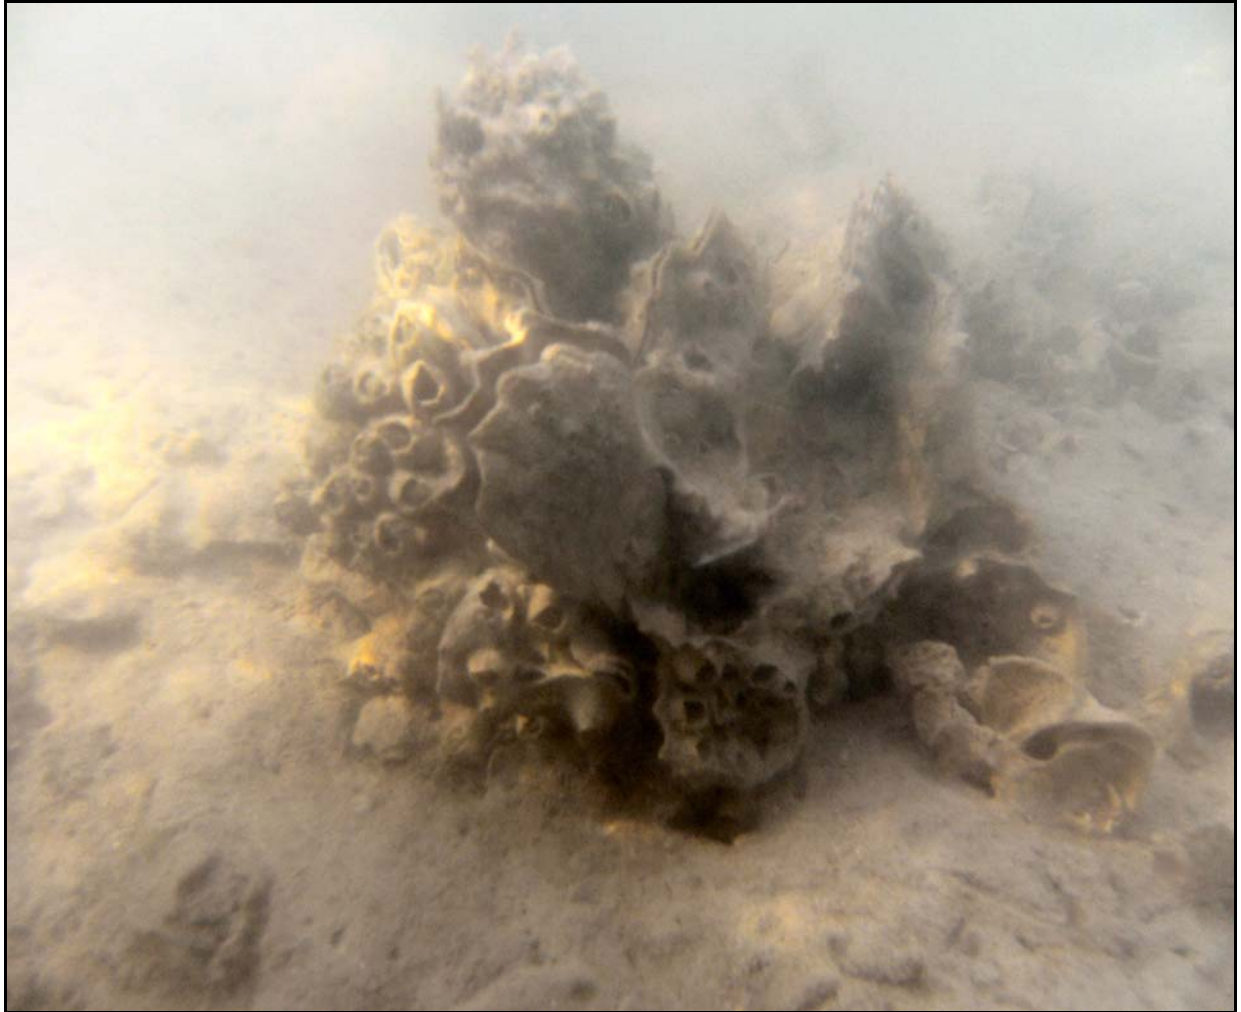
Photograph 4. Close-up view of *Crassostrea virginica* (American oysters), with barnacles adhering to the shells in Survey Area #1. While only sparse macroalgae was found along the sandy substrate, no seagrass was recorded in this area.

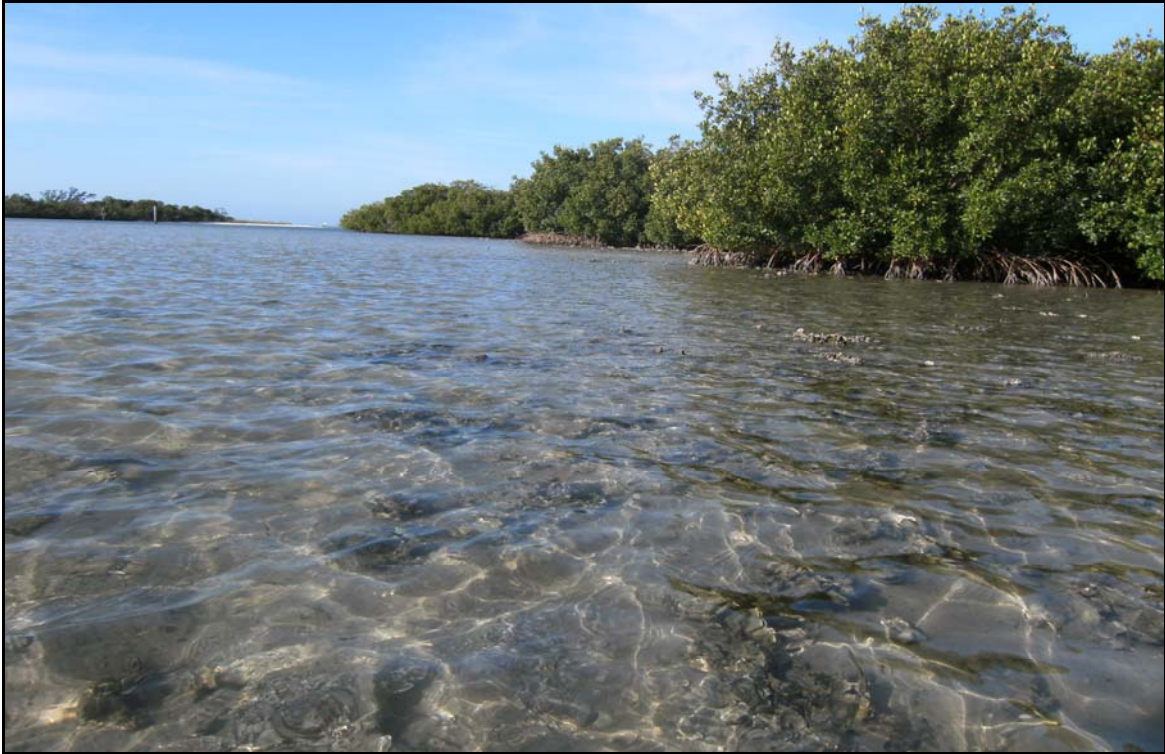
Photograph 5. Top-side view of Survey Area #3, showing persistent oyster beds throughout.

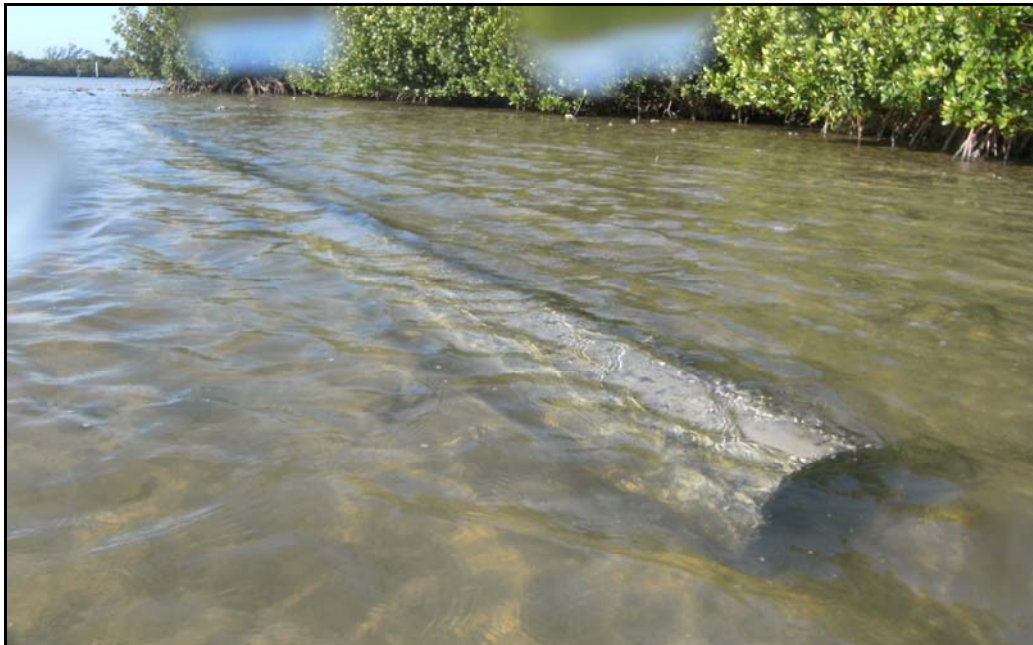
Photograph 6. Even though it is of an artificial nature, this submerged concrete pipe in Survey Area #3 was the only potential hardbottom substrate available for colonization.

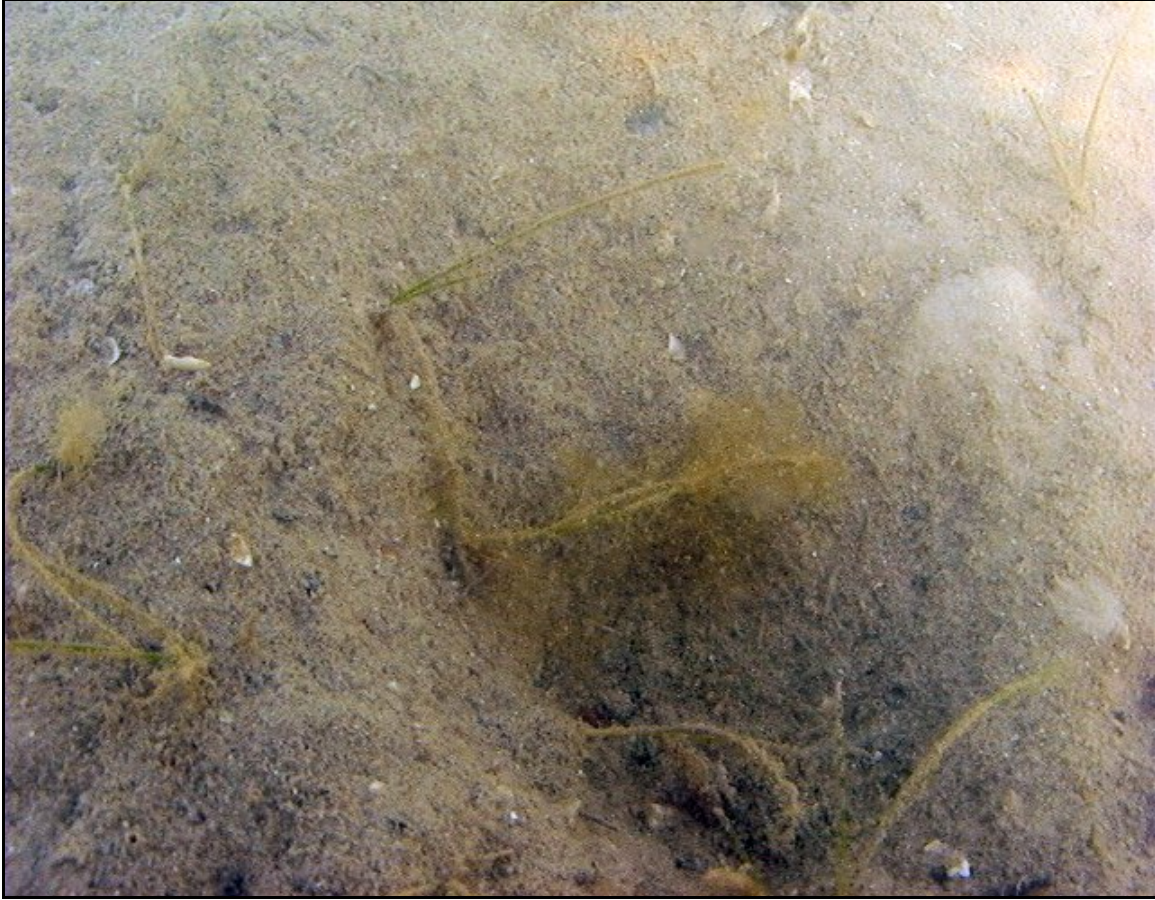
Photograph 7. The seagrass species documented, *Halodule wrightii* (shoal grass), was recorded in very sparse amounts with Survey Areas #6 & #7. A common species to the Gulf of Mexico, the thin, narrow blades of *H. wrightii* can reach a maximum length of six inches.

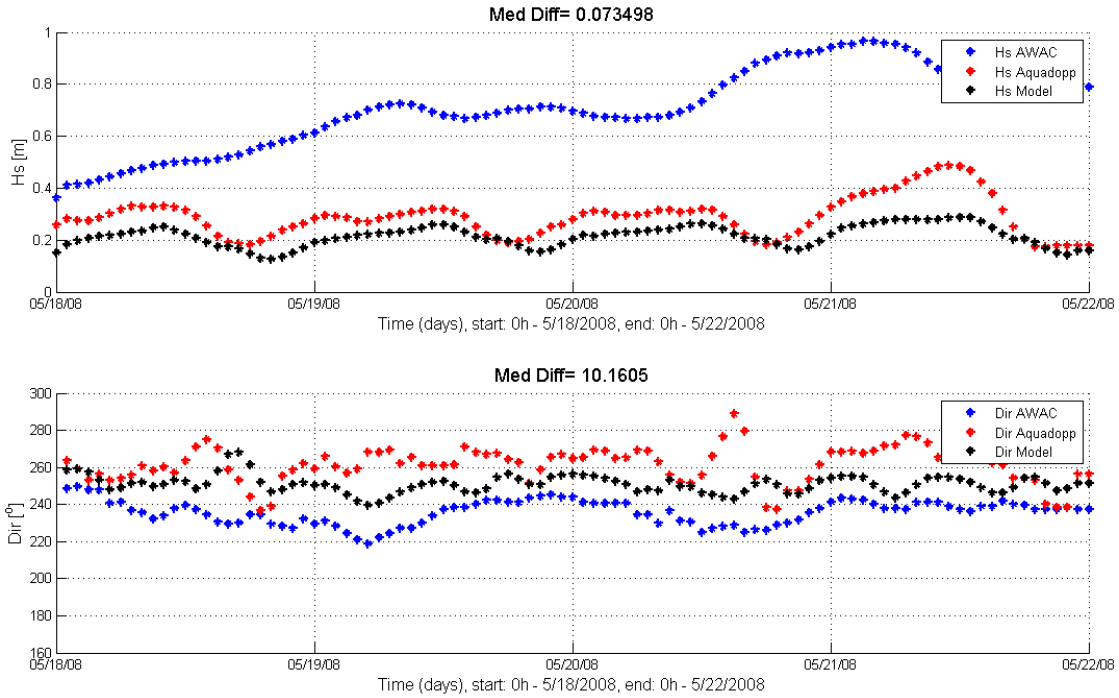
Figure A1 – Significant wave height (upper panel) and peak wave direction (lower panel) measured at AWAC, Aquadopp and simulated by the Delft3D model. Scenario with wave-current interaction and without wind-growth processes. Jonswap bottom friction coefficient = 0.067, depth-induced breaking alfa parameter = 1 and depth-induced breaking gamma parameter = 0.73. These are default model parameters.

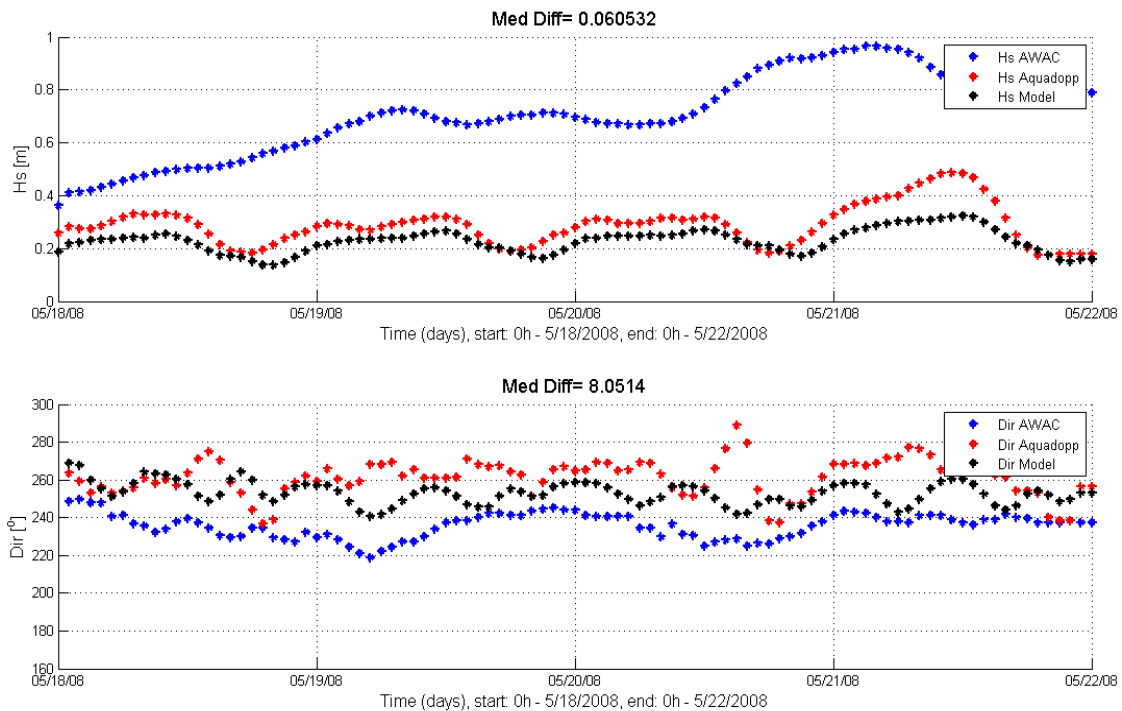
Figure A2 – Significant wave height (upper panel) and peak wave direction (lower panel) measured at AWAC, Aquadopp and simulated by the Delft3D model. Scenario with wave-current interaction and wind-growth processes activated. Jonswap bottom friction coefficient = 0.067, depth-induced breaking alfa parameter = 1 and depth-induced breaking gamma parameter = 0.73.

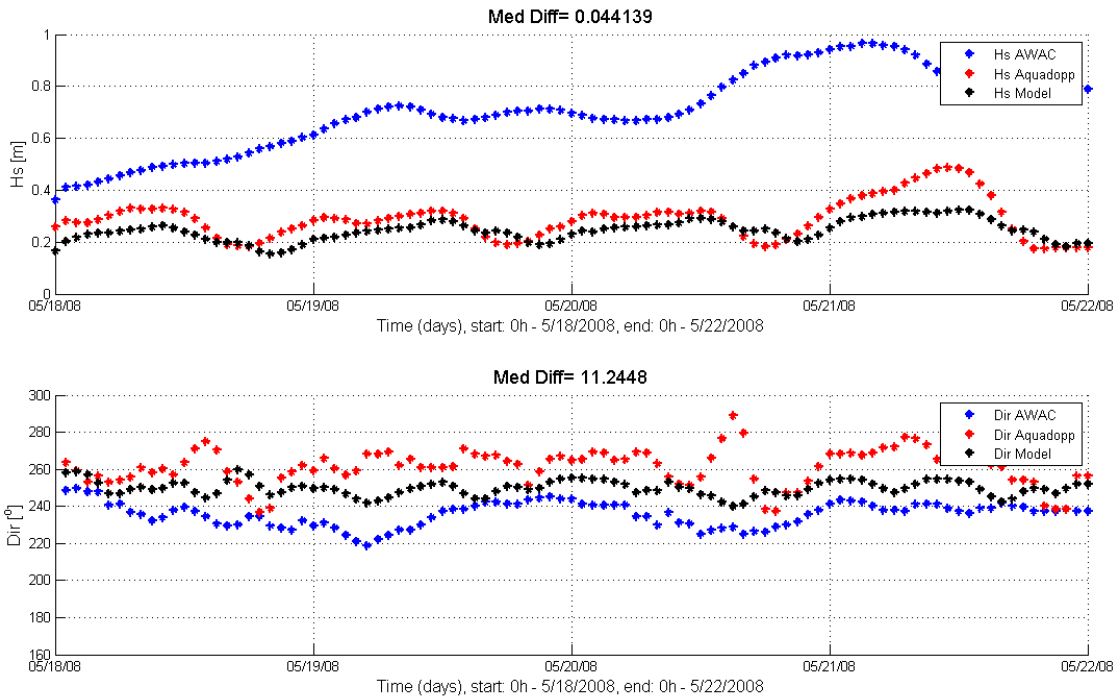
Figure A3 – Significant wave height (upper panel) and peak wave direction (lower panel) measured at AWAC, Aquadopp and simulated by the Delft3D model. Scenario with wave-current interaction and without wind-growth processes. Jonswap bottom friction coefficient = 0.0335, depth-induced breaking alfa parameter = 1 and depth-induced breaking gamma parameter = 0.73.

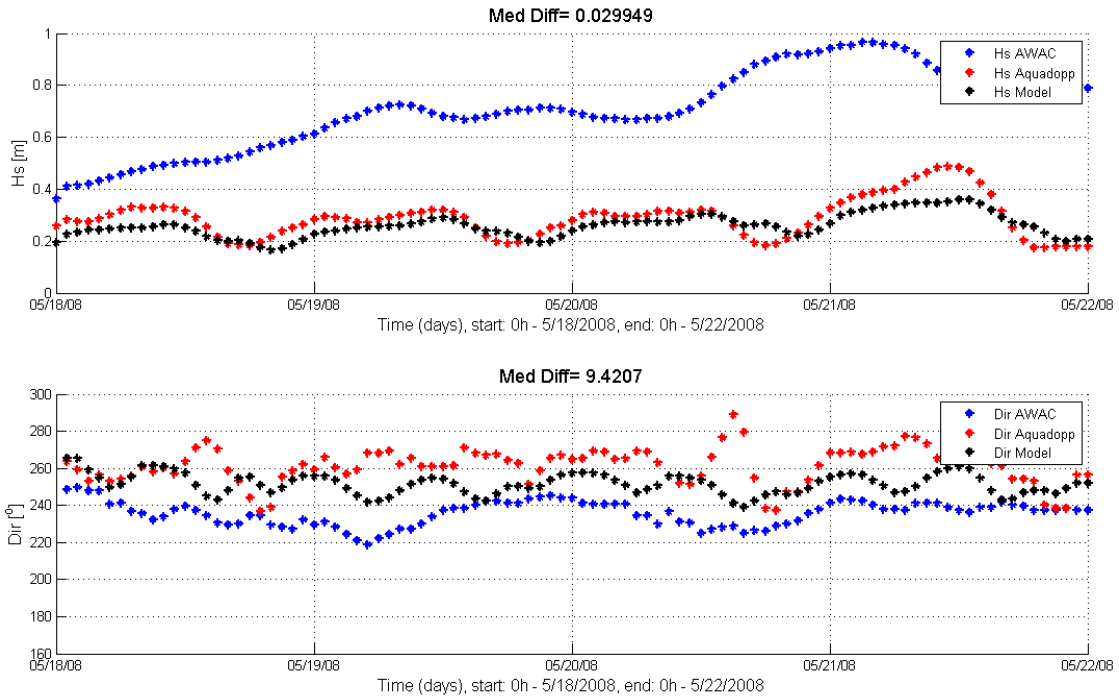
Figure A4 – Significant wave height (upper panel) and peak wave direction (lower panel) measured at AWAC, Aquadopp and simulated by the Delft3D model. Scenario with wave-current interaction and wind-growth processes activated. Jonswap bottom friction coefficient = 0.035, depth-induced breaking alfa parameter = 1 and depth-induced breaking gamma parameter = 0.73.
