**APPENDIX I**

**Wiggins Pass Resource Investigation Report**

**WIGGINS PASS, COLLIER COUNTY  
2008 RESOURCE INVESTIGATION REPORT**

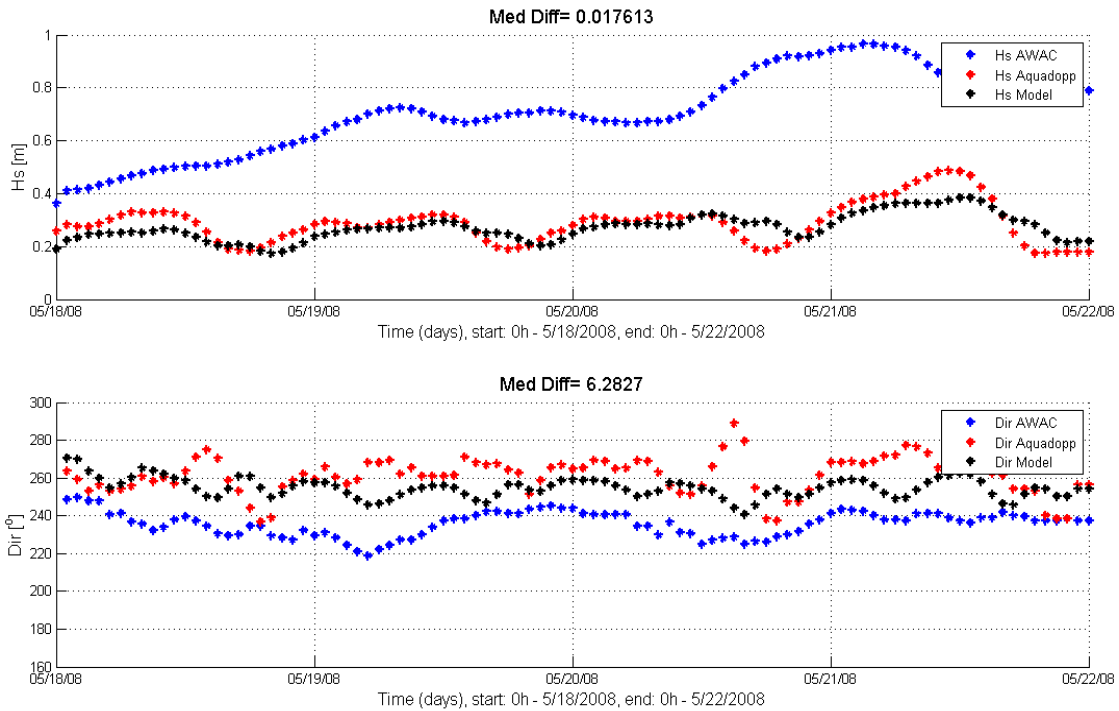
Figure A5 – Significant wave height (upper panel) and peak wave direction (lower panel) measured at AWAC, Aquadopp and simulated by the Delft3D model. Scenario with wave-current interaction and wind-growth processes activated. Jonswap bottom friction coefficient = 0.067, depth-induced breaking alfa parameter = 1 and depth-induced breaking gamma parameter = 1.

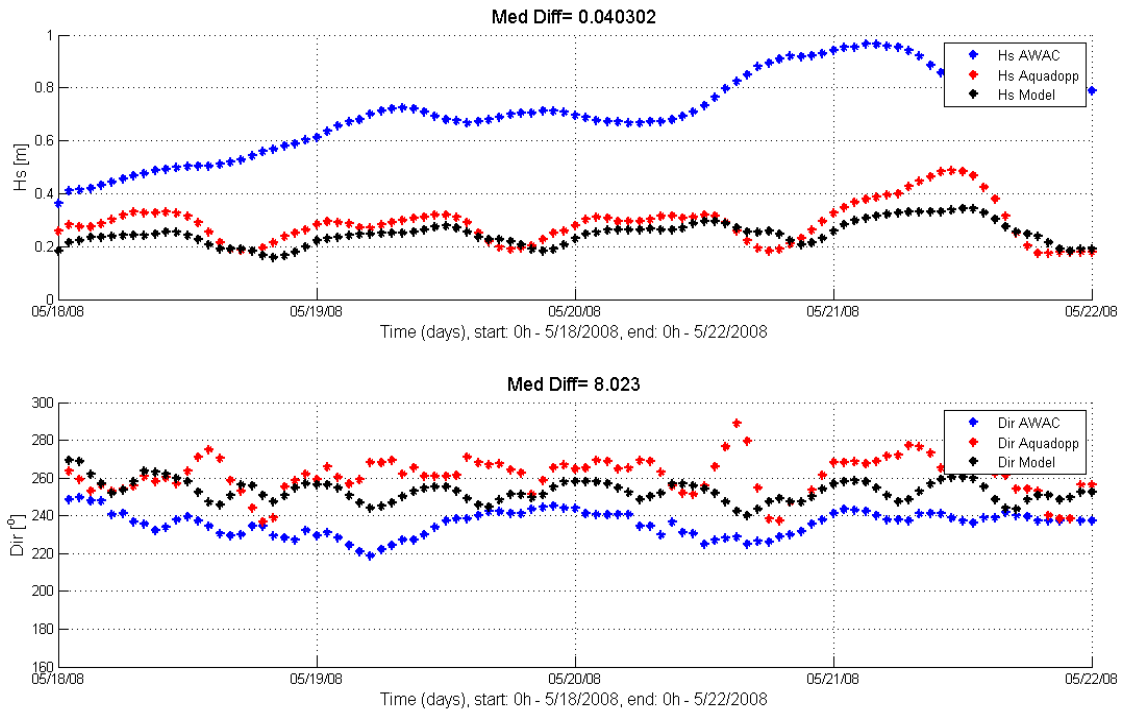
Figure A6 – Significant wave height (upper panel) and peak wave direction (lower panel) measured at AWAC, Aquadopp and simulated by the Delft3D model. Scenario with wave-current interaction and wind-growth processes activated. Jonswap bottom friction coefficient = 0.067, depth-induced breaking alfa parameter = 0.5 and depth-induced breaking gamma parameter = 0.73.

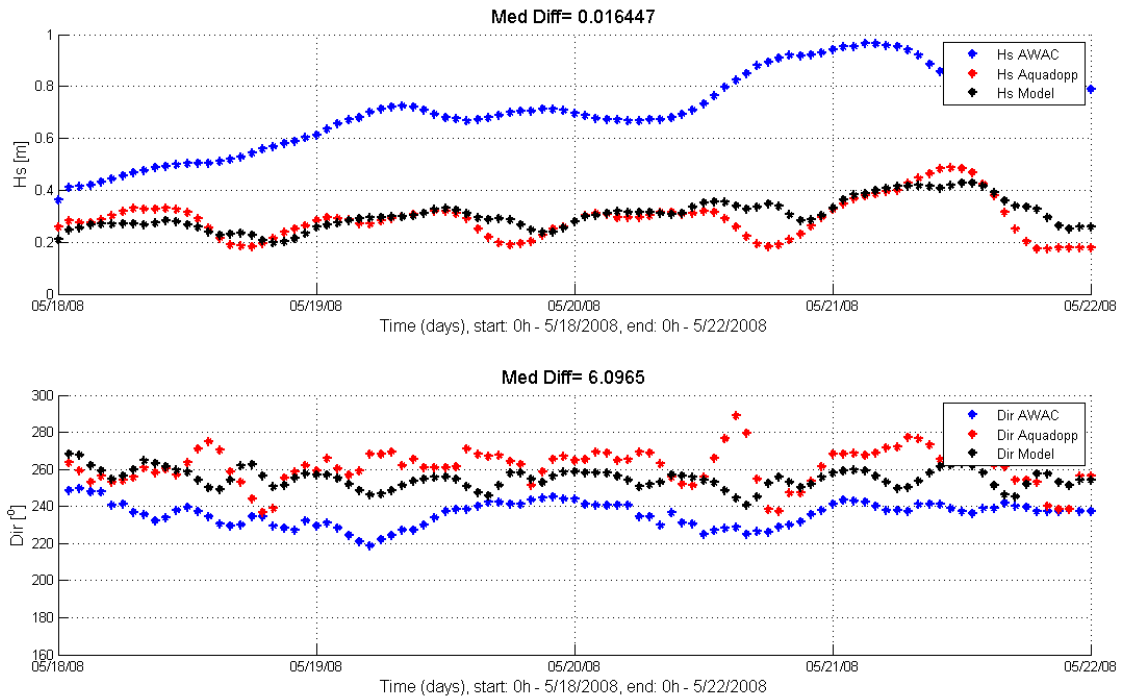
Figure A7 – Significant wave height (upper panel) and peak wave direction (lower panel) measured at AWAC, Aquadopp and simulated by the Delft3D model. Scenario with wave-current interaction and wind-growth processes activated. Jonswap bottom friction coefficient = 0.0335, depth-induced breaking alfa parameter = 0.5 and depth-induced breaking gamma parameter = 1.

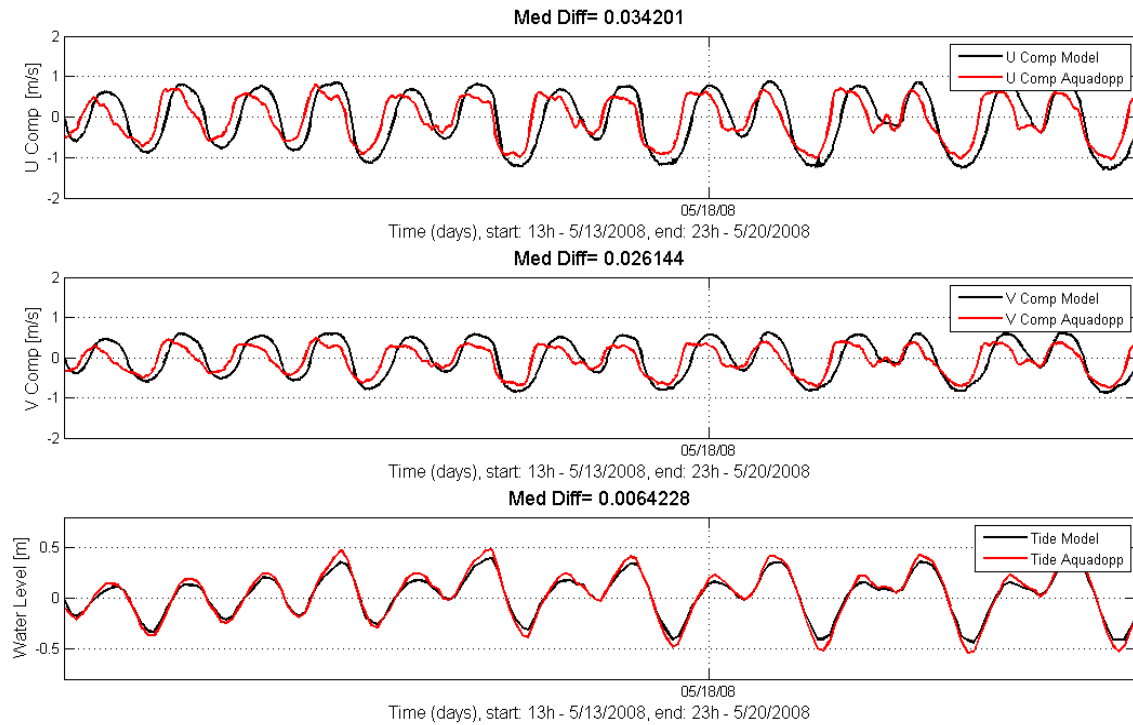
Figure A8 – Comparison between measured and simulated current U component, current V component and water level, Wiggins Pass, May 13 to May 23. Chezy =  $65 \text{ m}^{0.5} \text{ s}^{-1}$  (model default value).

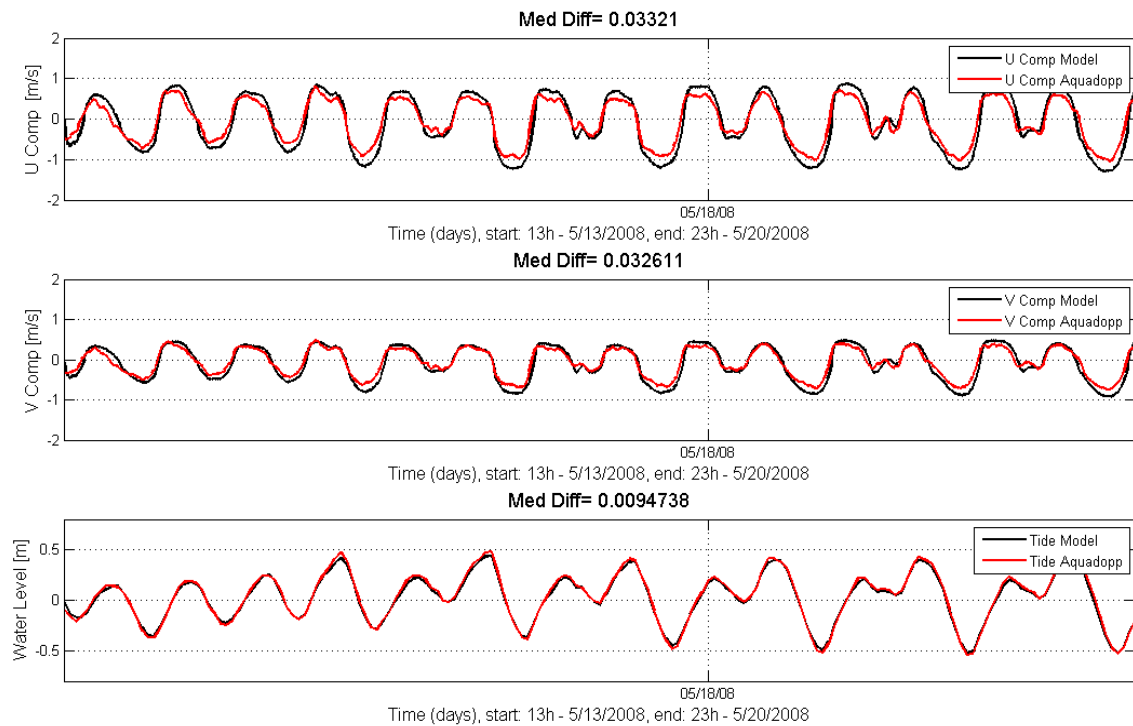
Figure A9 – Comparison between measured and simulated current U component, current V component and water level, Wiggins Pass, May 13 to May 23. Chezy =  $55 \text{ m}^{0.5} \text{ s}^{-1}$ .

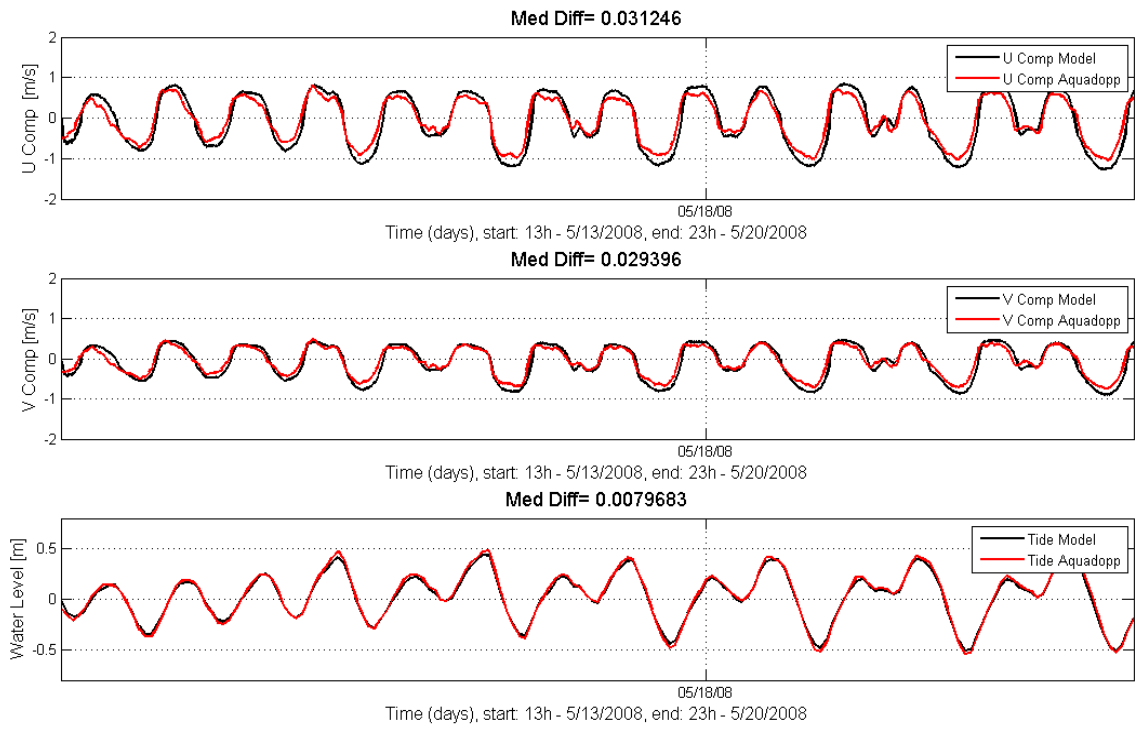
Figure A10– Comparison between measured and simulated current U component, current V component and water level, Wiggins Pass, May 13 to May 23. Chezy =  $50 \text{ m}^{0.5} \text{ s}^{-1}$ .

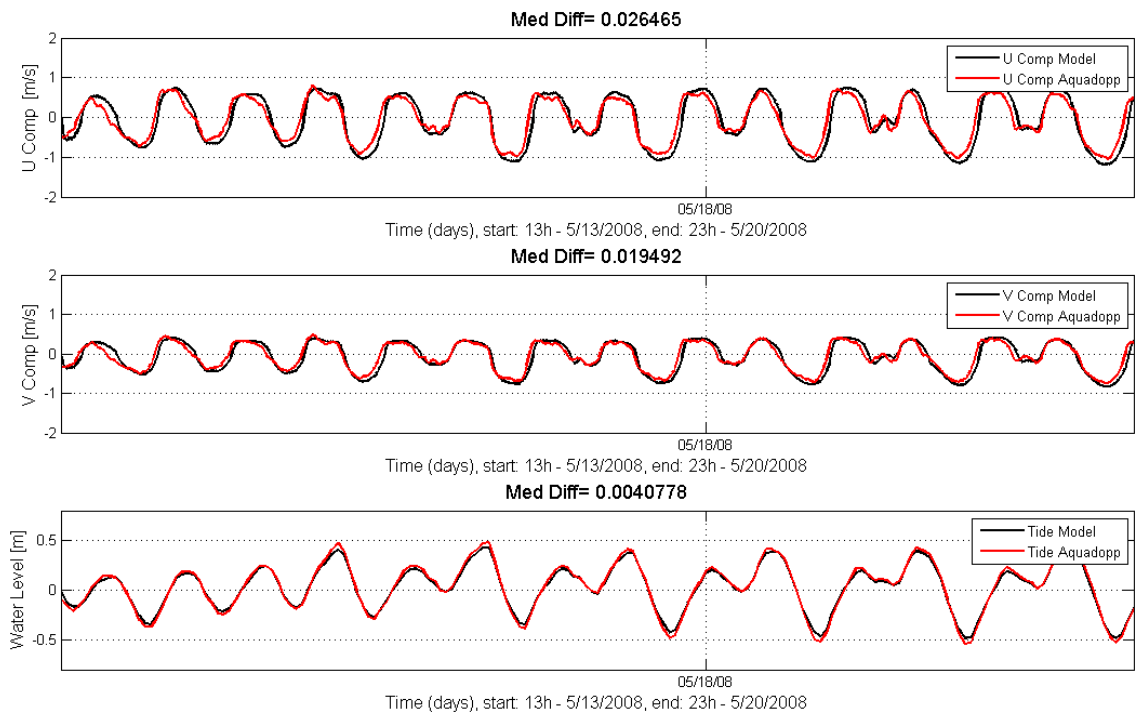
Figure 1 – Comparison between measured and simulated current U component, current V component and water level, Wiggins Pass, May 13 to May 23. Chezy =  $40 \text{ m}^{0.5} \text{ s}^{-1}$ .

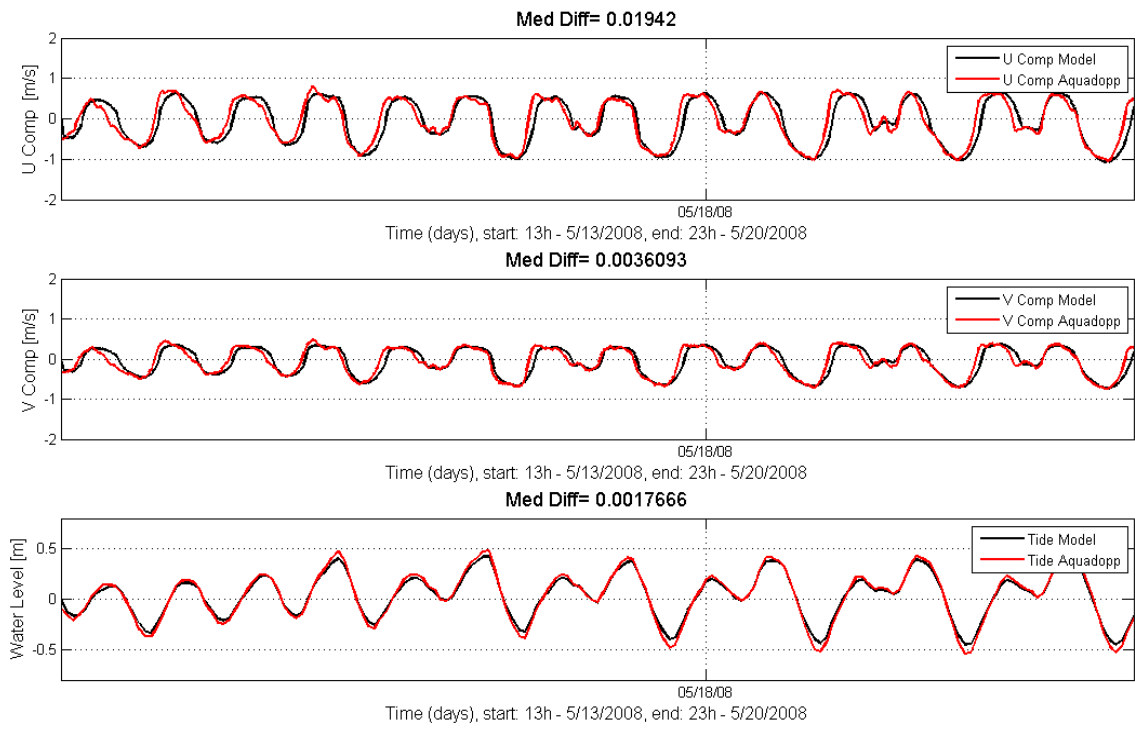
Figure 2 – Comparison between measured and simulated current U component, current V component and water level, Wiggins Pass, May 13 to May 23. Chezy =  $30 \text{ m}^{0.5} \text{ s}^{-1}$ .
