**DRAFT**  
**WIGGINS PASS, COLLIER COUNTY, FL**  
**NUMERICAL MODELING OF WAVE PROPAGATION,**  
**CURRENTS AND MORPHOLOGY CHANGES**  
**PHASE II: NUMERICAL MODELING**  
**OF ALTERNATIVES REPORT**

**COLLIER COUNTY**  
**WIGGINS PASS MODELING EVALUATION WORKING GROUP**  
**AND**  
**COASTAL ZONE MANAGEMENT DEPARTMENT**

**COASTAL PLANNING & ENGINEERING, INC.**

**JANUARY 2009**

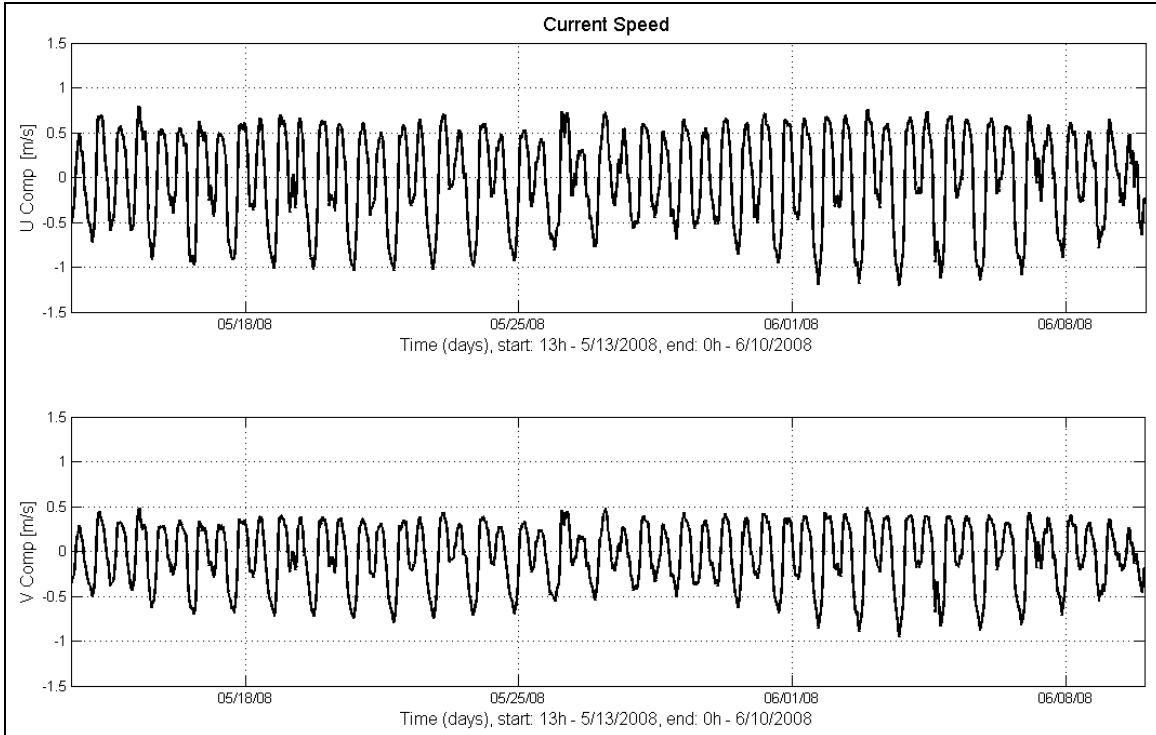
Figure 9. Measured tidal currents, depth averaged. U velocities indicate east-west currents and V velocities indicate north-south currents.

Measured currents are shown in Figures 9 and 10. Due to the orientation of Wiggins Pass both u and v components (east-west and north-south components) have significant speeds (Figure 9). The vectorial sum of these components indicates that ebb currents reach up to 1.5 m/s (4.92 ft/s) during flood tide. This velocity is significantly above the 1 m/s threshold, which is referred to as the “equilibrium velocity” for tidal inlets. Normally, an inlet throat with such strong currents would either scour deeper, or become wider; however, this is not observed at Wiggins Pass possibly due to obstructions to scouring such as a consolidated bed or very coarse sediments.

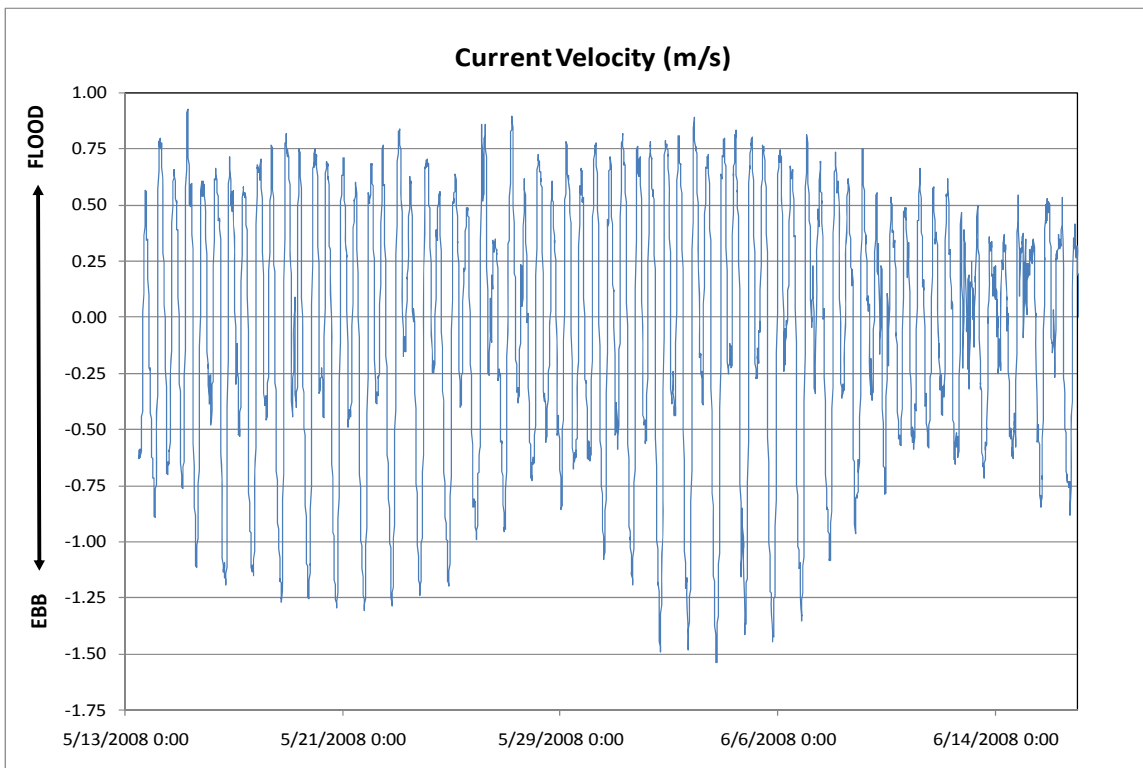
Figure 10. Measured tidal currents, depth averaged. Ebb velocities reach 1.5 m/s (4.9 m/s) during spring tide.

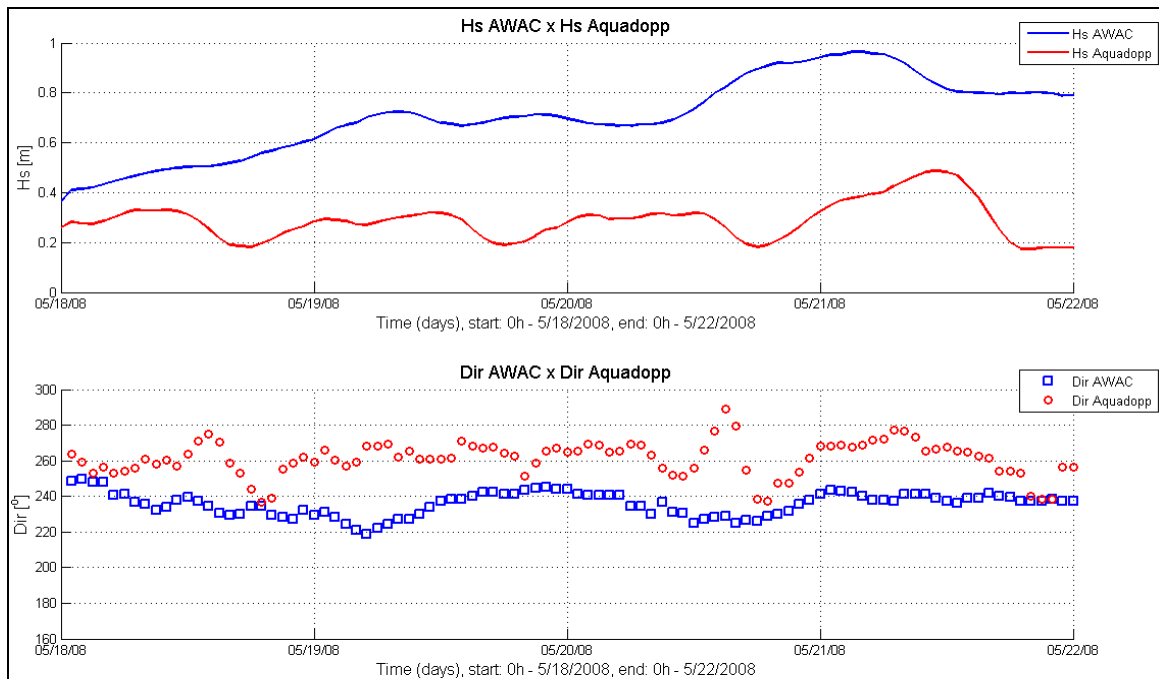
Figure 12. Wave height (above) and direction (below) measurements.

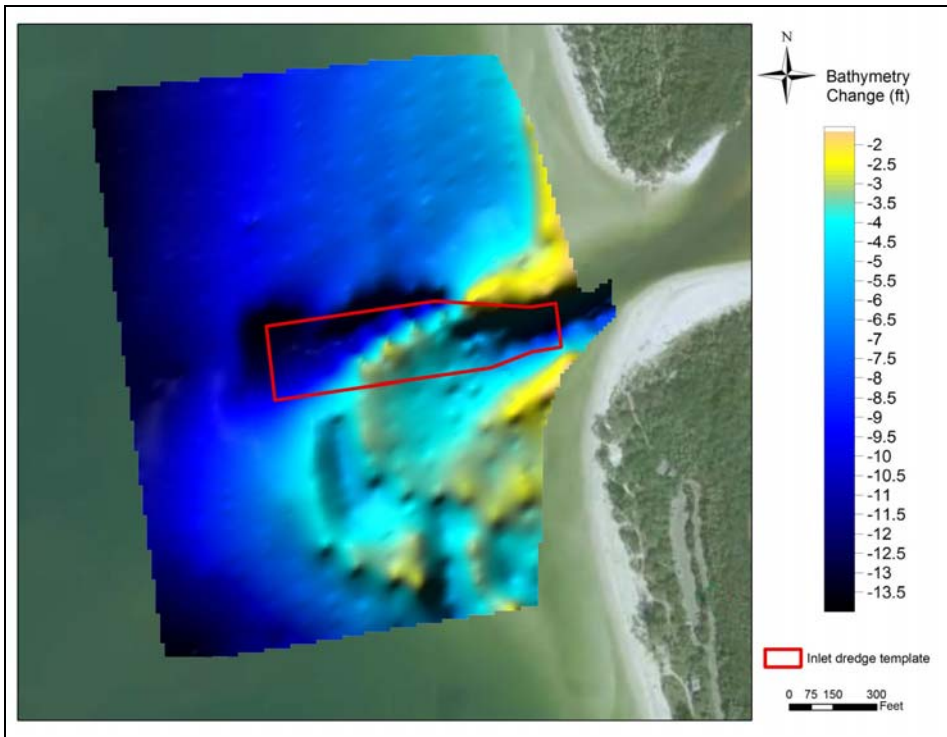
Figure 14. Three-dimensional surface plot of the bathymetric survey conducted by CPE (2008). The elevations are referenced to the datum NAVD88, in feet.

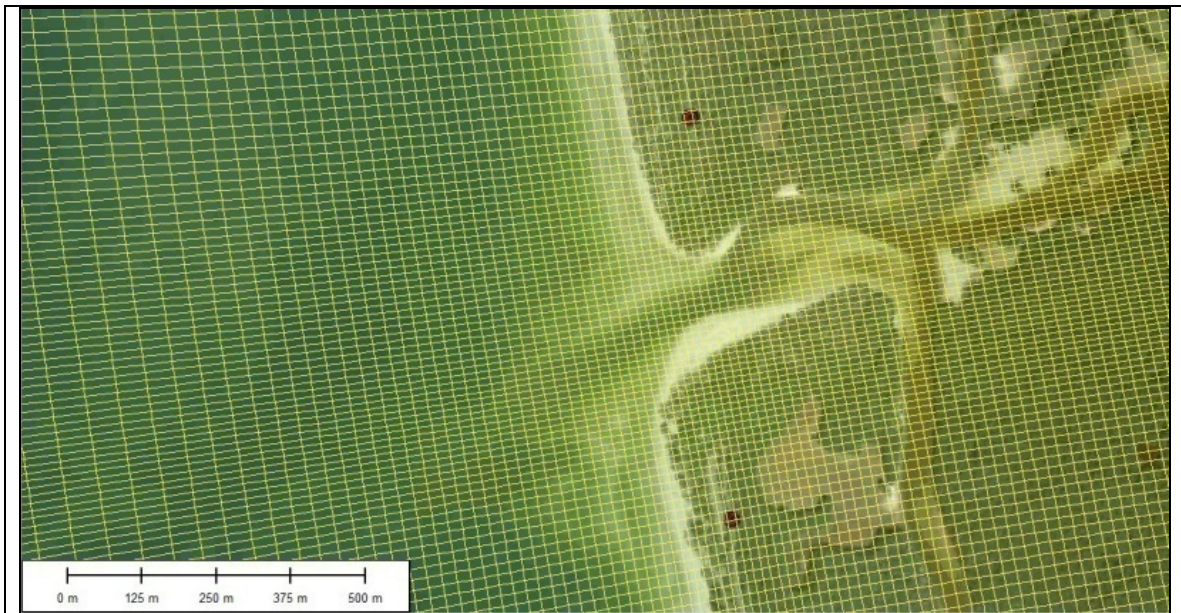
Figure 19. Detailed views of the hydrodynamic and morphology grid at Wiggins Pass.

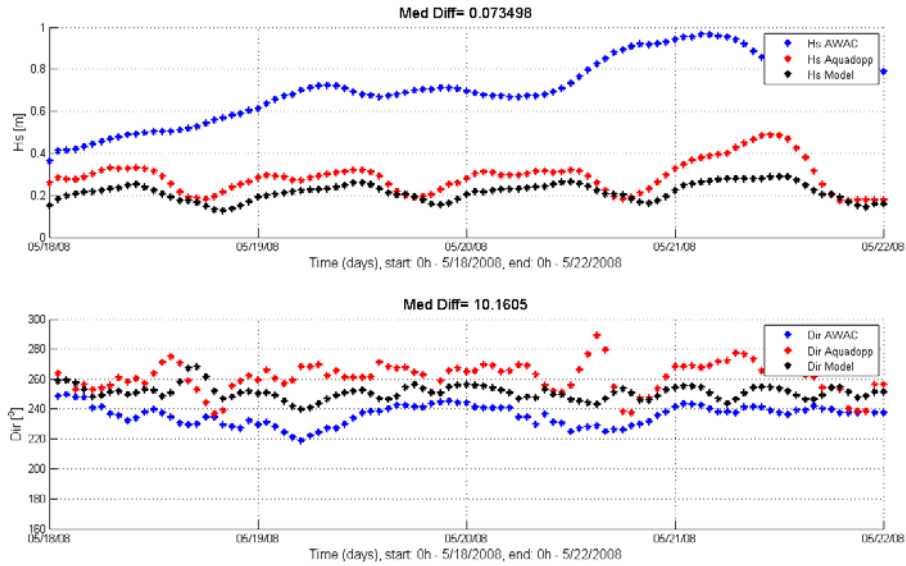
Figure 23 – Significant wave height (upper panel) and peak wave direction (lower panel) measured at AWAC, Aquadopp and simulated by the Delft3D model. Scenario with wave-current interaction and without wind-growth processes. Jonswap bottom friction coefficient = 0.067, depth-induced breaking alpha parameter = 1 and depth-induced breaking gamma parameter = 0.73. These are default model parameters.

Results from two calibration simulations (initial and final) are shown in Figures 23 and 24. Additional results are shown in Appendix III. Improvement in the correlation between data and model were observed when the wind growth and wave-current interaction

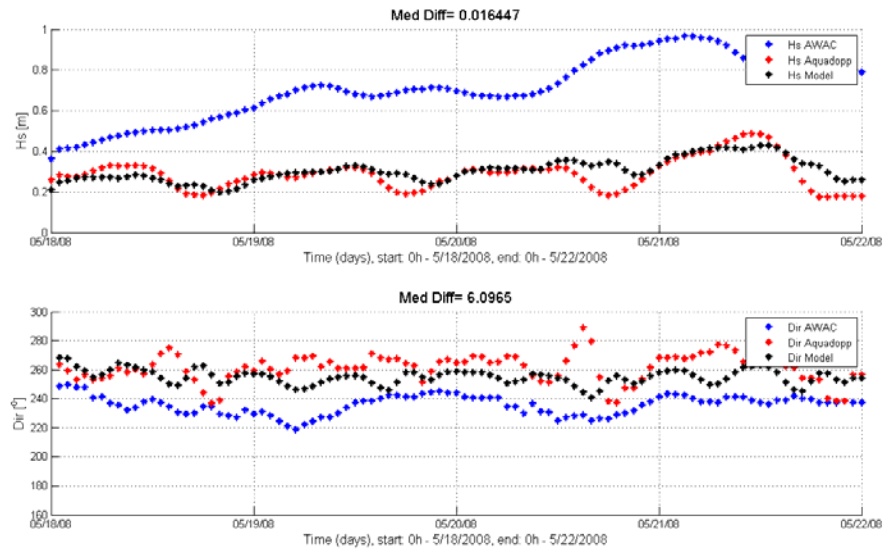
Figure 24 – Significant wave height (upper panel) and peak wave direction (lower panel) measured at AWAC, Aquadopp and simulated by the Delft3D model. Final calibration run with wave-current interaction and wind-growth processes activated. Jonswap bottom friction coefficient = 0.0335, depth-induced breaking alpha parameter = 0.5 and depth-induced breaking gamma parameter = 1.

processes were included in the simulation. The Jonswap bottom friction coefficient was lowered from 0.067 to 0.0335, and the depth induced breaking alpha parameter was reduced from 1 to 0.5. Due to steep slopes and shallow water depths across the ebb shoal, the waves were breaking and dissipating all energy with an alpha parameter of 1. Modification of the alpha parameter to 0.5 allowed for some wave energy to penetrate into the inlet and resulted in better agreement between the measurements and model (Figure 24).

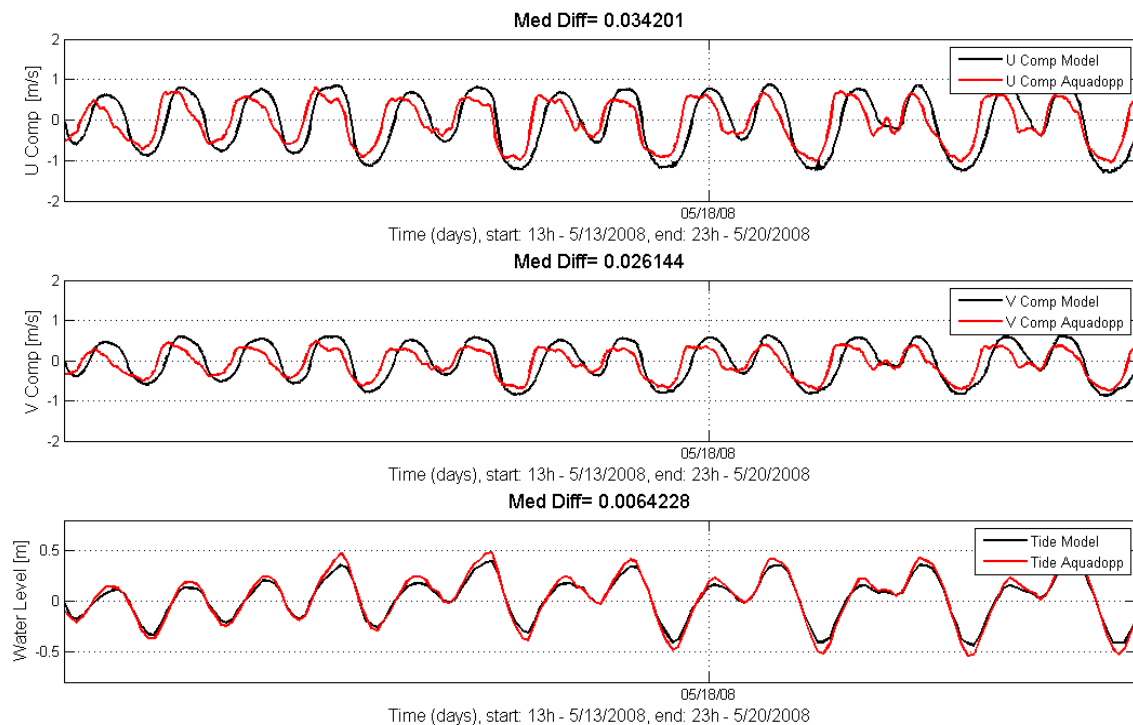
Figure 25 – Comparison between measured and simulated current U component, current V component and water level, Wiggins Pass, May 13 to May 23. Chezy =  $65 \text{ m}^{0.5}\text{s}^{-1}$  (model default value).

The default value of  $65 \text{ m}^{0.5}\text{s}^{-1}$  provided a reasonable agreement between measured and predicted water levels, but a relative difference in magnitude and phase between measured and predicted U and V current components was observed (Figure 25). Modification of Chezy coefficients were evaluated in a series of calibration runs in Appendix II. Reasonable results were observed for all values of Chezy coefficients tested. The smallest difference between measurements and model were obtained with a Chezy value of  $30 \text{ m}^{0.5}\text{s}^{-1}$ , but Chezy values of  $40 \text{ m}^{0.5}\text{s}^{-1}$  (Figure 26) and  $55 \text{ m}^{0.5}\text{s}^{-1}$  also produced acceptable results (see Appendix III). Appendix III and Figures 25 and 26 indicate that the best results between measured and modeled currents were achieved when bottom roughness was increased. This is probably due to the presence of very coarse sediments with shell fragments in the bed.

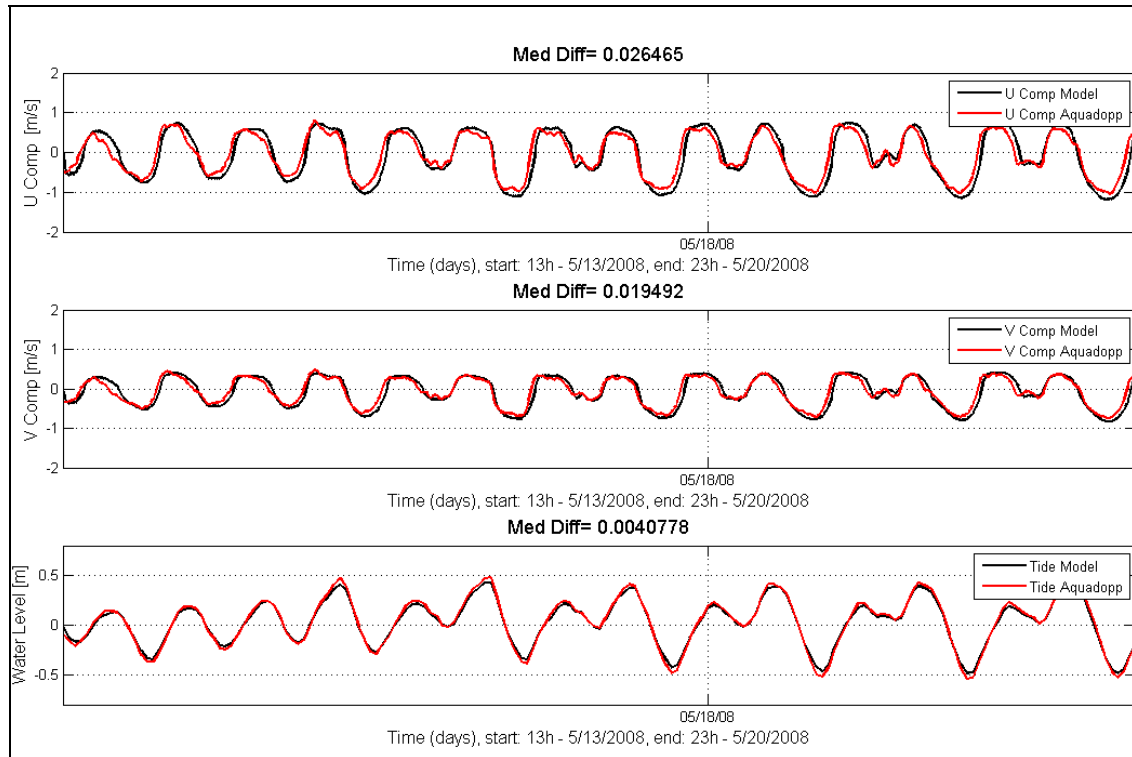
Figure 26 – Comparison between measured and simulated current U component, current V component and water level, Wiggins Pass, May 13 to May 23. Chezy =  $40 \text{ m}^{0.5} \text{ s}^{-1}$ .

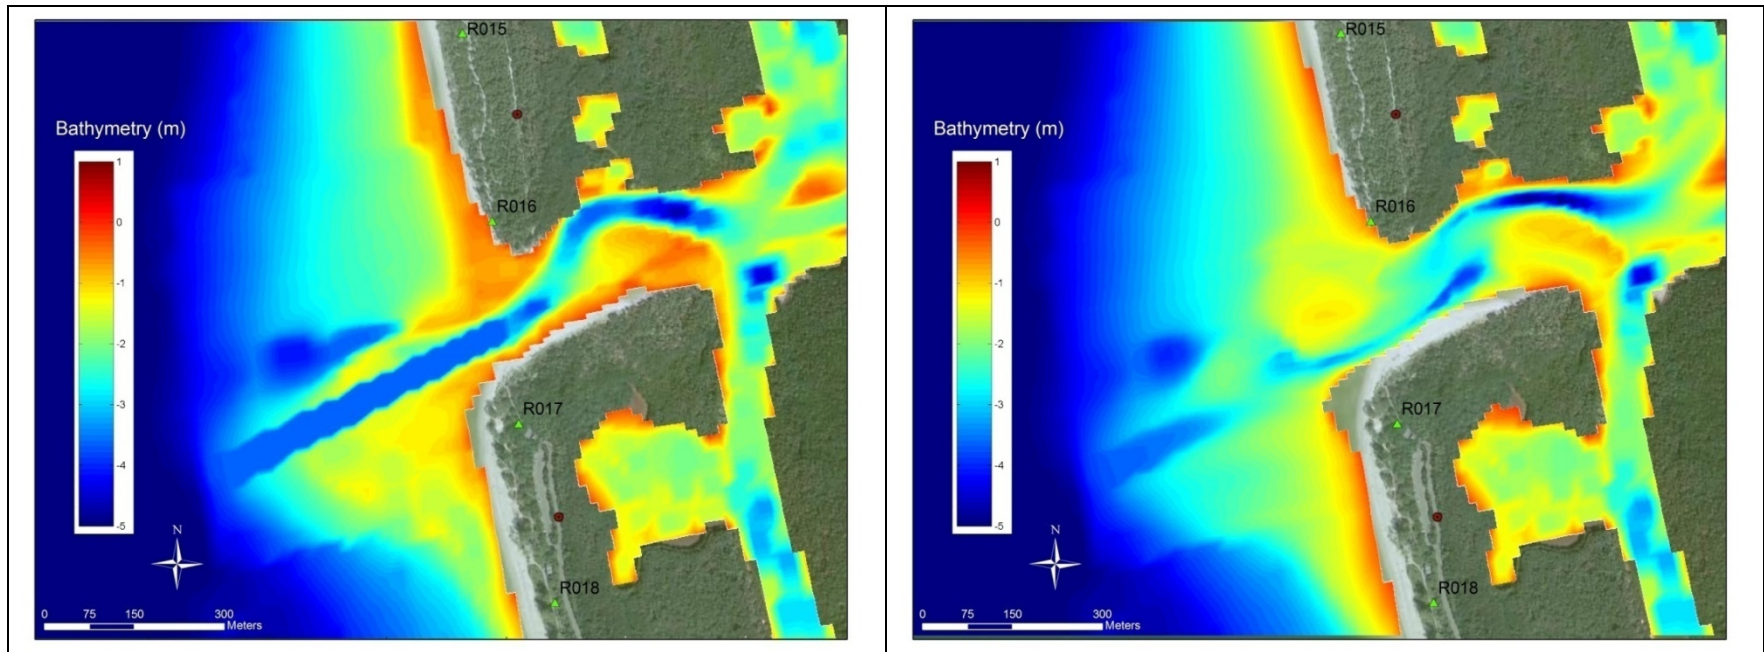
Figure 44. Initial bathymetry (left) and bathymetry simulated after 1 year (right) Alternative 4.

- 2.14 m MSL (7.7 ft NAVD or 6 ft MLW according to USACE recommendations) deep (Figure 43).
- Alternative 4: Gulf channel re-aligned to the southwest with 46 m (150 ft) wide and 3.7 m MSL (12.6 ft NAVD or 11 ft MLW) deep (Figure 44).

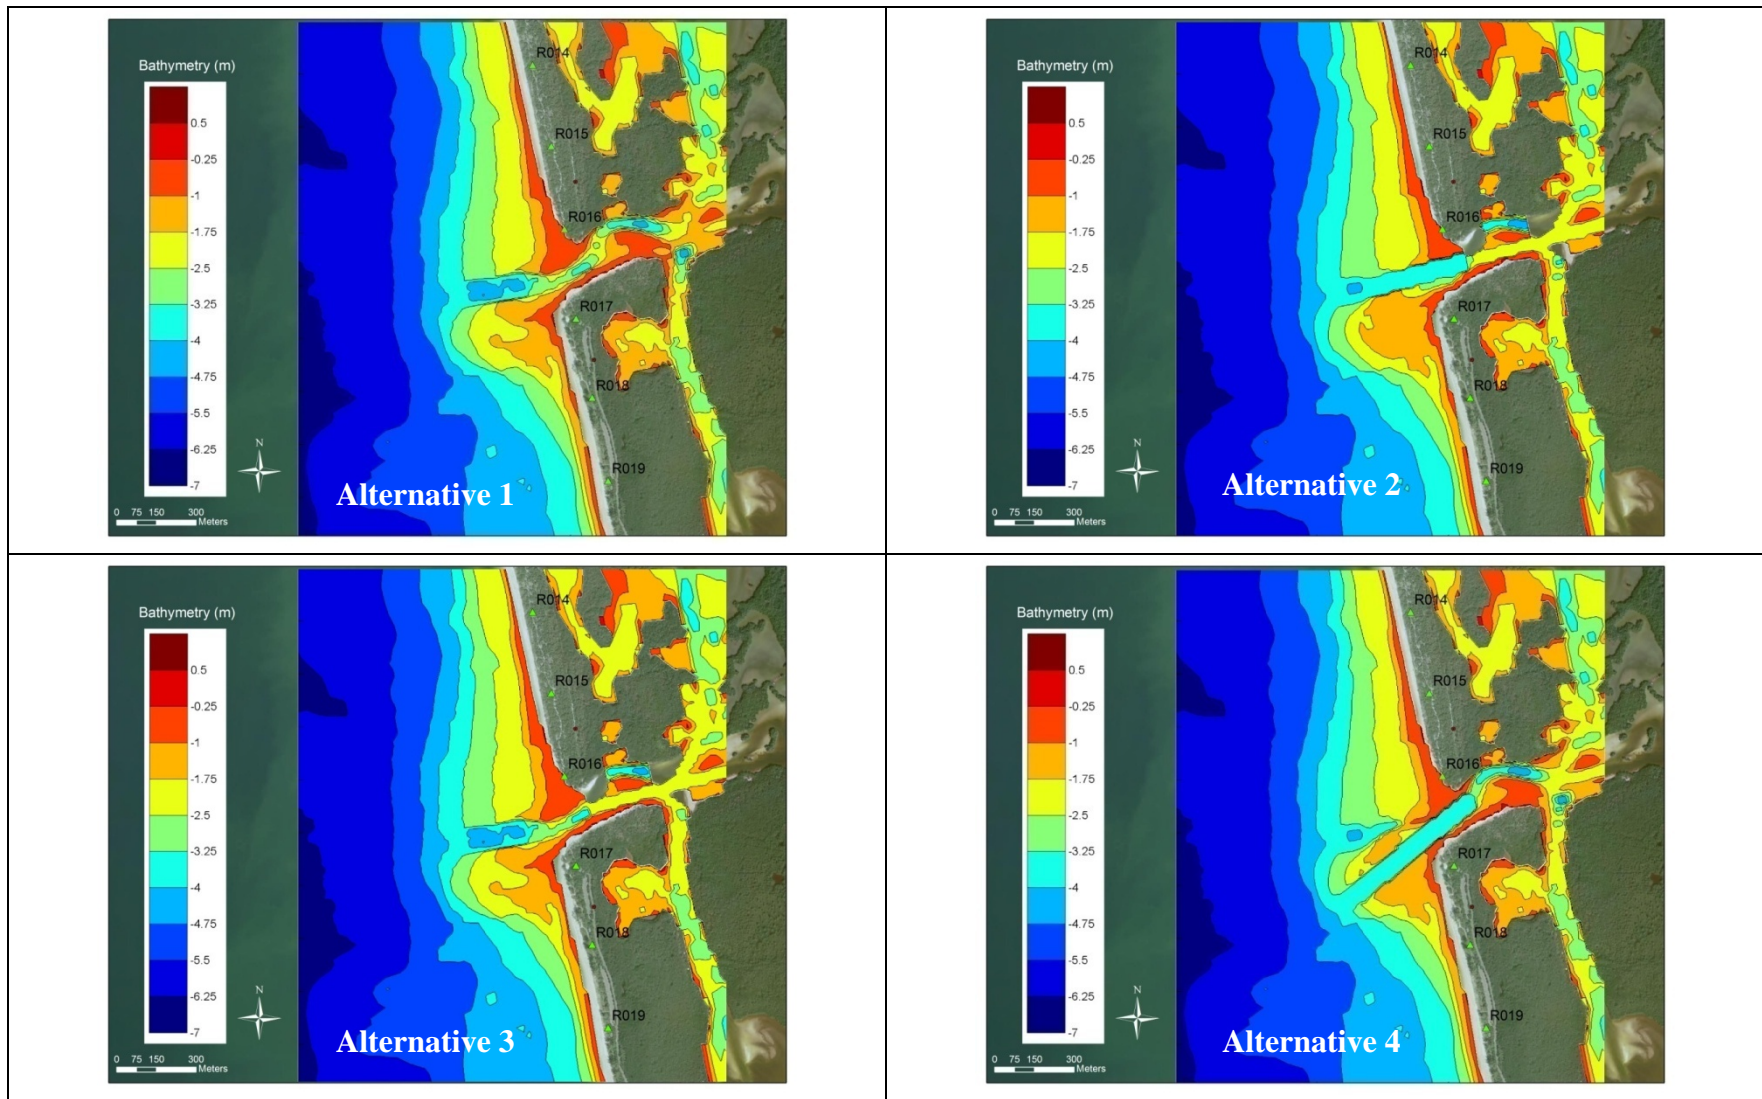
Figure 51. Four alternatives simulated for the third modeling reviewing committee meeting.

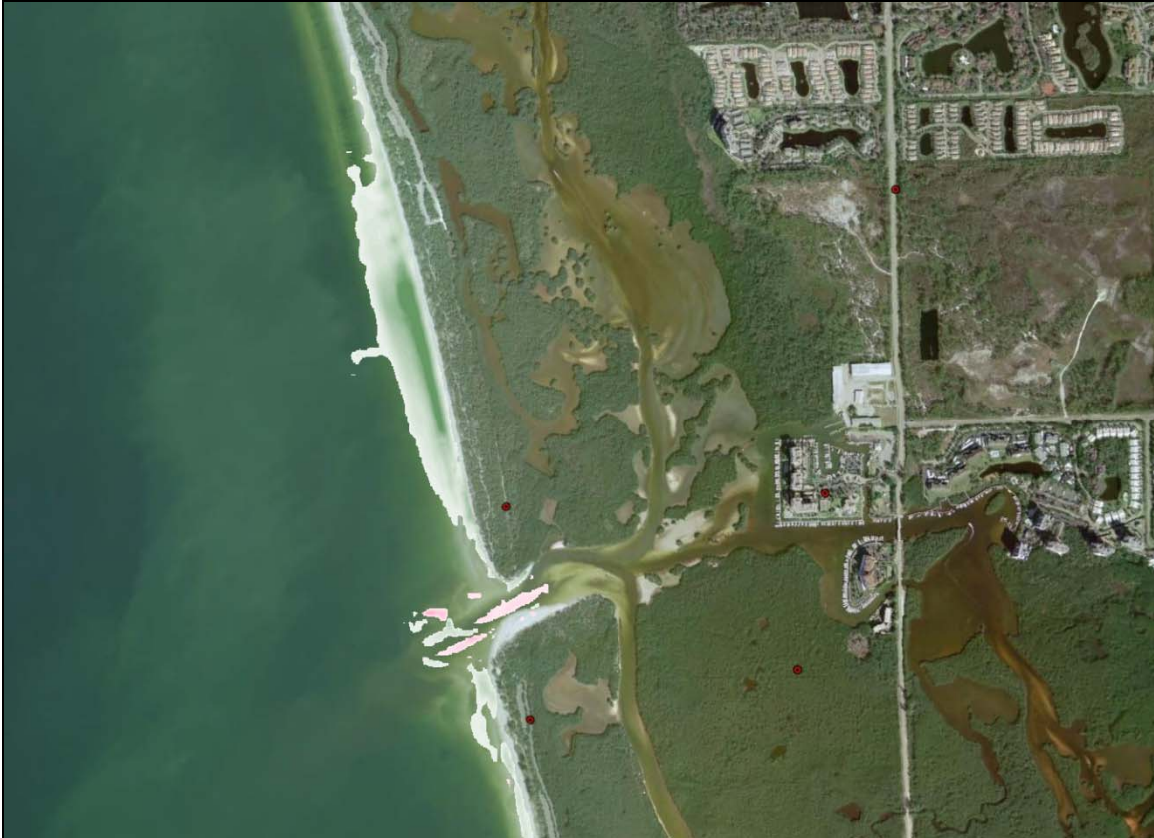
Figure 61. Relative bathymetry changes for the one-year simulation of Alternative 1, with the beach fill, in relation to the one-year simulation of Alternative 1, without the beach fill.

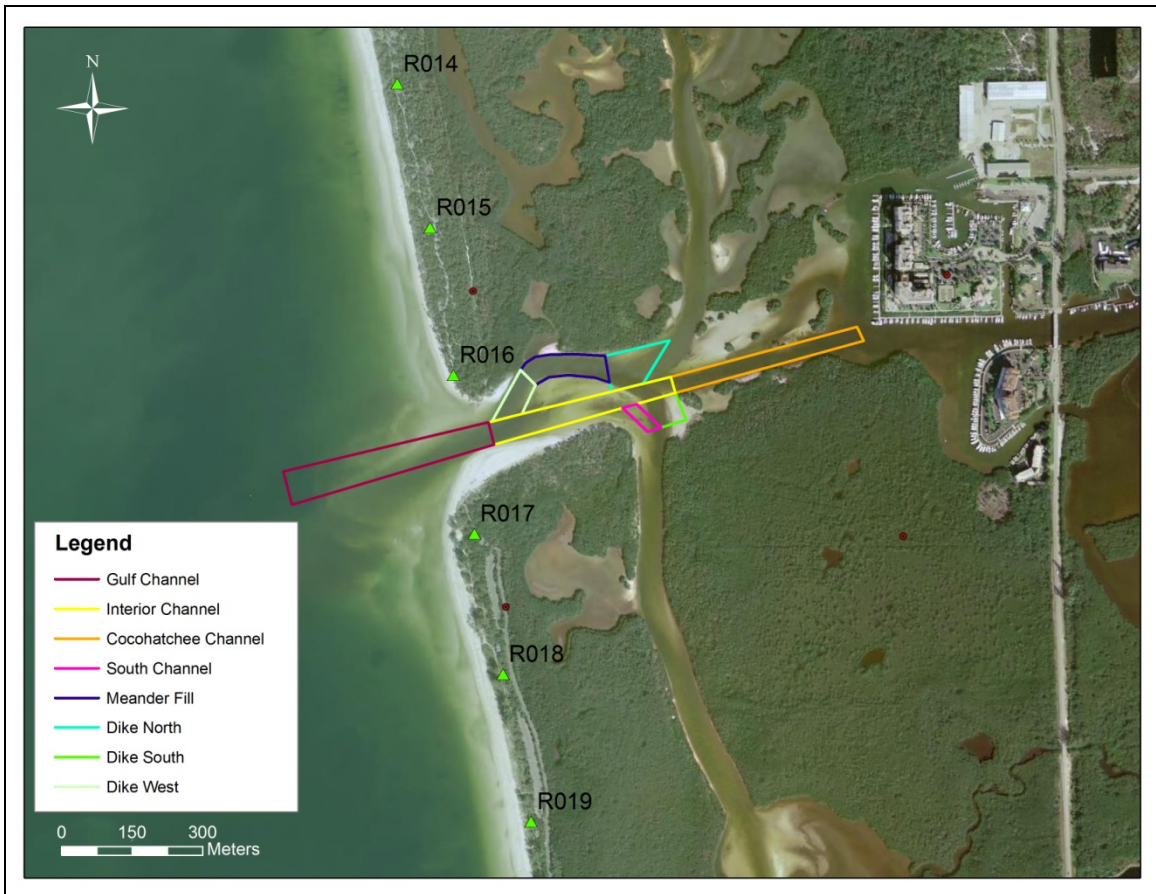
Figure 63. Components of the final alternative overlaying an aerial photograph of Wiggins Pass.
