Vanderbilt Drive Bicycle and Pedestrian Safety Improvement Study

Prepared for:
**The Collier County
Transportation Planning Department**

Prepared by:
**Stantec Consulting Services Incorporated
3200 Bailey Lane
Suite 200
Naples, Florida 34105**

December 2013

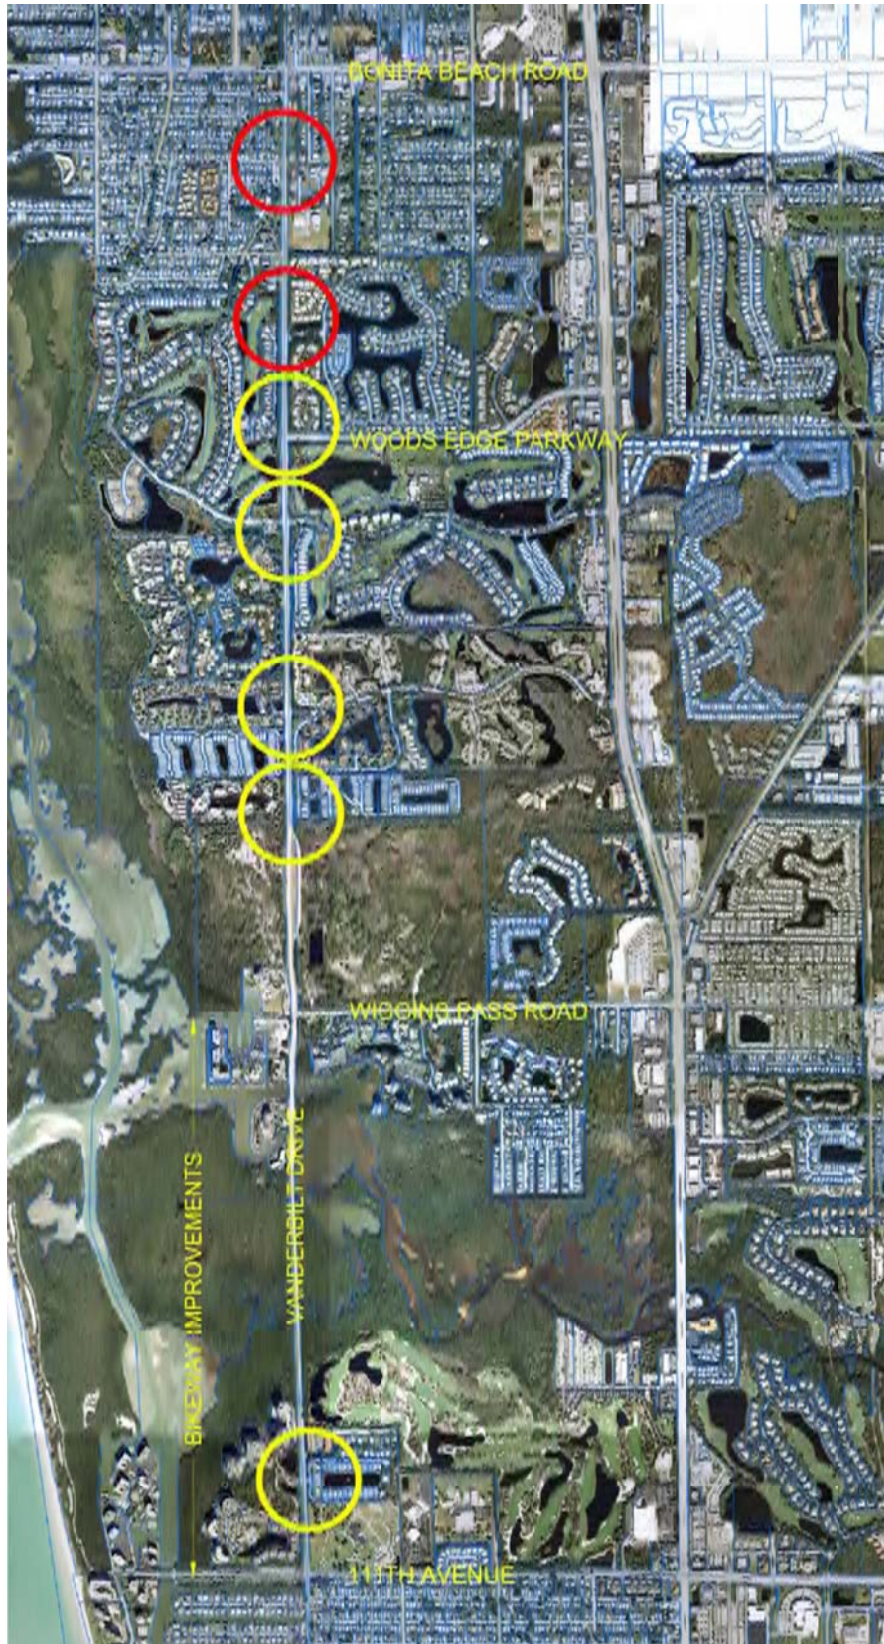
Figure 1: Study Area

The Study Area is comprised of the Vanderbilt Drive roadway corridor which extends from Bonita Beach Road on the north to 111th Avenue North/Bluebill Avenue on the south. Vanderbilt Drive is intersected by Woods Edge Parkway and Wiggins Pass Road. See **Figure 1**.

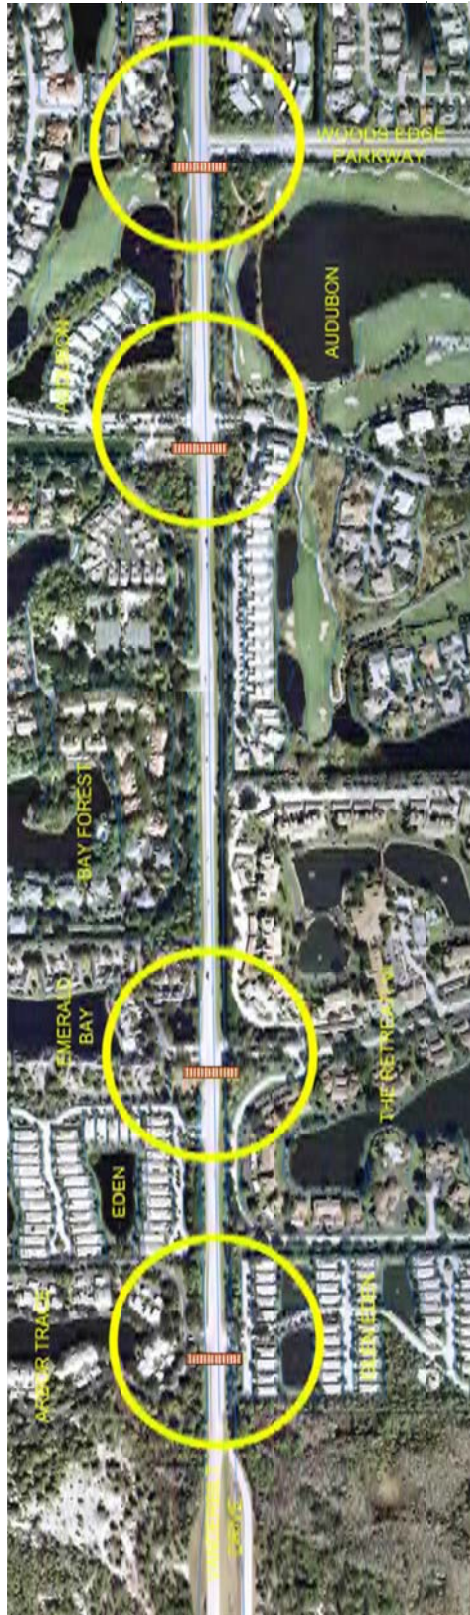
Figure 2: North Crosswalk Locations - Option 1

The locations, shown in **Figure 2**, included:

- Woods Edge Parkway Intersection
- Audubon/Audubon
- Emerald Bay/The Retreat
- Arbor Trace/Glen Eden

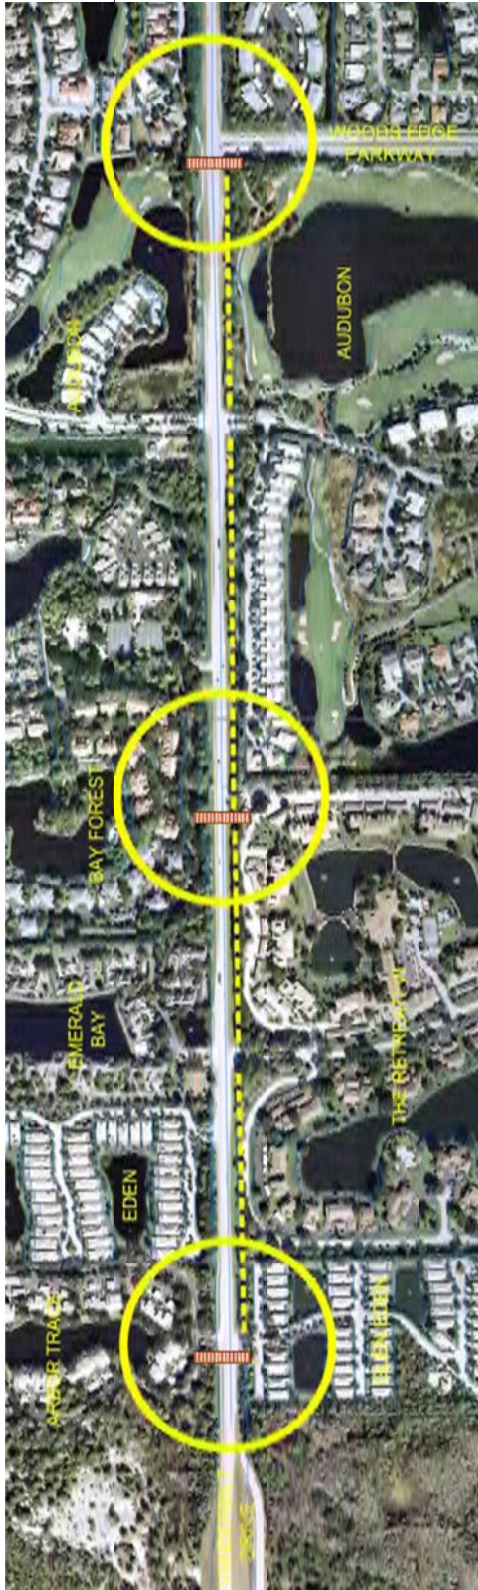
FIGURE 3: North Crosswalk Locations – Option 2

- The single “mid-block” crossing affords the shortest distance for pedestrian’s to cross, and there are no other conflicting movements for pedestrians or motorists to deal with at that location.

- Mid-block location might allow sufficient space for a pedestrian refuge area (in between the travel lanes) without having to add additional pavement to one or more of the outside roadway edges, by narrowing the travel lanes. This would encourage motorists to reduce speed through the crosswalk area.

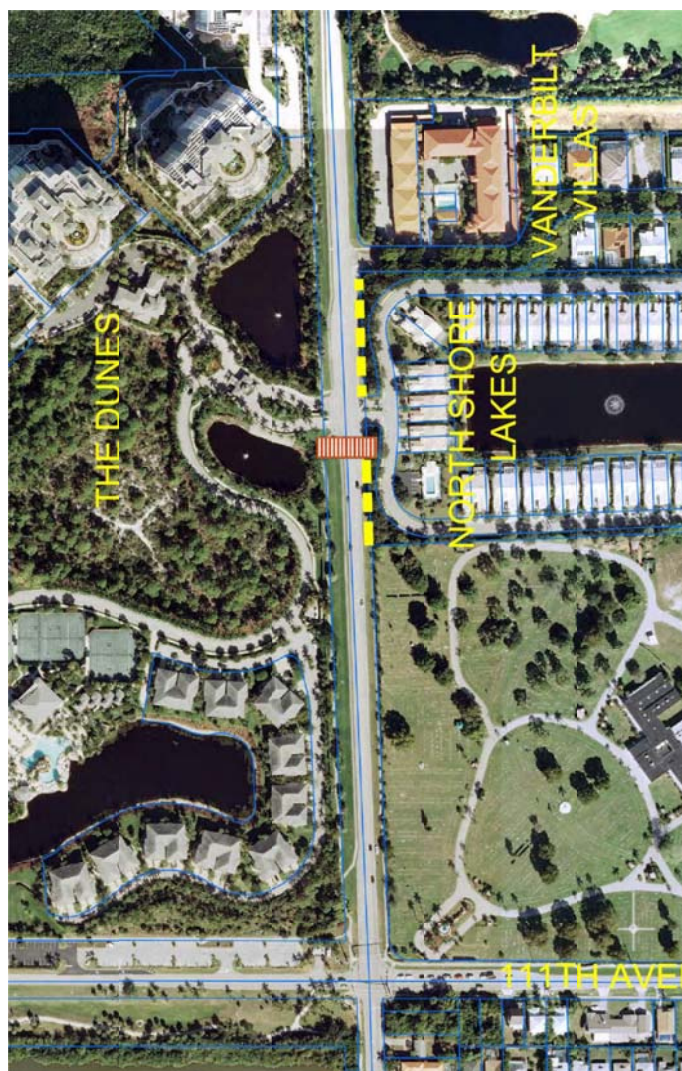
FIGURE 4: South Crosswalk Locations Option 1

As in all cases, a connecting sidewalk from the crosswalk/sidewalk into each development would be required. The County would construct interconnecting sidewalks within the right-of-way, while the adjacent developments would be responsible for the interconnection from the edge of right-of-way to the internal sidewalk/roadway system.

Additionally, it would be appropriate to consider extending the sidewalk a distance of approximately 365 feet south of the North Shore Lakes crosswalk to the northern terminus of the existing sidewalk on the east side of Vanderbilt Drive fronting the Naples memorial Gardens. Although not absolutely necessary, extending the sidewalk would provide safe and convenient access to facilities to the south without having to cross Vanderbilt Drive first.

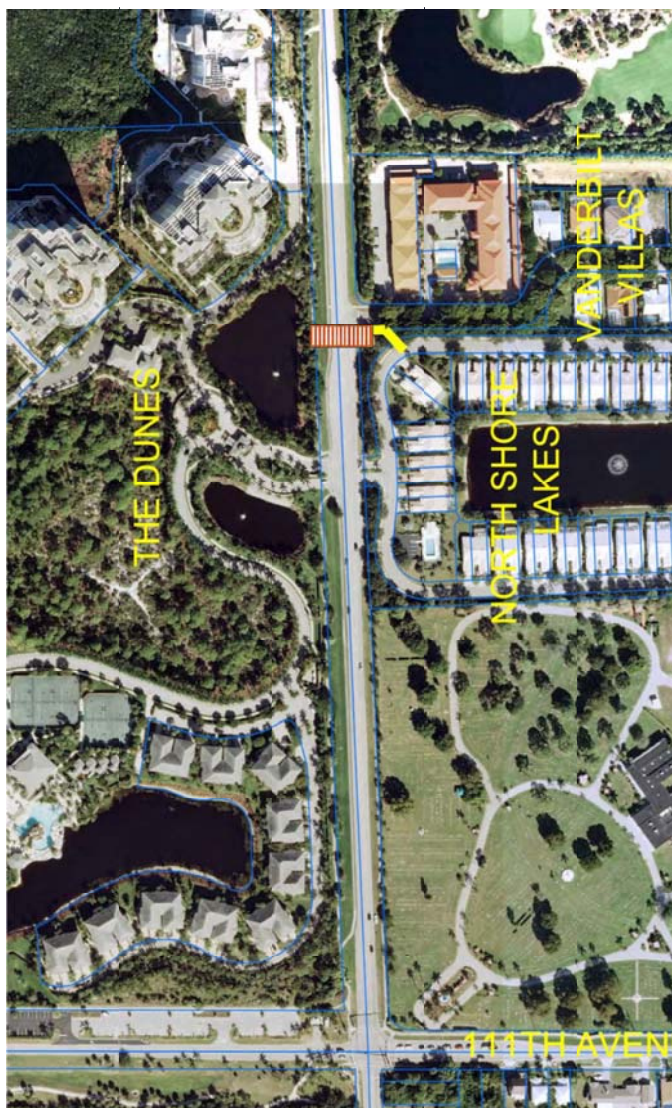
FIGURE 5: South Crosswalk Locations Option 2

An alternative location for the crosswalk would be to locate it north of the Option 1 location, and immediately north or south of the Vanderbilt Villas entrance road. This location, shown in **Figure 5**, would require a short interconnecting sidewalk to connect the North Shore Lakes internal system to the crosswalk at the northwest corner of the development. No sidewalk along the east side of Vanderbilt Drive would be necessary, although it would be appropriate to consider constructing a sidewalk as described in Option 1 to facilitate convenient access to the existing sidewalk that terminates at the northwest corner of the Naples Memorial Gardens.

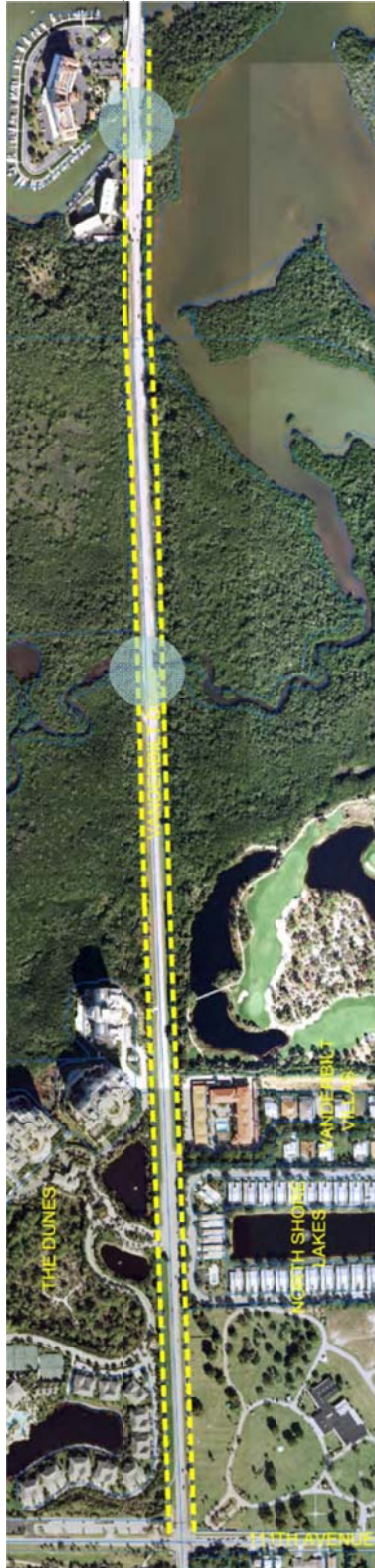
FIGURE 6: Southern Segment Bike Lanes or Paved Shoulders

4.1.5 Bike Lanes/Paved Shoulders South of the Cocohatchee River Bridge

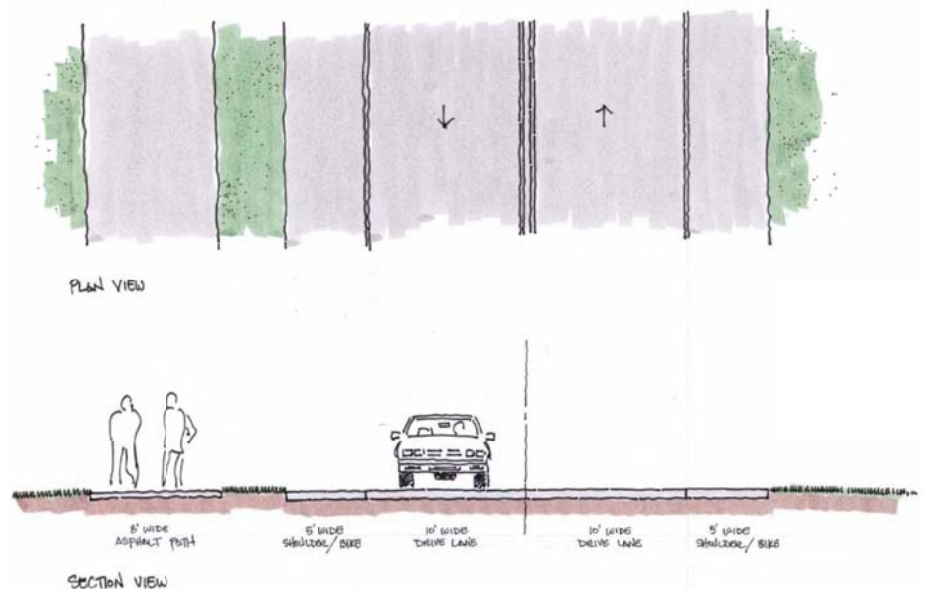
FIGURE 7

The portion of the Vanderbilt Drive corridor north of Cocohatchee River Bridge to Bonita Beach Road, consists of a 2-lane rural cross section with 11' travel lanes, with the occasional 11' wide left- and right-turn lanes at approaches to developments, and designated 5' bike lanes. In contrast, the 1.25 mile segment of the corridor south of the Cocohatchee River Bridge consists of a 2-lane rural cross section with 10' travel lanes and no bike lanes or paved shoulders (**Figure 6**). The existing 6' paved pathway meanders along the west shoulder, often only 6' or less from the outside edge of the travel lane. In order to improve safety for motorists and on-road cyclists, the County has expressed an interest in constructing bike lanes/paved shoulders along this segment of the corridor (**Figure 7**).

South Corridor – Paved Shoulders

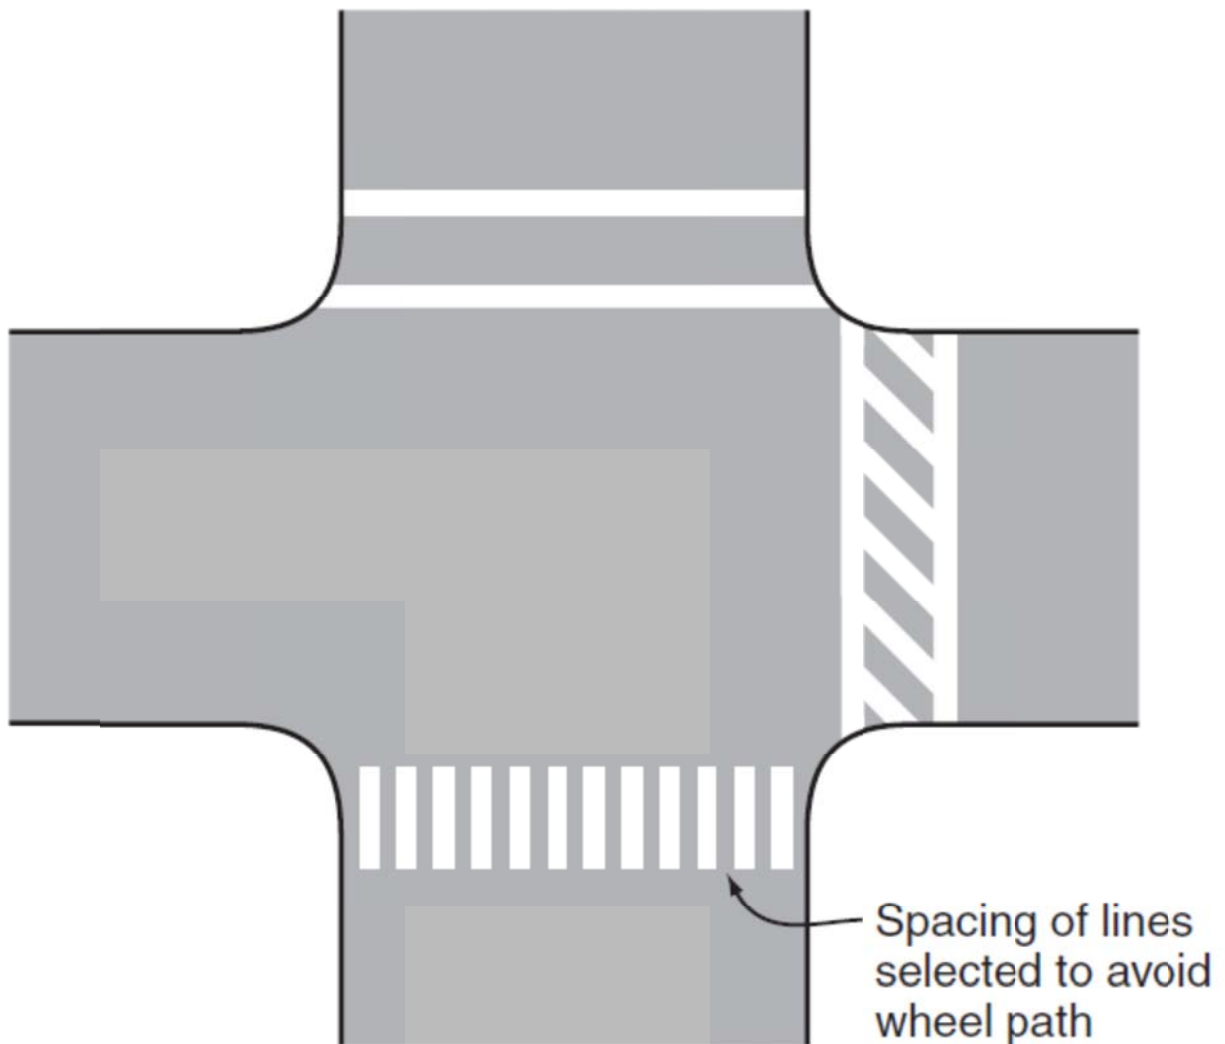
The style of crosswalk marking may vary according to established guidance as shown in **Figure 8**. High visibility crosswalks, e.g., the “piano key” style are encouraged where maximum visibility is advised. Surface treatments, discussed later in this section, can further enhance the visibility of the crosswalk.

FIGURE 8: Examples of Crosswalk Markings (Source: MUTCD Figure 3B-19)

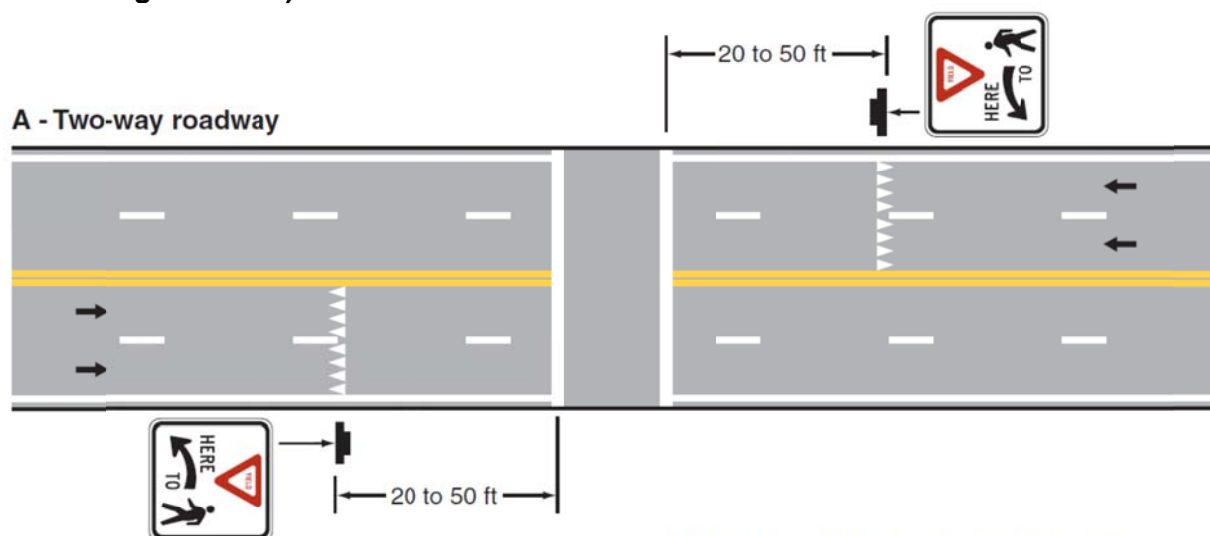
FIGURE 11: Example of Yield Lines at an Unsignalized Midblock Crossing (Source: MUTCD Figure 3B-17)

Note: If Stop Here for Pedestrians signs are used instead of Yield Here to Pedestrians signs, stop lines shall be used instead of yield lines.

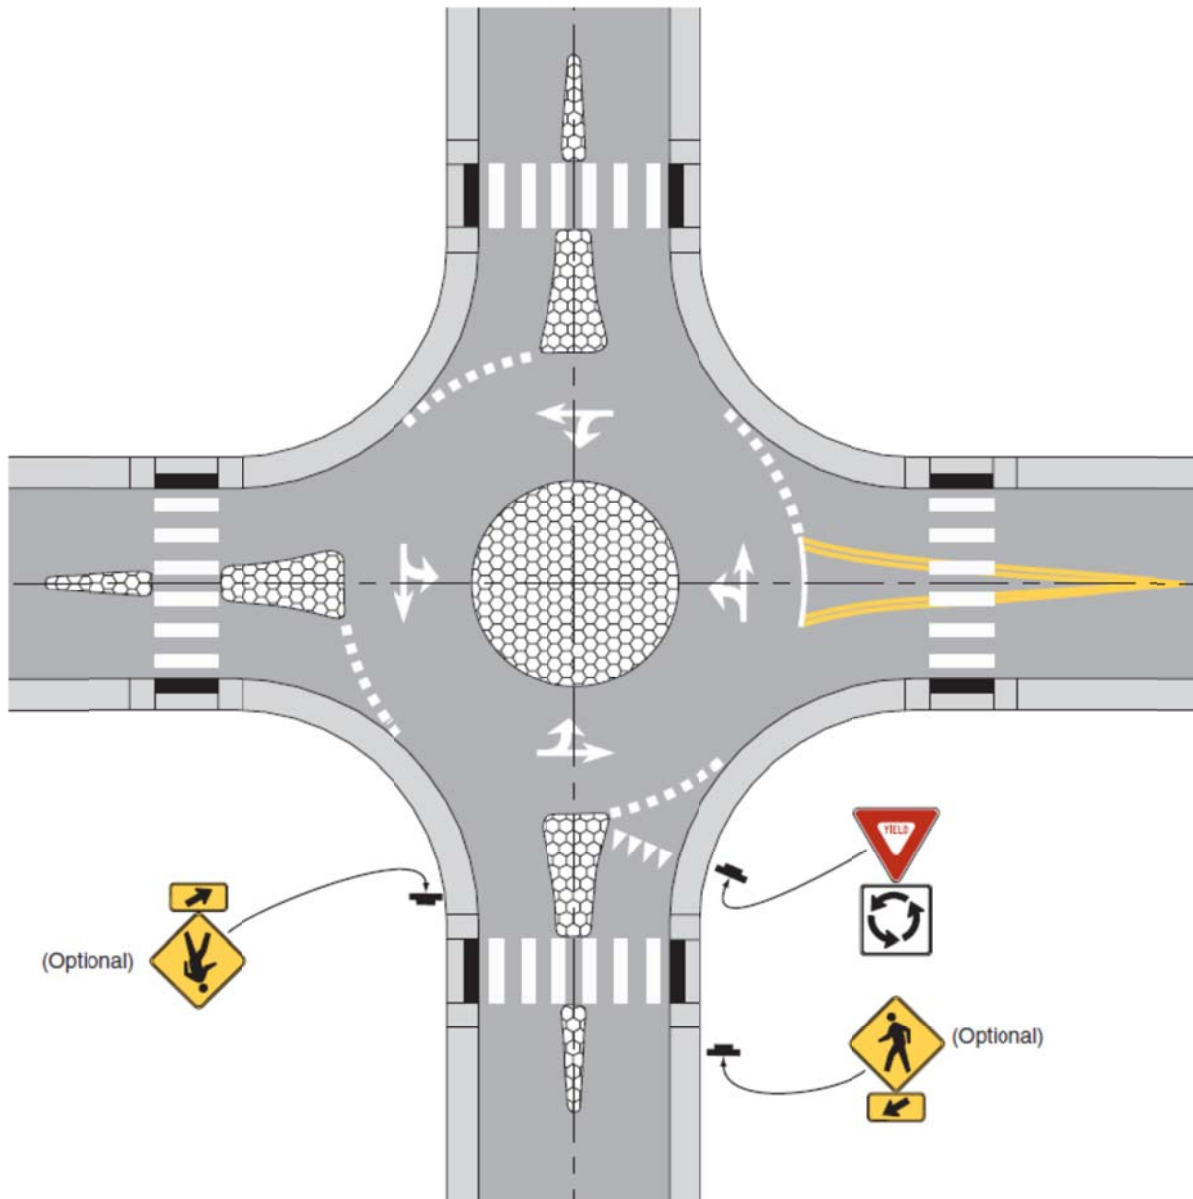
The use of roundabouts also facilitates the marking of crosswalks, and frequently may include the use of refuge islands that offer pedestrians an area to wait for an acceptable gap before proceeding across the travel lane (**Figure 12**).

FIGURE 12: Example of Marking & Signing for a Mini-Roundabout (Source: MUTCD Figure 2B-21)

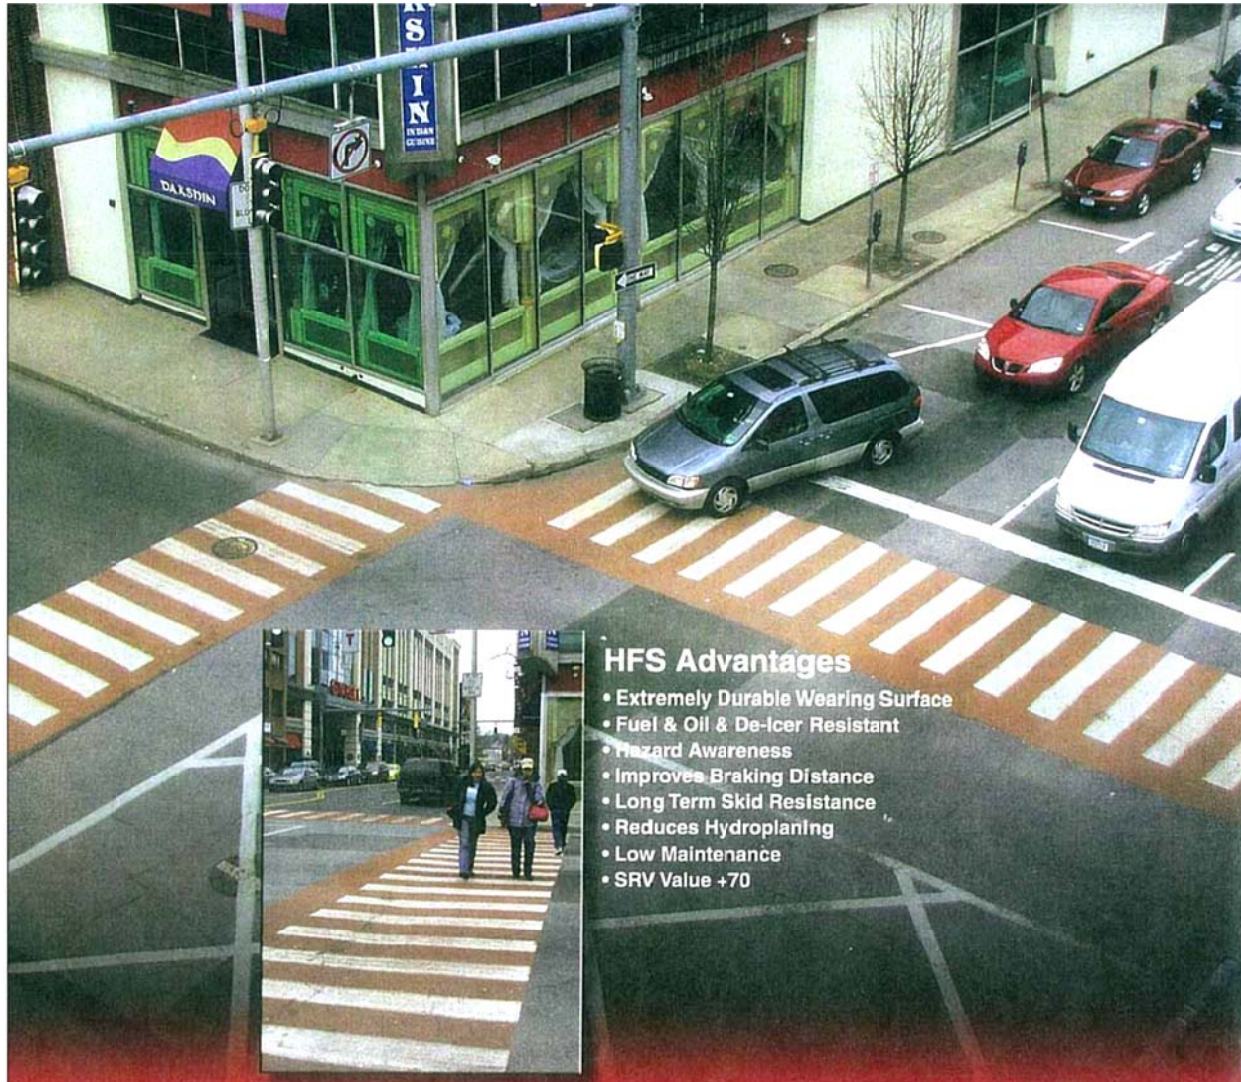
The surface of the crosswalk can be enhanced to provide both visual and tactile feedback to motorists. Colored and contrasting surfaces (**Figure 13**) increase visual attention to the location, making it easier for motorist to recognize the crosswalk location as they approach.

FIGURE 13: Example of Color-Contrasting High Friction Surface Treatment Crosswalk

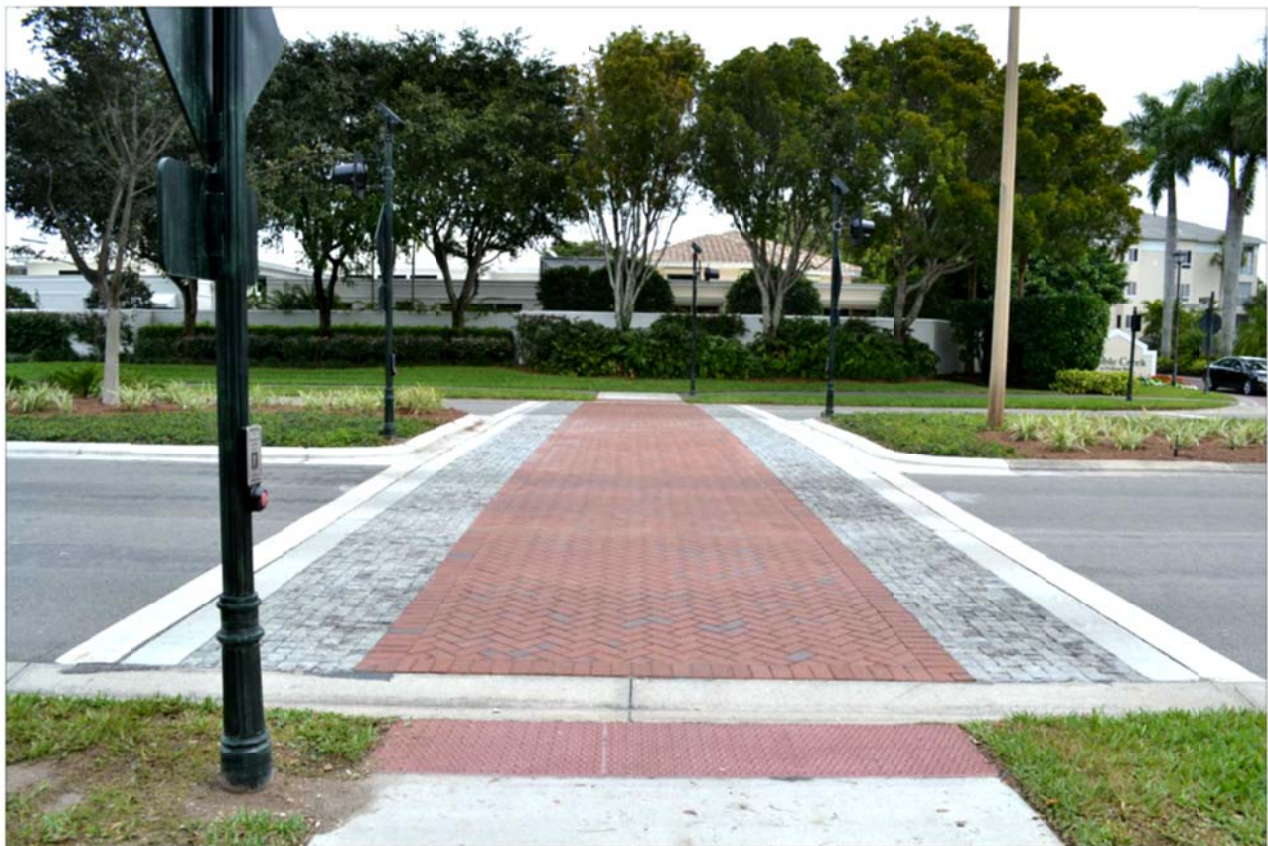
More robust surface treatments such as brick pavers or cobbles (**Figure 14**) add yet another level of awareness as a driver passes over the crosswalk, sensitizing the motorists to the crosswalks both visually and through a tactile response. While painted surfaces can be relatively inexpensive, brick pavers and cobbles bring an increased cost to the improvement. Stamped asphalt and bonded aggregate offer less expensive alternative treatments.

FIGURE 14: Paver/Cobble Crosswalk Treatment

PAVER CROSSWALK WITH COBBLE BANDS

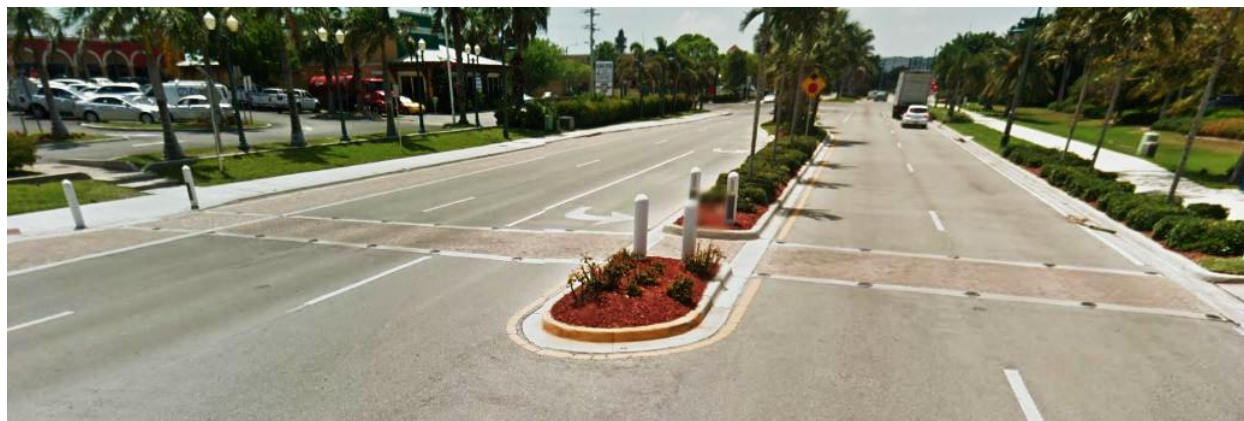
The placement of pedestrian refuge areas can be done permanently, or in a “temporary” fashion as for a trial period. Permanent installations would normally involve the construction of a raised median island using concrete curbing (**Figure 15**) necessitating a significant construction and maintenance of traffic effort.

FIGURE 15: Example Mid-Block Pedestrian Refuge Island

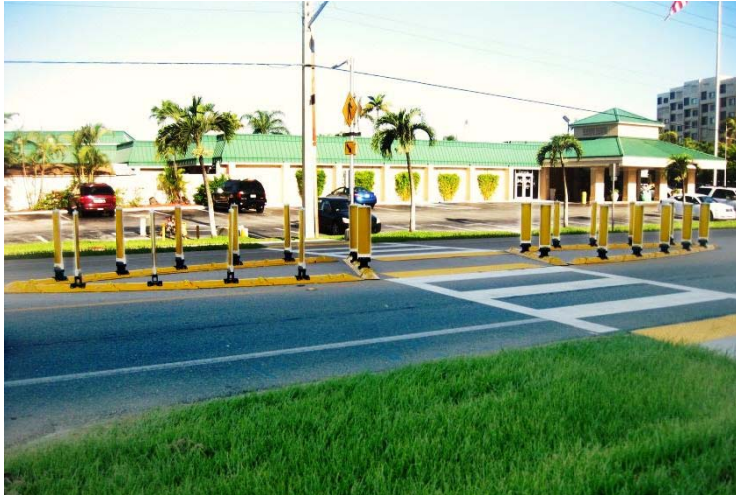
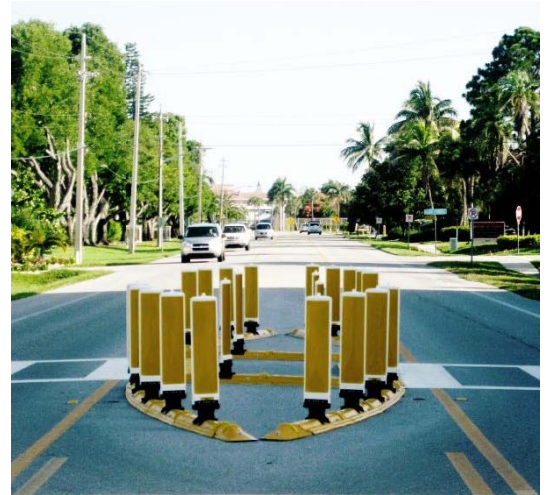
The implementation of “temporary” refuge islands involves the use of pre-fabricated products that can be installed quickly without incurring a lot of maintenance of traffic “down time”. Recently, Lee County installed temporary refuge islands at new crosswalk installations using pre-fabricated curbing called **Qwick Kurb** to form the outer perimeter of the refuge “islands” (**Figure 16**). Another type of pre-fabricated product, called **Redipave**, uses recycled rubber to create raised island components that are pieced together in the desired size/shape. Both types of products can be installed (or removed) quickly and economically by agency road crews (**Figure 17**), minimizing the impact to the movement of traffic during installation and offering a more economical alternative to the construction of permanent raised median island refuges.

FIGURE 16: Example Mid-Block Pedestrian Refuge Island – Qwick Kurb (Estero Blvd., Fort Myers Beach, FL)

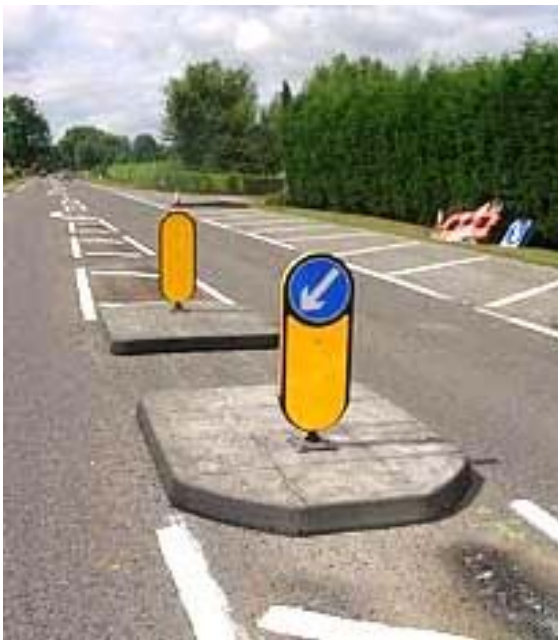
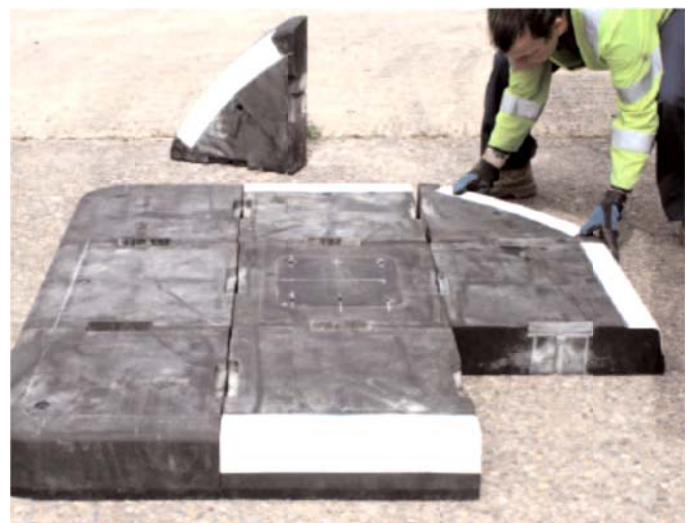
FIGURE 17: Example Mid-Block Pedestrian Refuge Island – RediPav (Images courtesy of Professional Pavement Products, Inc., Jacksonville, FL)

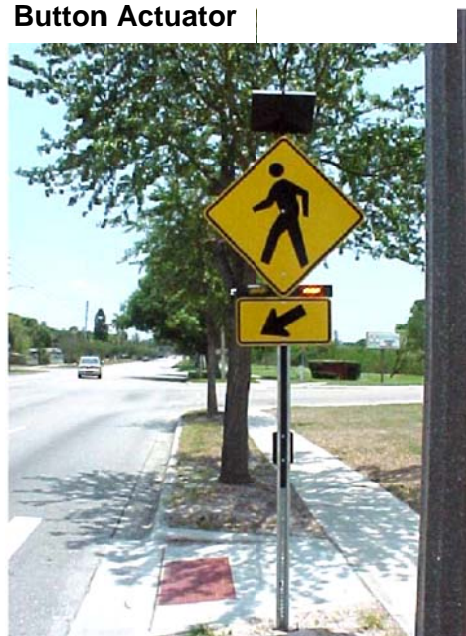
Equally important, the very high yielding rates were sustained even after 2 years in operation, and no identifiable negative effects have been found. The RRFB's very high compliance rates

FIGURE 18: RRFB w/Push Button Actuator

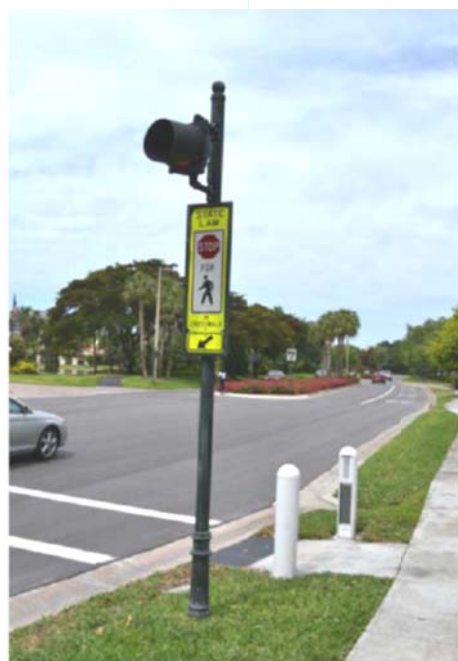
FIGURE 19: Amber Beacon w/Bollard Sensor Actuator

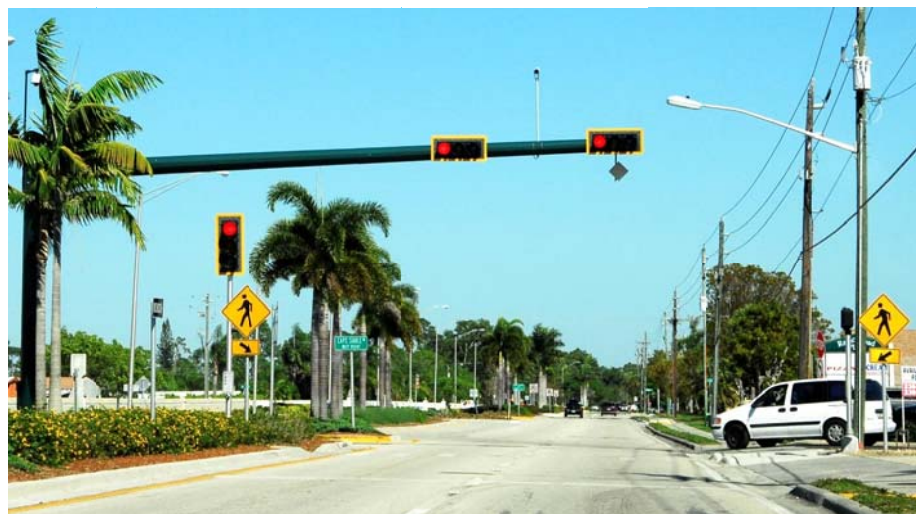
Operationally, a fully controlled signal (Figure 20) operates the same way at a mid-block location as it does at an intersection, including green, amber and red indications with pedestrian output displays (the "Walk/Don't Walk" sign) indicating when it is appropriate for the

FIGURE 20: Fully Signalized Crosswalk

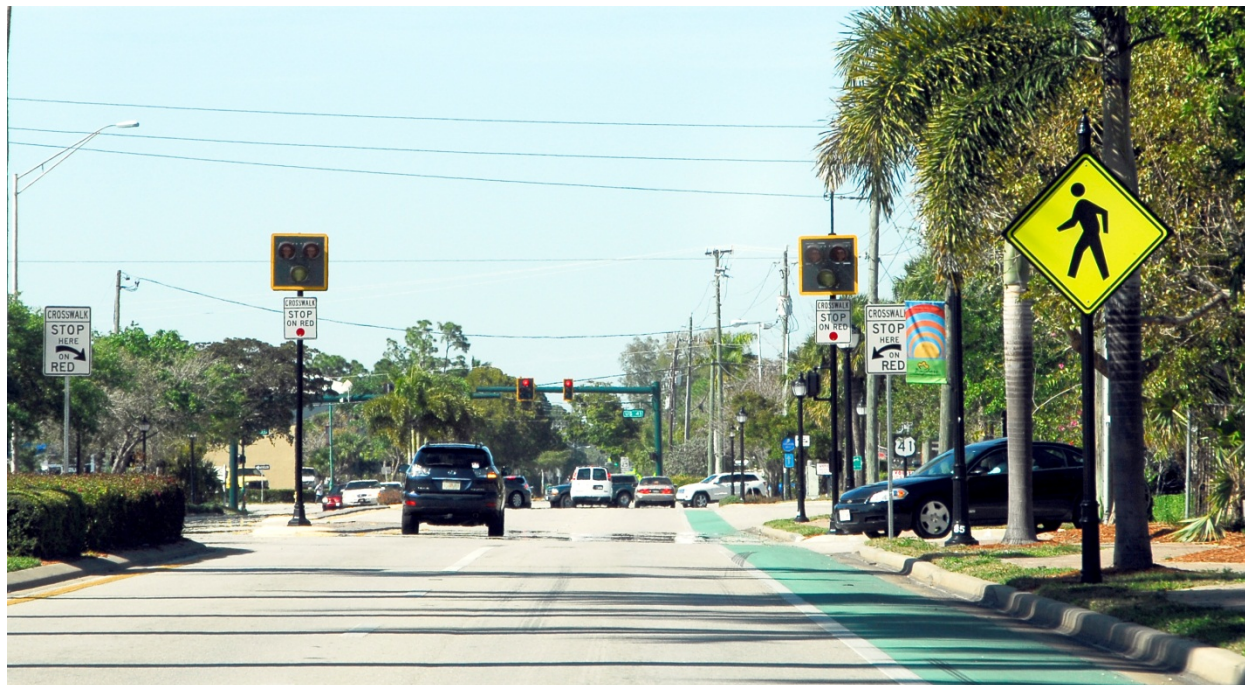
The "HAWK" is used at mid-block locations or un-signalized intersections to provide a cost-effective method of protecting a pedestrian movement. Until activated by the pedestrian, the "HAWK" signal rests in a dark state for the vehicle, allowing normal flow through the mid-block area/un-signalized intersection while displaying a constant “Don’t Walk” indication for the pedestrian crossing. Activation by a pedestrian causes the amber (CAUTION) indication to flash. This is then followed by solid amber, followed by a solid red (STOP) indication, followed by a flashing red indication during which time motorist may proceed with caution (after stopping), once the pedestrians have cleared the crosswalk. The signal once again goes dark after the flashing red phase. Throughout this cycle, the pedestrian output identifies when it is safe for pedestrians to proceed.

FIGURE 21: HAWK Signal

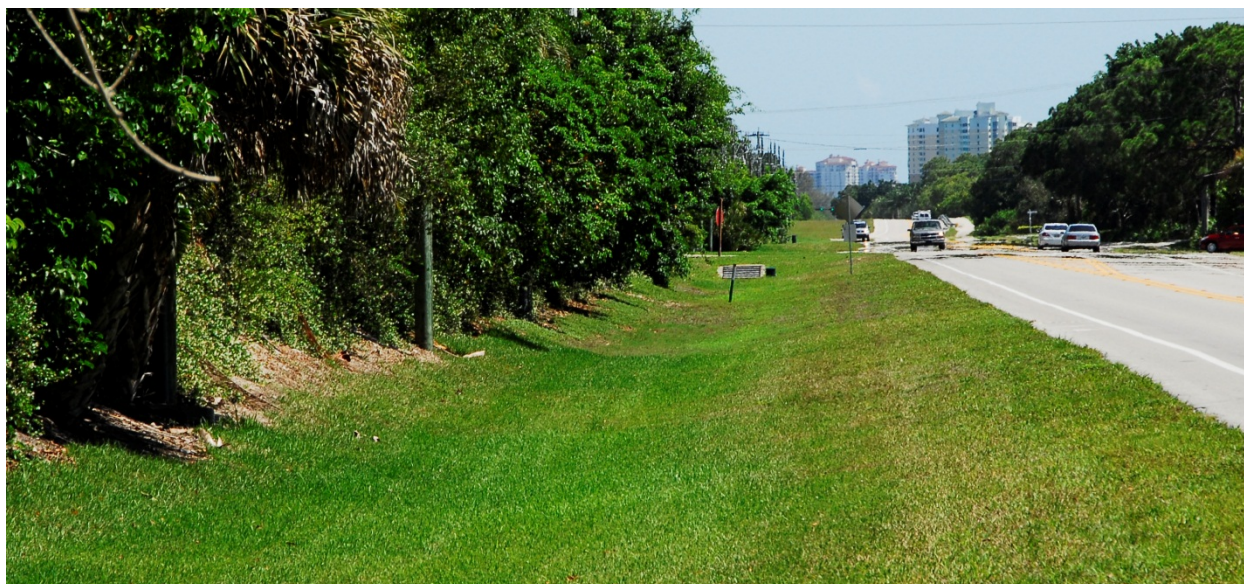
Within the rural cross section drainage swales generally consume all of the right-of-way between the edge of pavement and the right-of-way/private property line (**Figure 22**). Adding a 6' sidewalk within this area is likely to be especially challenging in many areas, resulting in higher construction costs. Preliminary survey data indicates a significant amount of alteration to many of the swale areas would be required in order to retain the required side slopes and maintain required drainage designs.

FIGURE 22: Roadway Drainage Swale

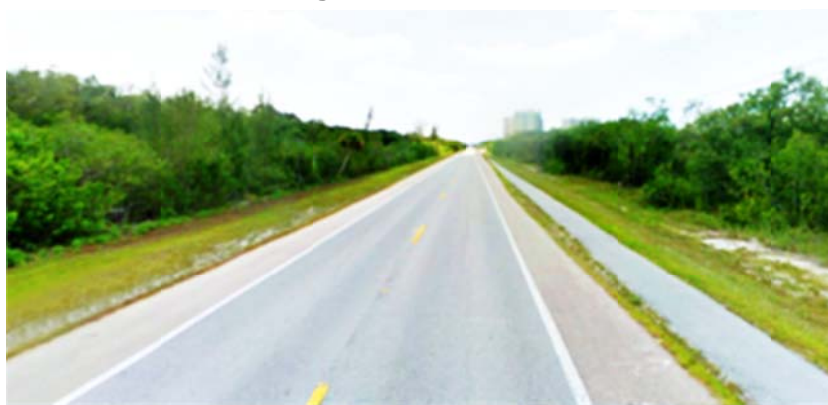
The County has recognized the need to improve this section of the corridor with either designated bike lanes or un-marked paved shoulders (**Figure 23**). Either solution is acceptable and would yield a marked improvement in the travel characteristics of the roadway.

FIGURE 23: Rendering of Additional Paved Shoulders

As mentioned previously, a review of the existing condition of the corridor revealed that for the majority of distance in this segment, the existing off-road asphalt pathway is frequently located 6' or less from the edge of the travel way. A review of the design plans for the Greenway indicates that throughout much of the segment of the corridor, the new Greenway will be 4' off the edge of pavement. This condition (existing and future) would prohibit the adding the additional bike lane/paved shoulder improvement to the west side of the roadway, requiring all of the additional asphalt to be placed along the east edge of the existing roadway, necessitating at a minimum the restriping of the travel lanes, and at a maximum a complete overlay of the roadway. If the County reconsiders the design of the Greenway improvement based upon recent public input, this may offer an opportunity to relocate the proposed Greenway further away from the travel way and allow the additional bike lanes/paved shoulders to be added to both sides of the existing roadway.
