RECENT HISTORY OF SEAGRASS PRESENCE IN CLAM BAY

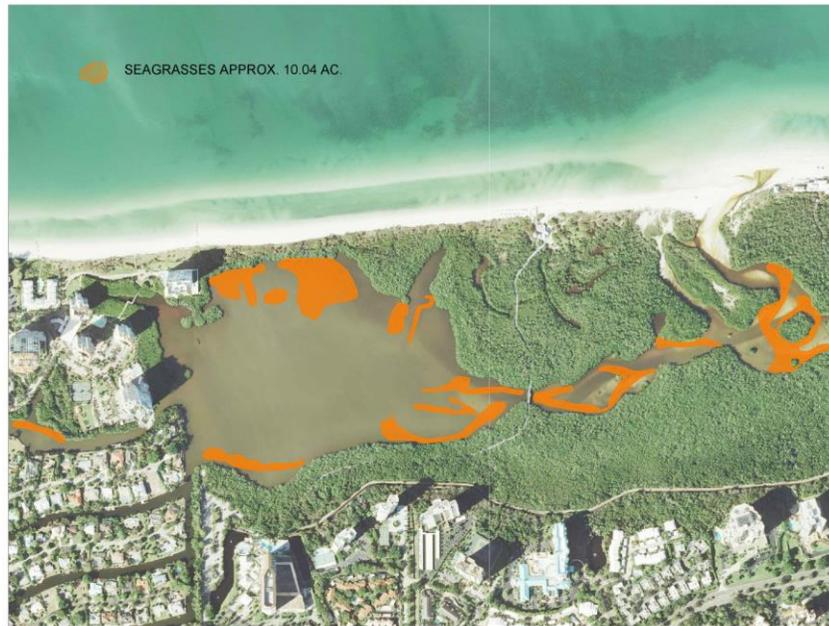
Approximation of 1994 Sea Grass Coverage (10.04 AC)

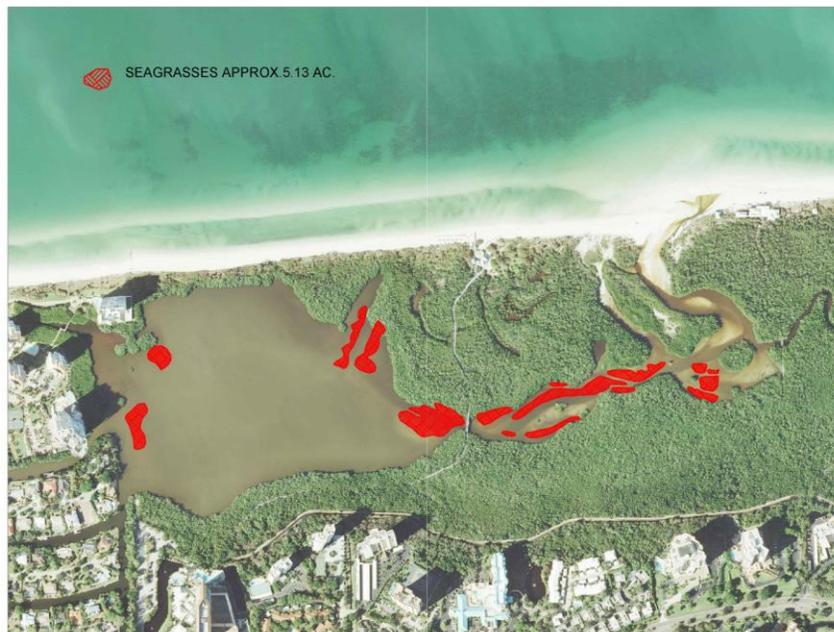
1999 Seagrass Coverage (approx. 5.13 AC)

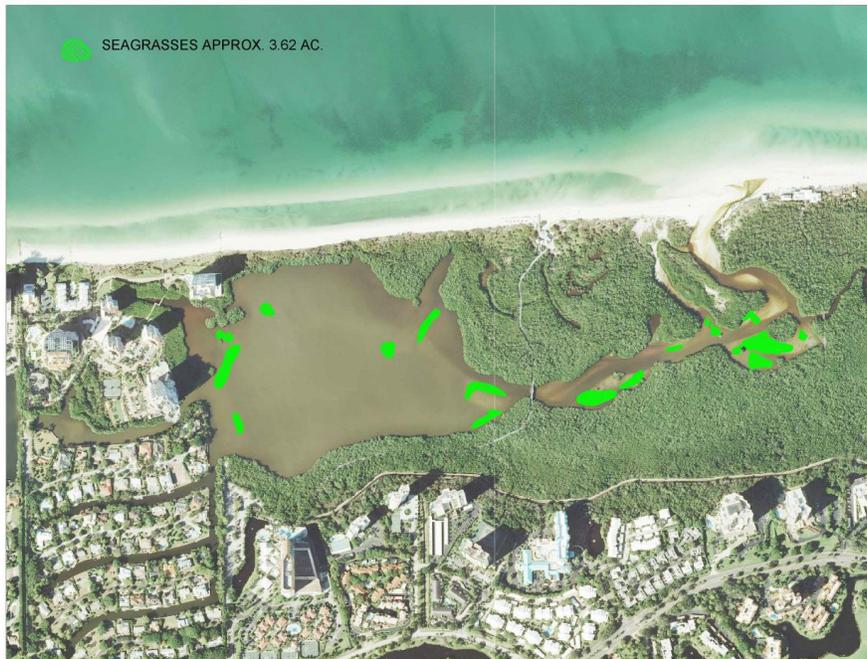
2006 Seagrass Coverage (3.62 AC)

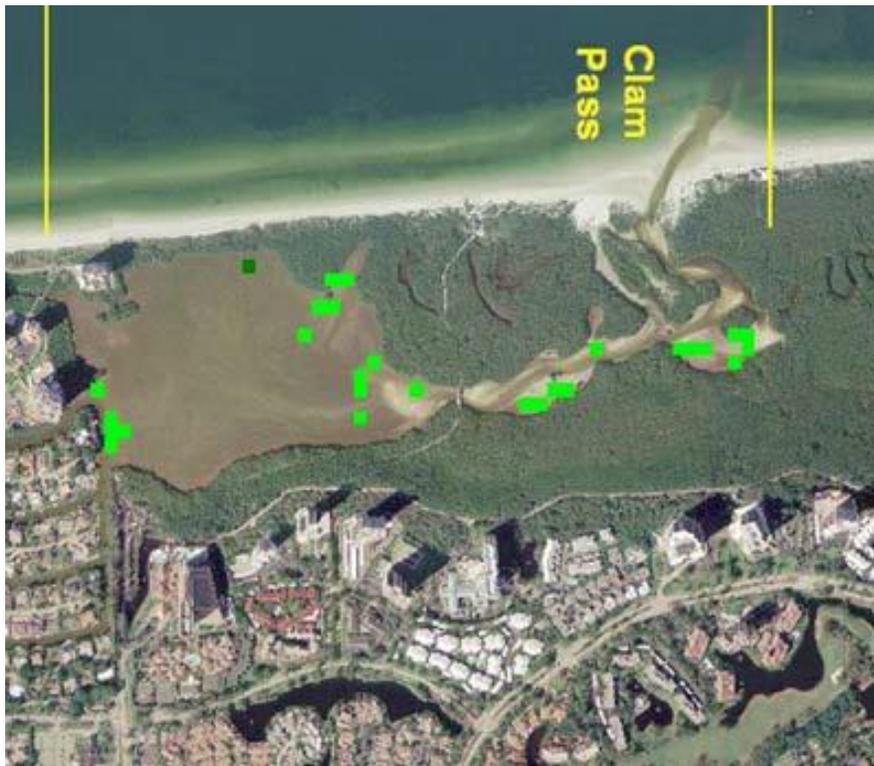
**2011 Benthic Habitat Assessment,
Conservancy of Southwest Florida (est. 4.3 AC)**

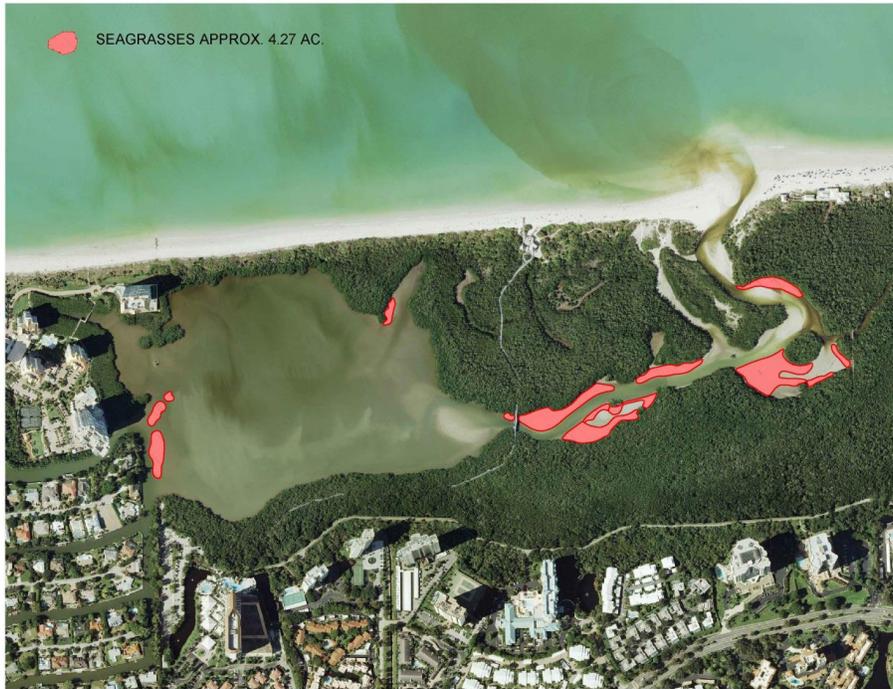
2012 Seagrass Study (4.27 AC)

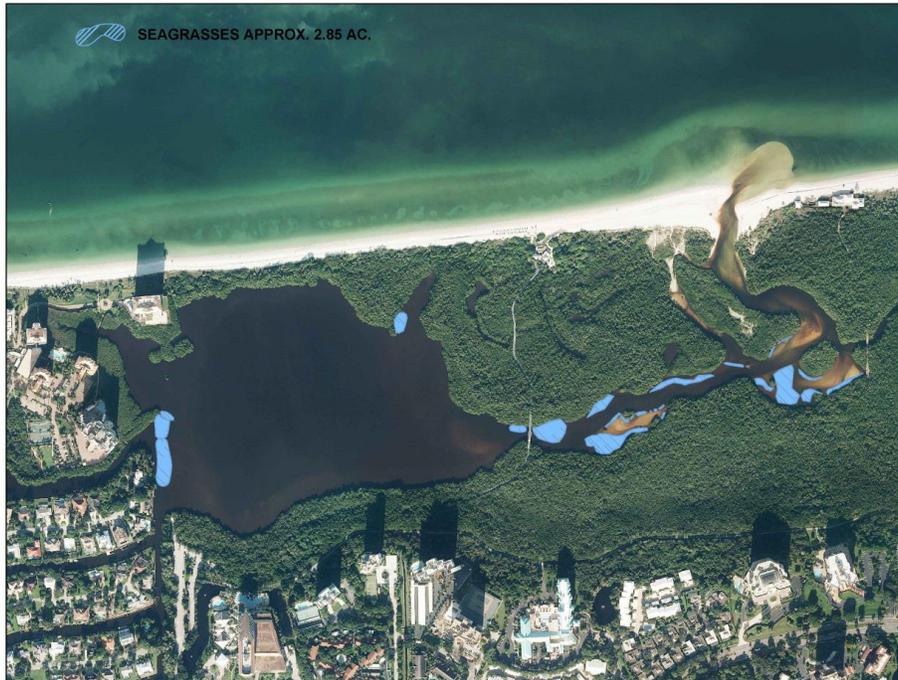
2013 Seagrass Coverage (2.85 AC)

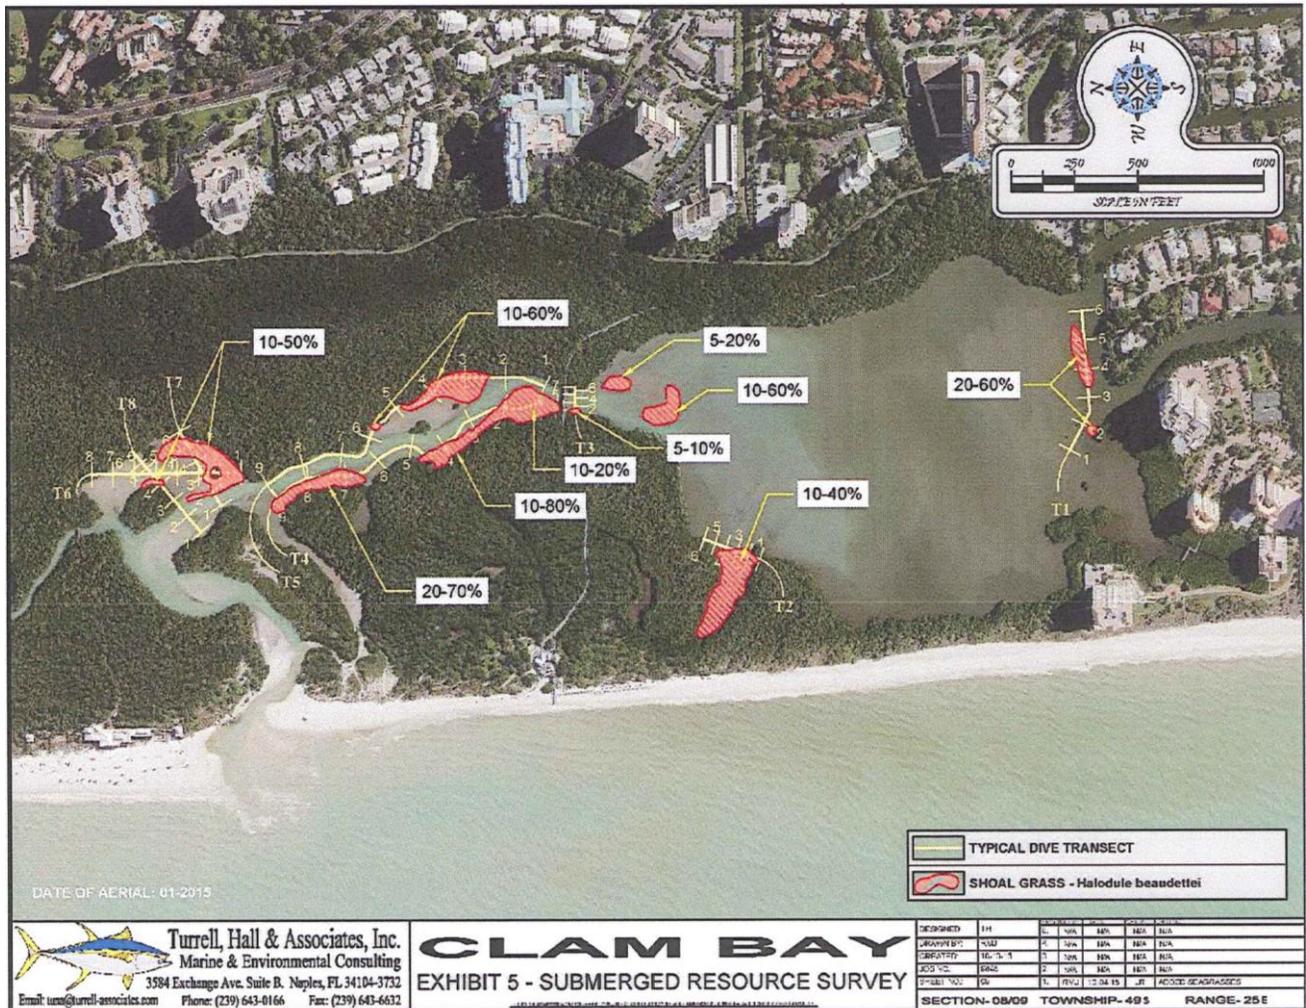
2015 Seagrass Coverage (4.17 AC)
