Conservation Collier Initial Criteria Screening Report

Property Name: Arias Properties
Folio Numbers: 41560080008, 41560040006

Staff Report Date:
November 13, 2006

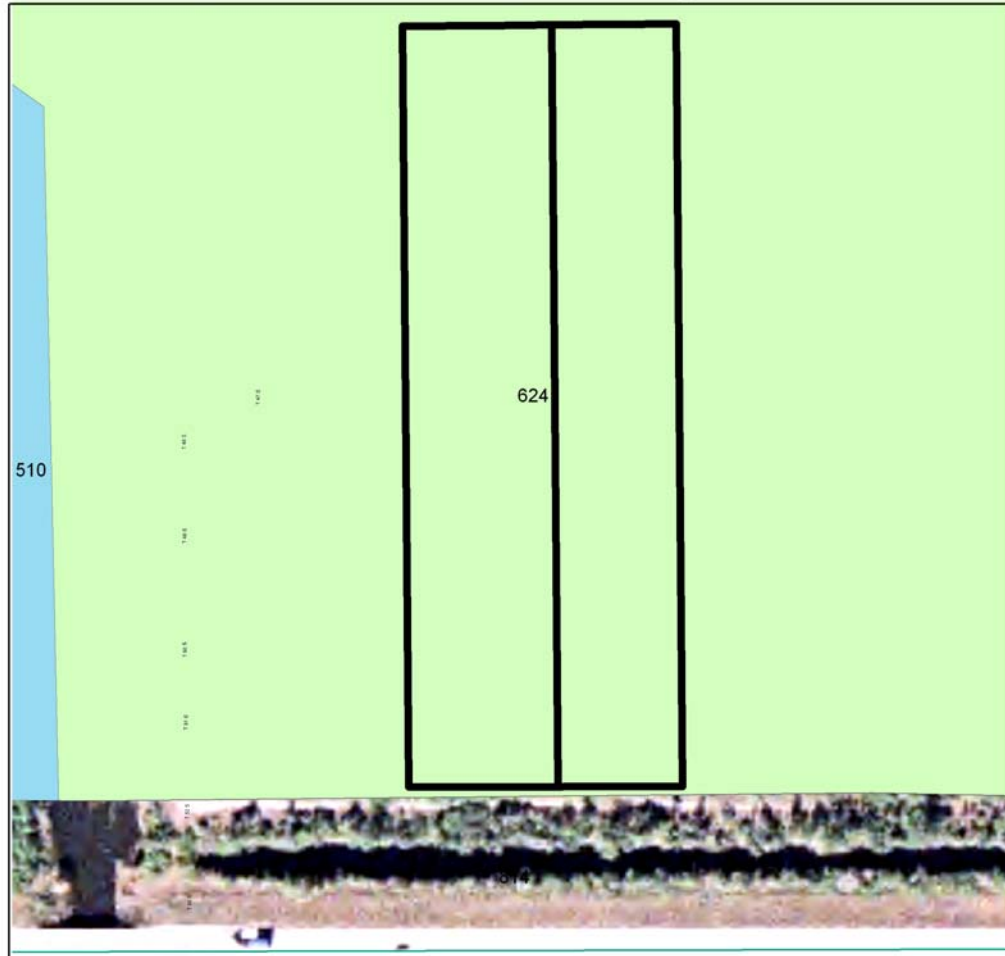
Exhibit A. FLUCCs Map

- 624- Cypress- Pine -Cabbage Palm

Arias Properties Land Use Cover Map

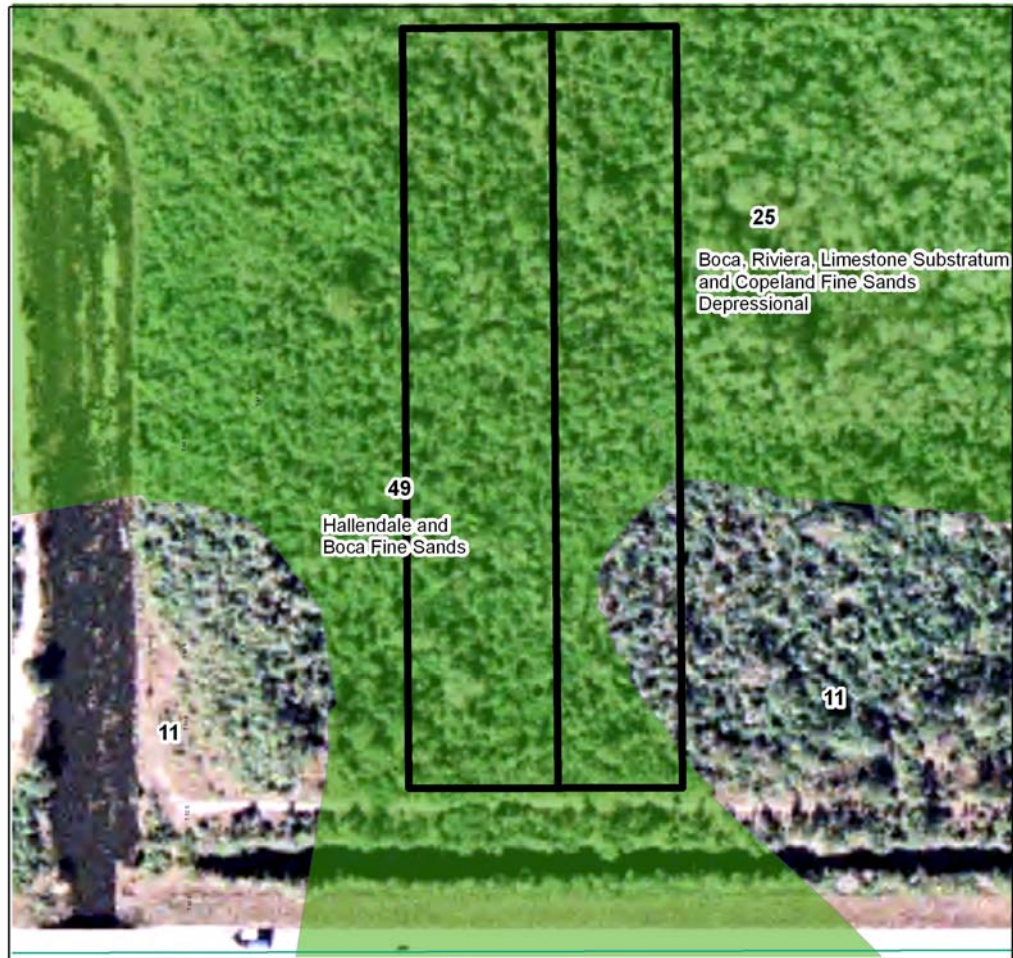
Exhibit B. Soils Map

Soils: Soils data is based on the Soil Survey of Collier County Area, Florida (USDA/NRCS, 1990). The northern half of the properties were mapped as containing Boca, Riviera, and Copeland soils, which are poorly-drained depressional soils found in cypress swamps and marshes. Vegetation consistent with these soil types includes cypress, pickerel weed, rushes, and Florida willow. The southern half of the properties was identified as Hallendale and Boca fine sand. This sand is a poorly drained soil found in sloughs and poorly defined drainage ways. Natural vegetation that exists in these soil types includes scrub cypress, sand cord grass, wax myrtle and maidencane. Wax myrtle and Cypress were found on both properties, but currently, Brazilian pepper is the predominant vegetative species.

Arias Properties Soils Map

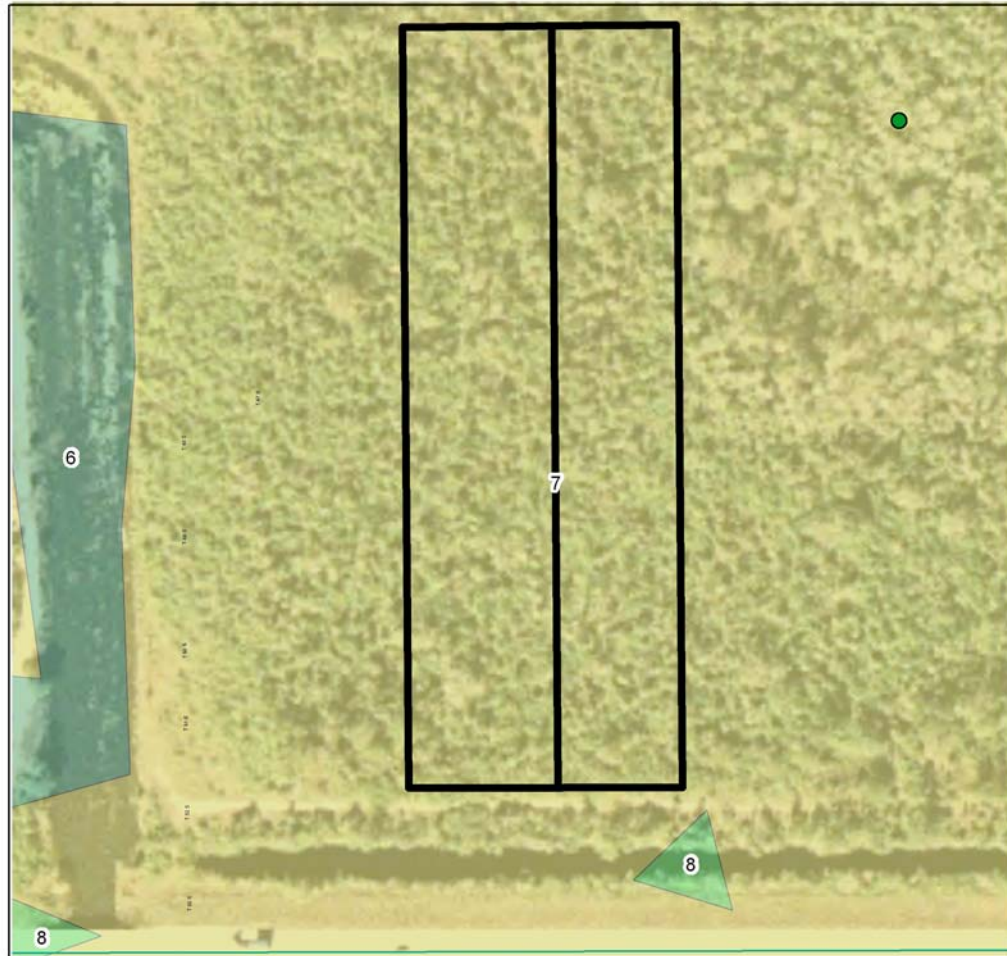
Exhibit C. Species Richness Map

FWCC-derived species richness score: The score for both parcels was 7 out of a scale of 10, indicating slightly above average potential for species richness.

Arias Properties Species Richness Map

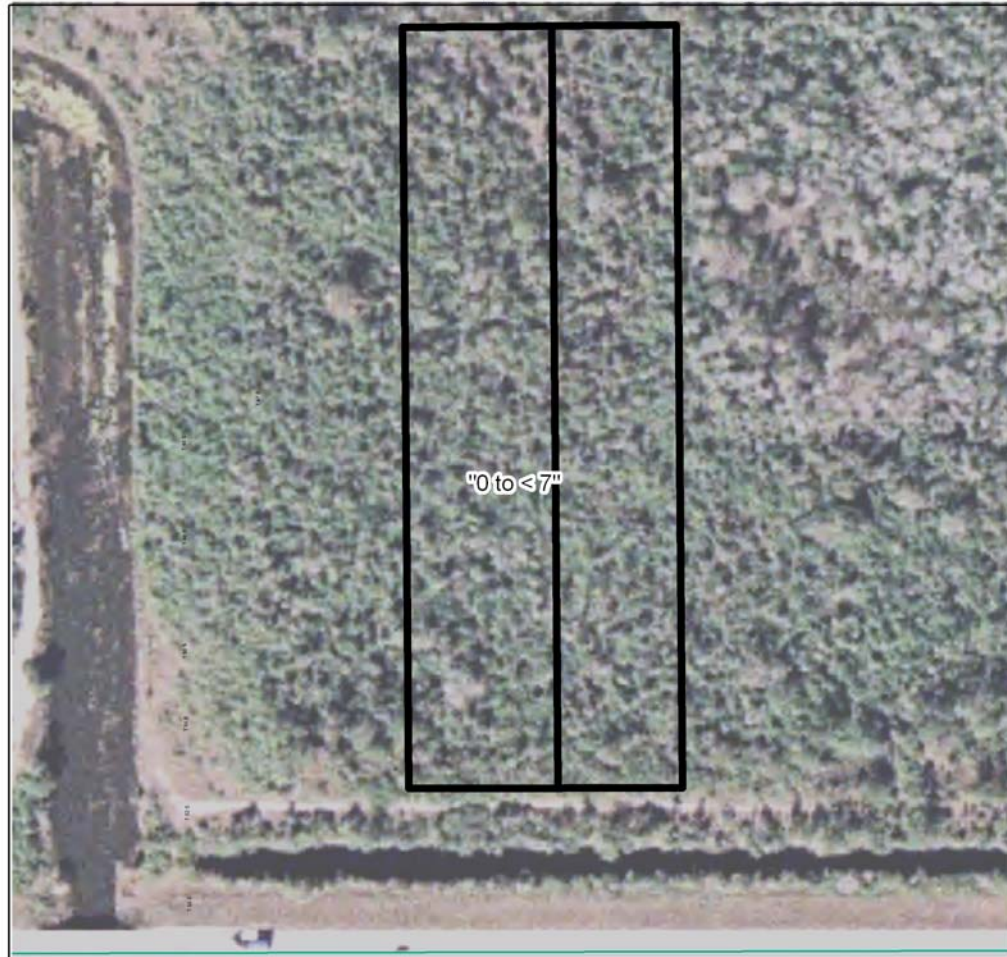
Lower Tamiami recharge Capacity: Capacity for recharge to the Lower Tamiami Aquifer is low, mapped in GIS at 0-7" annually.

Arias Properties Lower Tamiami Aquifer Recharge Map

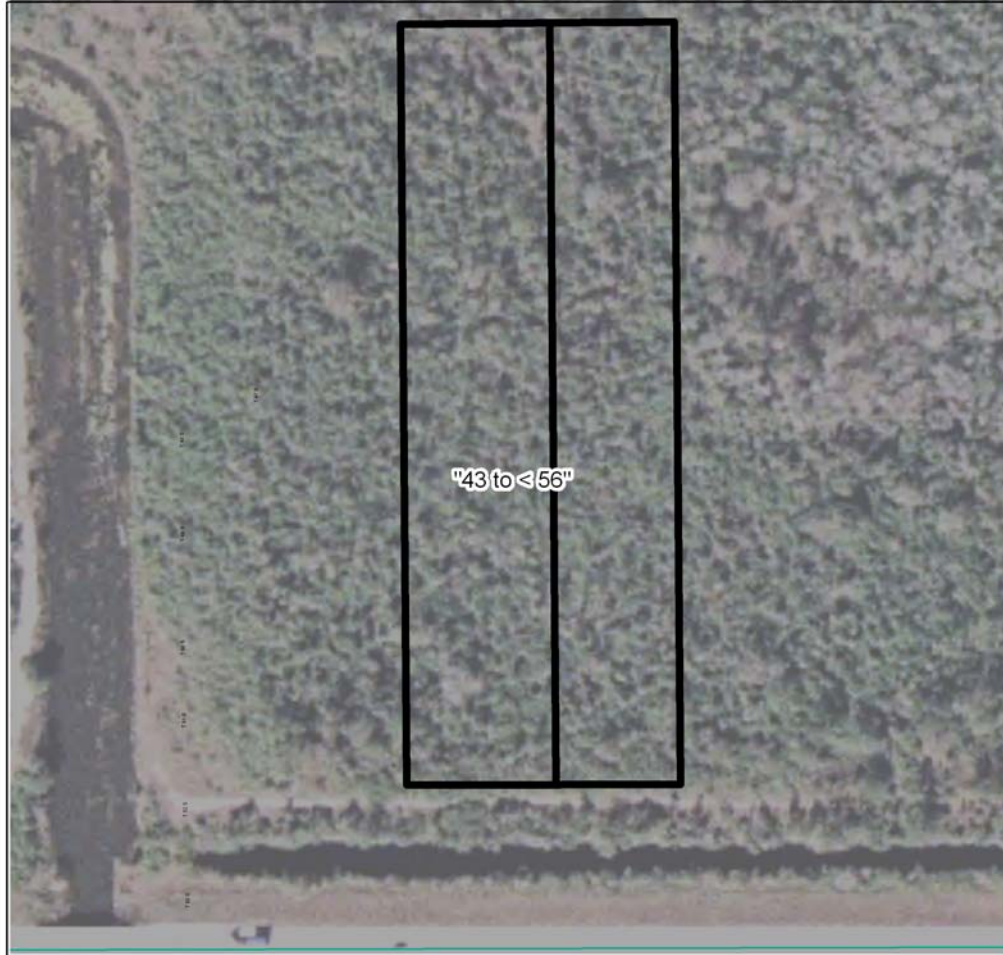
Surficial Aquifer Recharge Capacity: Capacity for recharge into the Surficial Aquifer is moderate, mapped in GIS at 43-56" annually.

Arias Properties Surficial Aquifer Recharge Map

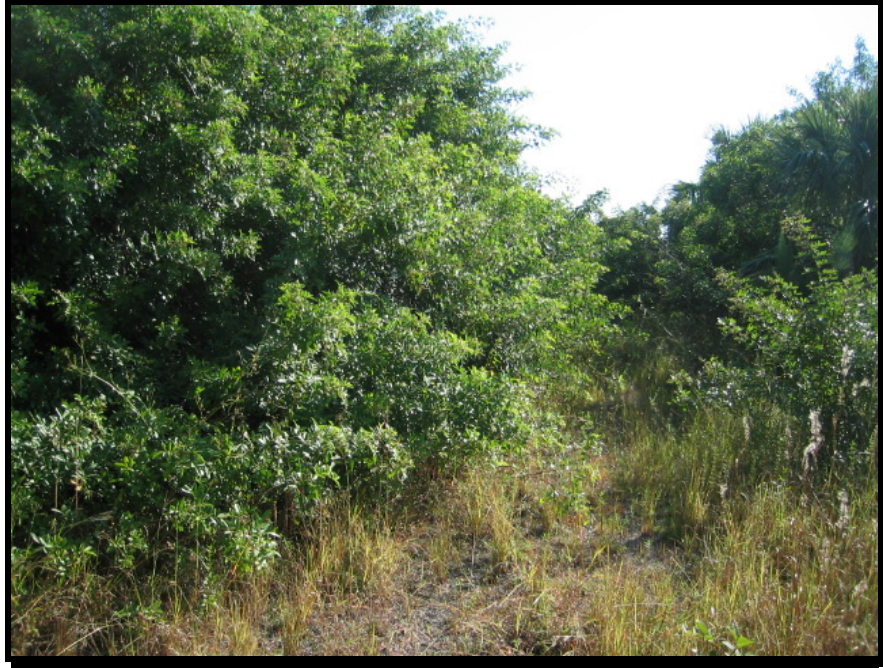
Photo 1. Access to the property. Brazilian pepper infested.

Recommended Site Improvements: Public access would need to be secured to this property over the FDOT I-75 ROW that fronts the canal. Encroaching Brazilian pepper would need to be trimmed back from the track, and a trail would need to be created. A small parking area would also be necessary for access, possibly at the end of Desoto Boulevard.

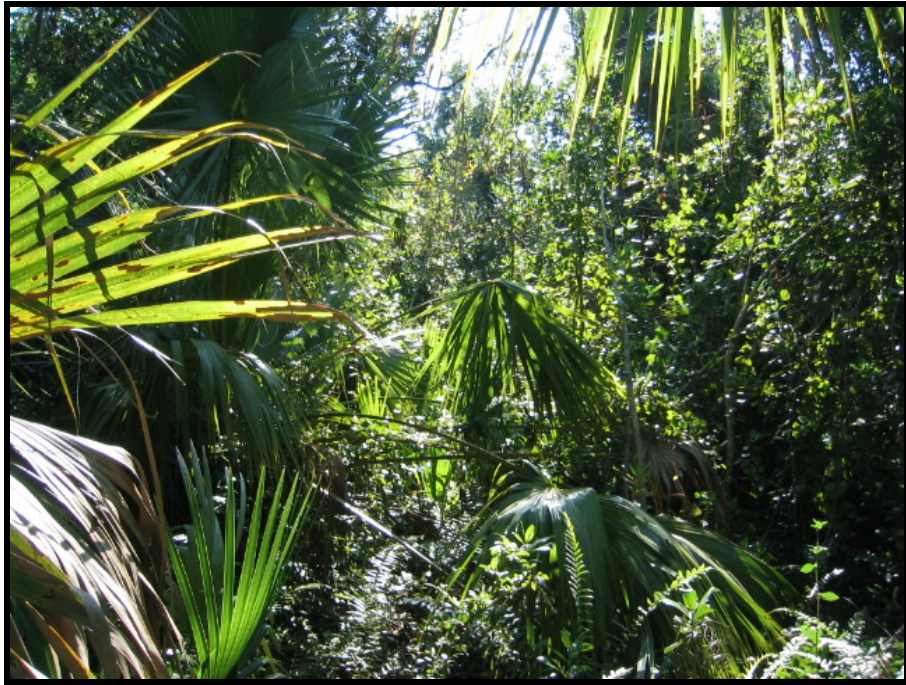
Photo 2. View from the interior in the southern portion of the western parcel

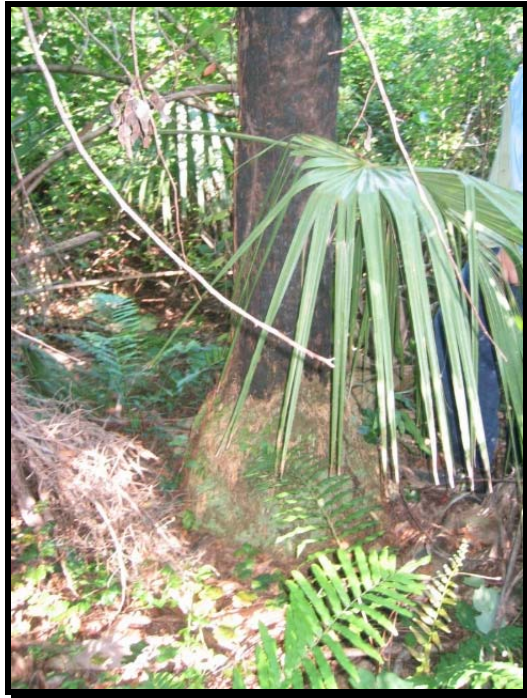
Other Hydrologic indicators observed: Cabbage palm root balls were raised with moss growing on their bases, indicating wetland conditions in the past.

Photo 3. Sabal Palm root ball raised with moss cover, indicative of past wetland conditions

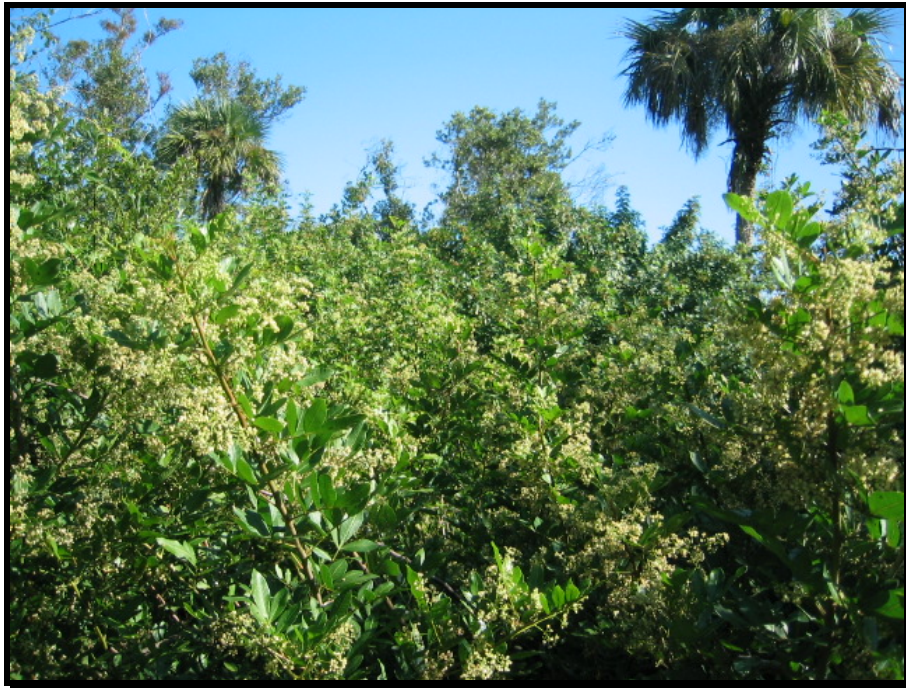
Exotic, Invasive Plants Present: The properties are infested with Brazilian pepper (*Schinus terebinthifolius*) to such a degree that dense thickets impede passage. Caesars weed (*Urena lobata*) is also present in the under story.

Photo 4. Thick Brazilian pepper in the center of the western property

Based on cost estimates provided by a contractor who routinely contracts with the County parks and Recreation Department for exotic removal, estimated costs for the level of infestation observed would total **\$21,000** to treat exotics with herbicide in place or to cut and stack the debris onsite, and **\$31,500** to cut, treat the stumps and remove the debris to a waste facility.

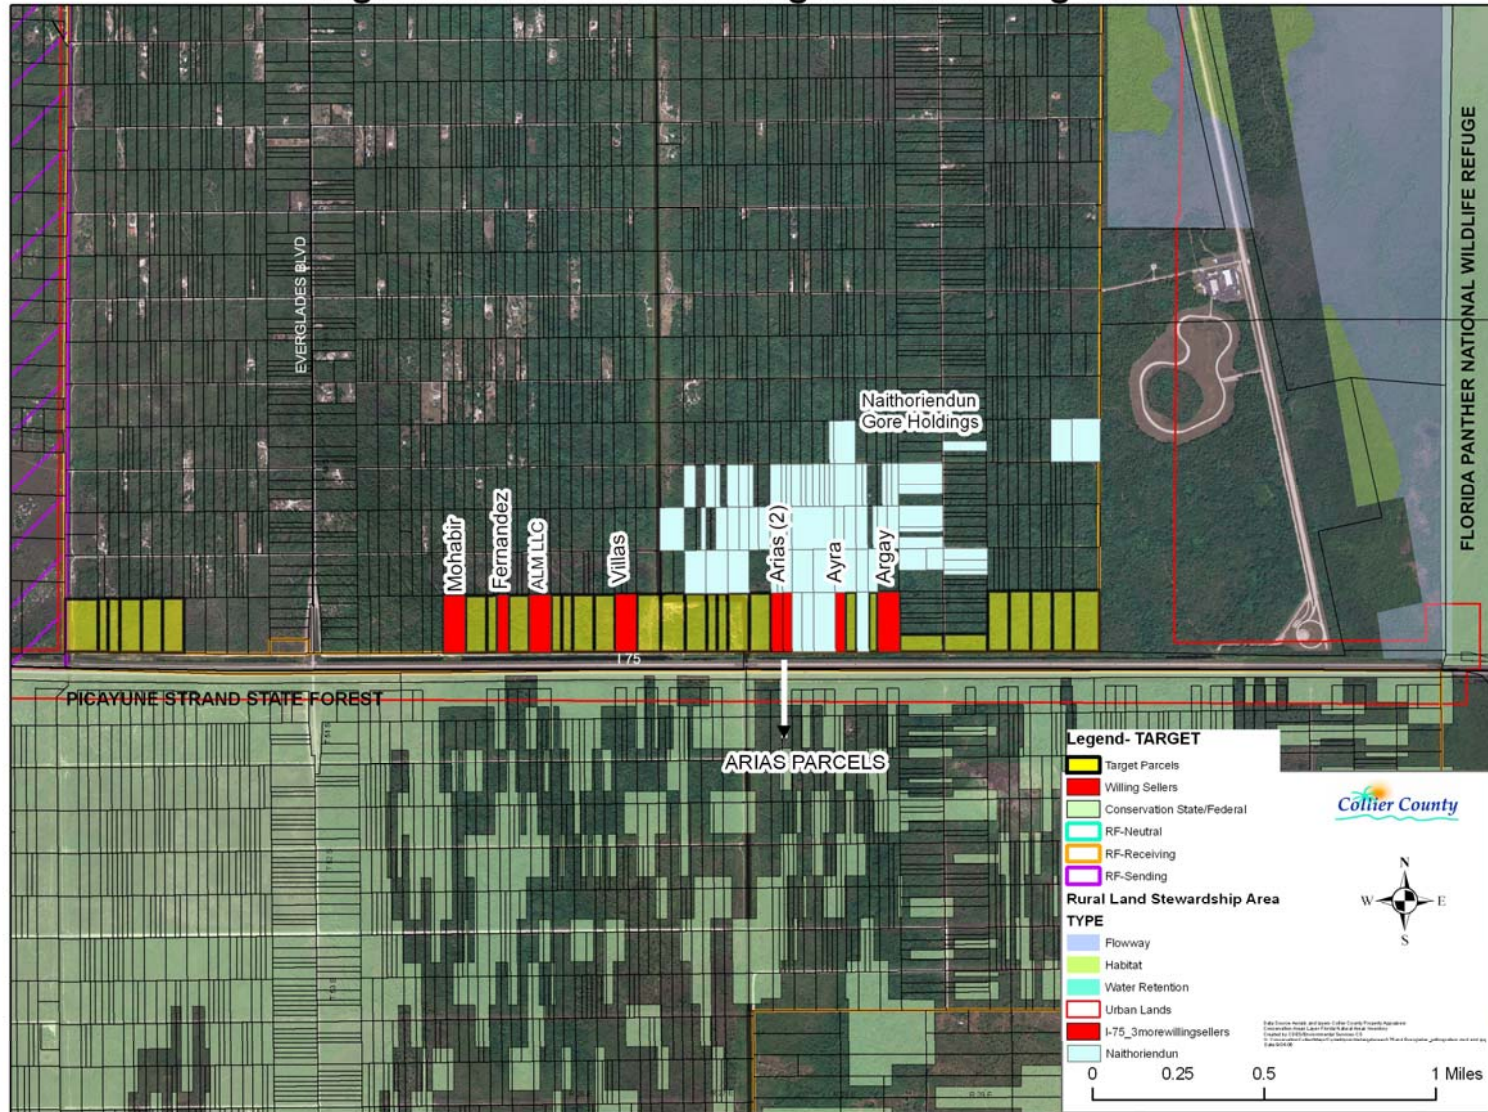
Exhibit G. Surrounding Willing Sellers and Adjacent Private Wildlife Sanctuary

Target Parcels I-75 and Everglades & Willing Sellers
