Project: LELY GOLF ESTATES BEAUTIFICATION, M.S.T.U. **Landscape Architect Observation Report:** November 2020
Location: MSTU DISTRICT ROADWAYS
Project Manager: Dan Schumacher, Collier County Public Services Division, Public Transportation & Neighborhood Enhancements Department
Consultant: McGee & Associates **Consultant's Representative:** Michael A. McGee, rla, isa
Contractor: Superb Maintenance **Contractor's Representative:** Robert Kindelan, Gary Gorden
Report Date: FY20-21, 11/5/2020 **Observation Date:** 11/5/2020 **Report No.** 2 (FY21)

LELY GOLF ESTATES BEAUTIFICATION, M.S.T.U.

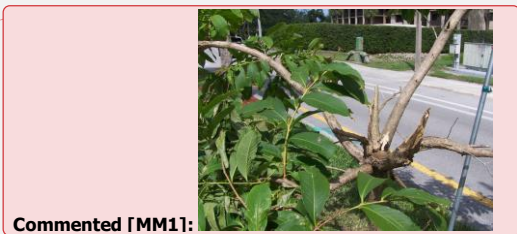
<u>Median #2</u>					No major issues observed.	
<u>Median #3</u>	X	X			(2) Washingtonia palms @ address 105 remain in the median for possible removal.	Deferred into October
		X	X	5	Second Queen's Crape Myrtle tree from the west end of median has damaged main trunk and needs to be replaced. (photo)	
	X	X	X	18	At address 105: Expand the Plumbago bed 8 ft. both eastward and 12 ft. westward to add (12-14) Plumbago 3 gal. (9) plants to the west & (5) plants to the east (6) on east end and (8) on west end. Will require (4) additional spray sprinkler heads and (3) bubblers locations with (2) adjustable flood bubblers per tree.	Committee Approved: Yes, 5/16/19. 7/6/20 M&A Recommend doing installation of Plumbago shrubs. Two turf areas will also need to be removed. 9/30/20 M&A: Turf areas removed bed prepared for planting shrubs.
<u>Median #4</u>		X	X	2	On west end: Recommend adding (15) 1 gal. Perennial Peanut 'Golden Glory' where existing peanut is missing.
