PELICAN BAY SERVICES DIVISION

NOTICE OF PUBLIC MEETING

JANUARY 12, 2021

12.0 SUMMARY

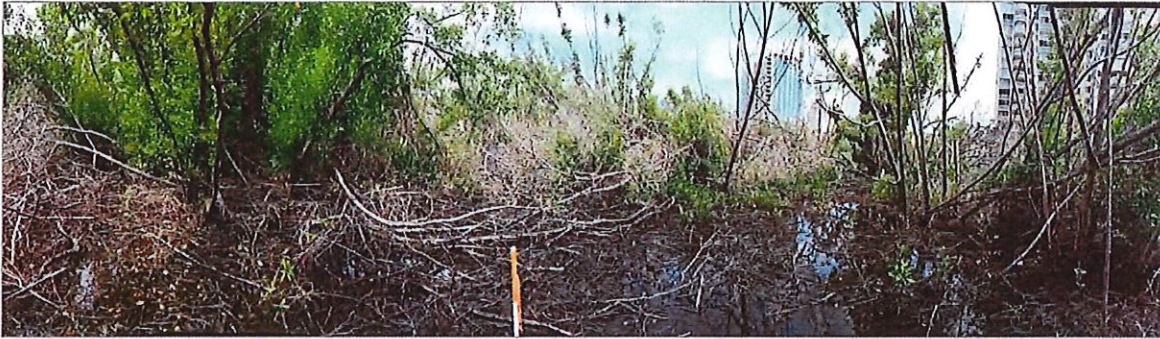
Photo Station 2 panorama facing north - September 11, 2018

3.2.23 Photo Station 2

This station is located north of Photo Station 1, east of Inner Clam Bay and approximately 200 feet off the berm. This station was installed and marked with a PVC pole and flagging tape on March 7, 2018. It was added as a fourth station after the other three were already installed. It was in a high Hurricane Irma (2017) impact zone. The plot has shown increased recruitment since, with an intense burst of white mangrove recruitment in 2020. Channel maintenance in the surrounding area could potentially lead to continued improved health of the area.

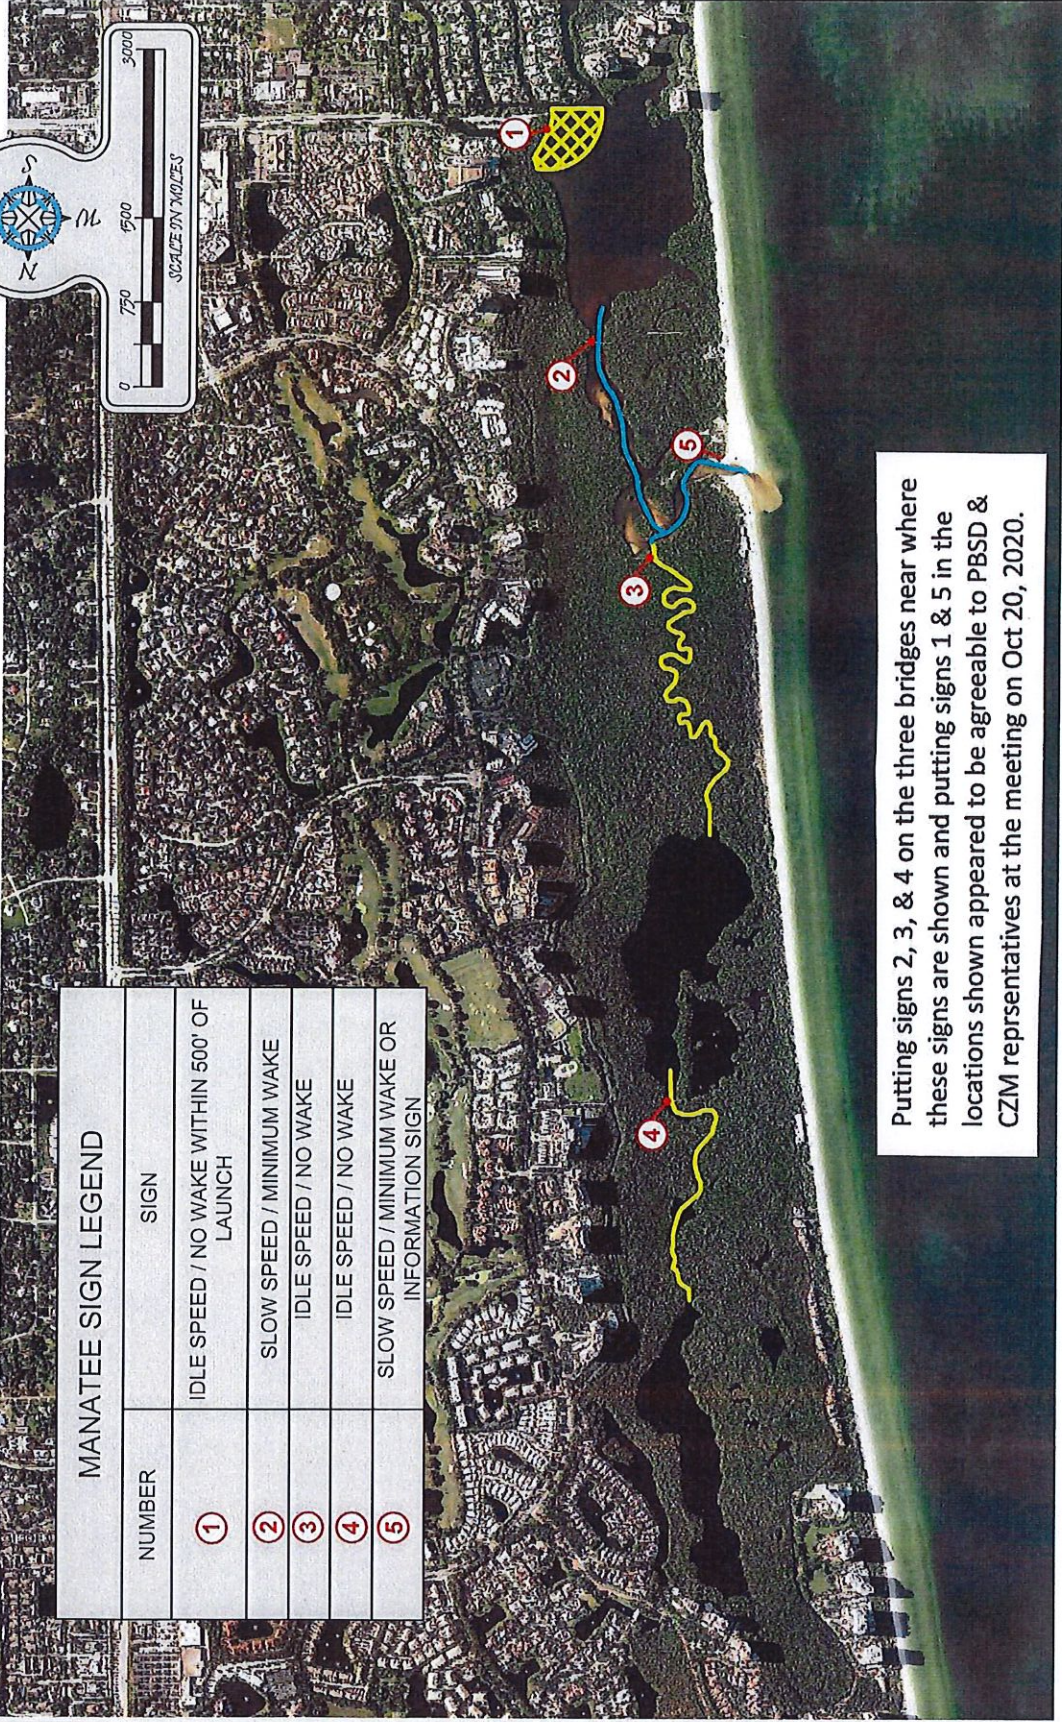
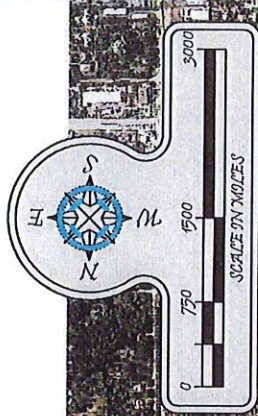
SPEED ZONES AND SIGNAGE LOCATIONS

MANATEE SIGN LEGEND	
NUMBER	SIGN
①	IDLE SPEED / NO WAKE WITHIN 500' OF LAUNCH
②	SLOW SPEED / MINIMUM WAKE
③	IDLE SPEED / NO WAKE
④	IDLE SPEED / NO WAKE
⑤	SLOW SPEED / MINIMUM WAKE OR INFORMATION SIGN

Putting signs 2, 3, & 4 on the three bridges near where these signs are shown and putting signs 1 & 5 in the locations shown appeared to be agreeable to PBSD & CZM representatives at the meeting on Oct 20, 2020.

Ms. O'Brien commented that she recently attended a meeting with Mr. Hall, Mr. Coleman, Ms. Jacob, and County Coastal Zone Management (CZM) staff to discuss obtaining speed restriction signage for Clam Bay. She noted that ultimately PBF approval is required for all Clam Bay signage. Mr. Hall commented that putting signs on the three bridges, a sign at the kayak launch, and a sign on the PBF beach were discussed at the meeting and that we will continue to work with CZM staff to achieve our goal of obtaining all the signage that we are entitled to. The County is suggesting that all signs should say "slow speed" instead of "idle speed."
