2019 CENTRAL MARCO BEACH REGRADE PROJECT 2.5-YEAR MONITORING SUMMARY

DEP PERMIT 0235209-008-JM USACOE PERMIT SAJ-2016-01224(IP-WDD)

PREPARED BY
HUMISTON & MOORE ENGINEERS
HM File No. 23065

2019 CENTRAL MARCO BEACH REGRADE PROJECT 2.5-YEAR POST-CONSTRUCTION MONITORING SUMMARY

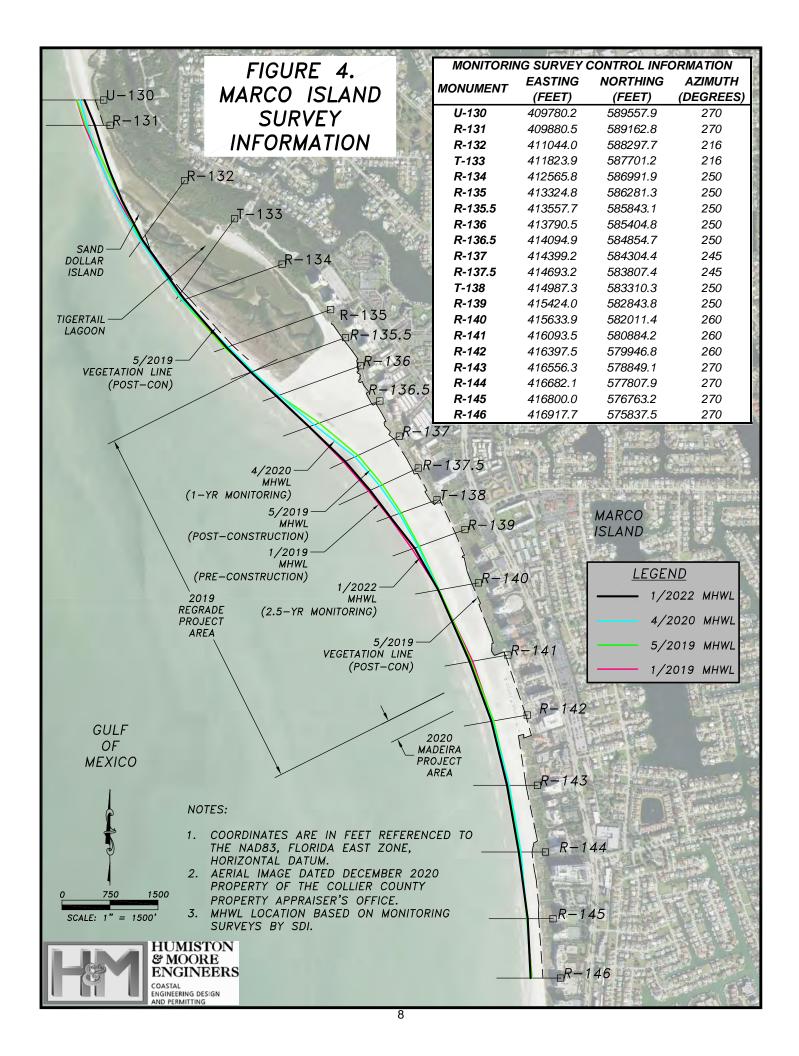
Figure 4 shows the pre-construction, post-construction, one-year, and 2.5-year monitoring survey MHWL locations for the monitoring area overlaid on an ortho-rectified aerial image acquired in December 2020, 20 months post-construction. The shoreline recession on Sand Dollar Island near monuments U-130 and R-131 and the shoreline recovery from R-136 south to R-140 is evident in **Figure 4**. The shoreline recession near U-130 and R-131 is due to overwash of Sand dollar Island from high frequency storms/fronts, the extensive overwash is evident in the beach profiles provided in **Appendix A**, and the center of Sand Dollar Island also feeds the beaches to the north and south.

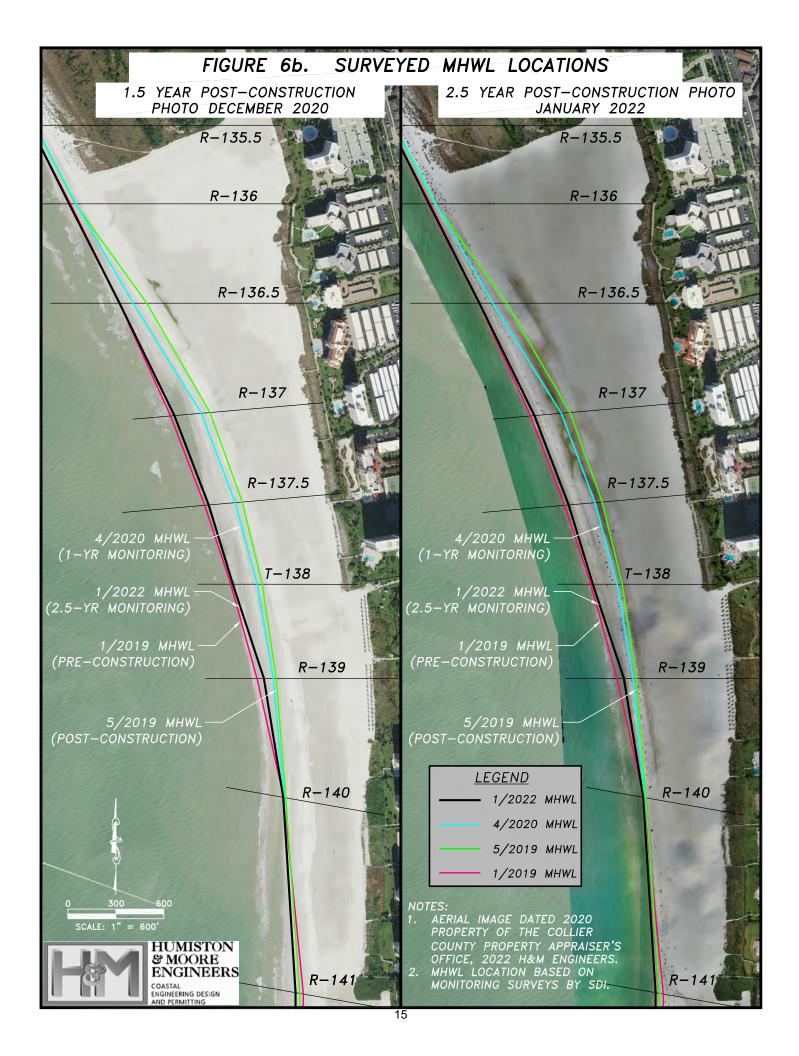
The shoreline and volume change analysis shows the beach has maintained a similar erosion and accretion trend as documented prior to the project. The area north of the project is generally erosional, as identified by the average 50 foot (Table 3a; -51) shoreline loss and associated total volumetric loss of 80,000 cubic yards (Table 3b;-78,340) of sand in the most recent monitoring period. The erosion occurs primarily at the north end of this reach, where Sand Dollar Island continues to migrate landward into the lagoon area. Erosion at the monuments immediately adjacent to the project is comparatively small. The shift in the MHWL is evident in the aerial exhibits provided in **Figures 4, 6a and 6b**.

The raised beach berm along Central Marco Beach provides improved resiliency to the coastal region providing a higher level of storm protection and beach fill for habitat. As the beach continues to accrete, natural processes rework the seaward side. This results in mounding of higher berm levels and valleys along the seaward side that continue to create ponding near the shoreline. This, however, is a much more manageable area than prior to the project and is recommended to be addressed with periodic grading as part of the ongoing beach cleaning operation. The ponding area is evident landward of the berm in the cross sections provided in **Appendix A** and in the January 2022 image in **Figure 6b**.

The project fill area has remained elevated with positive seaward slope. The ponding that was previously observed throughout the wide beach berm rarely occurs. Within the areas of continued accretion, onsite monitoring of the beach is recommended to determine if minor grading of the beach berm is required. Continued annual monitoring shall occur to further evaluate the ongoing changes in this evolving beach system.
