**2020 SOUTH MARCO BEACH NOURISHMENT PROJECT
TWO-YEAR POST-CONSTRUCTION
ANNUAL MONITORING SUMMARY**

April 2022

**DEP PERMIT 0235209-008-JC
USACOE PERMIT SAJ-2005-2726(SP/MOD-MMB)**

PREPARED BY
HUMISTON & MOORE ENGINEERS
HM File No. 29018

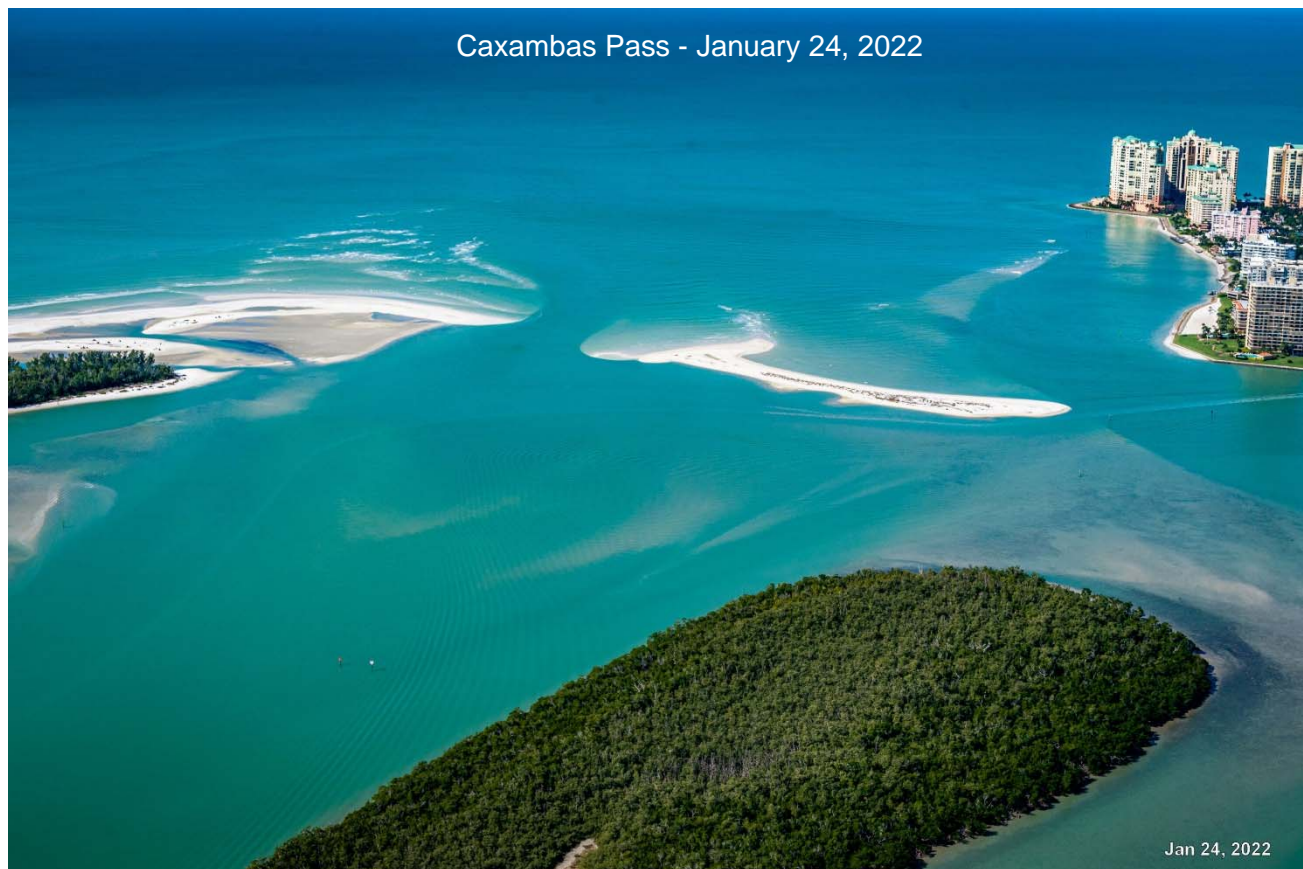
**FIGURE 4.
MARCO & KICE
ISLAND SURVEY
INFORMATION**

A plan view of the physical monitoring area is shown in **Figure 4** including DEP reference monuments R-139 south to G-5 on the northern side of Caxambas Pass, K-1 & K-2 south of the pass on Kice Island, the fill, and borrow areas. The survey report for the January 2022 monitoring survey by SDI is provided in **Appendix C-1**. The analysis in this monitoring report is based on data from the surveys listed below and shown graphically on the beach profiles provided in **Appendix C-2**.

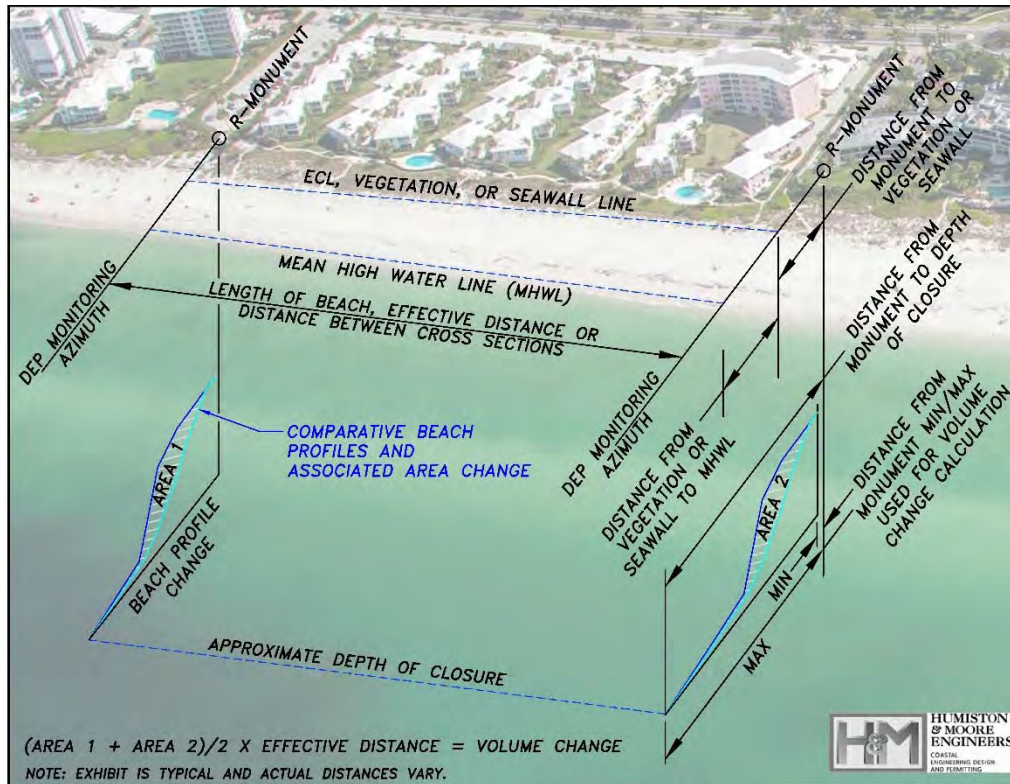
Figure 5. Schematic Diagram for Typical Shoreline and Volumetric Change Analysis

Figure 5 is a schematic depiction of the elements involved in the analysis of shoreline and volume change in this report. Two adjacent DEP reference monuments and associated monitoring azimuths are shown along with the mean high water line (MHWL) and approximate DOC. Also shown are comparative beach profiles at the adjacent monuments and the associated area change between the monitoring survey profiles to be compared. Shoreline change is the difference in the beach width for different monitoring surveys measured at the MHWL. Volumetric change, determined by the formula shown (at the bottom of the figure) for the average *end area method*, utilizes the cross-sectional area change for different monitoring surveys at adjacent monuments and the length of beach between those monument profiles. The comparative profiles are analyzed from the landward extent of the survey data to the approximate depth of closure as shown in the figure and **Table 2a**.

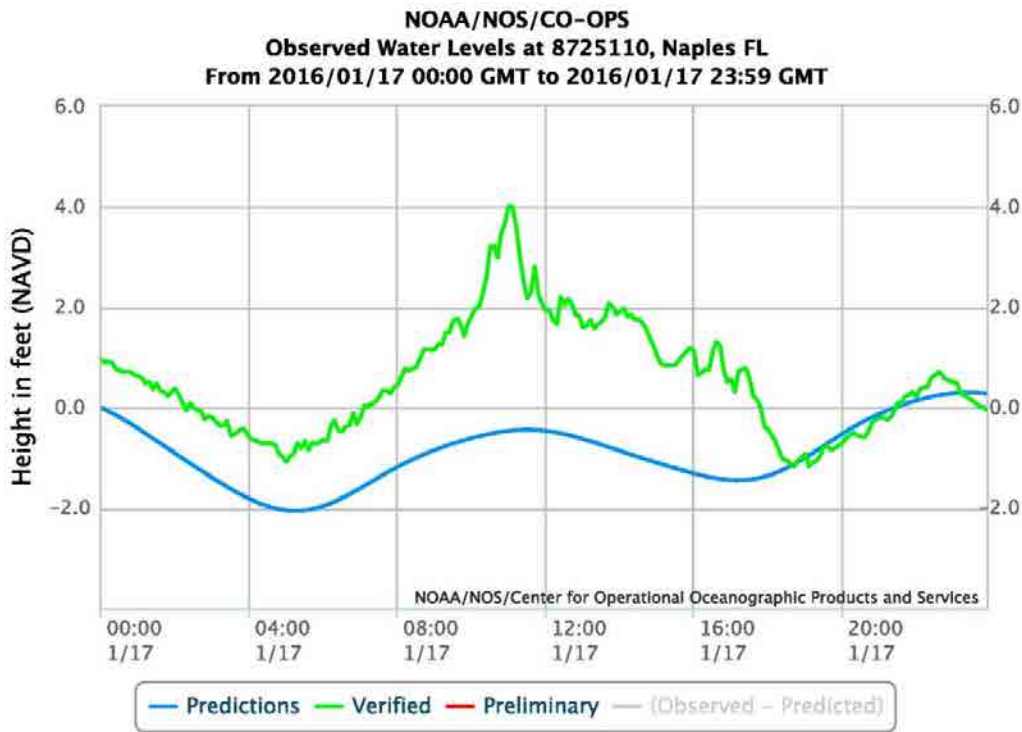
Figure 2. Observed Water Level in Naples Florida on January 17, 2016.

The City of Naples experienced a meteotsunami¹ in January 2016. A graph of the observed water levels at the Naples Tide Station on January 17, 2016 documenting the meteotsunami is shown in **Figure 2**.

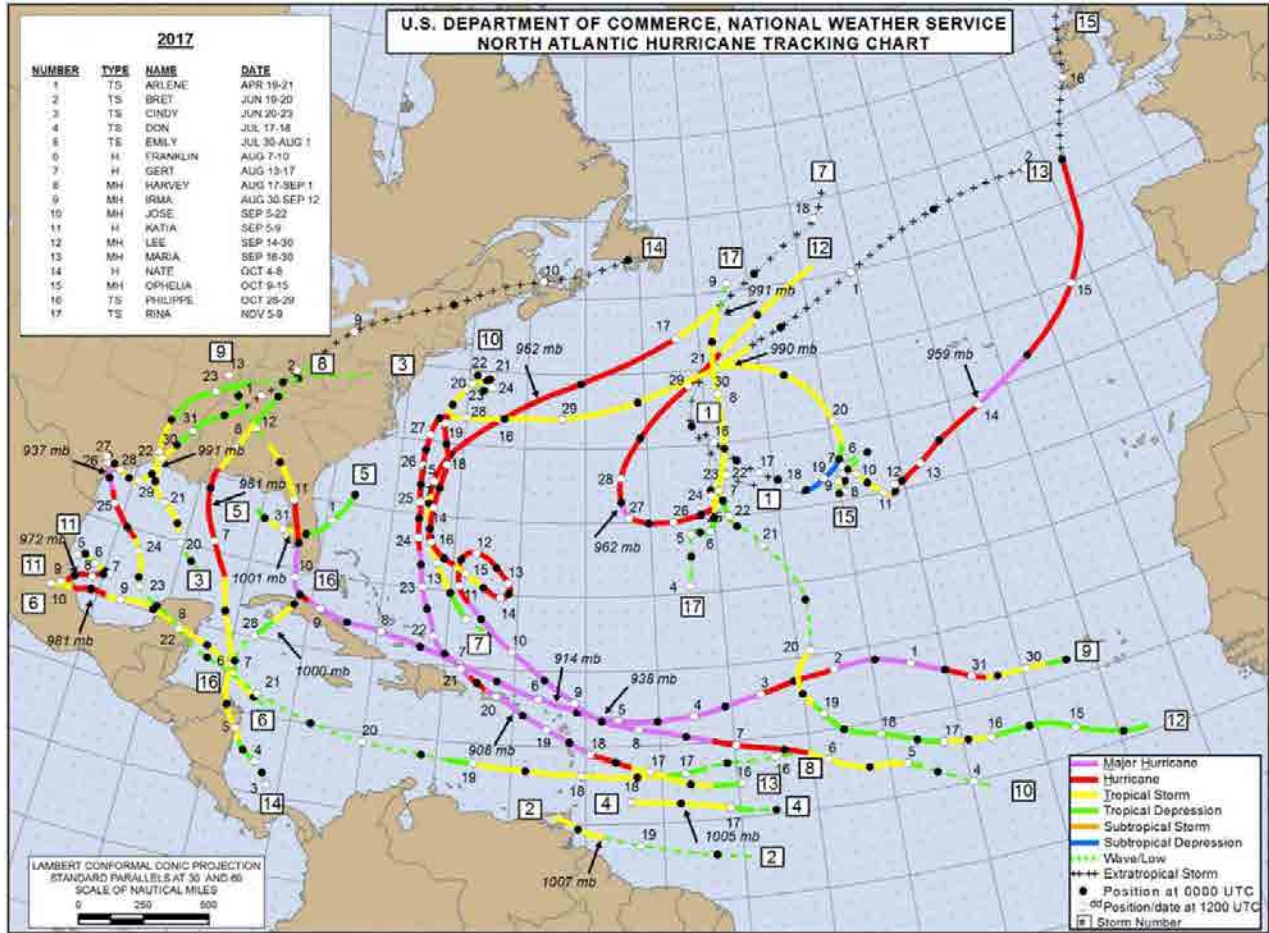
Figure 3. Hurricane Tracking Chart for 2017.

By the time the minimal hurricane reached northwest Florida (on the morning of September 11th), the wind gusts across south Georgia and northwest Florida were generally in the 45 to 60 MPH range (Fig. 8). Conditions improved rapidly once the storm center passed by as strong, dry southwest winds aloft made the system asymmetric, with nearly all of the rain and most of the strongest winds being along and north of the poorly-defined center. Irma weakened to a tropical storm in south Georgia in the afternoon, and further into a tropical depression while moving north across central Georgia in the evening. See the **Figure 3** in this section showing the 2017 storm tracks.

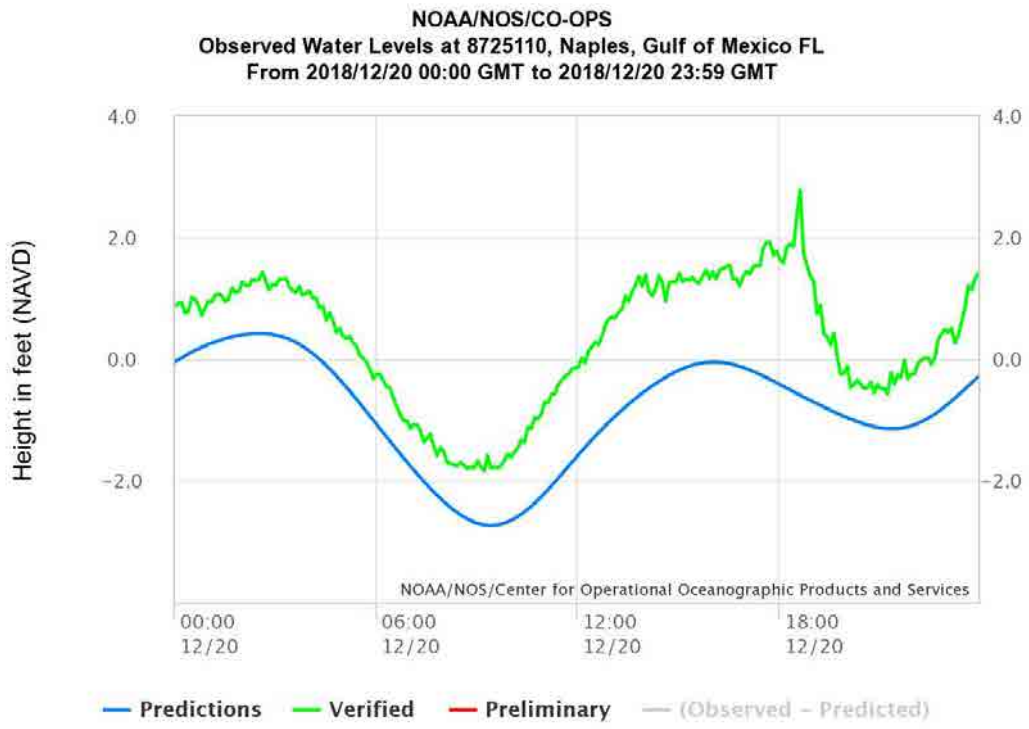
Figure 4. Observed Water Level in Naples Florida on December 20, 2018.

According to the National Weather Service, wind gusts over 50 mph and heavy rain impacted the Naples area on Thursday December 20, 2018. At approximately 1:30 pm another meteotsunami hit the Naples area with wave heights momentarily increasing by 3 feet over the projected level and decreasing rapidly over the next hour. **Figure 4** shows the predicted and actual water levels on December 20, 2018.
