Pier Substructure

Naples Pier - Pier Wood Structure/Deck Replacement Conceptual Estimate

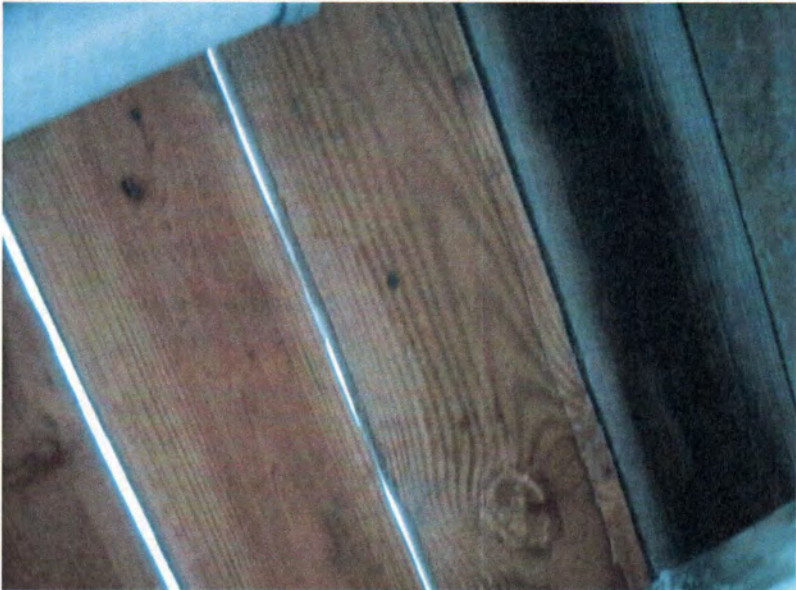
<p><u>Description:</u> Typical view of the substructure framing and the condition of the decking in the vicinity of Pier #12. Note the multiple replacement boards besides the old boards.</p>

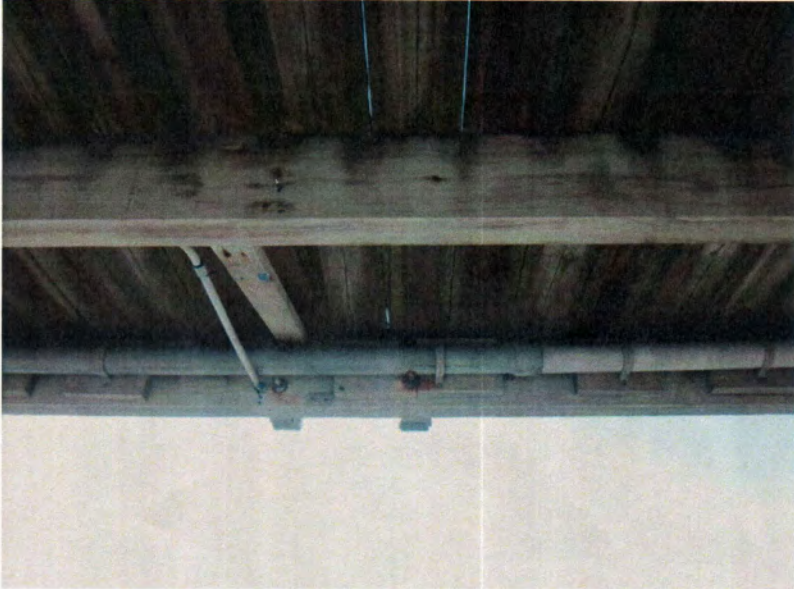
<p>Description: Typical view of the substructure framing and the condition of the decking underside between Pier #9 and Pier#10.</p>

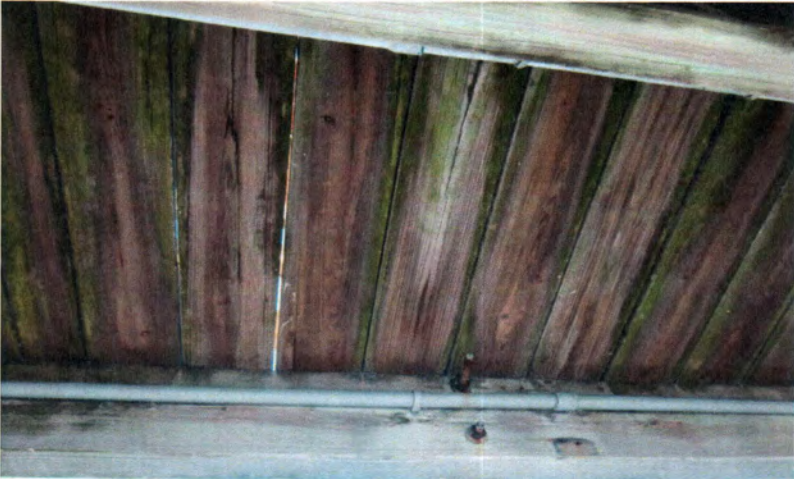
<p>Description: Typical view of the substructure framing and the condition of the decking underside between Pier #10 and Pier#11.</p>

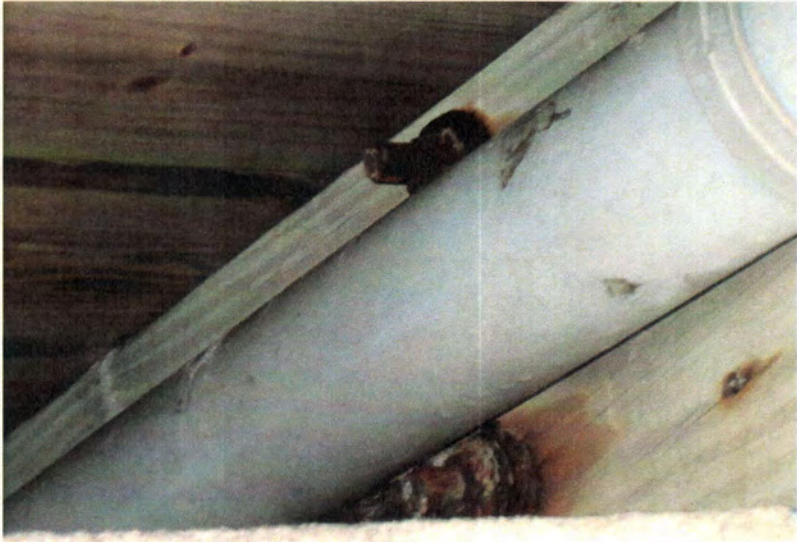
<p><u>Issue:</u> See preceding issue.</p> <p><u>Resolution:</u> See preceding resolution.</p>

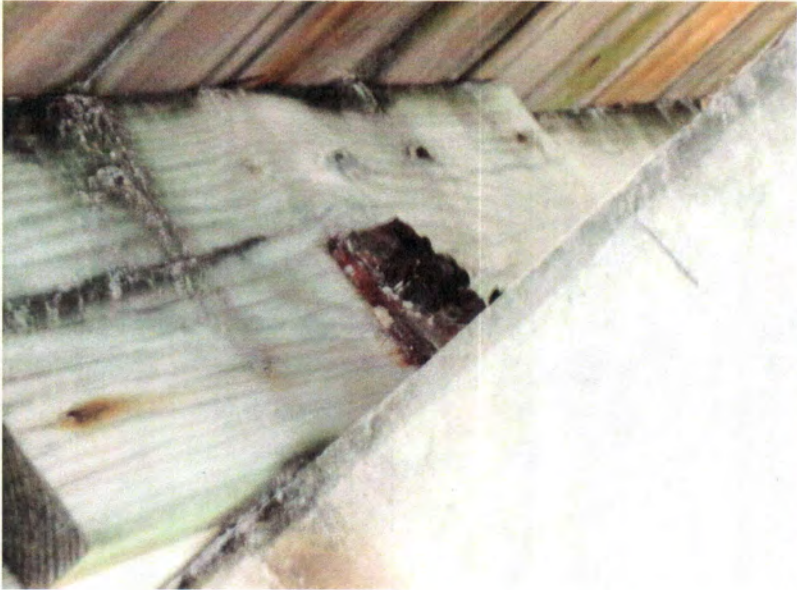
<p><u>Issue:</u> See preceding issue.</p> <p><u>Resolution:</u> See preceding resolution.</p>

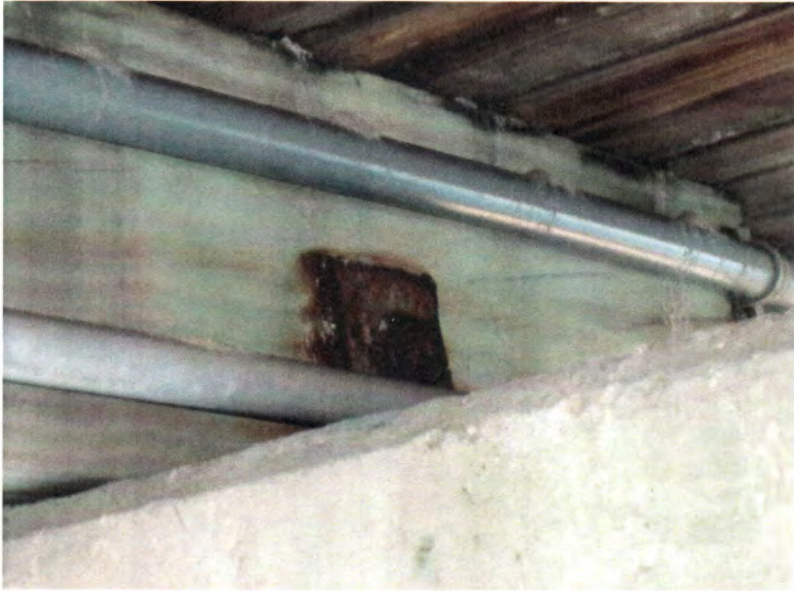
<p><u>Issue:</u> Pier #8. See preceding issue.</p> <p><u>Resolution:</u> See preceding resolution.</p>

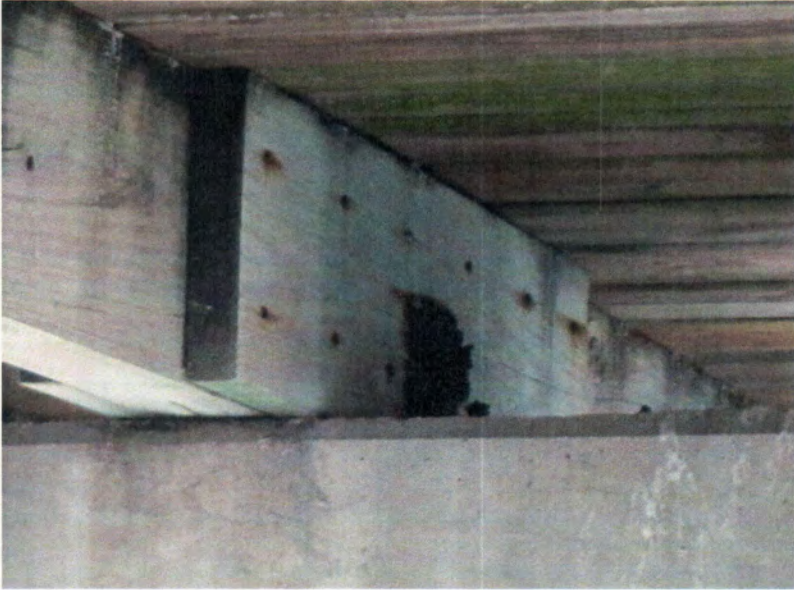
<p><u>Issue:</u> See preceding issue.</p> <p><u>Resolution:</u> See preceding resolution.</p>

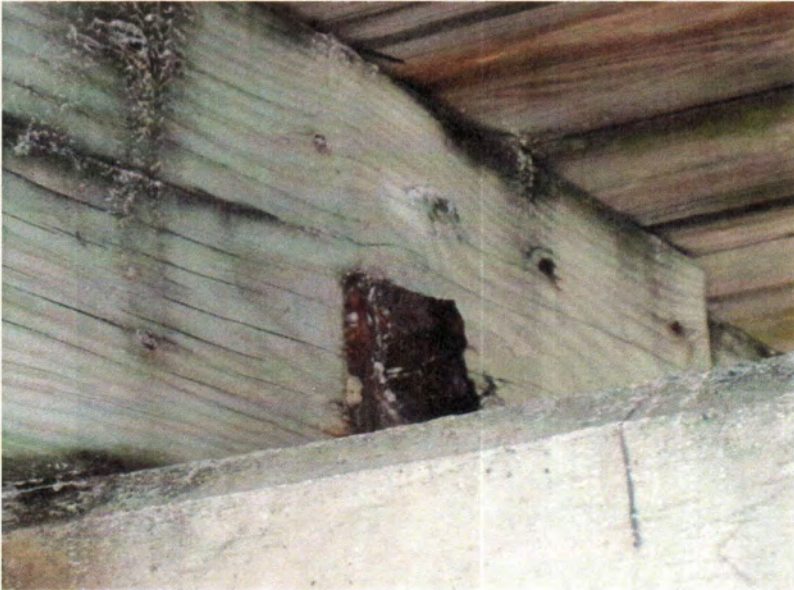
<p><u>Issue:</u> See preceding issue.</p> <p><u>Resolution:</u> See preceding resolution.</p>

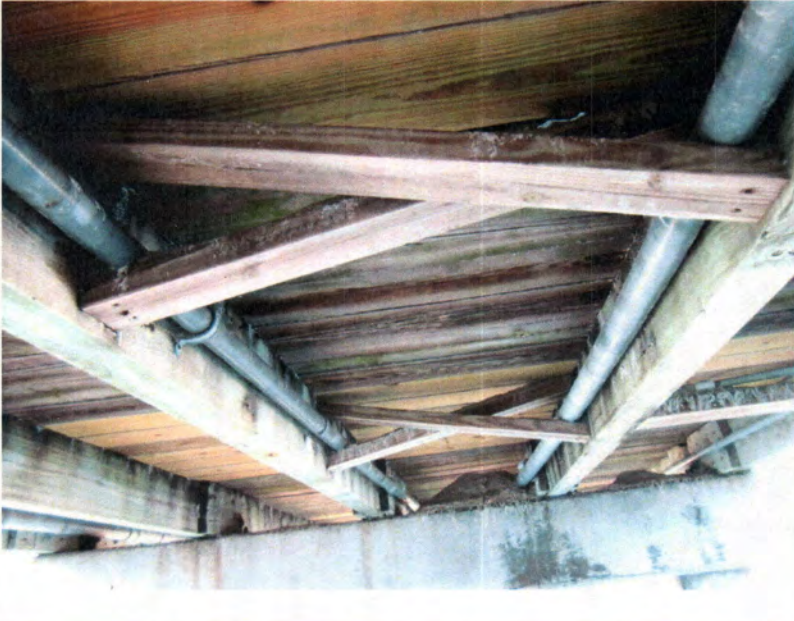
<p><i>Description:</i> Typical view of the substructure framing and the condition of the decking underside in the vicinity of Pier # 7.</p>

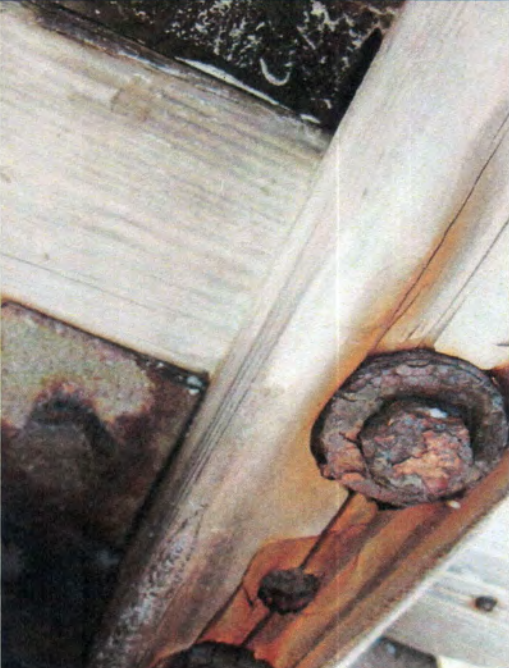
<p>Issue: Sea spray took a heavy toll on metal hardware on the pile cap. The structural integrity and safety of the guardrail system on this part of the pier is questionable, not to mention the structural strength at the connection of the stringers to the pile cap to guard against wind uplift in future storm events.</p> <p>Resolution: Immediately inspect/remove/replace all deteriorated metal hardware.</p>

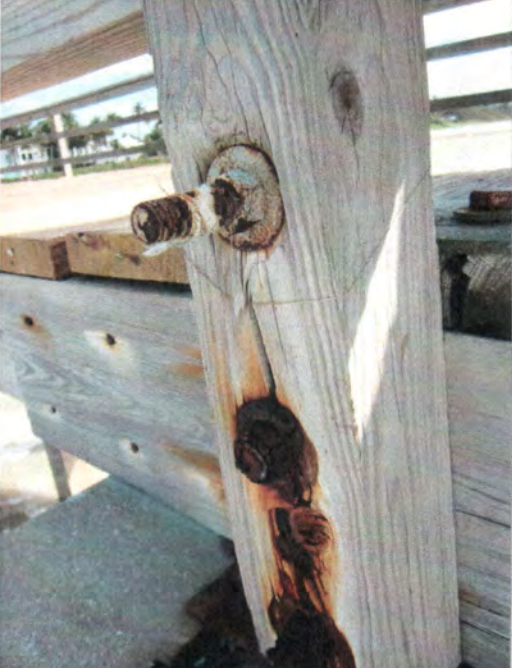
<p>Issue: Similar pattern of rail post and thru-bolt connection issue.</p> <p>Resolution: See preceding resolution.</p>

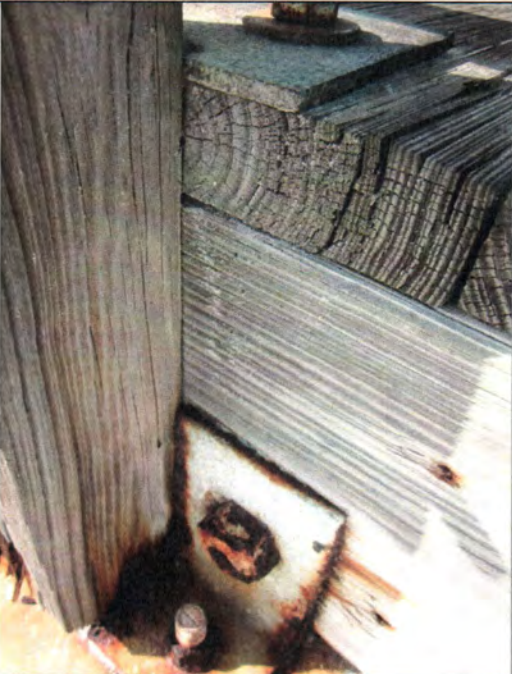
A close-up photograph of the anchor bolt/clip angle assembly connecting the stringer to the pile cap. The image shows a vertical wooden post, a horizontal wooden stringer, and a metal clip angle. A hex-head lag screw is visible, fastening the clip angle to the deck board.	<p>Description: Close-up view of the anchor bolt/clip angle assembly connecting the stringer to the pile cap. Note the hex-head lag screws fastening the rail post clip angle to the deck board.</p>

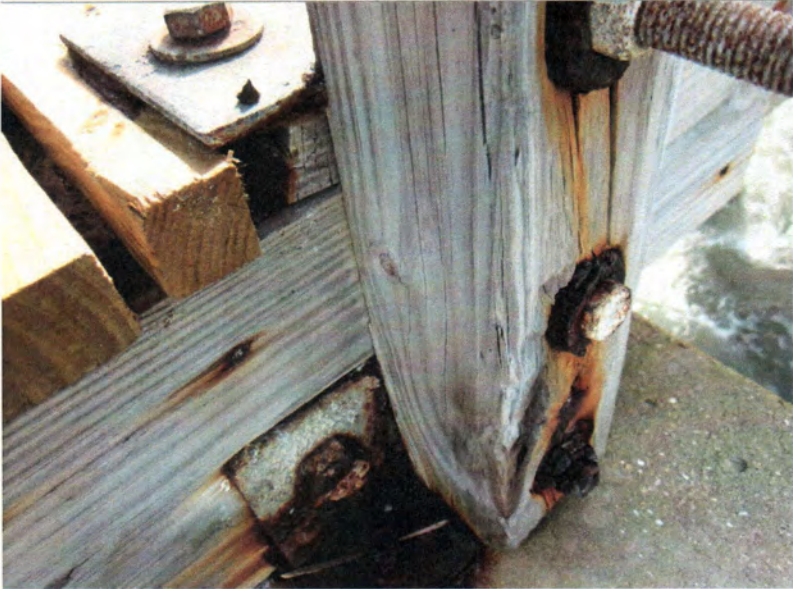
<p><u>Issue:</u> Similar pattern of rail post and thru-bolt connection issue.</p> <p><u>Resolution:</u> See preceding resolution.</p>

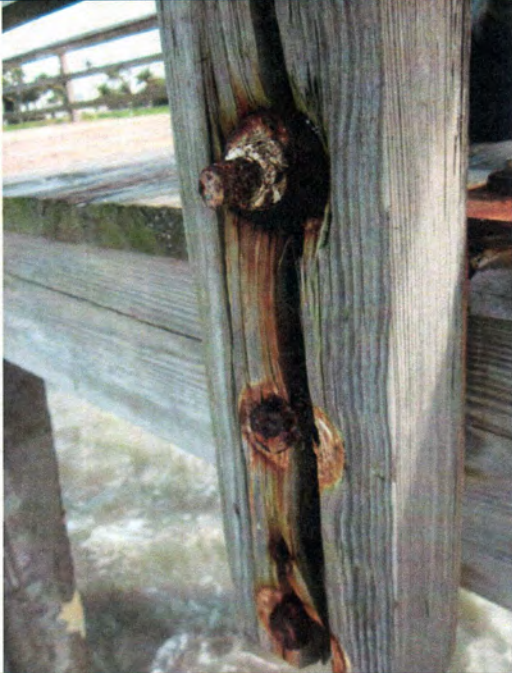
<p><u>Issue:</u> Similar pattern of rail post and thru-bolt connection issue.</p> <p><u>Resolution:</u> See preceding resolution.</p>

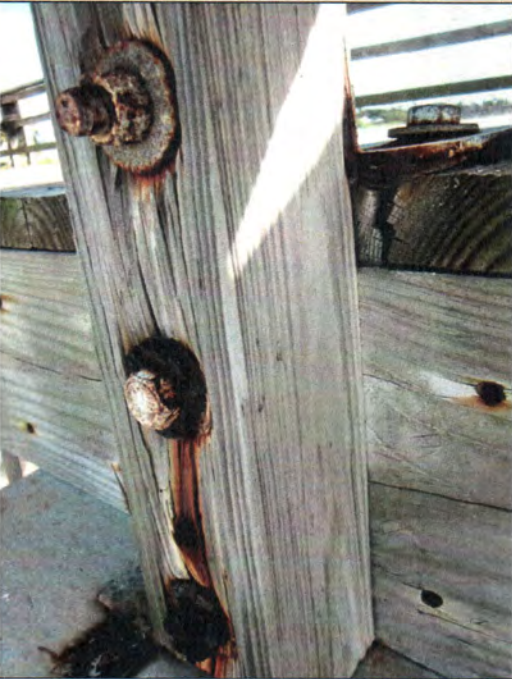
<p><u>Issue:</u> Similar pattern of rail post and thru-bolt connection issue.</p> <p><u>Resolution:</u> See preceding resolution.</p>

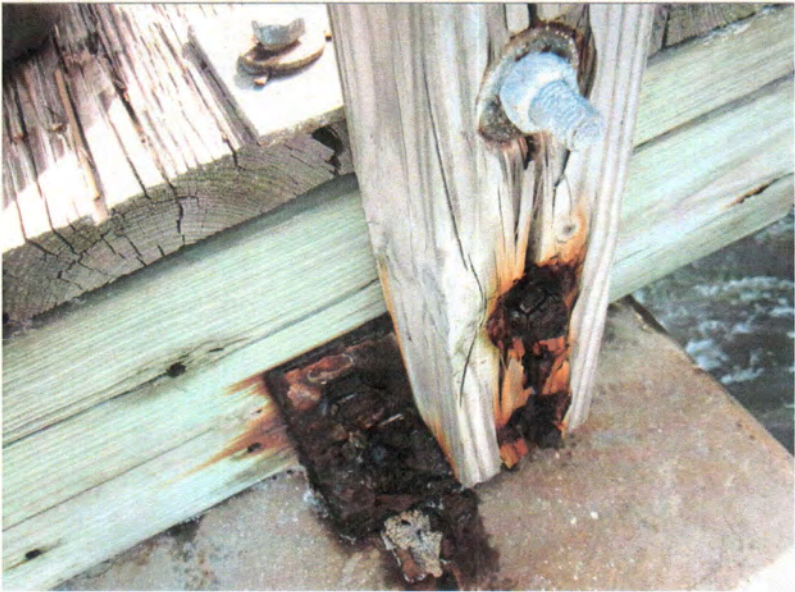
<p>Issue: Similar pattern of rail post and thru-bolt connection issue.</p> <p>Resolution: See preceding resolution.</p>

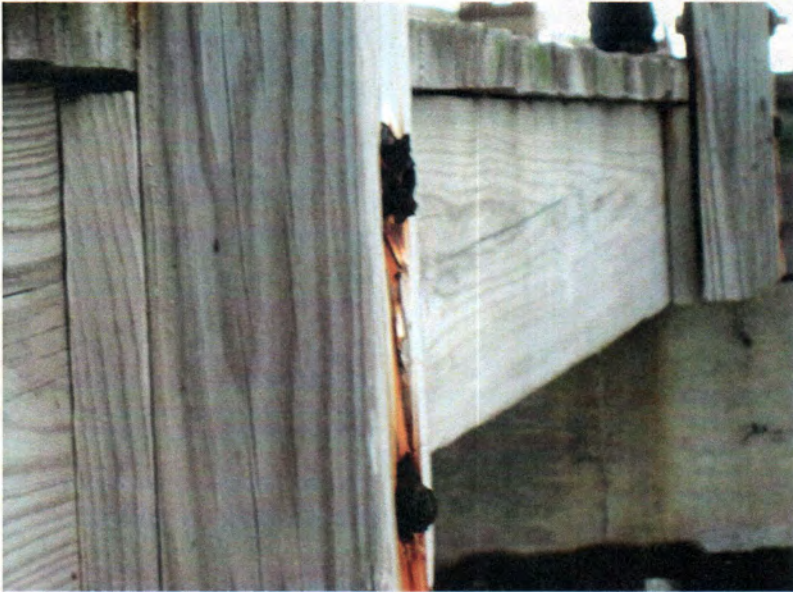
<p><u>Issue:</u> Similar pattern of rail post and thru-bolt connection issue.</p> <p><u>Resolution:</u> See preceding resolution.</p>

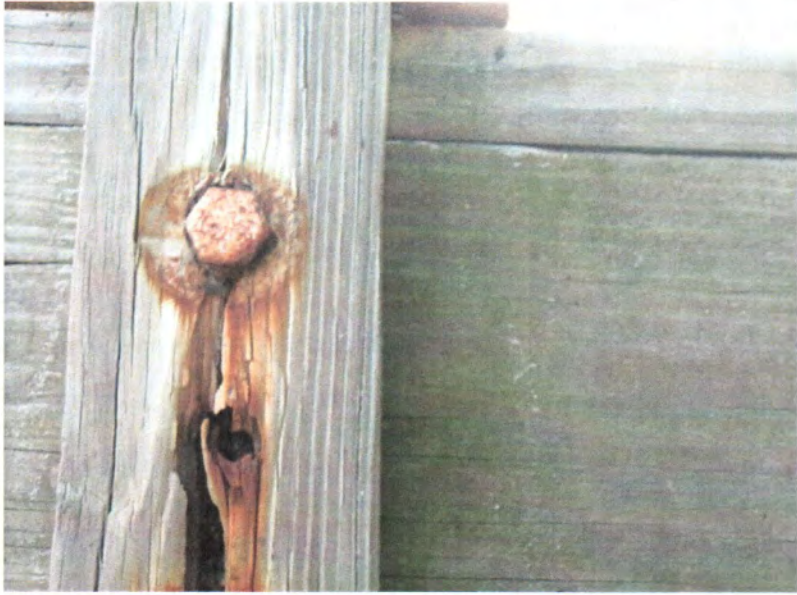
<p><u>Issue:</u> Similar pattern of rail post and thru-bolt connection issue.</p> <p><u>Resolution:</u> See preceding resolution.</p>

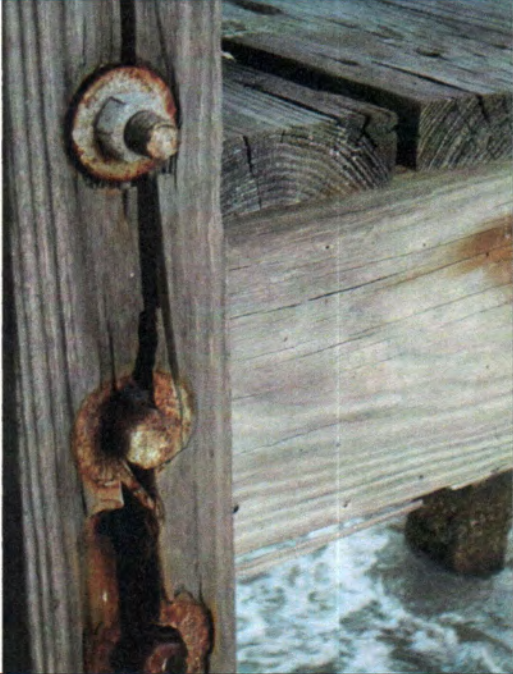
<p><u>Issue:</u> Similar pattern of rail post and thru-bolt connection issue.</p> <p><u>Resolution:</u> See preceding resolution.</p>

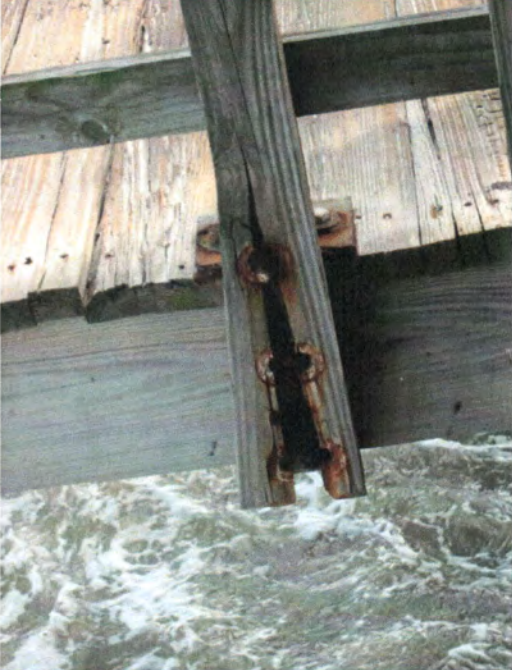
<p><u>Issue:</u> Similar pattern of rail post and thru-bolt connection issue.</p> <p><u>Resolution:</u> See preceding resolution.</p>

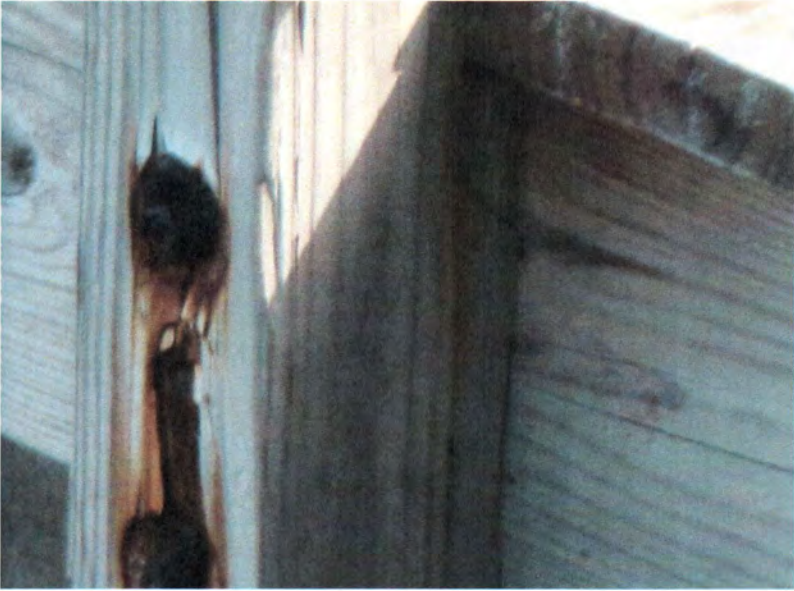
<p><u>Issue:</u> Similar pattern of rail post and thru-bolt connection issue.</p> <p><u>Resolution:</u> See preceding resolution.</p>

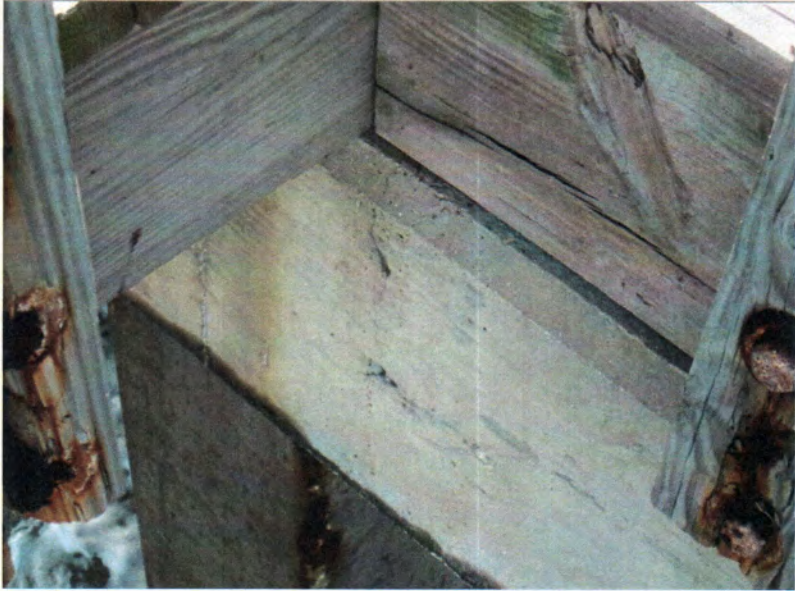
<p><u>Issue:</u> Similar pattern of rail post and thru-bolt connection issue.</p> <p><u>Resolution:</u> See preceding resolution.</p>

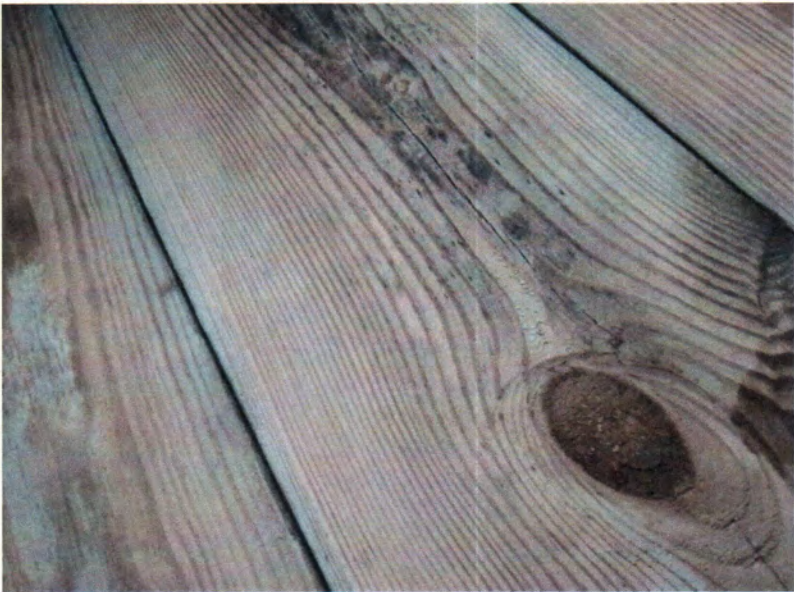
<p><u>Description:</u> Typical view of the substructure framing and the condition of the decking underside in the vicinity of Pier #31.</p>

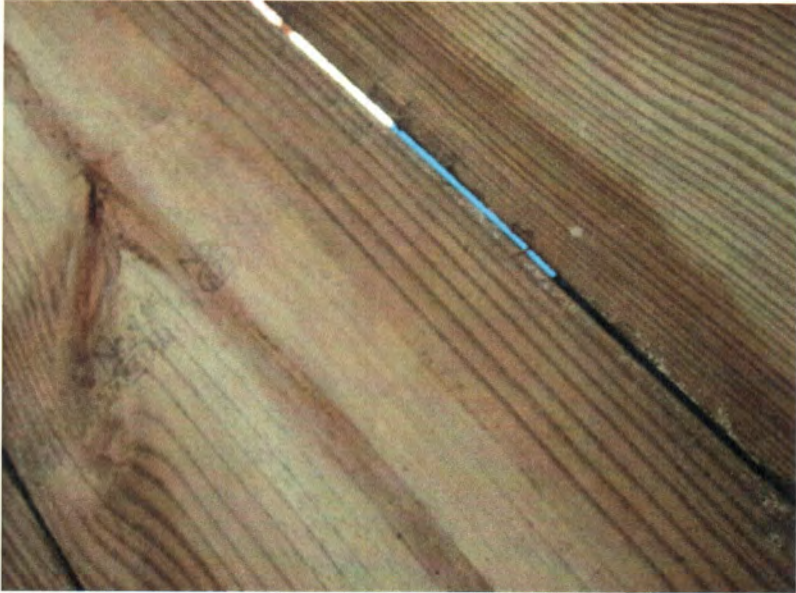
<p>Description: Typical view of the substructure framing and the condition of the decking underside between Pier #31 and Pier #32.</p>

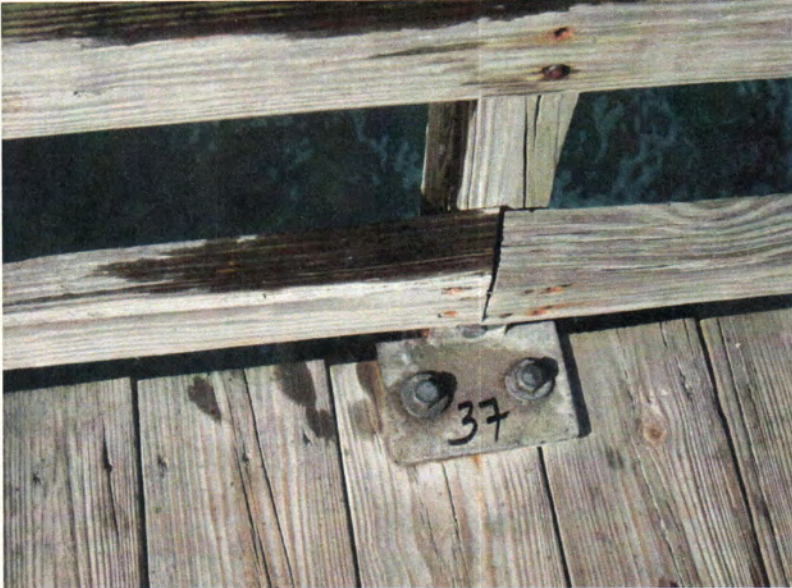
<p>Description: View over Pier #37. Metal hardware from here onward appears to generally fare much better than the previous stations possibly due to recent repair/replacement.</p>

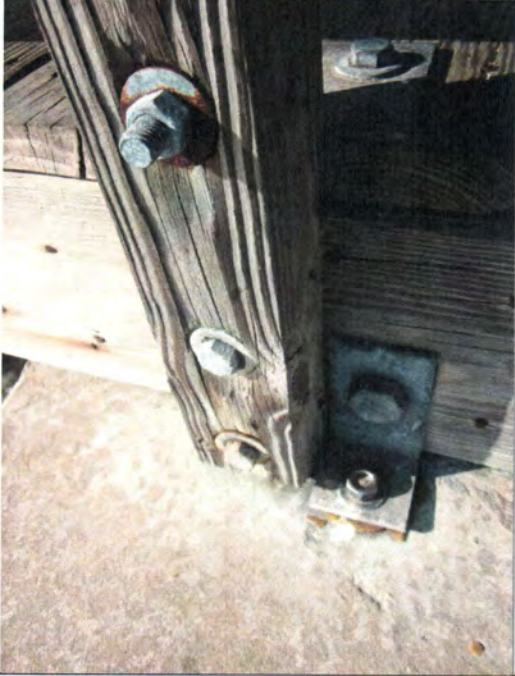
A close-up photograph of a weathered wooden pier post. The post is secured with several metal bolts and nuts. A metal plate is attached to the side of the post. The wood shows signs of aging and wear.	<p>Description: Metal hardware from here onward appears to generally fare much better than the previous stations possibly due to recent repair/replacement.</p>

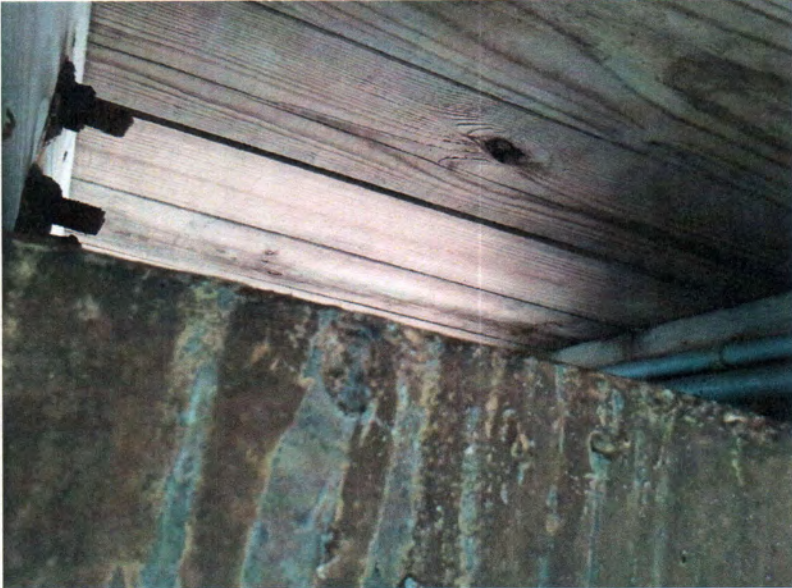
<p>Description: View of the underside at Pier #39. Note the rail post thru-bolt connectors display only mild corrosion.</p>

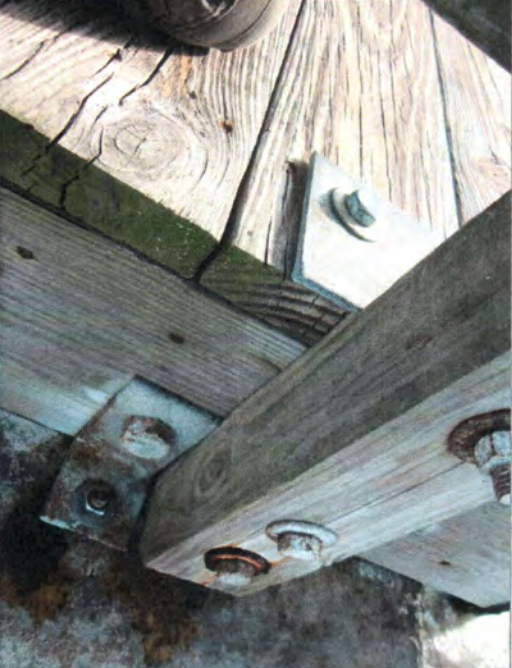
<p>Description: View over Pier #40.</p>

<p>Description: Metal hardware from here onward appears to generally fare much better than the previous stations possibly due to recent repair/replacement.</p>

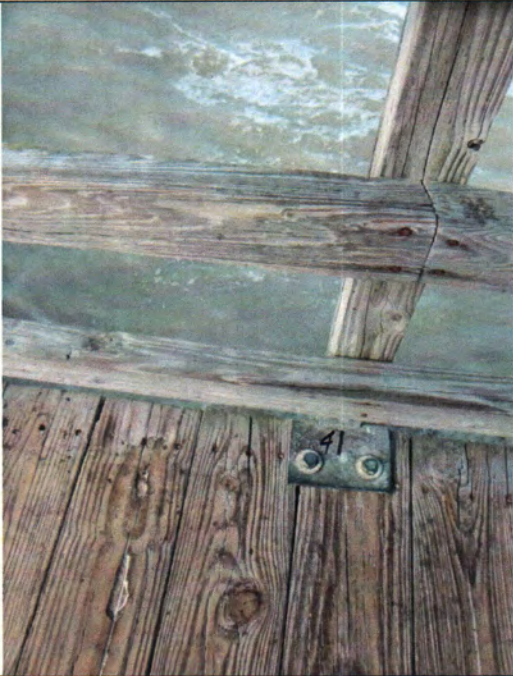
<p>Description: View over Pier #41.</p>

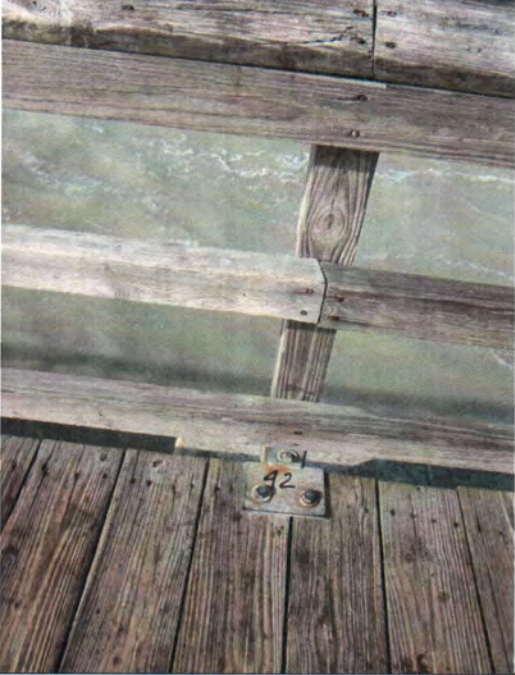
A photograph showing a view over a wooden pier structure. The foreground consists of weathered wooden planks. A metal plate with the number '42' is visible on the planks. In the background, there are several horizontal wooden beams and a vertical post, with a body of water visible beyond.	<p>Description: View over Pier #42.</p>

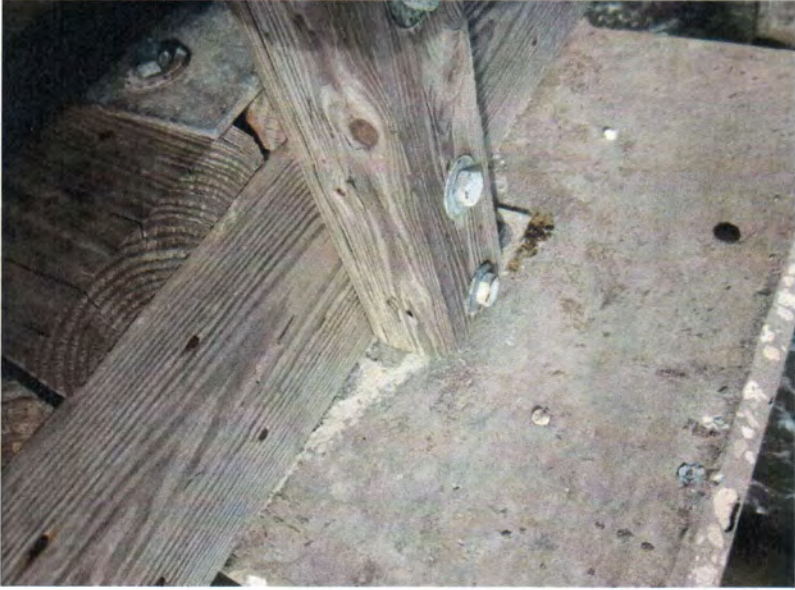
A close-up photograph of the wooden structure's hardware. It shows a wooden beam joined to a metal plate with several bolts. The metal hardware appears to be in good condition.	<p>Description: Metal hardware from here onward appears to generally fare much better than the previous stations possibly due to recent repair/replacement.</p>

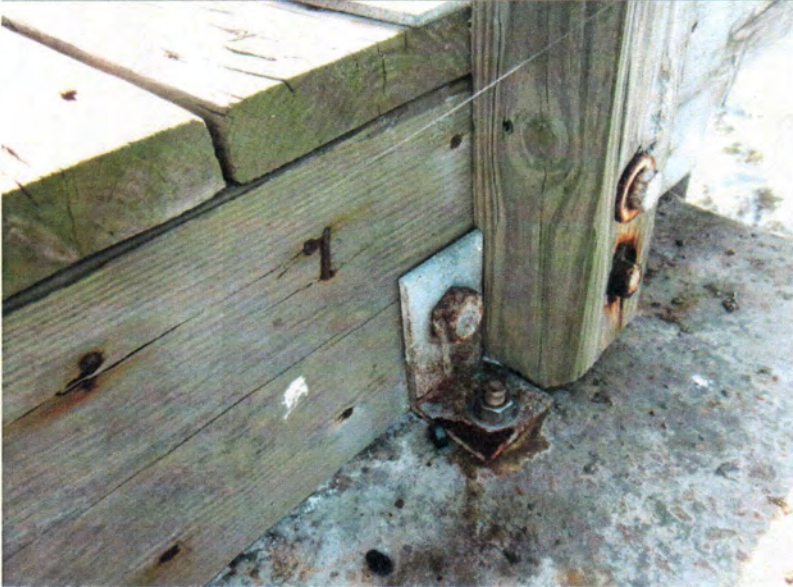
A close-up photograph showing a corner joint of a wooden pier. The wood is weathered and greyish. A metal plate is bolted to the wood, and a large metal nut and washer are visible at the bottom of the joint. The ground below is concrete.	<p>Description: Metal hardware from here onward appears to generally fare much better than the previous stations possibly due to recent repair/replacement.</p>

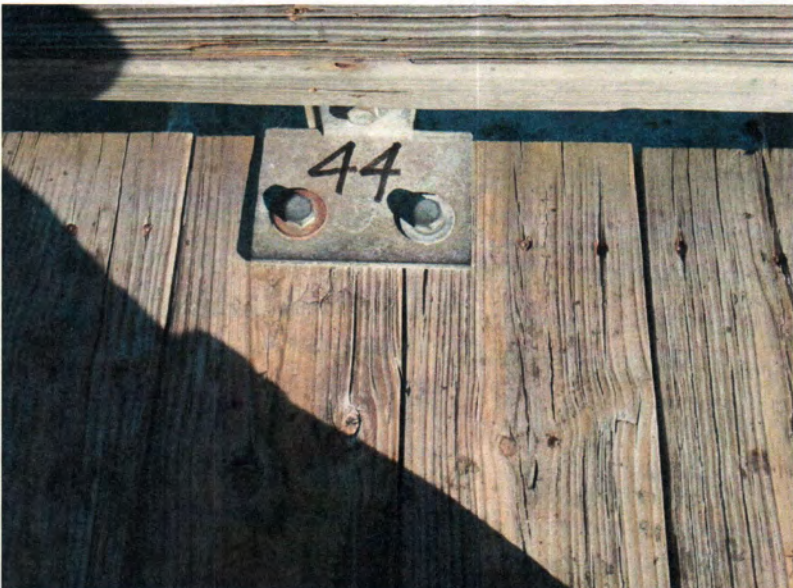
A photograph showing a wooden pier structure. A metal plate with the number '44' is bolted to the wood. The wood is weathered and greyish. The plate has two circular holes. The pier is supported by a concrete base.	<p>Description: View over Pier #44.</p>

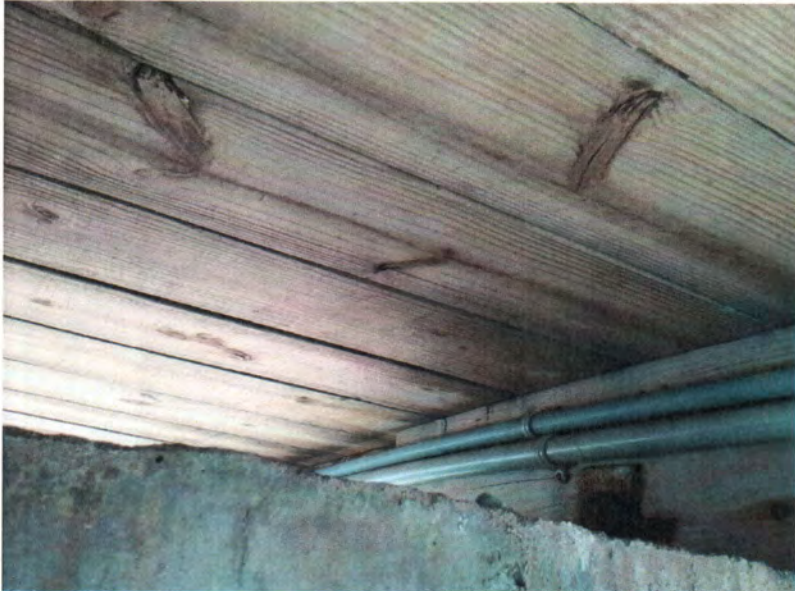
<p>Description: View of the underside at Pier #44. Note the stringer anchor bolt/clip angle displays only mild corrosion.</p>

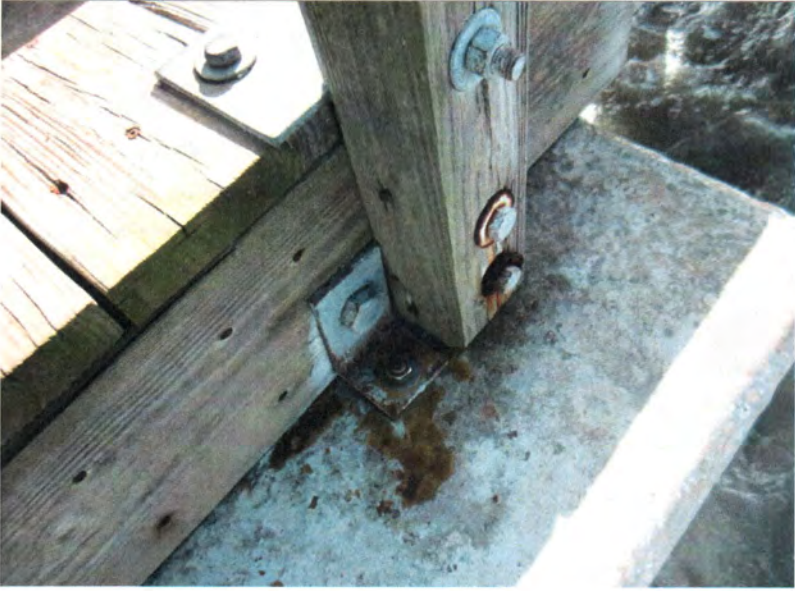
<p>Description: Metal hardware from here onward appears to generally fare much better than the previous stations possibly due to recent repair/replacement.</p>

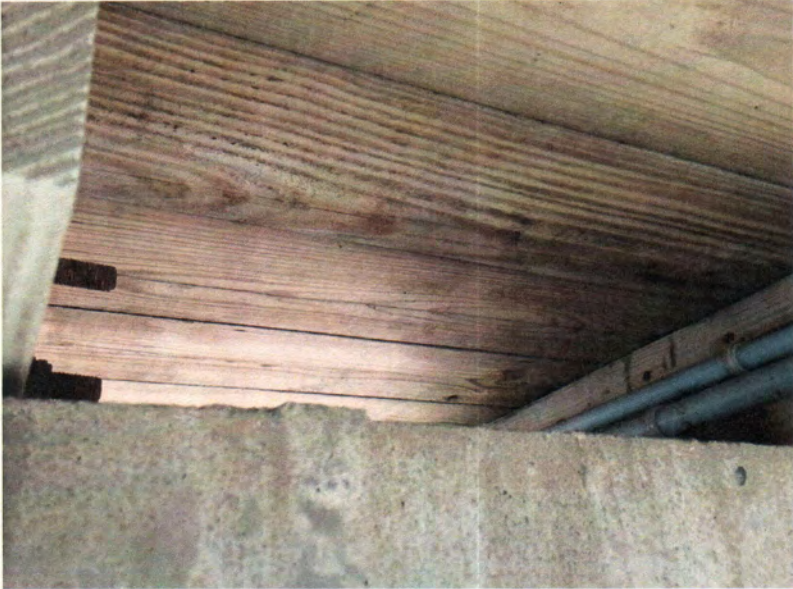
<p>Description: View of the underside at Pier #44. Note the rail post thru-bolt connectors display only mild corrosion.</p>

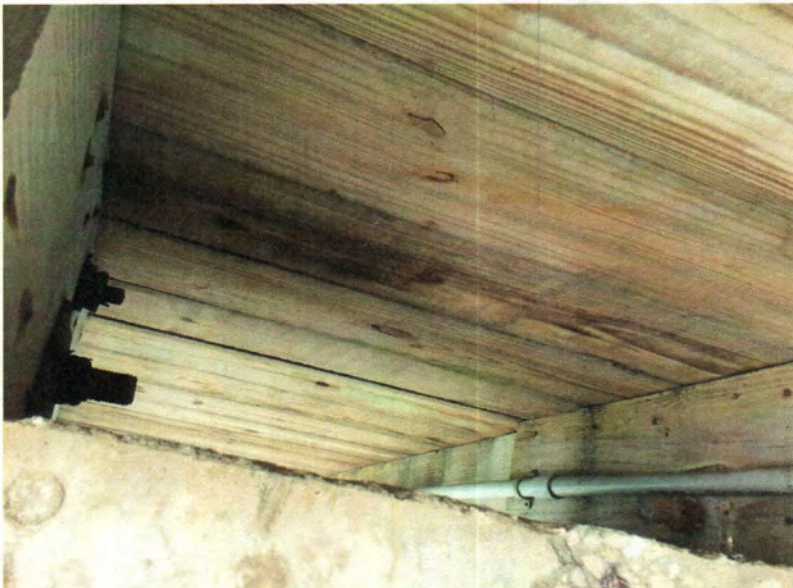
<p>Description: View of the underside at Pier #44. Note the rail post thru-bolt connectors display only mild corrosion.</p>

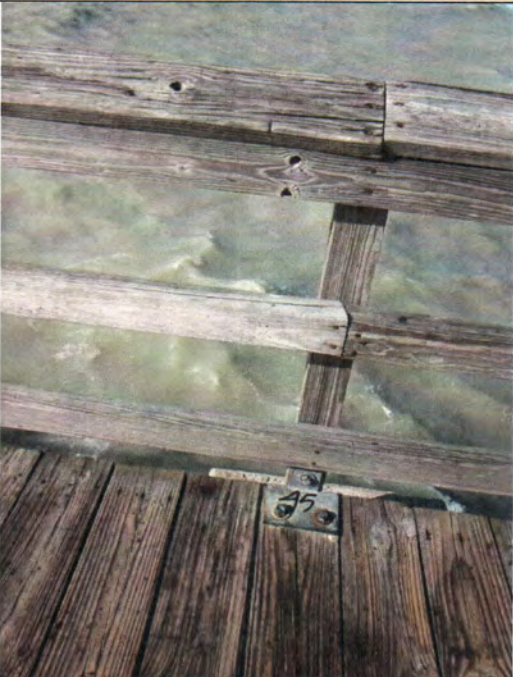
A photograph showing a view over a wooden pier structure. The pier is made of weathered wooden planks and beams. A metal fastener with the number '45' is visible on the deck. The background shows a body of water and a distant shoreline.	<p><i>Description:</i> View over Pier #45.</p>

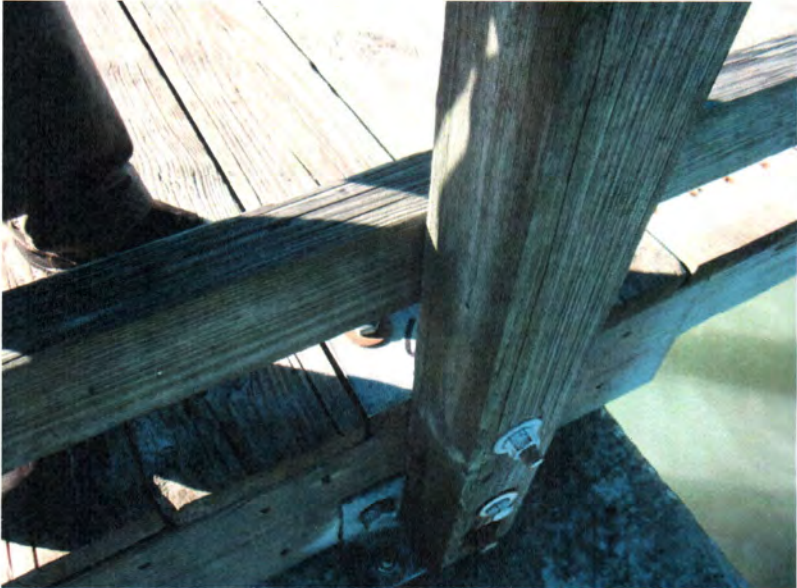
A close-up photograph of the wooden substructure of a pier. It shows a vertical wooden post connected to horizontal beams using metal hardware, including bolts and washers. The wood is weathered and shows signs of use.	<p><i>Description:</i> Metal hardware from here onward appears to generally fare much better than the previous stations possibly due to recent repair/replacement.</p>

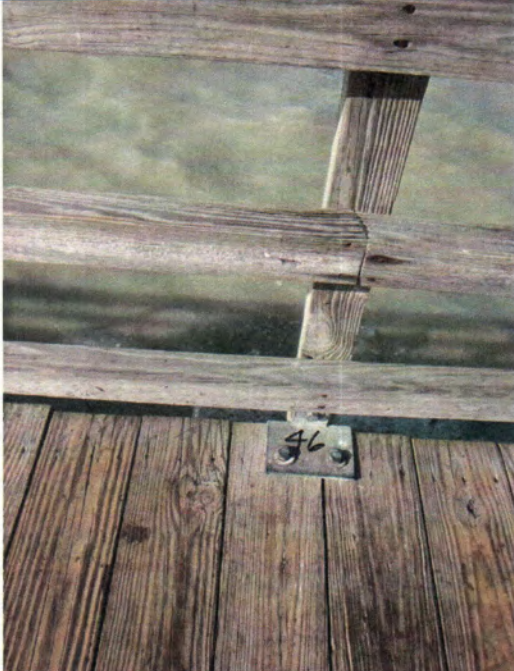
<p>Description: View over Pier #46.</p>

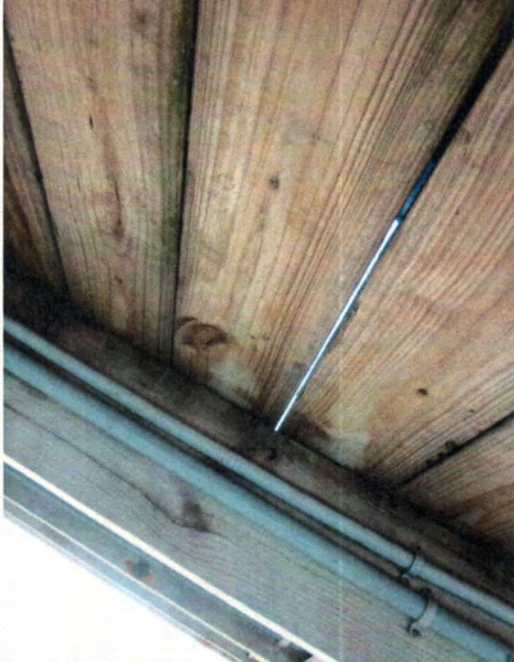
<p>Issue: In stormy day and high waves the deck is being washed in sea spray for the duration. Note the boards are soggy from such weather event.</p> <p>Resolution: Perform periodic inspection of the utility piping below deck. Repair/replace/remove broken piping. Provide new plastic pipe straps with better working strength and durability (i.e. more material thickness/cross-section, mass, etc).</p>

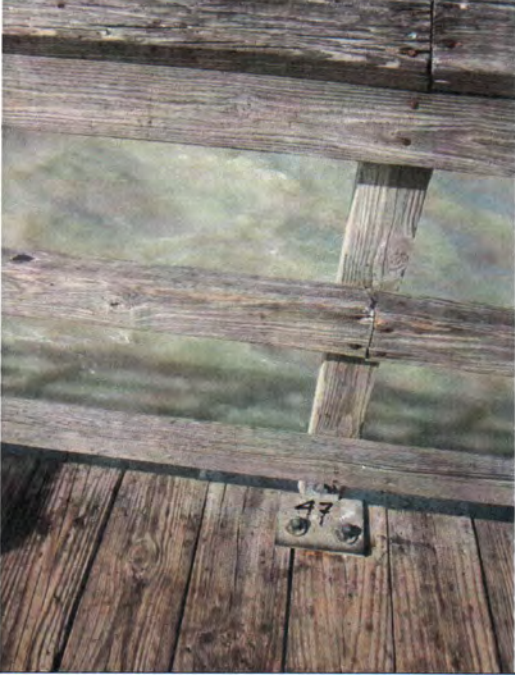
A photograph showing a view over a wooden pier structure. The pier is made of weathered wooden planks and beams. A metal fastener with the number '47' is visible on one of the planks. The background shows a body of water and a cloudy sky.	<p>Description: View over Pier #47.</p>

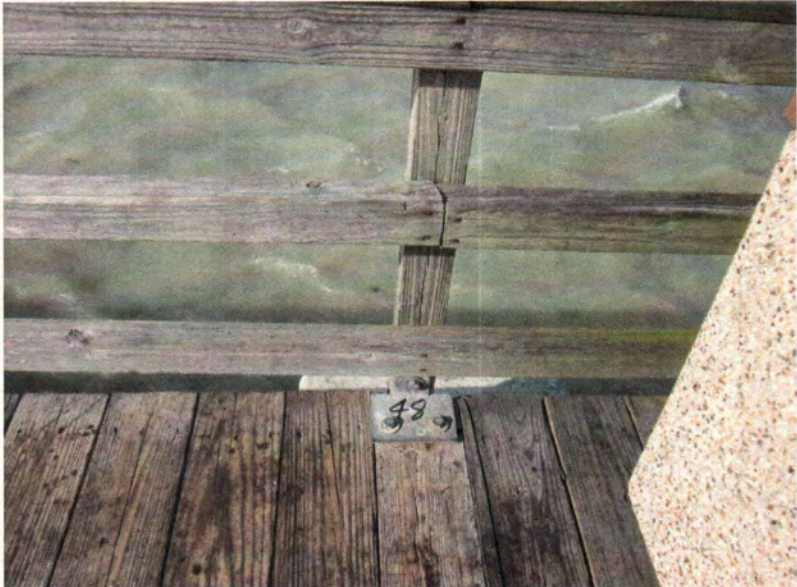
A photograph showing a wooden deck with a metal plate labeled '48' in the center. The deck is made of weathered wooden planks. In the background, there are several horizontal wooden beams and a vertical post. To the right, a concrete structure with a pebbled texture is visible.	<p>Description: View over Pier #48.</p>

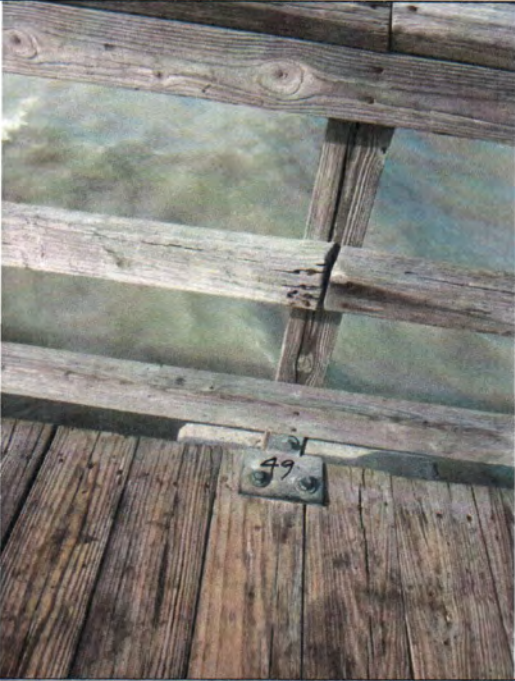
<p><u>Description:</u> View over Pier #49.</p>

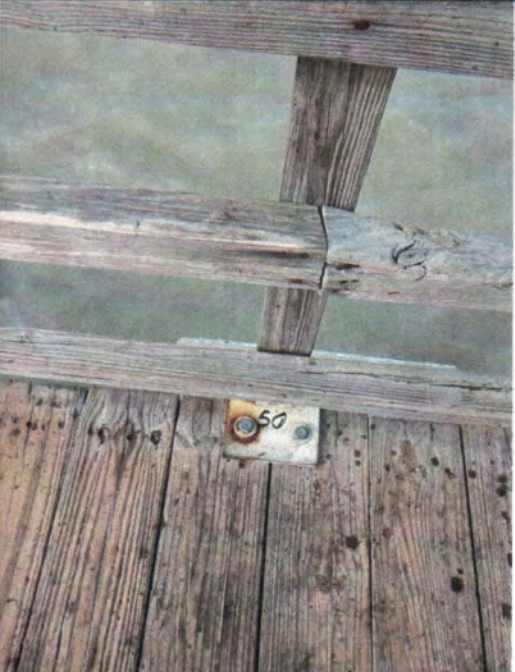
<p><u>Description:</u> View over Pier #50.</p>

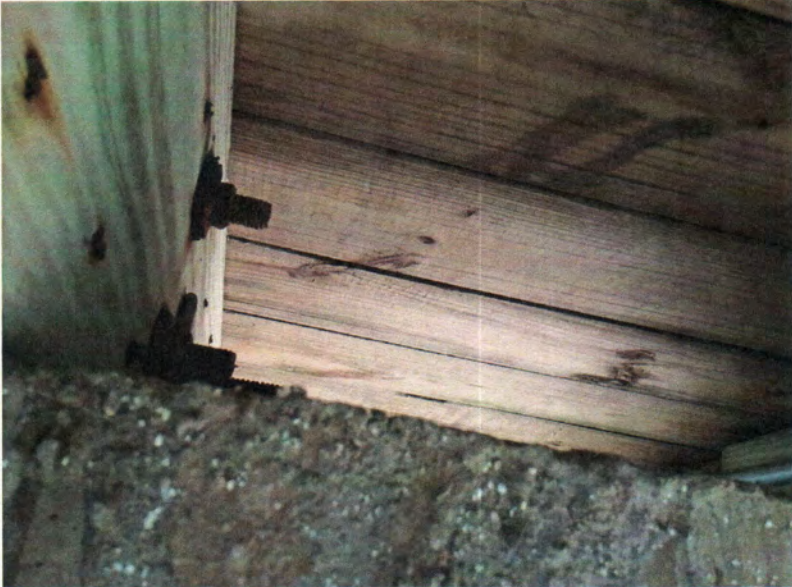
<p>Description: View of the underside at Pier #50. Note the rail post thru-bolt connectors display only mild corrosion.</p>

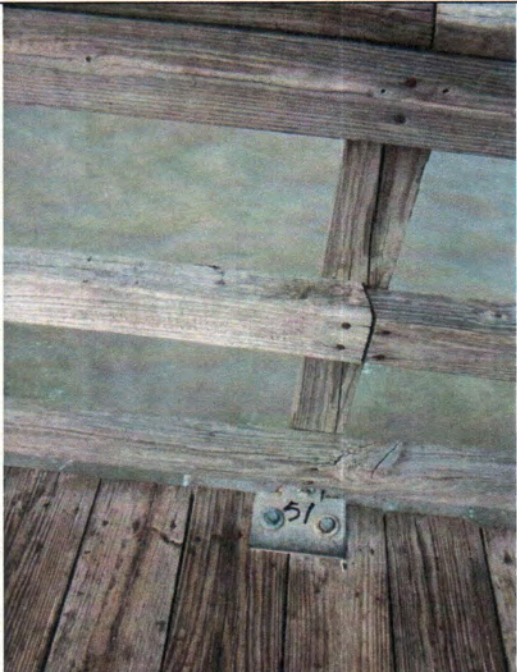
<p>Description: View over Pier #51.</p>

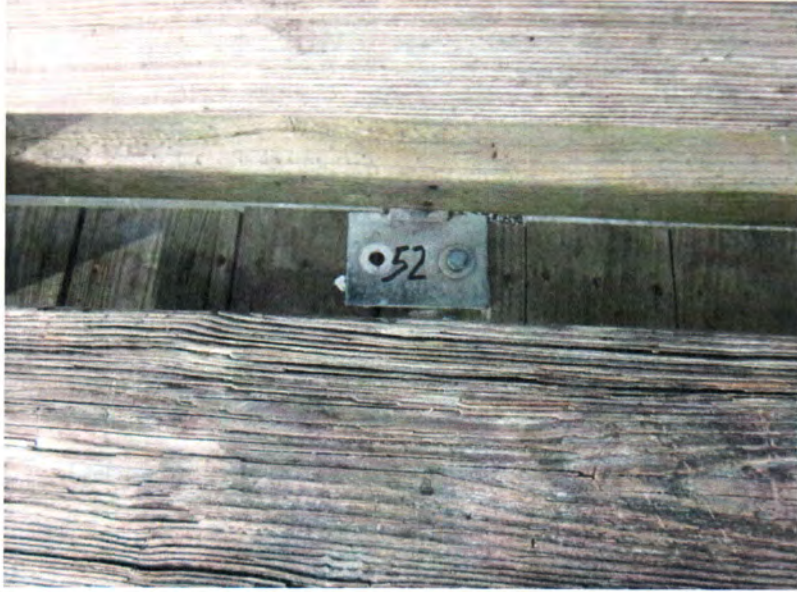
A close-up photograph of a wooden pier structure. A metal plate with the number '52' is attached to a horizontal wooden beam. The wood shows signs of weathering and discoloration.	<p><u>Description:</u> View over Pier #52.</p>

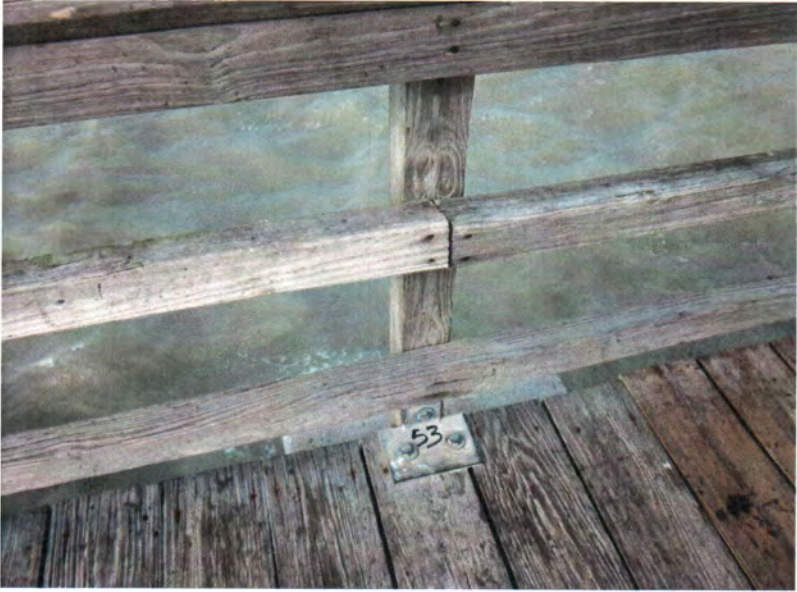
A photograph showing a view over a wooden pier structure. A metal plate with the number '53' is visible on a horizontal beam. The structure consists of several wooden beams and a vertical post, all showing weathering.	<p><u>Description:</u> View over Pier #53.</p>
