Pier Substructure

Naples Pier - Pier Wood Structure/Deck Replacement Conceptual Estimate

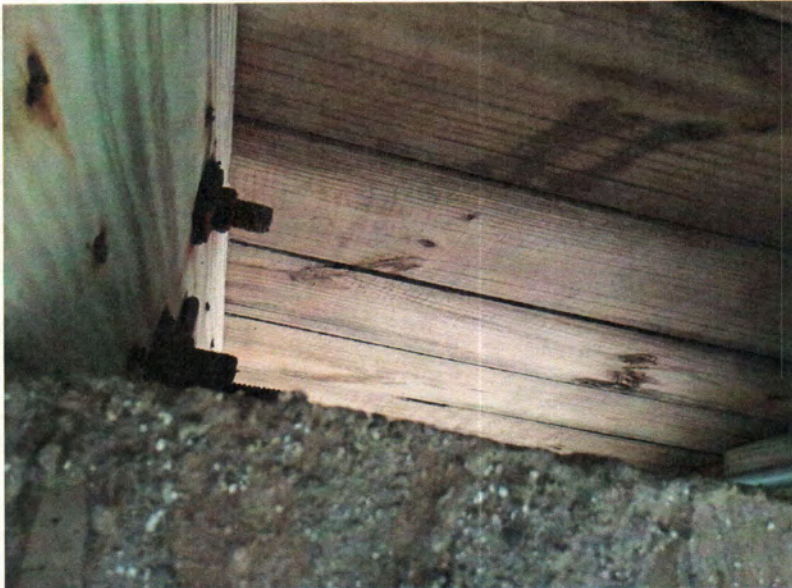
<p>Description: View of the underside at Pier #53. Note the rail post thru-bolt connectors display only mild corrosion.</p>

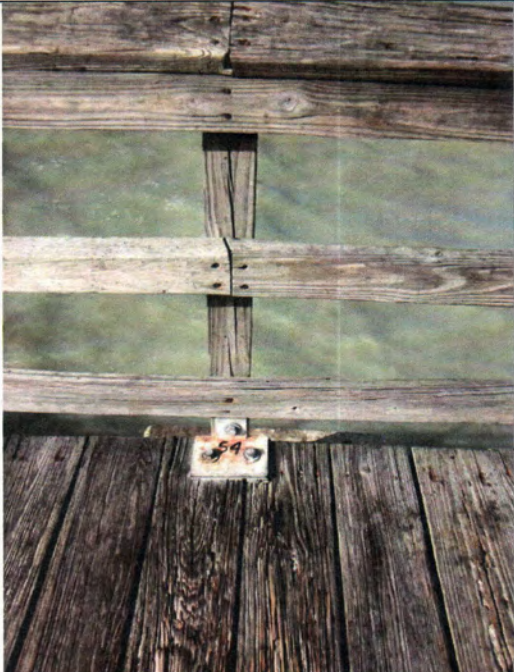
<p>Description: View over Pier #54.</p>

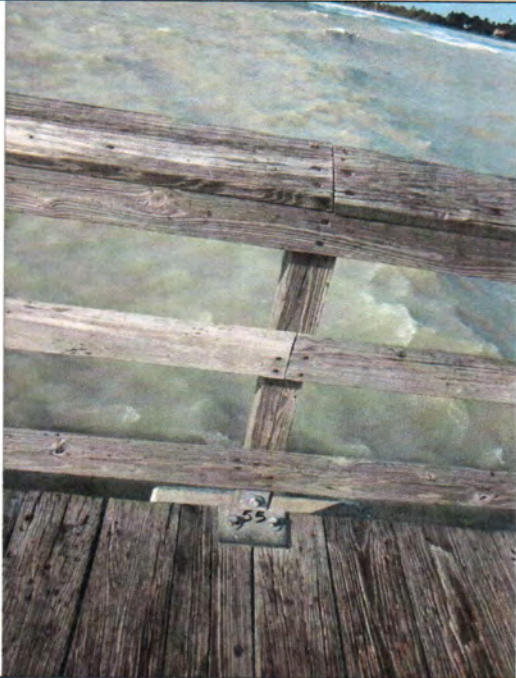
<p><u>Description:</u> View over Pier #55.</p>

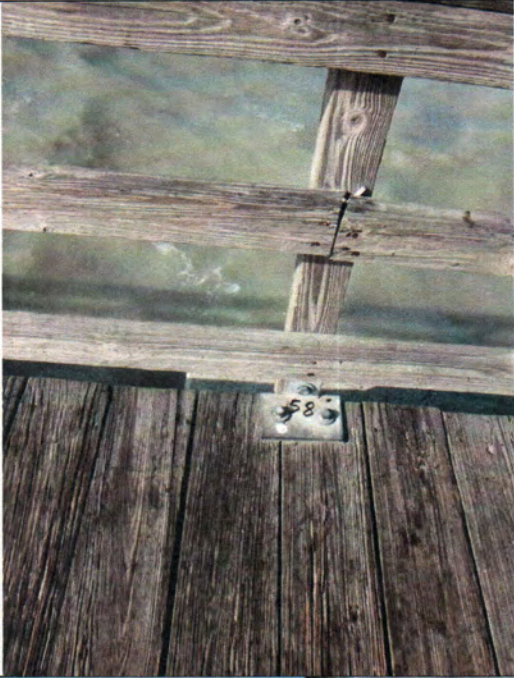
<p><i><u>Description:</u></i> View over Pier #58.</p>

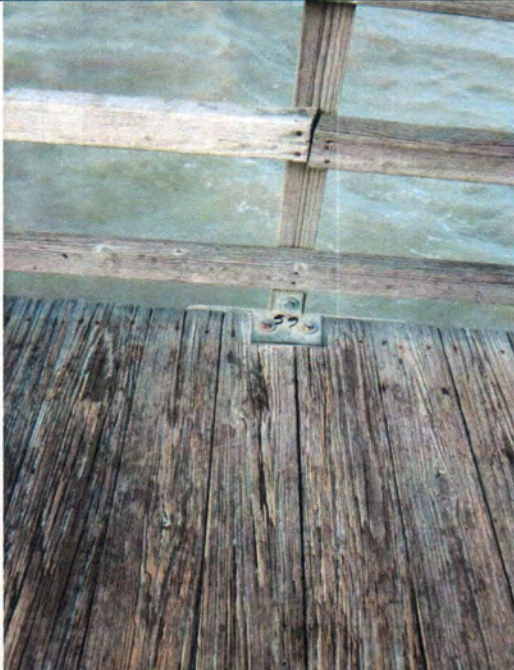
<p><i><u>Description:</u></i> View over Pier #59.</p>

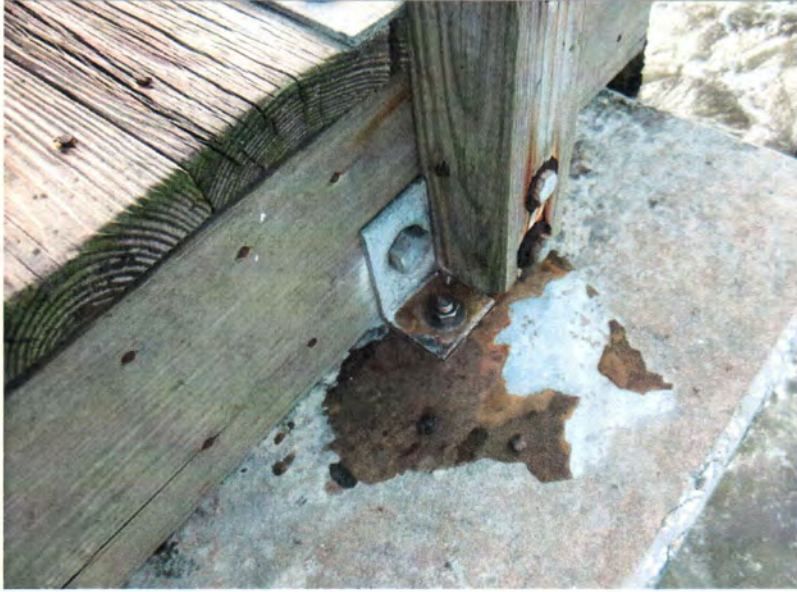
<p>Description: Metal hardware from here onward appears to generally fare much better than the previous stations possibly due to recent repair/replacement.</p>

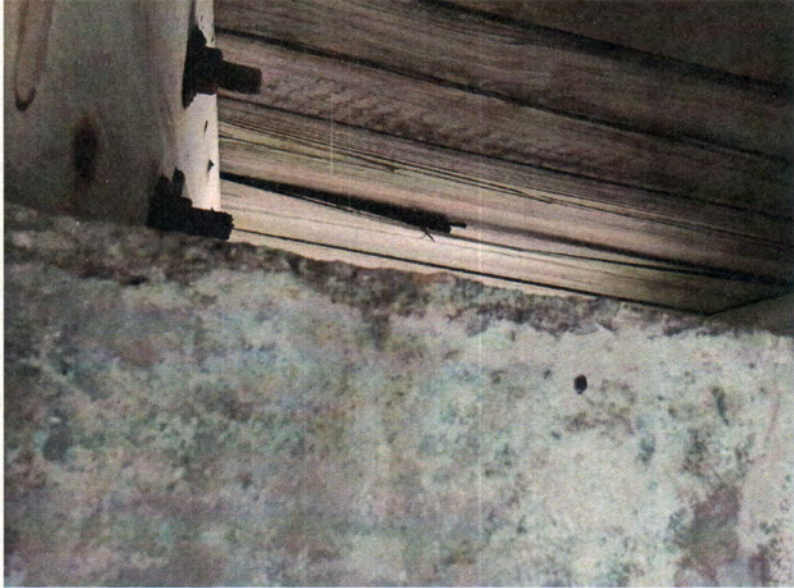
<p>Description: View of the underside at Pier #60. Note the rail post thru-bolt connectors display only mild corrosion.</p>
