**COLLIER COUNTY TOURIST DEVELOPMENT COUNCIL
CATEGORY "A" GRANT APPLICATION**

Naples Pier Deck Replacement and Structural Renovation

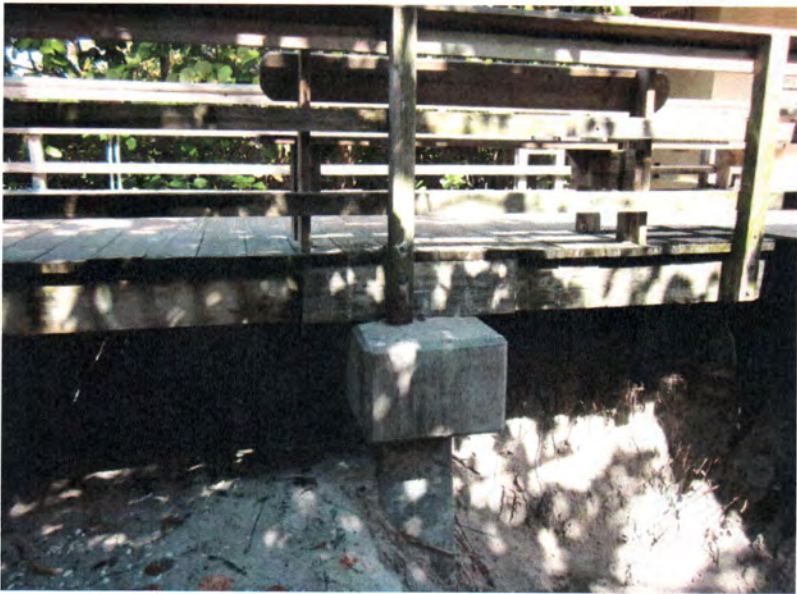
A close-up photograph of a rectangular precast concrete bent supporting a wooden deck and railing. The structure is situated on a sandy area with some vegetation in the background. The railing consists of wooden posts and horizontal rails.	<p>Description: View of the rectangular precast concrete bent and the deck and railing at Pier #2. Pier #1 is to the right immediately behind the Male Restroom rear wall.</p>

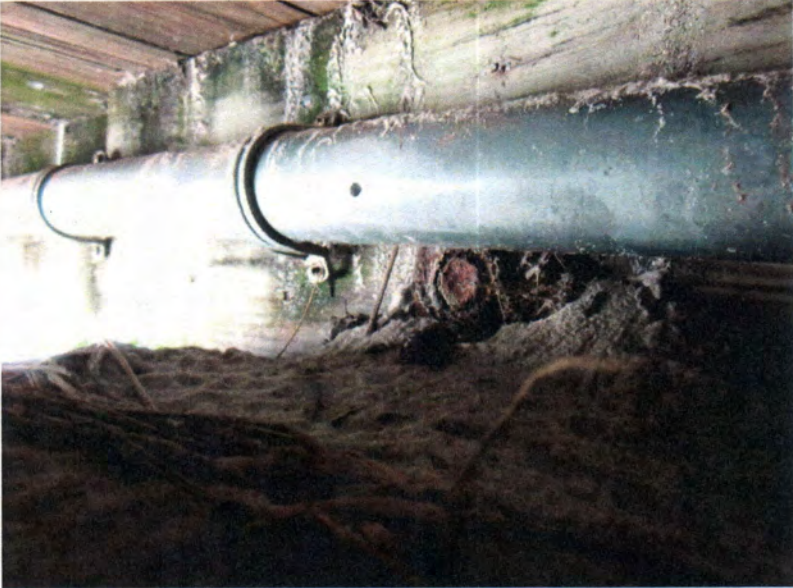
<p><u>Issue:</u> See preceding issue.</p> <p><u>Resolution:</u> See preceding resolution.</p>

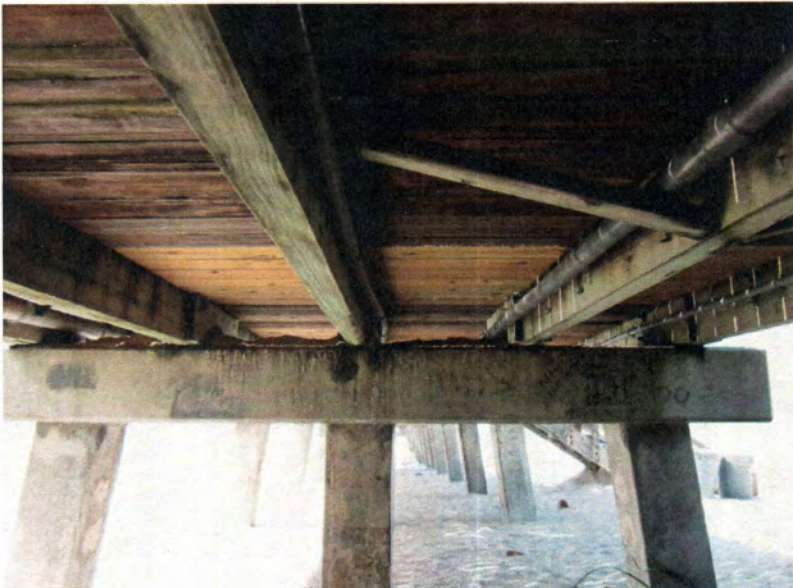
<p><u>Description:</u> General view of the decking underside and the substructure, looking seaward at Pier #4. Note the water piping and electrical conduits. Also note random horizontal cross-bracing.</p>

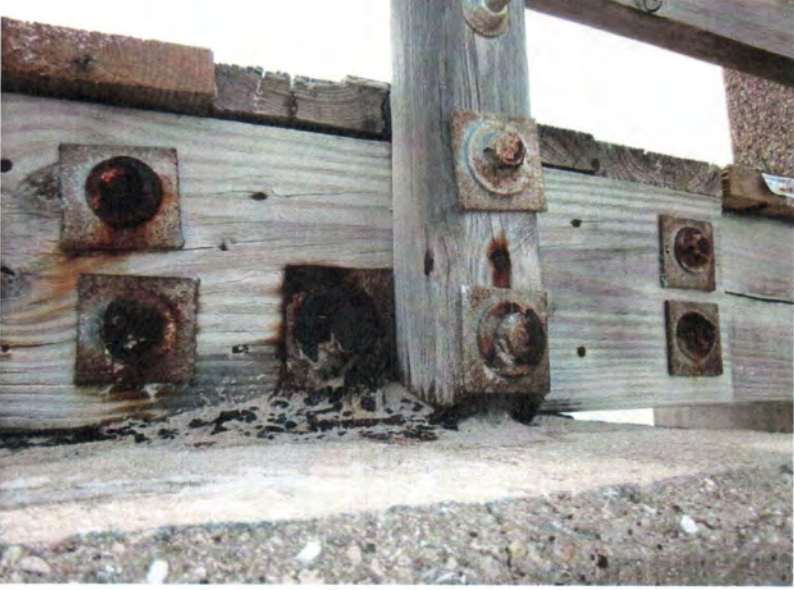
<p>Description: View on the exterior face of the splice assembly at Pier #5, where extra pairs of thru-bolt are used to stiffen up the outside stringer before the stair landing opening on the right.</p>

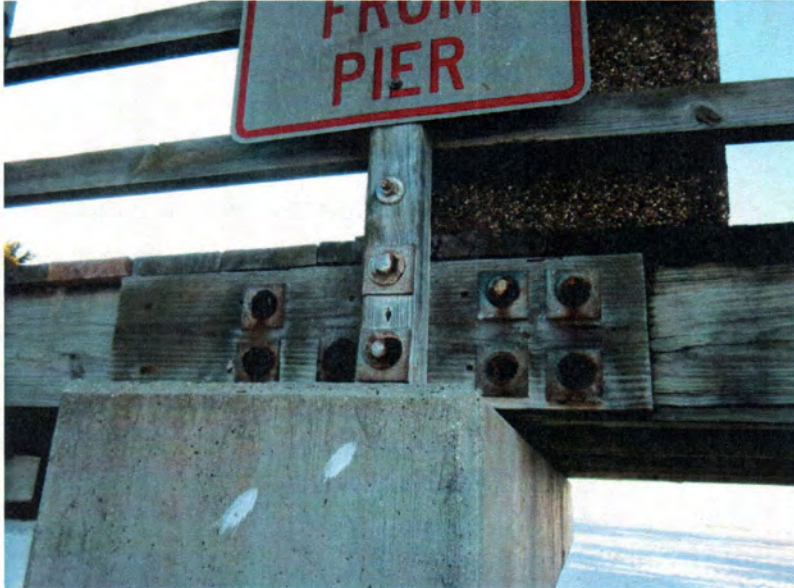
<p><i>Description:</i> View of an identical splice assembly at Pier #6, past the stair landing opening, where extra pairs of thru-bolt are used to stiffen up the outside stringer past the stair landing opening on the left.</p>

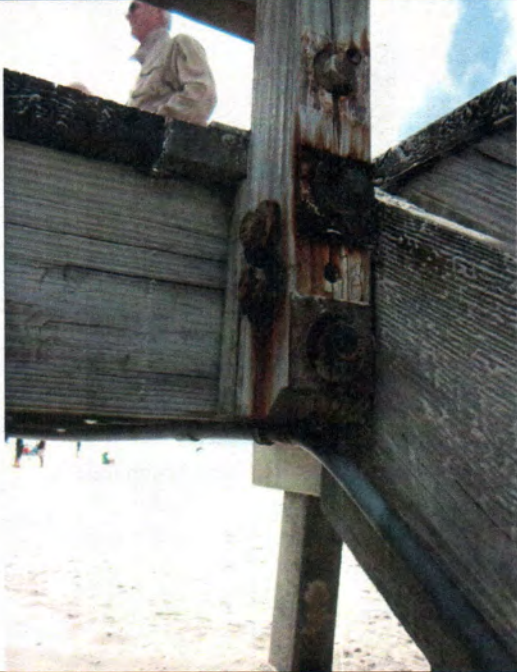
<p>Description: View of the East rail post/deck stringer/stair stringer assembly at the stair opening, between Pier #5 and Pier #6.</p>

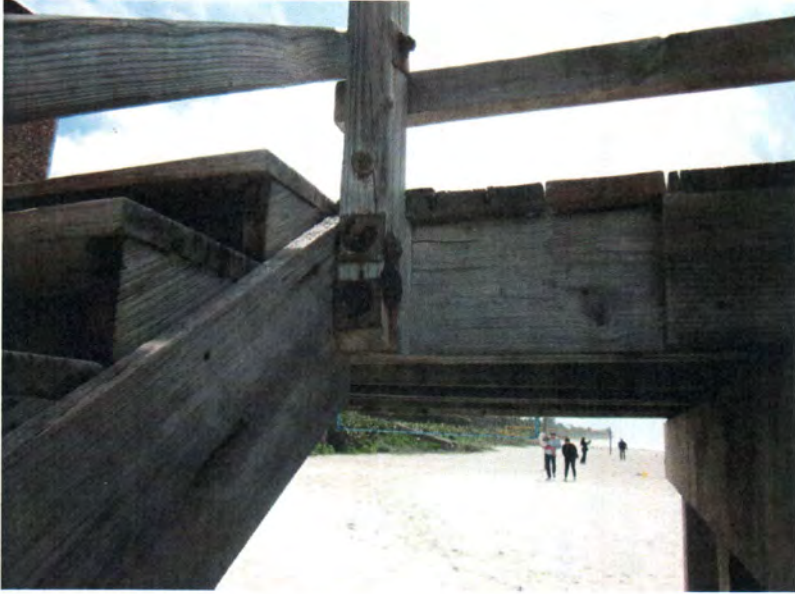
<p>Description: View of the West rail post/deck stringer/stair stringer assembly at the stair opening, between Pier #5 and Pier #6. Note Pier #6 immediately to the right.</p>

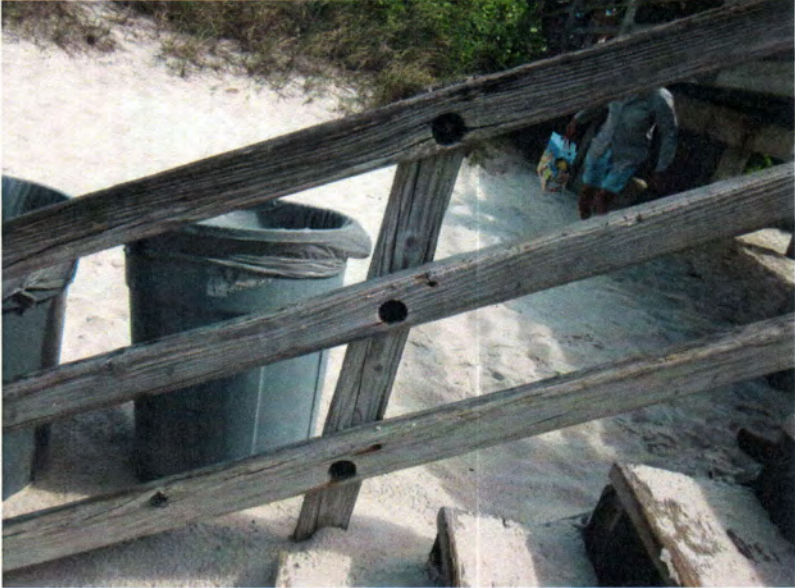
<p><u>Issue:</u> Stair stringer/deck stringer vertical connection assembly display severe corrosion of the metal hardware.</p> <p><u>Resolution:</u> Inspect and replace corroded metal hardware. To ensure structural soundness and durability, and to provide users a sense of safety and aesthetic, the entire stair may have to be rebuilt with better corrosion and weather resistant materials in near term.</p>

<p><u>Issue:</u> See preceding issue.</p> <p><u>Resolution:</u> See preceding resolution.</p>

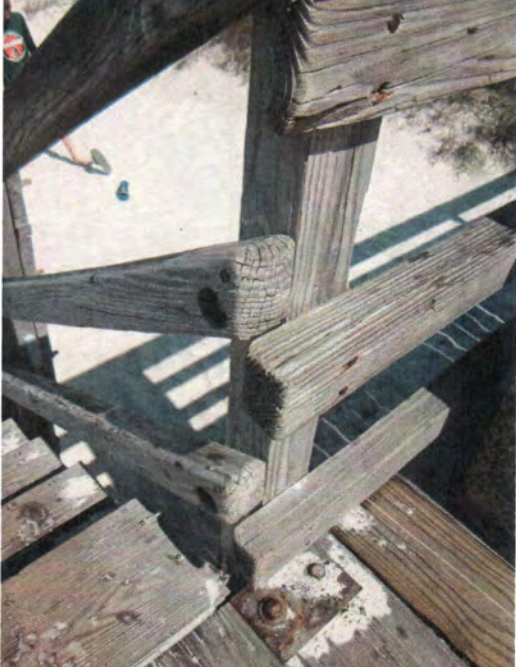
<p><i>Issue:</i> See preceding issue.</p> <p><i>Resolution:</i> See preceding resolution.</p>

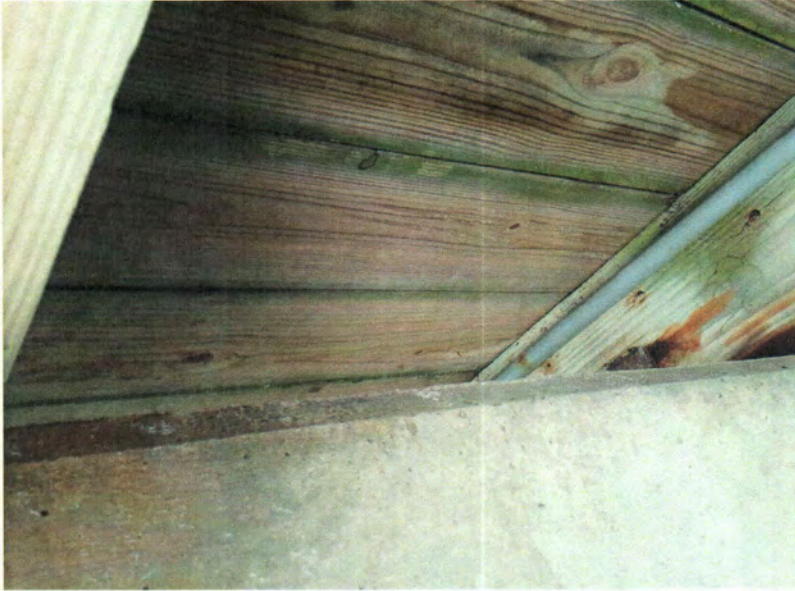
<p>Description: Typical view of the substructure framing and the condition of the decking underside from Pier #11.</p>

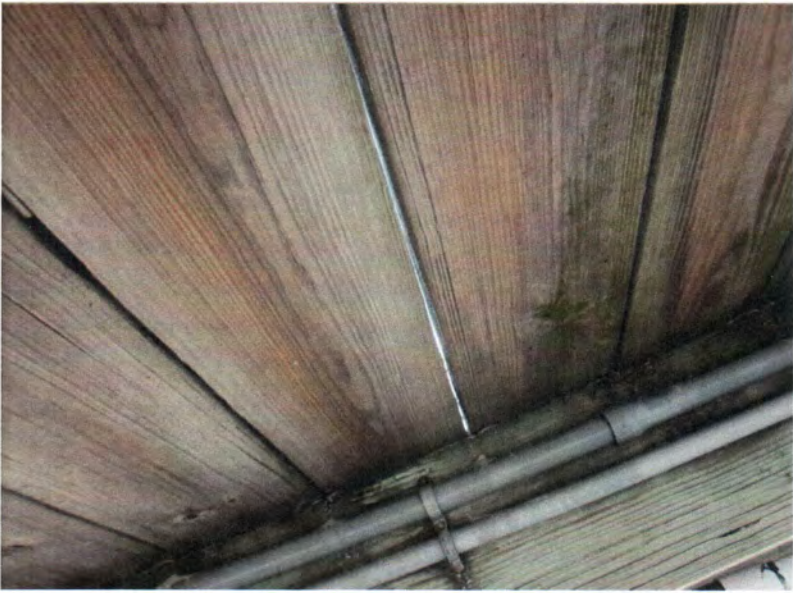
<p><i>Description:</i> Typical view of the substructure framing and the condition of the decking underside from Pier #11.</p>

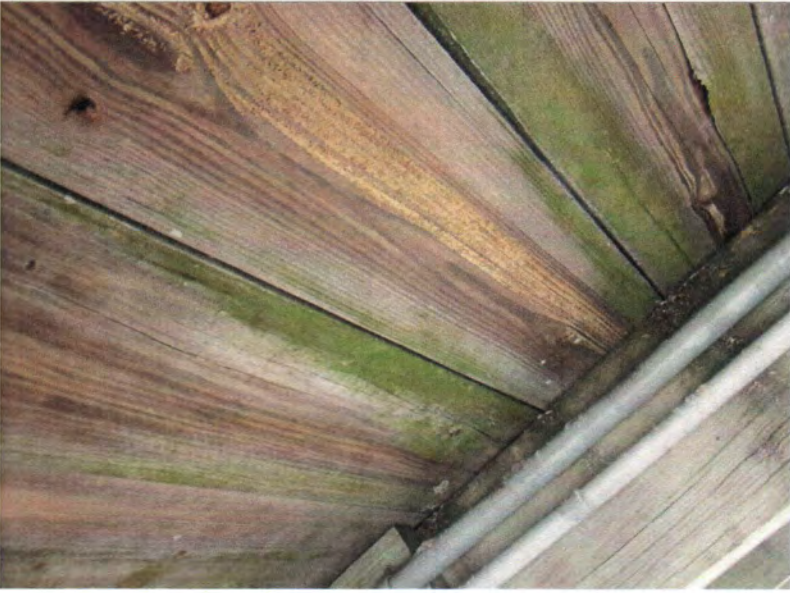
A photograph showing a typical view of the substructure framing and the condition of the decking underside from Pier #9. The image shows a close-up of the wooden framing, including a diagonal brace and a horizontal plank. The wood shows signs of weathering and greenish discoloration, likely due to algae or mold growth.	<p><i>Description:</i> Typical view of the substructure framing and the condition of the decking underside from Pier #9.</p>

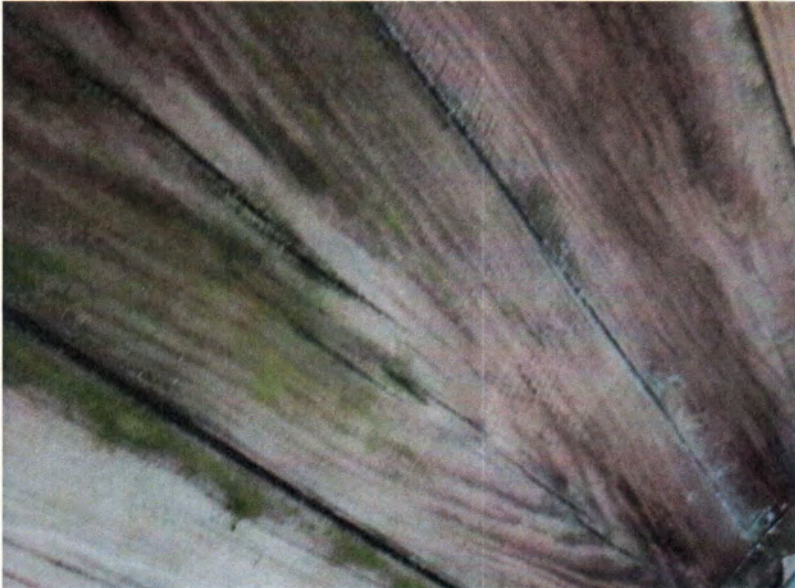
A close-up photograph of the substructure framing and the underside of the decking. The image shows the intricate wooden framework and the weathered, moss-covered surface of the decking planks.	<p><i>Description:</i> Typical view of the substructure framing and the condition of the decking underside from Pier #8.</p>

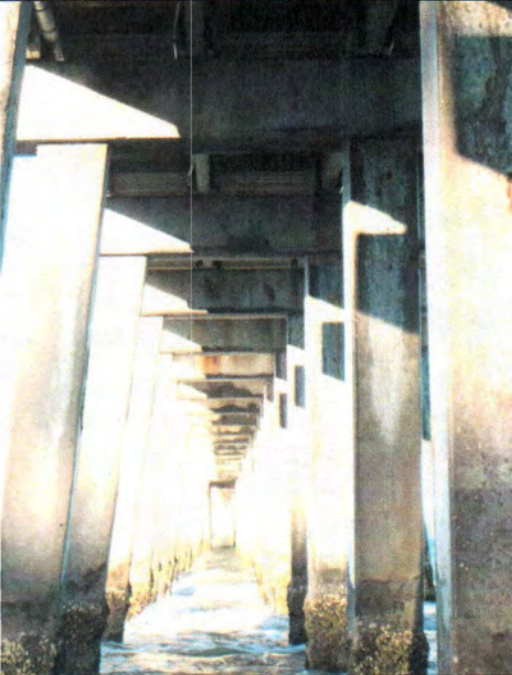
<p><i>Description:</i> Typical view of the substructure framing and the condition of the decking underside from Pier #13 left opening seaward.</p>

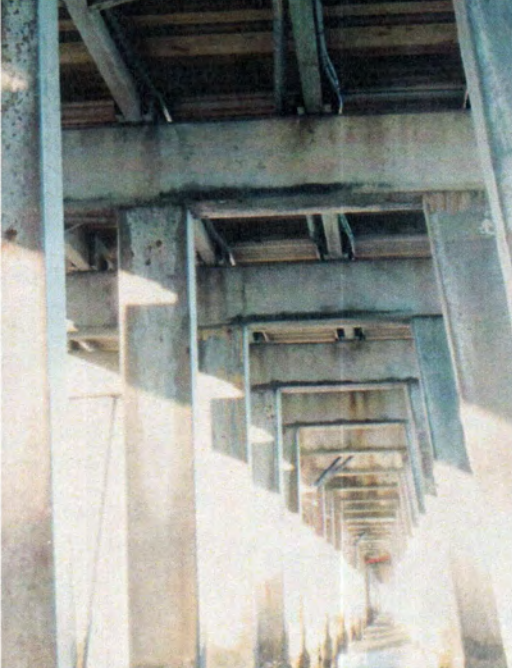
<p><i>Description:</i> Typical view of the substructure framing and the condition of the decking underside from Pier #13 right opening seaward.</p>

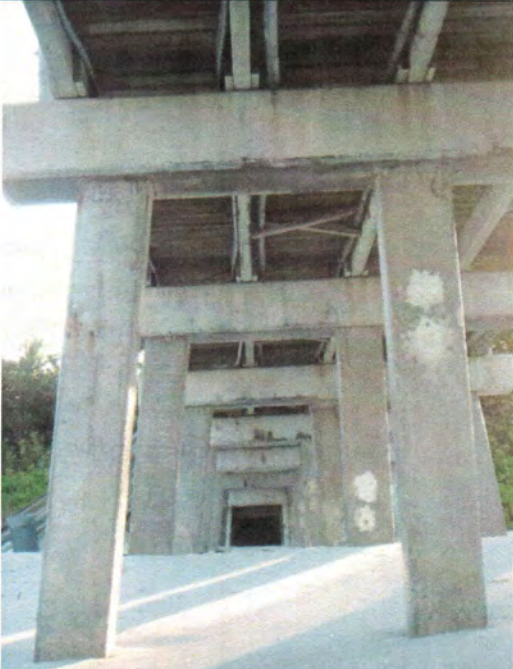
<p>Description: Typical view of the substructure framing and the condition of the decking underside from Pier #13 left opening backward.</p>

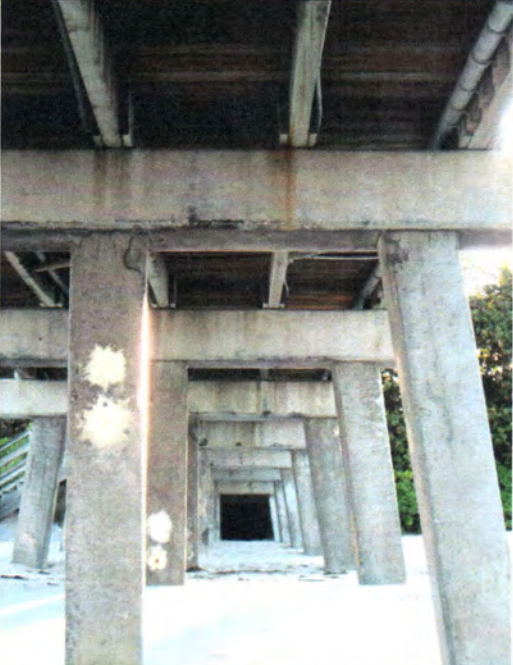
<p>Description: Typical view of the substructure framing and the condition of the decking underside from Pier #13 right opening backward.</p>

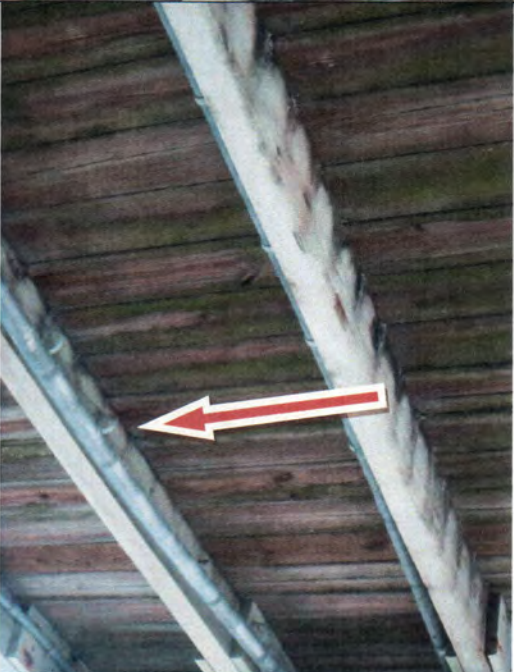
<p>Issue: The stress caused by the movement of the main power supply conduit is beyond the working strength of these thin plastic pipe straps. Note the conduit has dropped away from its strapping alongside the stringer.</p> <p>Resolution: Provide new plastic pipe straps with better working strength and durability (i.e. more material thickness/cross-section, mass, etc).</p>

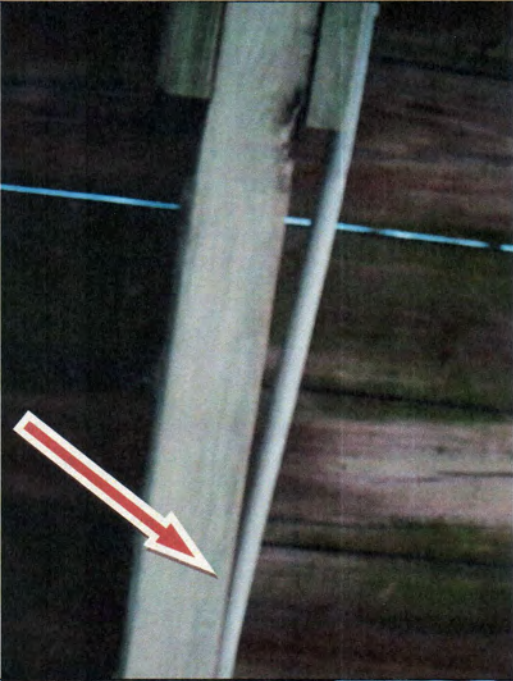
<p><u>Issue:</u> Pier #12 – Pier #13. The stress caused by the movement of the main power supply conduit is beyond the working strength of these thin plastic pipe straps. Note the conduit has dropped away from its strapping alongside the stringer.</p> <p><u>Resolution:</u> Provide new plastic pipe straps with better working strength and durability (i.e. more material thickness/cross-section, mass, etc).</p>

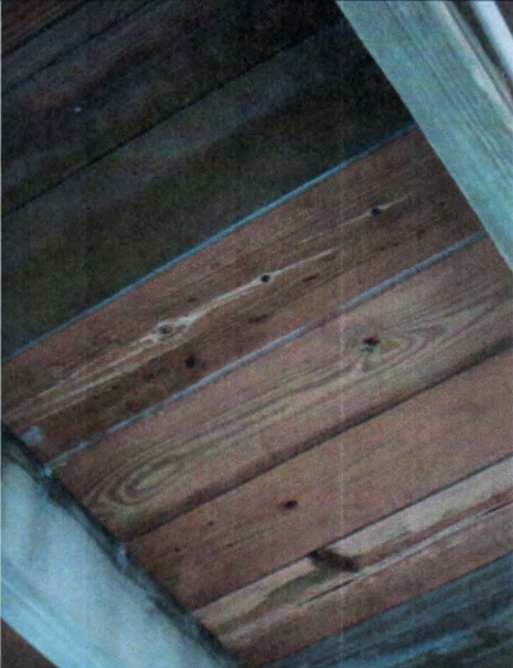
<p><u>Description:</u> Typical view of the substructure framing and the condition of the decking between Pier #12 and Pier #13. Note the multiple replacement boards besides the old boards.</p>
