Project: LELY GOLF ESTATES BEAUTIFICATION, M.S.T.U.
Location: MSTU DISTRICT ROADWAYS
Project Manager: Darryl Richards, r.l.a., C.C.P.S.D. – A.T.M. Dept.
Consultant: McGee & Associates
Contractor: Commercial Land Maintenance
Report Date: FY14-15, 02/16/15

Landscape Observation Report: January 2015 - February 2015
Consultant's Representative: Michael A. McGee, rla, isa
Contractor's Representative: Robert Kindelan
Observation Date: 02/16/15

Report No. 5

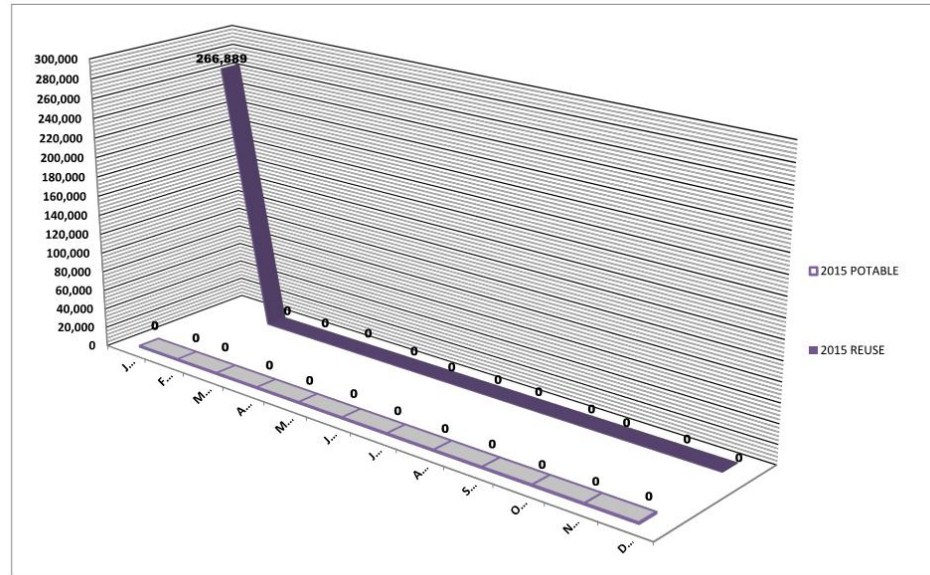
Lely Golf Estates Beautification MSTU Reuse Mixing Chamber Annual Water Use thru 1/15

Notes: 2014 Total Water Use: Reuse-2,336,976 gallons, Potable- 0
