**Project:** LELY GOLF ESTATES BEAUTIFICATION, M.S.T.U.  
**Location:** MSTU DISTRICT ROADWAYS  
**Project Manager:** Darryl Richards, r.l.a., C.C.P.S.D. – A.T.M. Dept.  
**Consultant:** McGee & Associates  
**Contractor:** Commercial Land Maintenance  
**Report Date:** FY14-15, 03/23/15

**Landscape Observation Report:** February 2015 - March 2015

**Report No. 6**

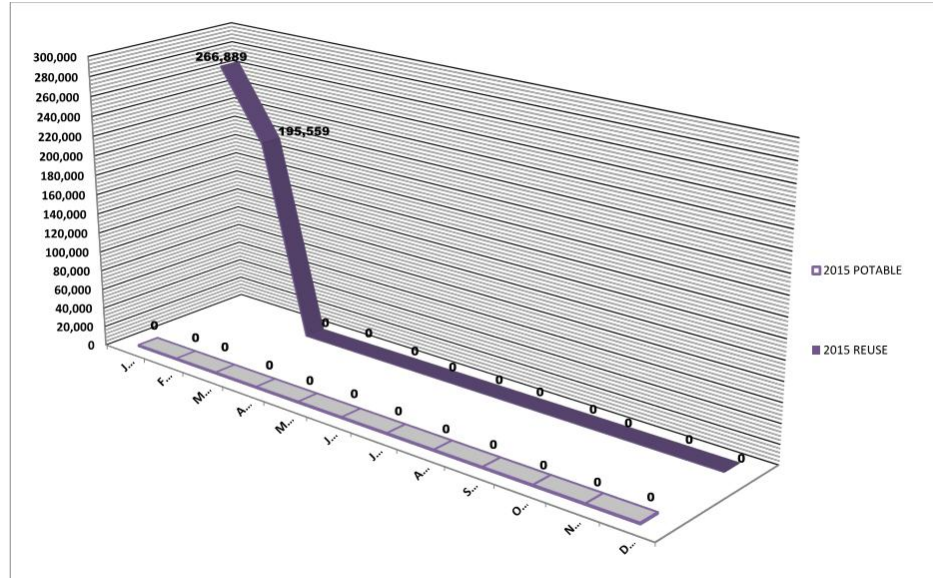
Lely Golf Estates Beautification MSTU Reuse Mixing Chamber Annual Water Use thru 2/15

Notes: 2014 Total Water Use: Reuse-2,336,976 gallons, Potable-0
