Project: GOLDEN GATE BEAUTIFICATION, M.S.T.U.
Project Manager: Harry Sells, MSTU Project Manager, C.C.P.S.D. – P.T.N.E. Dept.
Consultant: McGee & Associates
Contractor: Hannula Landscaping & Irrigation Inc.
Report Period: FY 14-15, June 2015

Location: Sunshine Blvd.
Consultant's Representative: Michael A. McGee, rla, isa
Contractor's Representative: Dale Hannula
Report No.: Nine - FY14-15

GOLDEN GATE BEAUTIFICATION, M.S.T.U.

Report No.: Nine

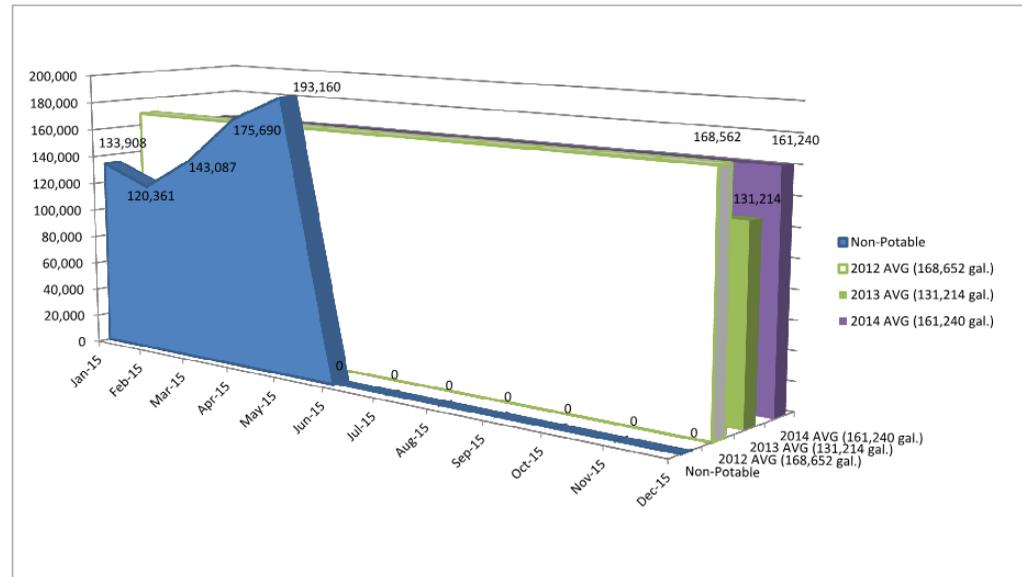
GG MSTU Sunshine Blvd. Well Annual Water Use for 2015

Water Use Goal:

(1.47 ac. of Plants & Turf)

Recommended: Supplemental watering rate of .75 to 1 inch per week. One inch per week equals 39,917 gallons per week or 159,668 gallons per month.
