FLOOD PROOFING TESTS

Tests of Materials and
Systems for Flood
Proofing Structures

August 1988

Structures Laboratory
US Army Engineer Waterways Experiment Station

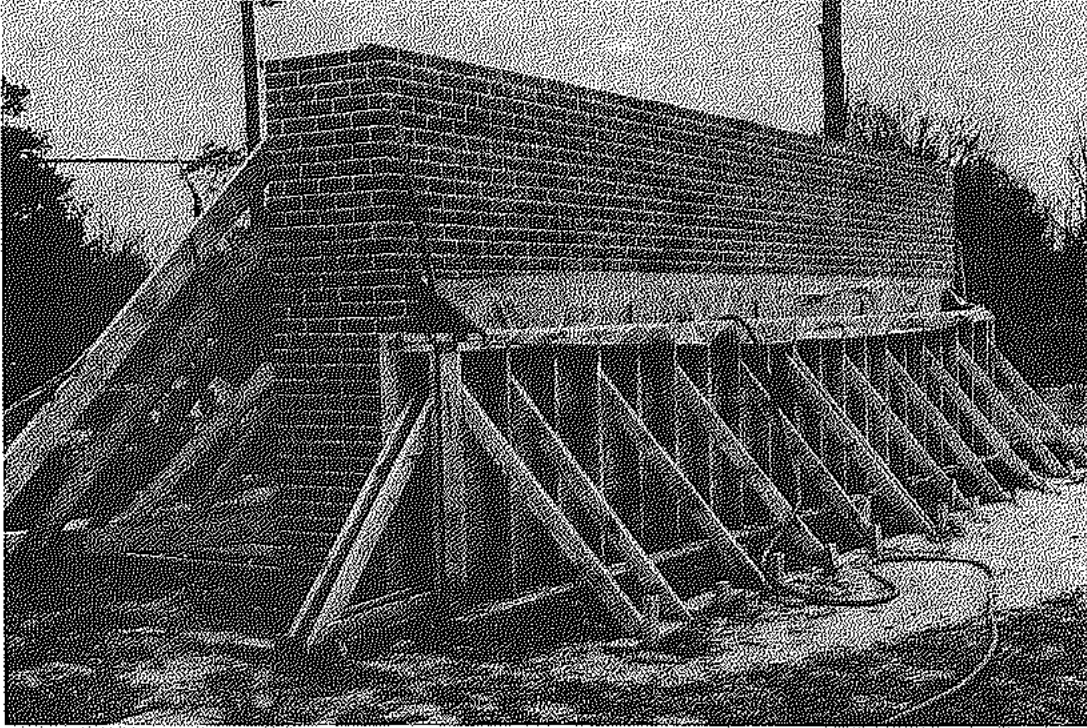
Of the three brick-veneer walls built for testing, Wall 1 (Figure 3) was a typical end wall of a home. In supporting loads, this wall is most critical because the top plate has no roof rafter and ceiling joist restraints to transfer resistance through the wall ties to the brick-veneer wall. Wall 2 and Wall 3 differed from Wall 1 as follows:

Figure 3. Overall view of Wall 1

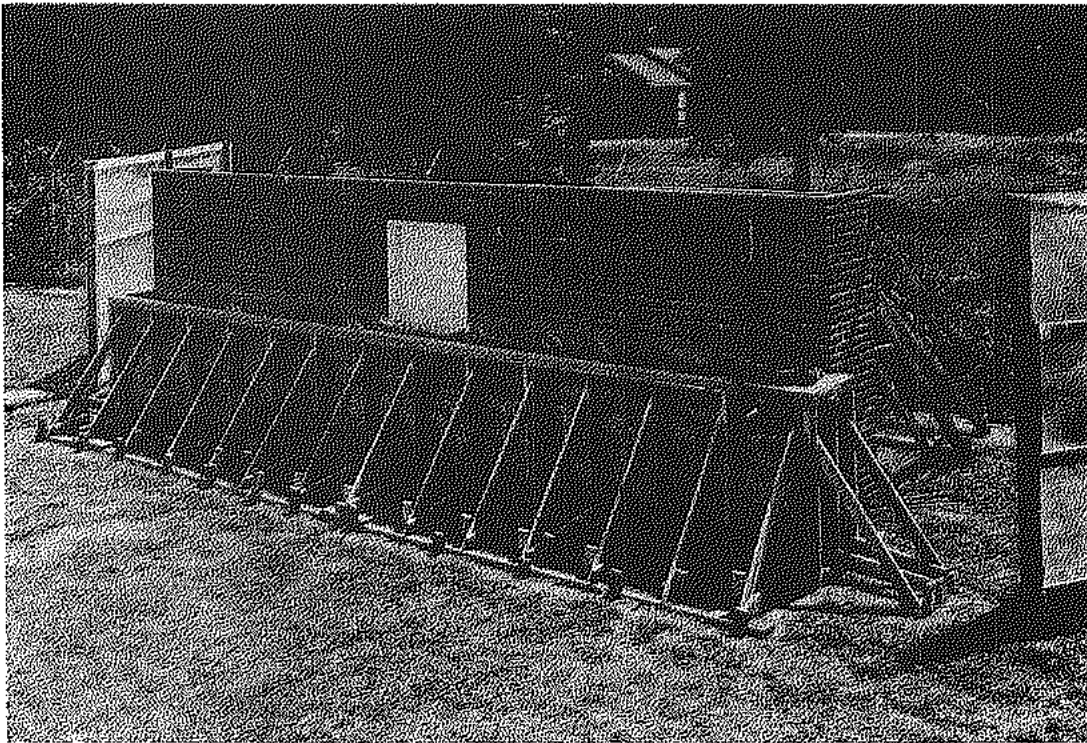
- Wall 2 had a 3-ft* door in its center (Figure 4).
- Wall 3 had roof rafter and ceiling joist restraints (Figure 5).

Figure 4. Overall view of Wall 2

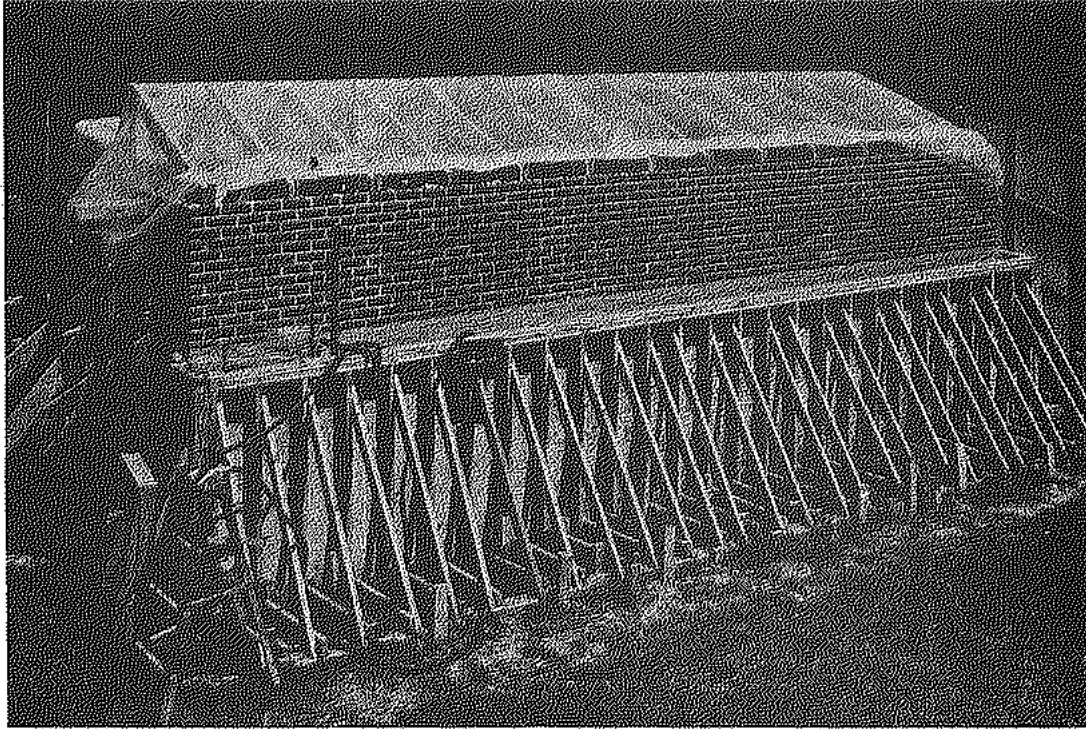
Figure 5. Overall view of Wall 3

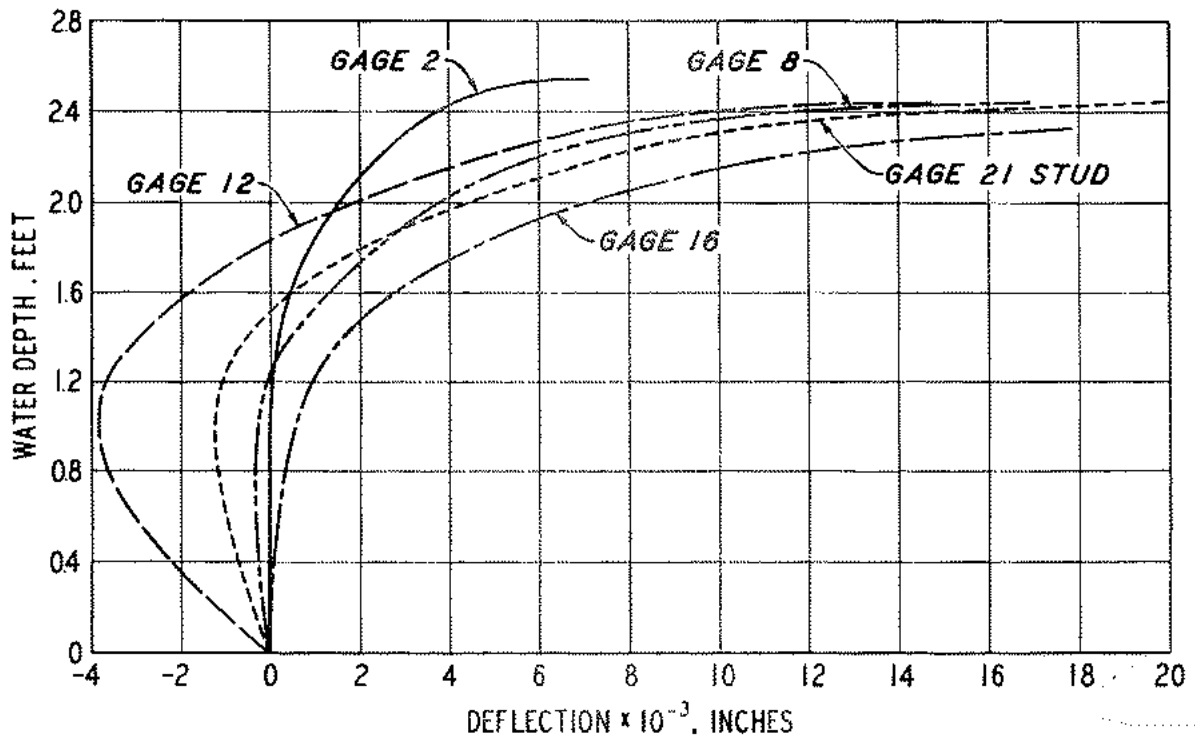
A severe loss of integrity began at 2 ft of water with complete loss occurring at 2.4 ft (Figure 8). The failure at 2.4 ft of water is presented in Figures 10 and 11.

Figure 8. Wall 1. Brick-veneer wall and stud deflections, vertical gage line

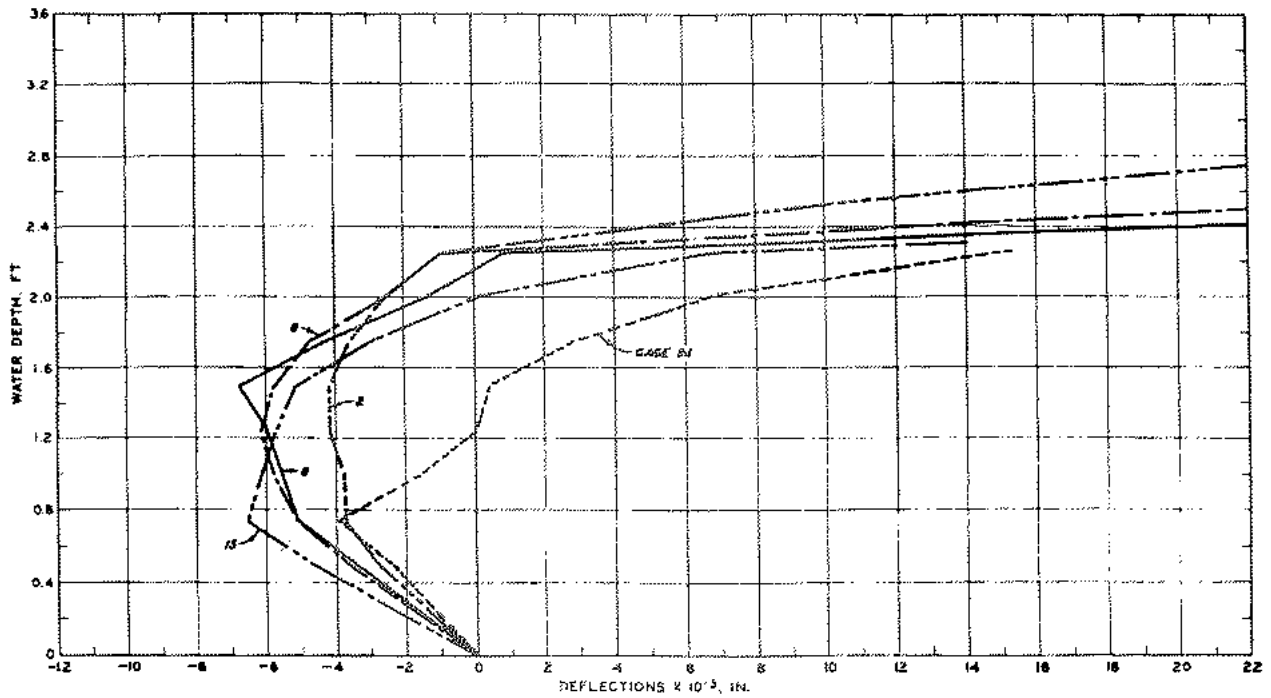
Figure 12. Wall 2. Brick-veneer wall deflections, vertical gage line, initial loading

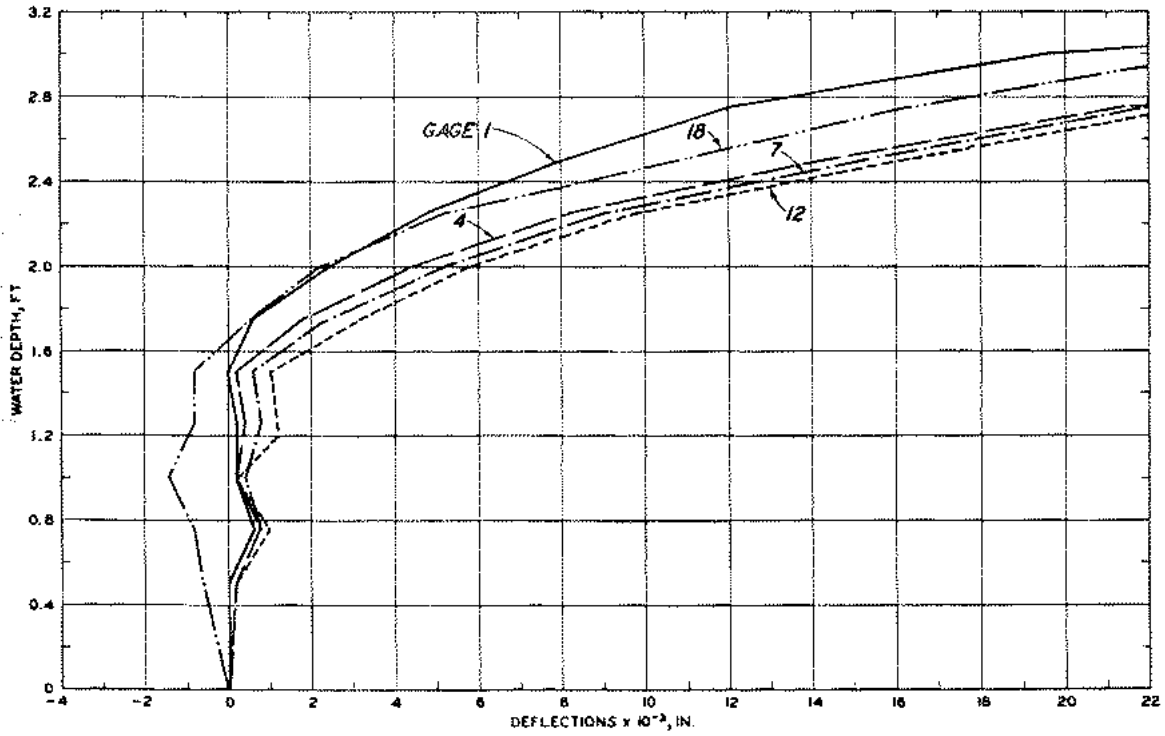
Figure 15. Wall 3. Brick-veneer wall deflection, vertical gage line

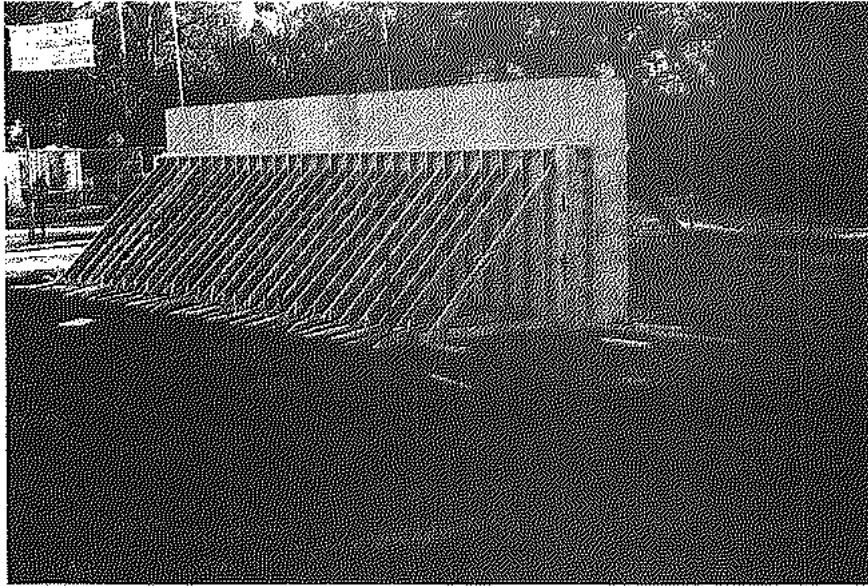
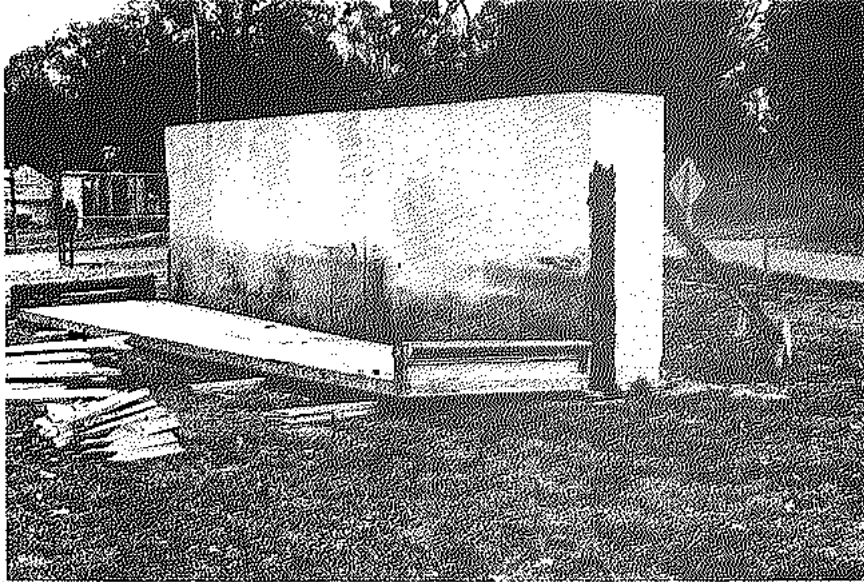
Figure 18. Block Wall 1

a. Before testing

b. After testing

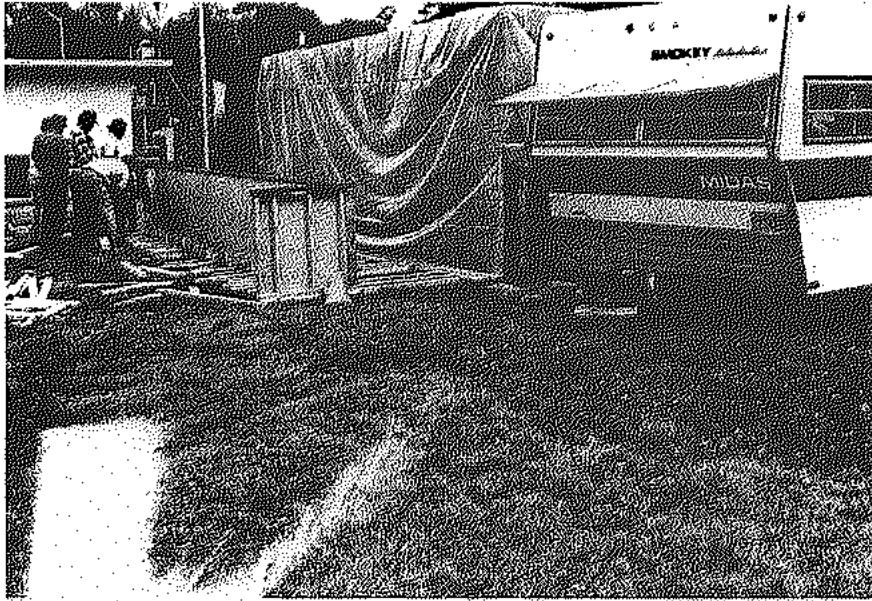
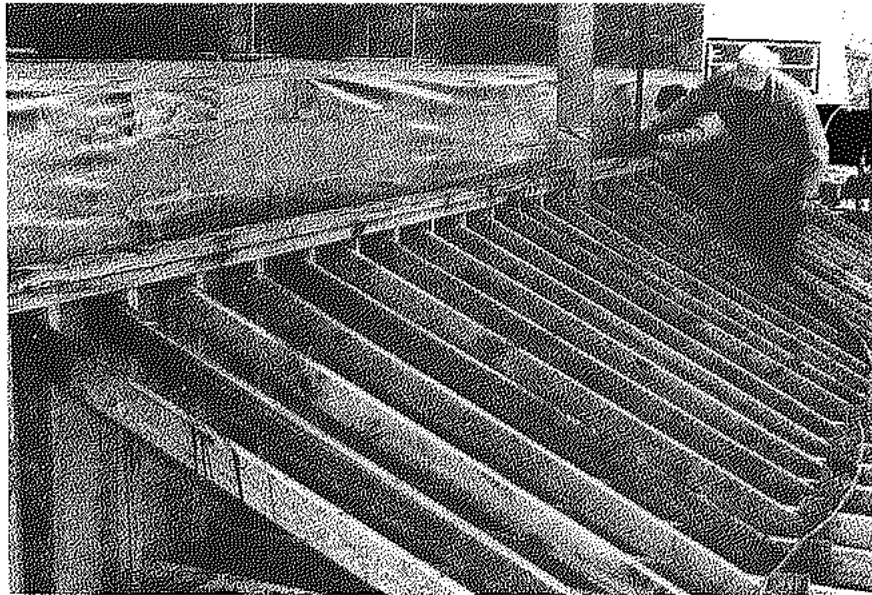
Figure 19. Block Wall 2

The first test performed on Block Wall 2 was to partially fill (approximately 1-1/2 ft) the trough to determine the leakage through the block wall (not treated or protected in any way). The leakage through the wall was severe and the test was stopped.

a. Preparing for testing

b. During testing

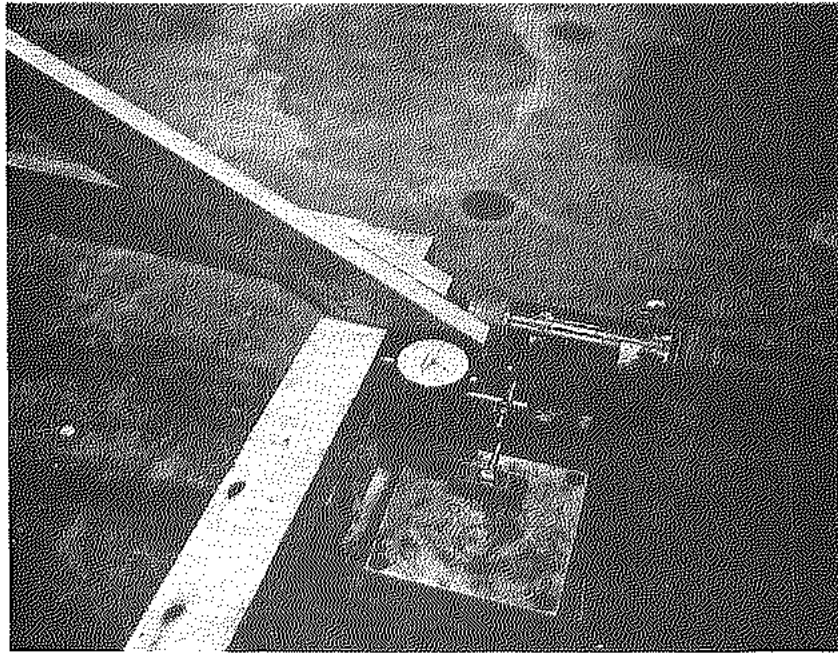
The roof rafter slope and dead load made no noticeable difference in the strength of the roof rafter and ceiling joist restraint. The connection was nailed in the standard manner with reasonable positioning of nails into the member. Later, tests were conducted with nails driven for maximum penetration into the top plate as well as going through enough of the roof rafter and ceiling joist. Connections with nails placed for maximum penetration were slightly stronger, but as long as the nails were placed in a reasonable manner the difference in the strength of the restraint was slight. The pine lumber caused an increase in the slope of the load deflection curves (Figure 23). The maximum restraint of this connection using spruce was about 1,200 to 1,500 lb (Figure 24).

Figure 22. Nailed roof rafter and ceiling joist connection (connection has been failed)

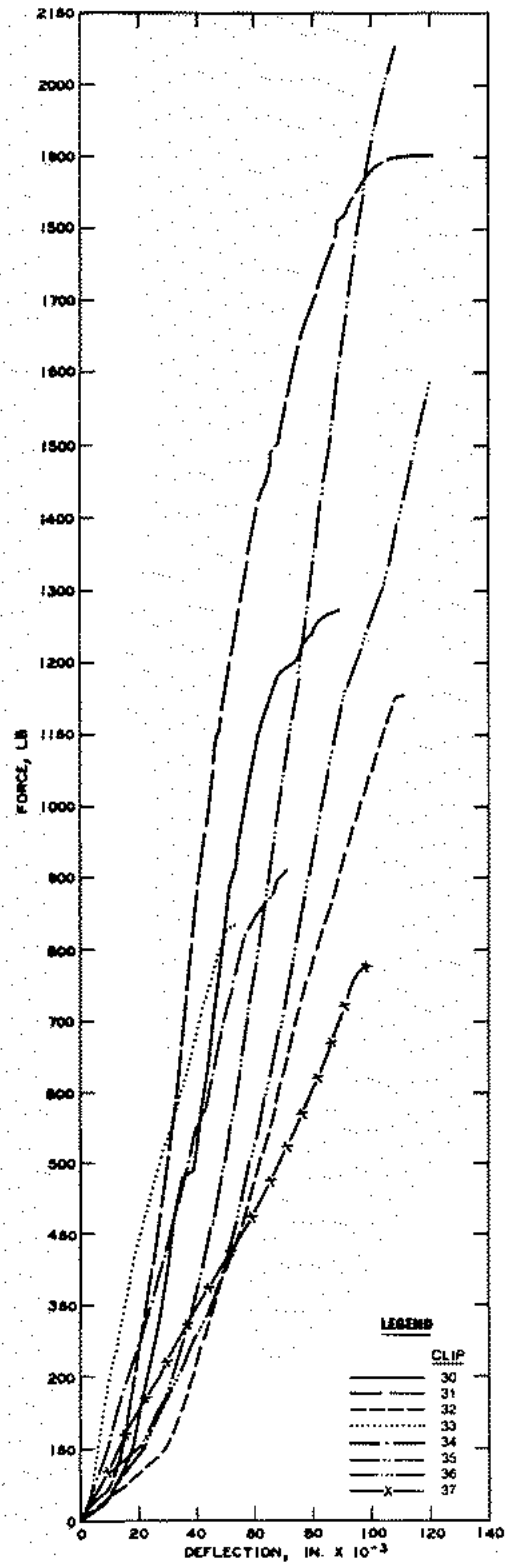
22-gage clips. Mortar that collects on the wall tie is the main factor that affects the load transfer capacity. Figure 27c shows that the load transfer increases drastically if mortar has caught on the wall clip between the studs and the brick wall. The load transfer, because of mortar, may be at least as high as 750 lb. The amount of mortar on a clip varies from none to a considerable amount. At first, it seems that the individual load deflection curves must be known for a wide variation in wall clip and mortar restraint. Fortunately, this is not the case because, for reasonable water loads, the required load transfer is much lower than the maximum. In fact, it is within a range where the slope of all curves is very similar and one relationship will reasonably represent the load transfer relation.

c. 22-gage wall ties with varying thicknesses of mortar

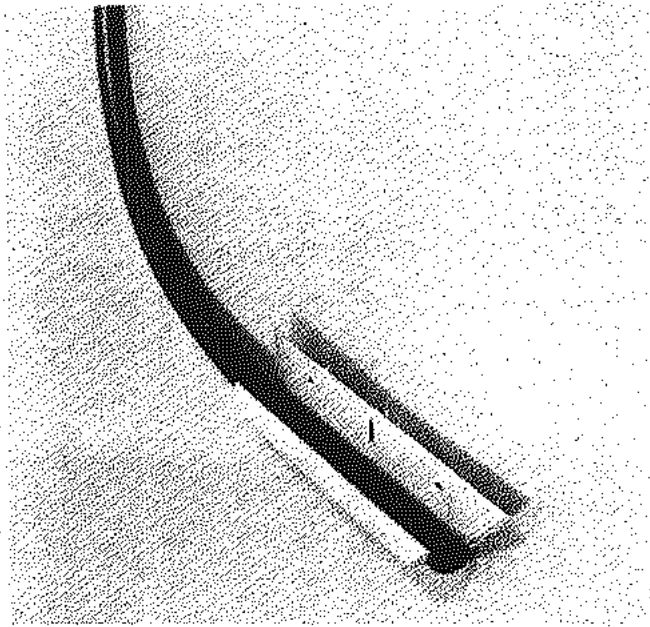
Figure 42. Footing, tubular seal, and plastic waterproofing barrier

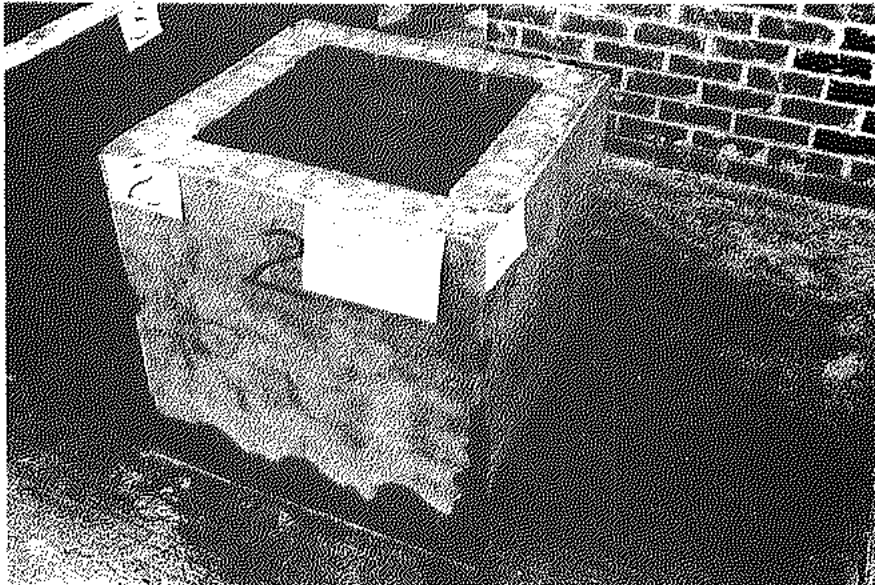
<u>Material</u>	<u>Coating No.</u>	<u>Comments</u>
Clear water-repellents	1	Repelled rainwater well. Sealed some small openings against 1 to 2 ft of waterhead, but did not seal brick or block walls against 1 to 2 ft of waterhead.
Clear water-repellents	2	
Clear water-repellents	3	
Cementitious materials	4	Expansive, hard to apply. Sealed a brick-veneer wall against 2 ft of waterhead but cracked and failed after 3 months.
Cementitious materials	5	Relatively inexpensive, good bond, good crack resistance, and was still effective after 8 years of use.
Cementitious materials	6	Good bond and cracked after 3 years of use.
Cementitious materials	7	Cracked and peeled from brick surface after 3 years of use.
Cementitious materials	8	Good bond and was still effective after 8 years of use.
Epoxy	9	Not effective in sealing a brick wall against 1 to 2 ft of waterhead.
Epoxy	10	Not effective in sealing a brick wall against 1 to 2 ft of waterhead.

a. Two hours after cube was filled with water

b. One day after cube was filled with water

Figure 45. Initial testing of coating 4

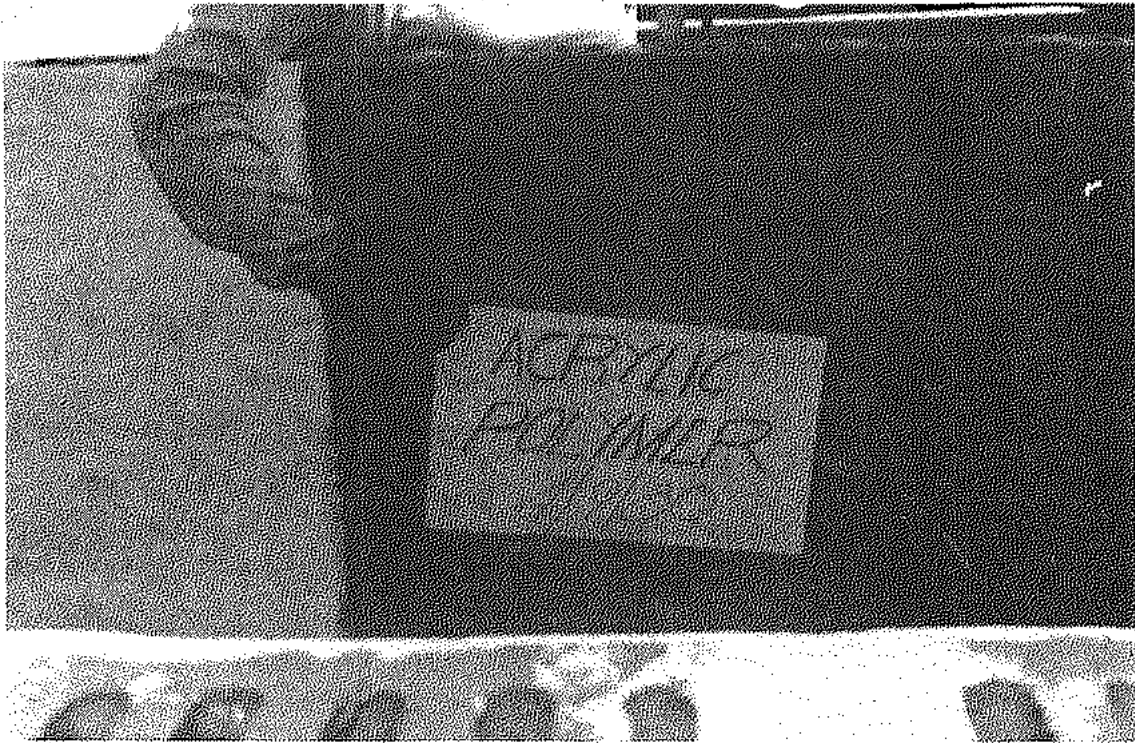
Figure 47. Coating 5

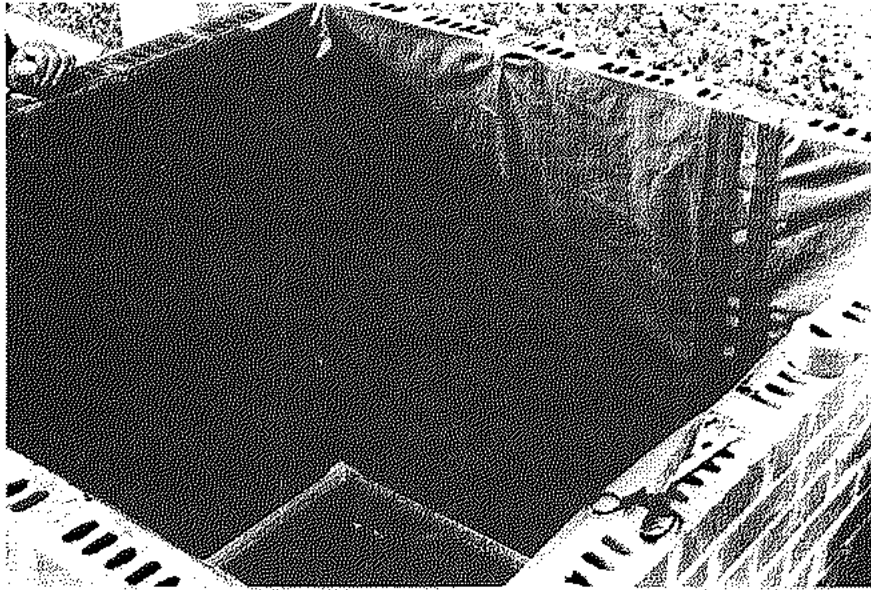
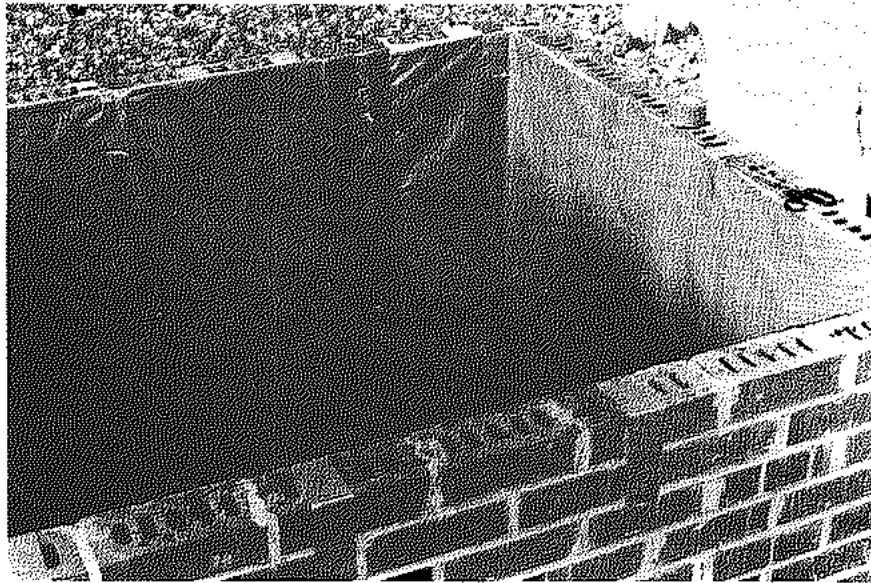
Five tests were made with the system using the specially designed seal strip. Figures 49 and 50 show details of the tests. It was found that care

Figure 50. Plastic sheeting and seal strip

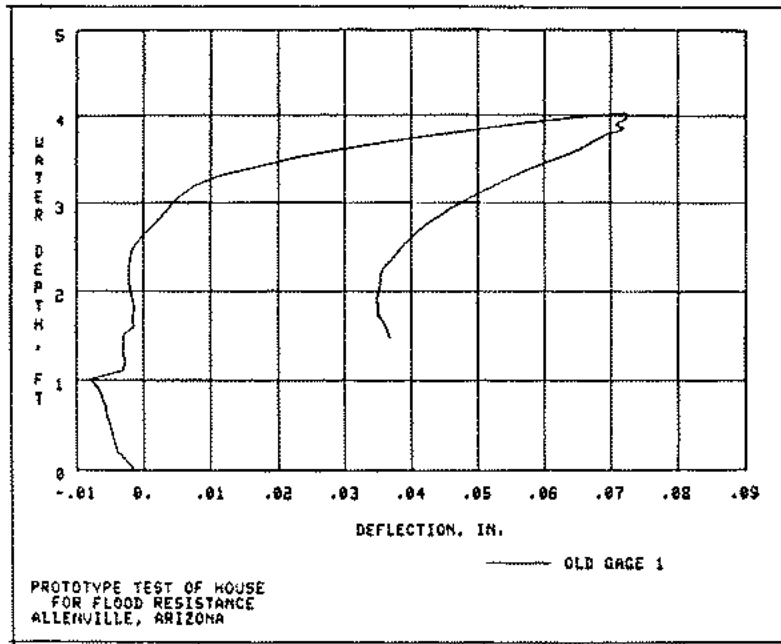
The deflections of the walls were recorded during both the loading and unloading of the house. Typical data are presented in Figure 61.

The walls of the house were damaged by a 4-ft waterhead. This damage is indicated by the test data in Figure 61. The unloading curves show permanent deformation in the walls. An inspection the next morning after the water load had been removed revealed that the brick wall had visual cracks in the mortar joints.

Figure 61. Prototype house test results, gage 1

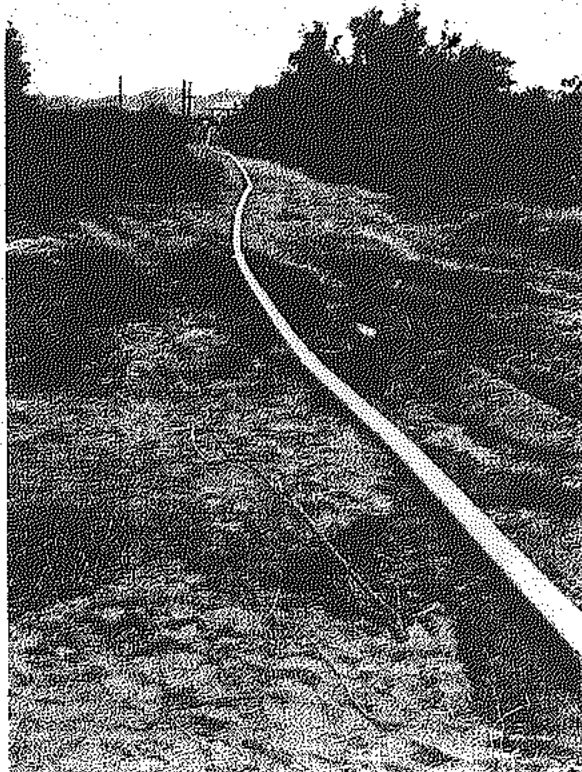
Water was obtained from a well and pumped to the test site (Figure 62). The water level was raised slowly on the outside of the house, and as the water level increased, some seepage did occur inside the house. About 1 in. of water leaked into the house during the test in which 4 ft of water flooded the outside.

Figure 62. Pipe through which water was pumped to test house
