McGee & Associates
Landscape Architecture

Project: LELY GOLF ESTATES BEAUTIFICATION, M.S.T.U. **Landscape Observation Report:** May 2019
Location: MSTU DISTRICT ROADWAYS
Project Manager: Dan Schumacher, Collier County Public Services Division, Public Transportation & Neighborhood Enhancements Department
Consultant: McGee & Associates **Consultant's Representative:** Michael A. McGee, rla, isa
Contractor: Commercial Land Maintenance **Contractor's Representative:** Robert Kindelan, Gary Gorden
Report Date: FY18-19, 5/7/19 **Observation Date:** 5/7/19

Report No. 8

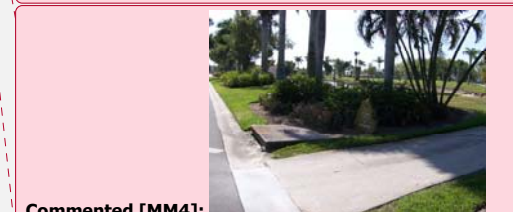
Commented [MM3]:

Median #17	X	X	X	19	At address 132: (2) Sabal palms with broken trunks.	Remove and replace with same. M&A: 6/12/18 hole filled and ready for replacement planting. M&A: 11-5-18 Approx. (9) Plumbago shrubs are dead or missing at the location where the tree was removed. Committee Approved: _____
	X	X	X	19	At address 124: (1) Tabebuia 'Ipe' remove.	Replace with same or crape myrtle species. M&A 5/7/19: Remove tree by excavation. Replace with same - Size: 30 gal., 2.5" cal., 7'-8' ht., 36"-48" spr., 28"-30" dia. root ball if B & B. Committee Approved: _____

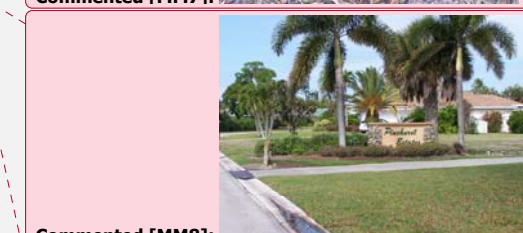
Commented [MM7]:

X	X	11	Remove and replace (2) Podocarpus shrubs at previous motorcycle accident location. 15 or 25 gal. container to match existing.	M&A: 9/11/18 Dead or damaged plants removed.
		X	X	17	All broken and damaged tree branches hanging over the Podocarpus hedge should be removed.	M&A: 8/7/18 Multiple tree branches are overhanging the Podocarpus hedge and over the sidewalk. The Podocarpus hedge is being shaded which will result in thinning and the less than 10-foot height branches over a sidewalk is not permitted.

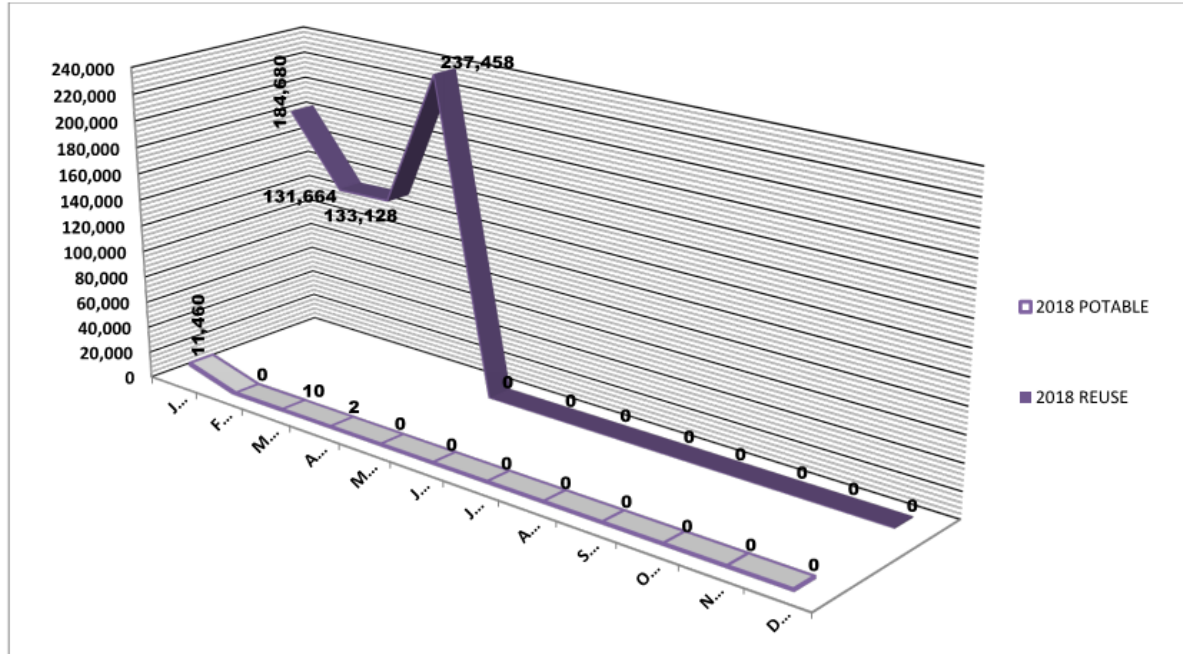
Lely Golf Estates Beautification MSTU Reuse Mixing Chamber Annual Water Use thru 4/19

Notes: 2014 Total Water Use: Reuse-2,336,976 gallons, Potable- 0
 2015 Total Water Use: Reuse - 1,795,449 gallons, Potable - 8,602 gallons
 09/2016 Potable water meter readings not complete. 11/9/16 Meter cleaned and readable
 2016 Total Water Use: Reuse 936,041 gallons, Potable 7,788 gallons.
 2017 Total Water Use: Potable water amounts amended to corrected totals. Reuse 594,189 gal., Potable 981,815 gal.
 2018 Total Water Use: Reuse 1,965,840 gallons, Potable 270,200 gallons
