PELICAN BAY SERVICES DIVISION
Municipal Services Taxing & Benefit Unit

NOTICE OF PUBLIC MEETING

PELICAN BAY

Lake 4-1 Analysis

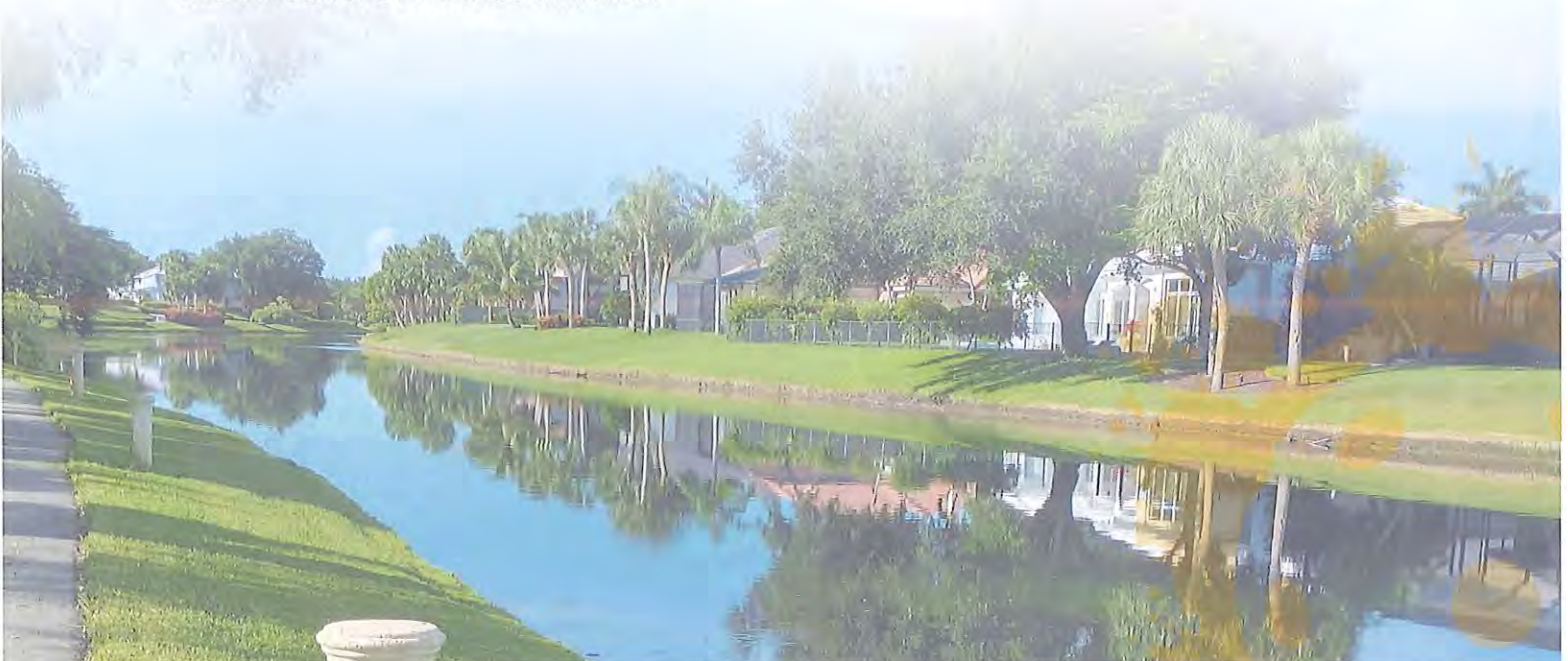
Wind is a major factor in creating waves, fortunately for Lake 4-1 the longest distance from the east to the west side of the lake is about 260 linear feet however the length from north to south is quite significant. Approximately 2600 linear feet separates the north and south sides of the lake, leaving it prone to erosion. Incoming cold fronts and increased wind from storms can create waves that worsen the condition of the lake banks and create additional problems. The long fetch allows the waves to build up energy before crashing into the lake bank requiring a more robust and reinforced shoreline.

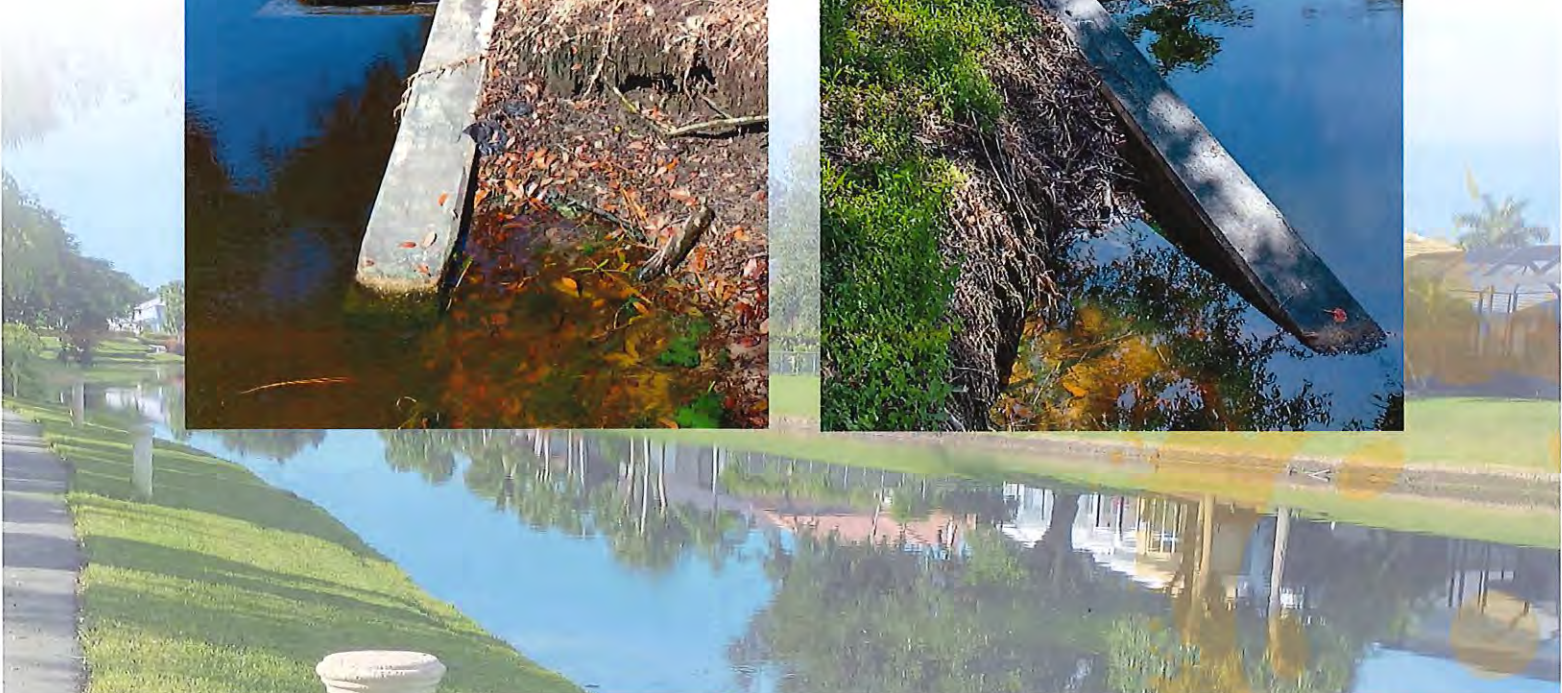
There is an outfall structure on the north side of the lake bank that showed signs of erosion behind the headwall. Typically, headwall is used to stabilize the soil around drainage structures to prevent the structure from falling into the water. In the picture below, the headwall has been exposed due to the receding lake bank. This presents not only a problem of erosion but may put the structure at risk in the long-term.

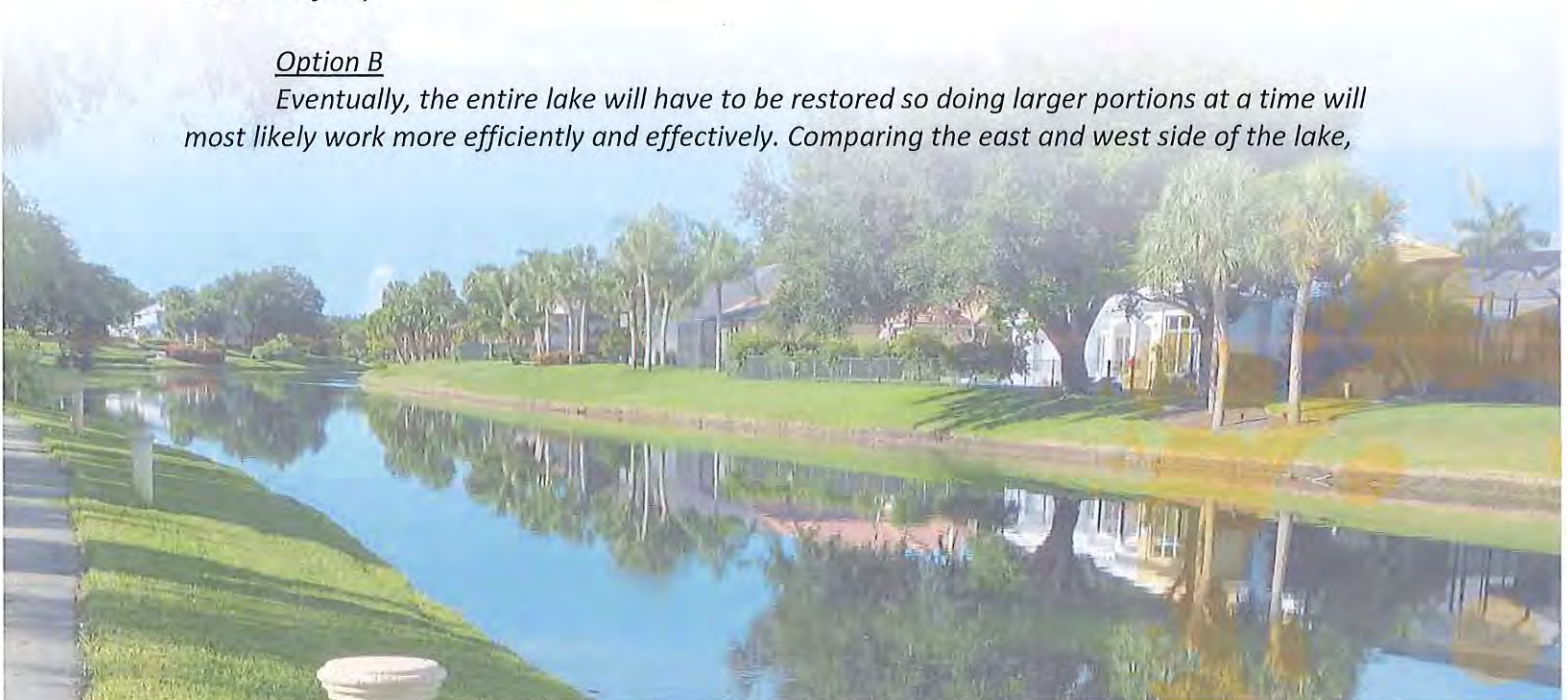
Option B

Eventually, the entire lake will have to be restored so doing larger portions at a time will most likely work more efficiently and effectively. Comparing the east and west side of the lake,

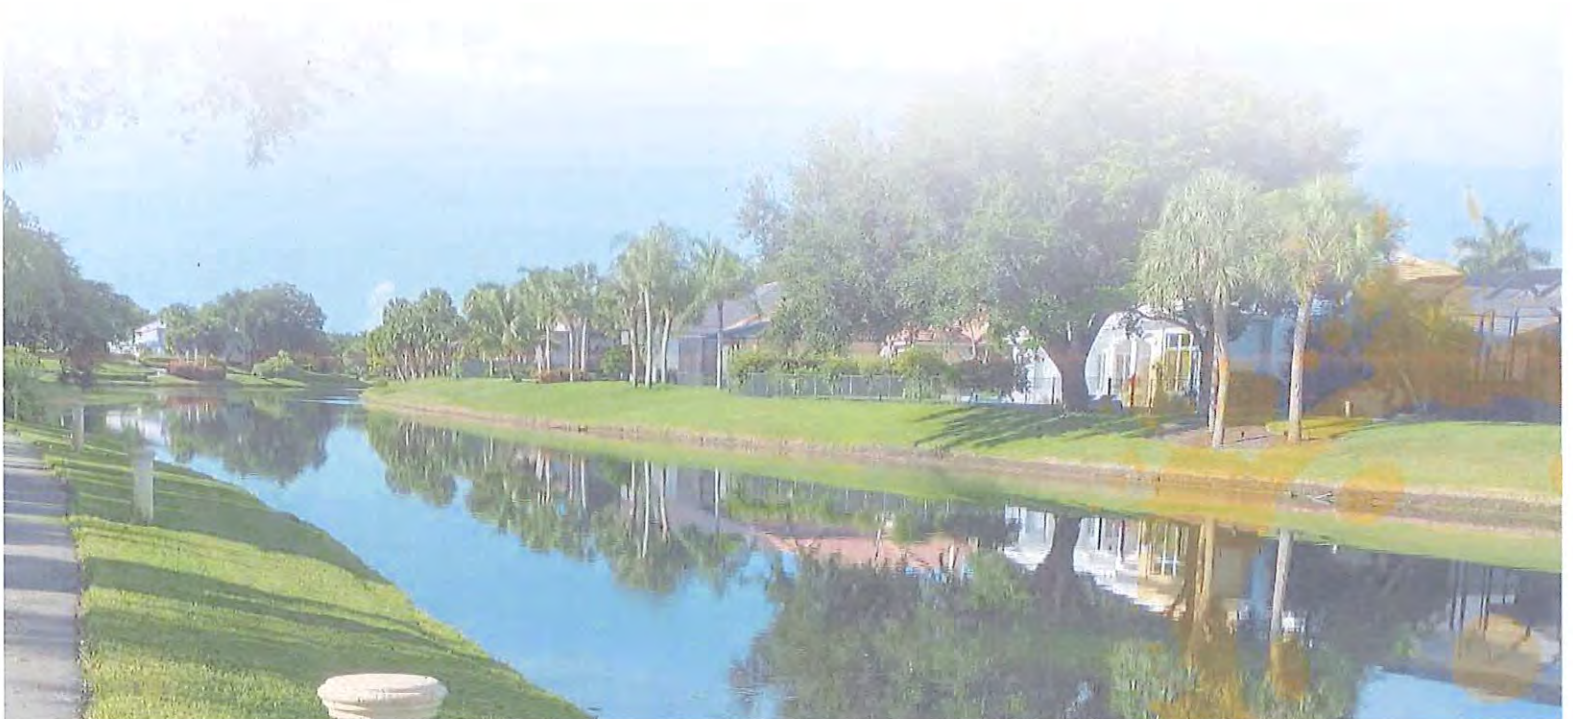
Option C proposes restoring the entirety of Lake 4-1. While this may be beneficial in avoiding multiple periods of construction, this will require a significant cost which would most likely not appeal to the community.

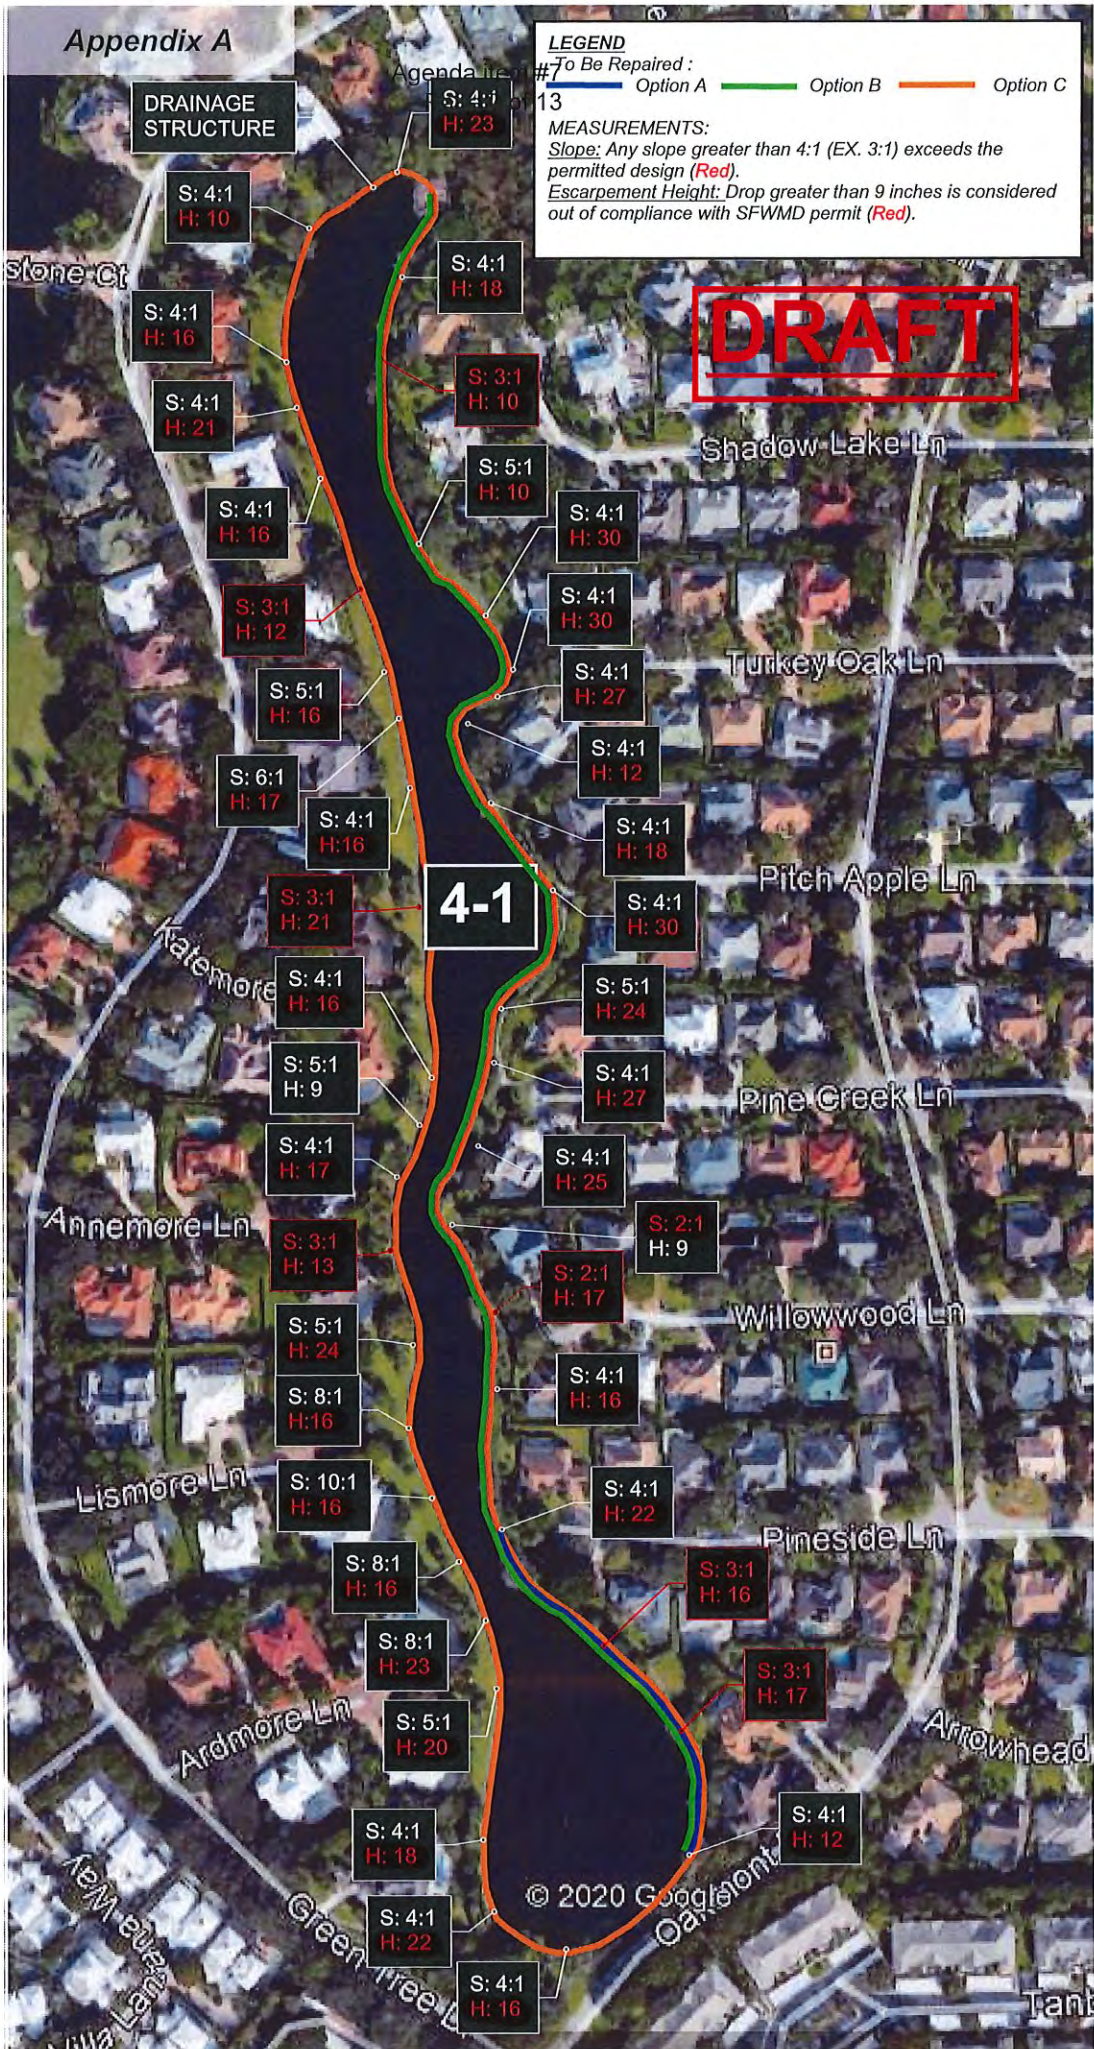
Appendix A

Escarpment Height: Drop greater than 9 inches is considered out of compliance with SFWMD permit (Red).

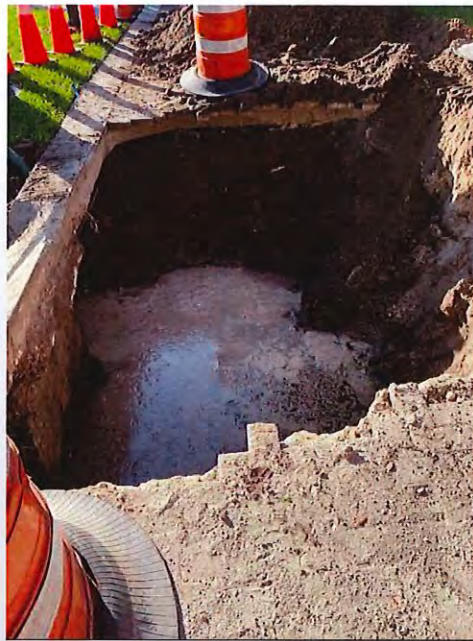
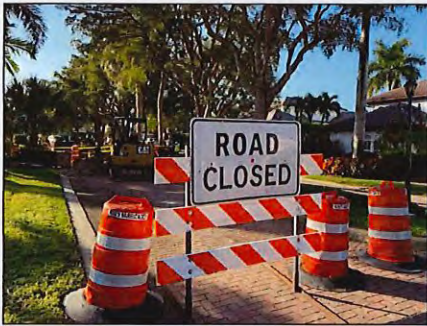
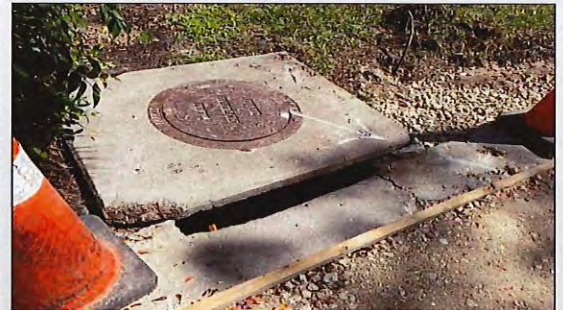
02/2020

Damaged 24' stormwater pipe

Bid award for repairs:
Quality Enterprises
